DESIGNATED SUBSTANCES & HAZARDOUS MATERIALS SURVEY

Butler's Barracks - Museum

SUBMITTED TO: Parks Canada

ISSUED: October 12, 2016

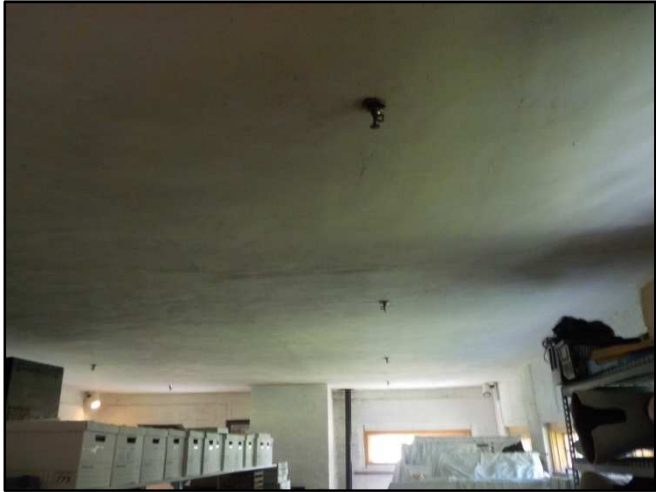
Sample Identification 00090.004-C01 00090.004-C02 00090.004-C03 Sample Code HC-01
	Sample Location of Material Second Floor
	Sample Description Plaster Ceiling
	Quantity of Material -
	Condition of Material -
Analytical Result: None Detected

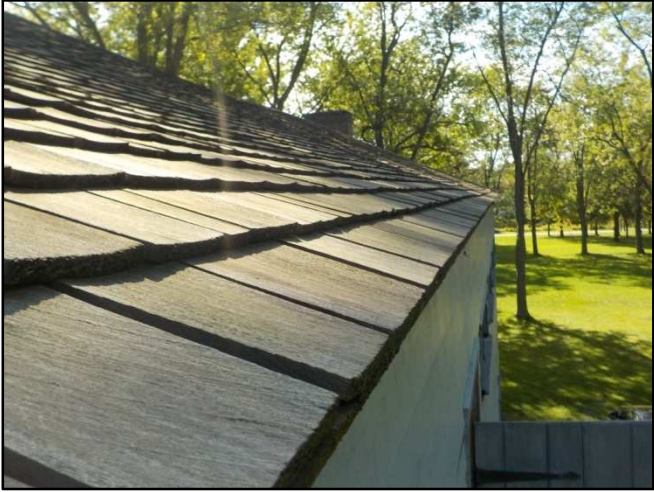
Sample Identification 00090.004-R01 00090.004-R02 00090.004-R03 Sample Code HR-01
	Sample Location of Material Exterior
	Sample Description Roofing paper under cedar shake roof
	Quantity of Material -
	Condition of Material -
Analytical Result: None Detected

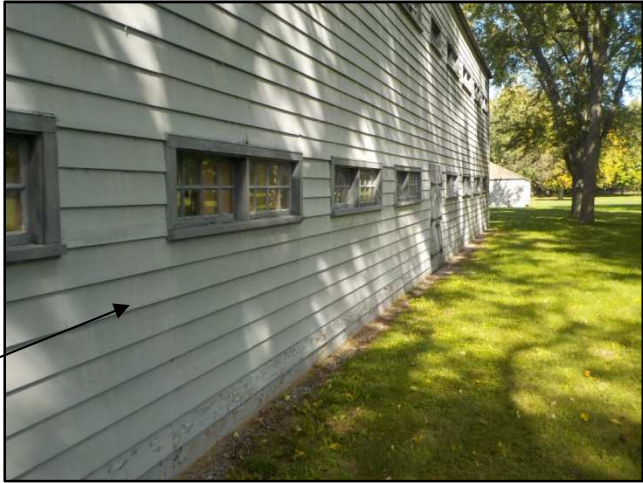
Sample Identification Light Grey Paint 00090.004-P01
	Arsenic Content <50 µg/g
	Mercury Content 4 µg/g
	Lead Content 397 µg/g
