DRAWINGS & SPECIFICATIONS

Parks Canada: Rehabilitation of Fire Suppression System at
Three Historic Sites
Fort Langley, BC

Project No. R.076121.001
March 2017

Appendix B Hazardous Building Materials Assessment

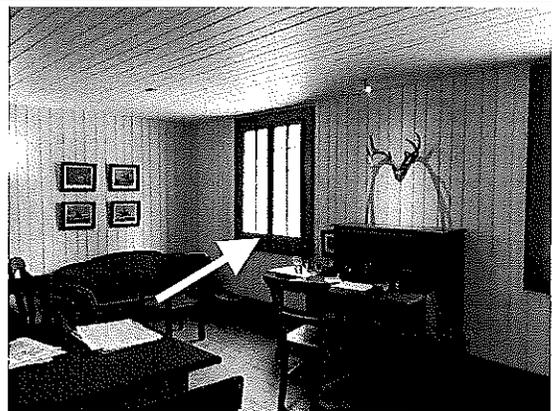
Identified LCP Description	Photo
Red colored paint on the interior trims. This paint was observed to be in good condition (not bubbling, flaking or peeling).

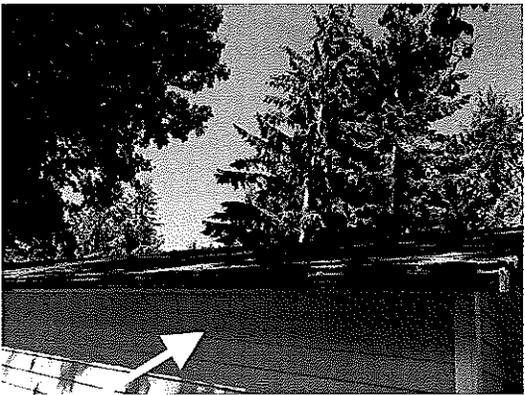
Identified LCP Description	Photo
Yellow colored paint on wood panels. This paint was observed to be in good condition (not bubbling, flaking or peeling).

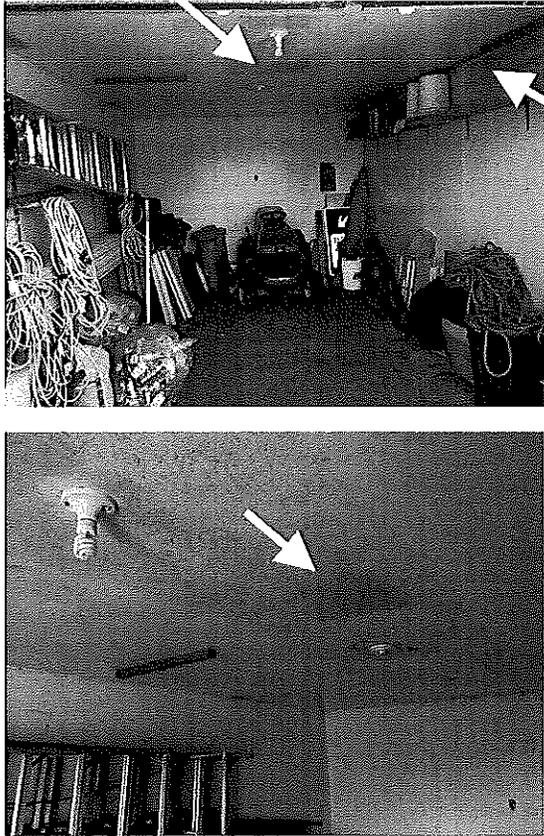
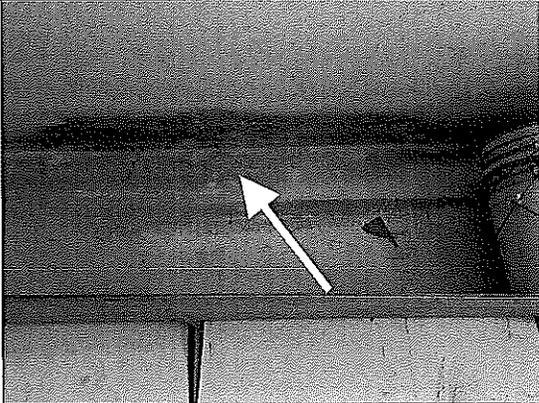
Identified Mould and/or Moisture Impacted Materials Description	Photo
<p>Moisture and mould impacted drywall materials were observed in various locations throughout the Garage - mainly in the ceiling and upper west wall. The suspected source of moisture is roof leaks or condensation.</p>

- Remove and dispose of mould-impacted drywall materials from the ceiling and upper west wall (approximately 75 square feet).
- Identified mould should be remediated in accordance with the Mould Guidelines for the Canadian Construction Industry (CAA 2004), by a competent person, who is knowledgeable of potential hazards of mould exposure, following remediation precautions.

An assessment to determine the likely source(s) of moisture intrusion should be undertaken. Issues leading to moisture impacts and/or mould growth should be identified and addressed prior to reinstating building materials to areas where mould abatement is conducted, to avoid the potential for re-wetting of new materials, and repeated mould growth.

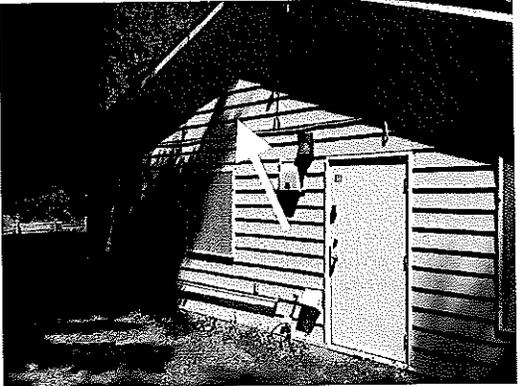
Identified LCP Description	Photo
<p>Yellow colored paint on the exterior siding. This paint was observed to be in good condition (not bubbling, flaking or peeling).</p>

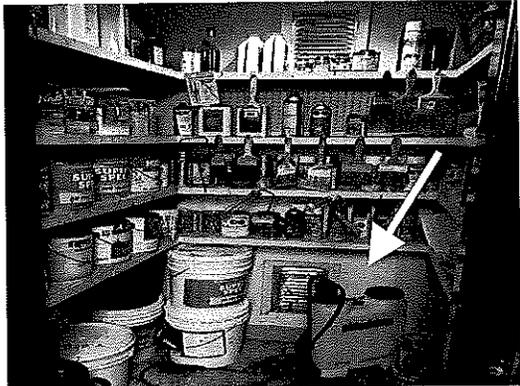
<p>Yellow colored paint on the interior walls of the storage rooms. This paint was observed to be in good condition (not bubbling, flaking or peeling).</p>

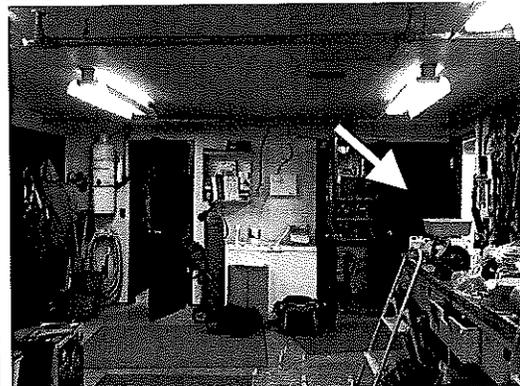
<p>Brown coloured paint on the interior trim. This paint was observed to be in good condition (not bubbling, flaking or peeling).</p>

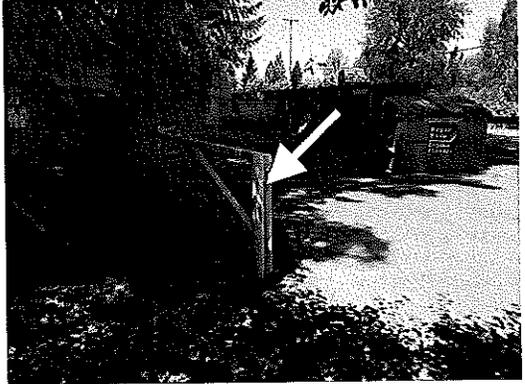
Identified LCP Description	Photo
<p>Yellow coloured paint on the exterior main gate. This paint was observed to be in good condition (not bubbling, flaking or peeling).</p>

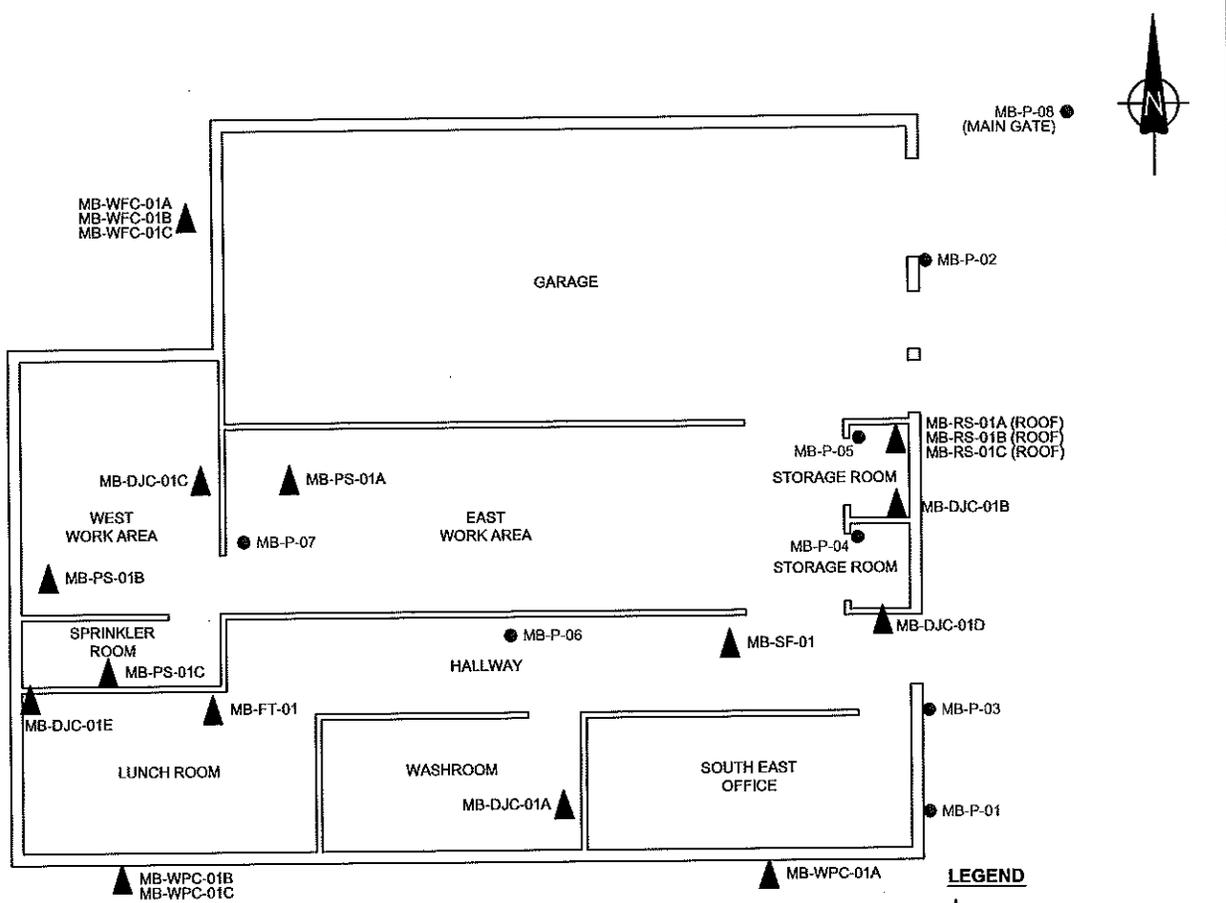
FLOOR PLAN SHOWING HAZARDOUS BUILDING MATERIALS AND BULK SAMPLE LOCATIONS
 FORT LANGLEY NATIONAL HISTORIC SITE OF CANADA, FORT LANGLEY
 23433 MAVIS AVENUE, FORT LANGLEY, BC

NOTES: 1. BLACK WINDOW PANE CAULKING THROUGHOUT IS ASBESTOS-CONTAINING.
 2. THIS DRAWING ILLUSTRATES SUPPORTING INFORMATION SPECIFIC TO A STANTEC CONSULTING LTD. REPORT AND MUST NOT BE USED FOR OTHER PURPOSES.

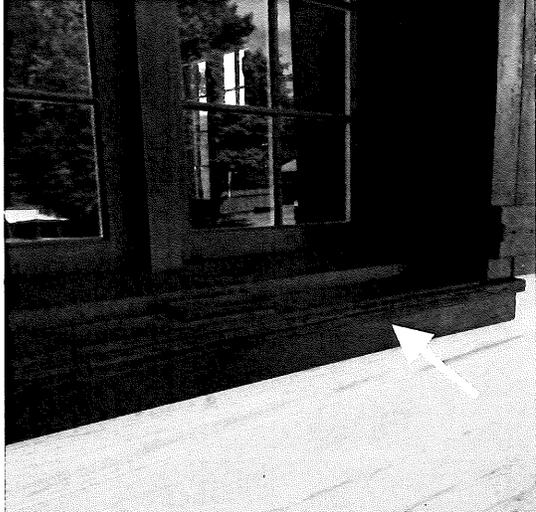
Identified LCP Description	Photo
<p>Brown colored paint on the exterior trim. This paint was observed to be in good condition (not bubbling, flaking or peeling).</p>

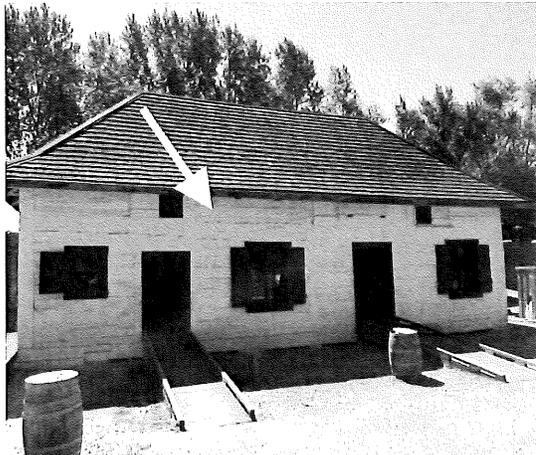
<p>White colored paint on the exterior. This paint was observed to be in good condition (not bubbling, flaking or peeling).</p>

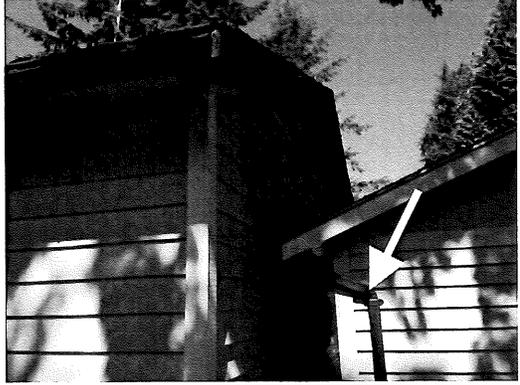
Identified LCP Description	Photo
Brown colored paint on the downspout. This paint was observed to be in good condition (not bubbling, flaking or peeling).
