**APPENDIX D**  
**GEO TECHNICAL INVESTIGATION REPORTS**

**MOUNT EDITH CAVELL ACCESS ROAD AND PARKING LOT  
GEOTECHNICAL INVESTIGATION**

**MOUNT EDITH CAVELL - ACCESS ROAD AND  
PARKING LOT RESTORATION**

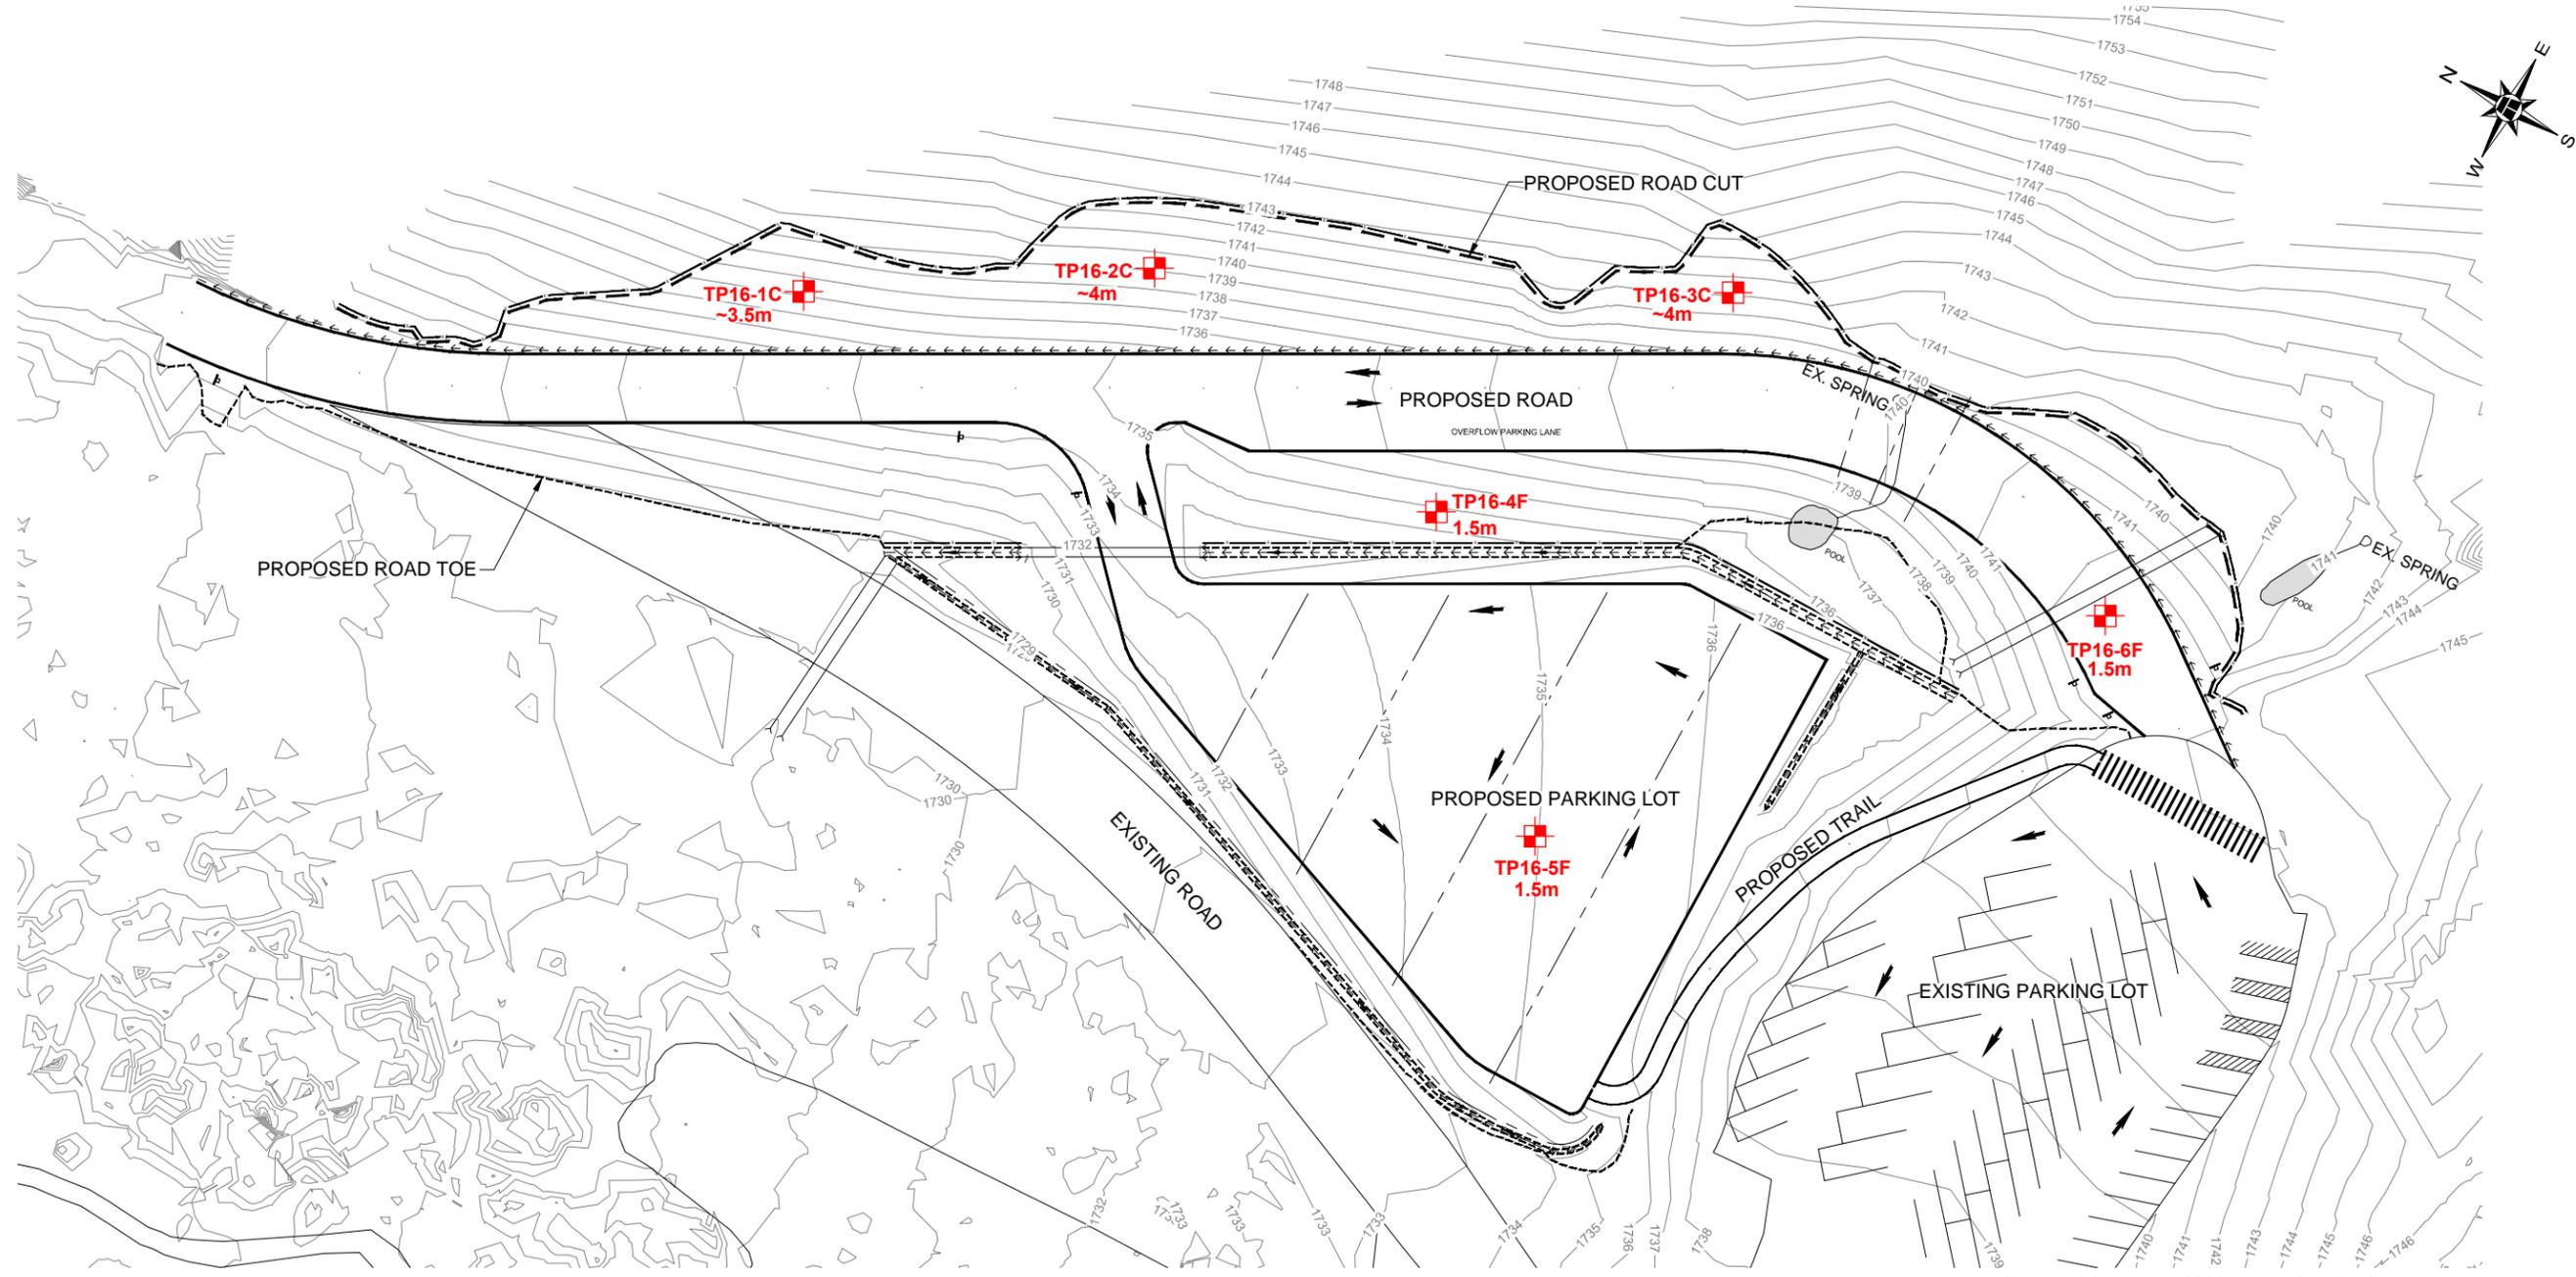
**DWG No. 17-123-970-1B**

A total of six test pits were completed within the footprints of the proposed road and parking lot, including: three test pits (TH16-1C, TH16-2C and TH16-3C) in cut sections to a maximum depth of 4 m below existing ground surface and three test pits (TH16-4F, TH16-5F and TH16-6F) in fill sections to a maximum depth 1.5 m. The test pits were advanced by Chevallier Geo-Con Ltd. using an excavator, as directed by Thurber. The test pit locations were selected by Thurber in coordination with AEAL. The ground coordinates of the test pits were determined on site by Mr. Arsenij Podolski, P.Eng, of AEAL using a hand held GPS navigator to an accuracy of  $\pm 3$  m. Drawing 19-123-970-1B in Appendix A shows the approximate test pit locations.

The test pits were generally dry, although minor seepage was noted in test pit TP16-6F at approximate depth of 0.7 m below existing ground surface. TP16-6F was located near a natural

watercourse at southern end of the site. In general, the moisture contents of samples recovered from test pits TP16-F through TP16-6F located on the flat plateau at the toe of the valley wall were higher than those of samples recovered from test pits TP16-1C through TP16-3C located further up the valley slope (refer to Drawing 19-123-970-1B for test pit locations).

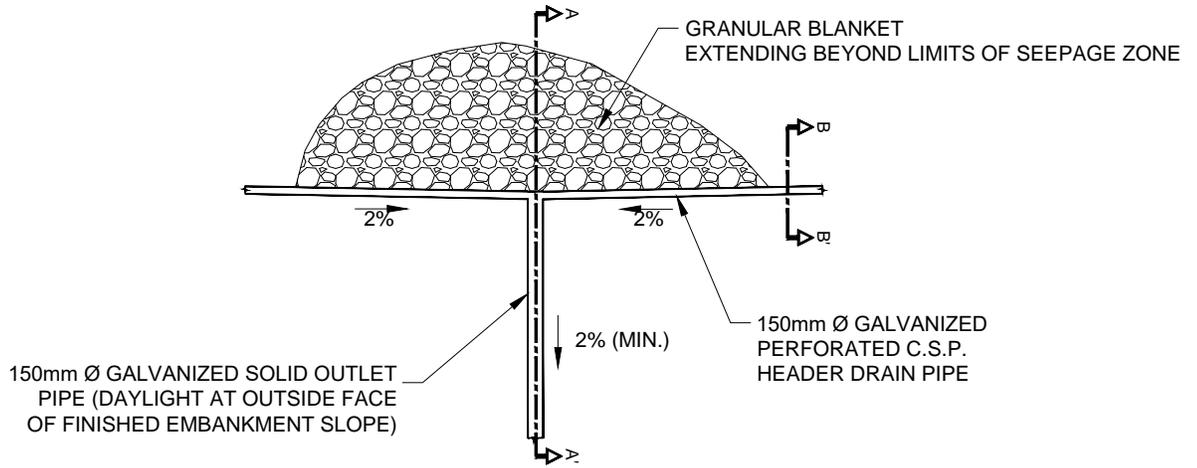
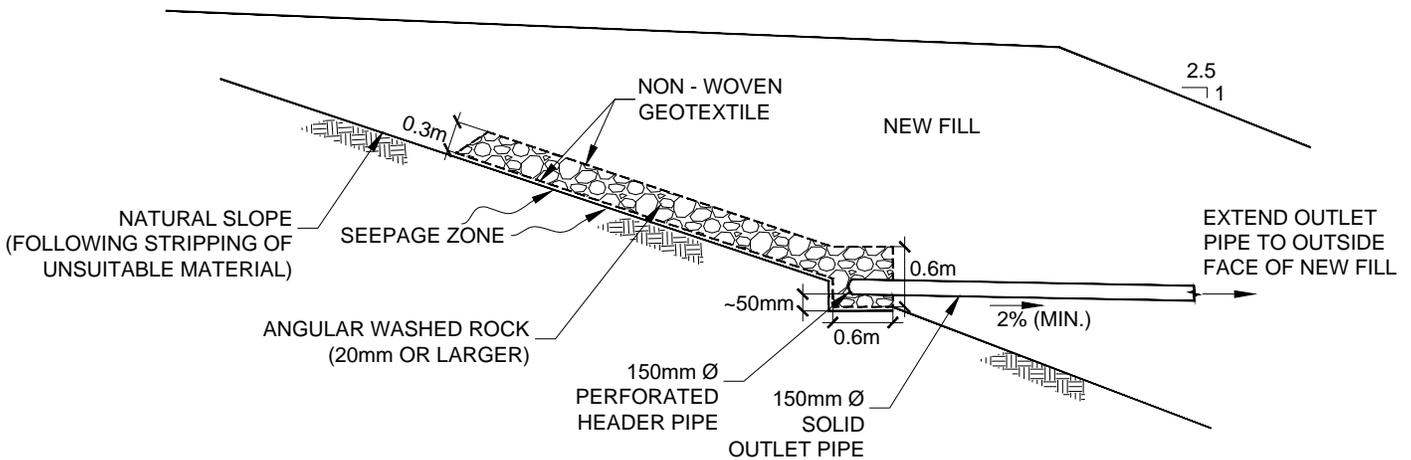
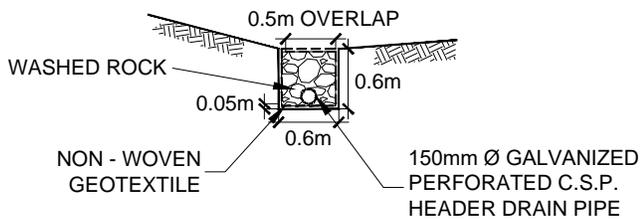
**FIGURE 1**

The results of the site investigation indicated that subsurface foundation soils comprise granular material. We also understand that the same material will be used for the construction of roadway and parking lot embankments. On that basis, it is expected that the proposed 2.5H:1V embankment side slopes should perform adequately. If seepage or natural springs are encountered in areas where embankment fill will be placed, drainage measures should be installed to minimize the risk of water pressure building up at the base of the fill. A typical detail of drainage measures in fill situations is presented in Figure 1 in Appendix A.

1. INVERT OF HEADER PIPE IS APPROXIMATELY 50mm ABOVE BASE OF WASHED ROCK.
2. HEADER PIPE SHALL BE SURROUNDED BY WASHED ROCK ENVELOPED IN GEOTEXTILE.
3. EROSION PROTECTION MEASURES MAY NEED TO BE INSTALLED AROUND THE DISCHARGE LOCATION OF OUTLET PIPE, DEPENDING ON AMOUNT OF SEEPAGE.
4. POSITIVE SURFACE DRAIN SHALL BE PROVIDED TO DRAIN WATER FROM THE OUTLET PIPE AWAY FROM THE NEW EMBANKMENT.

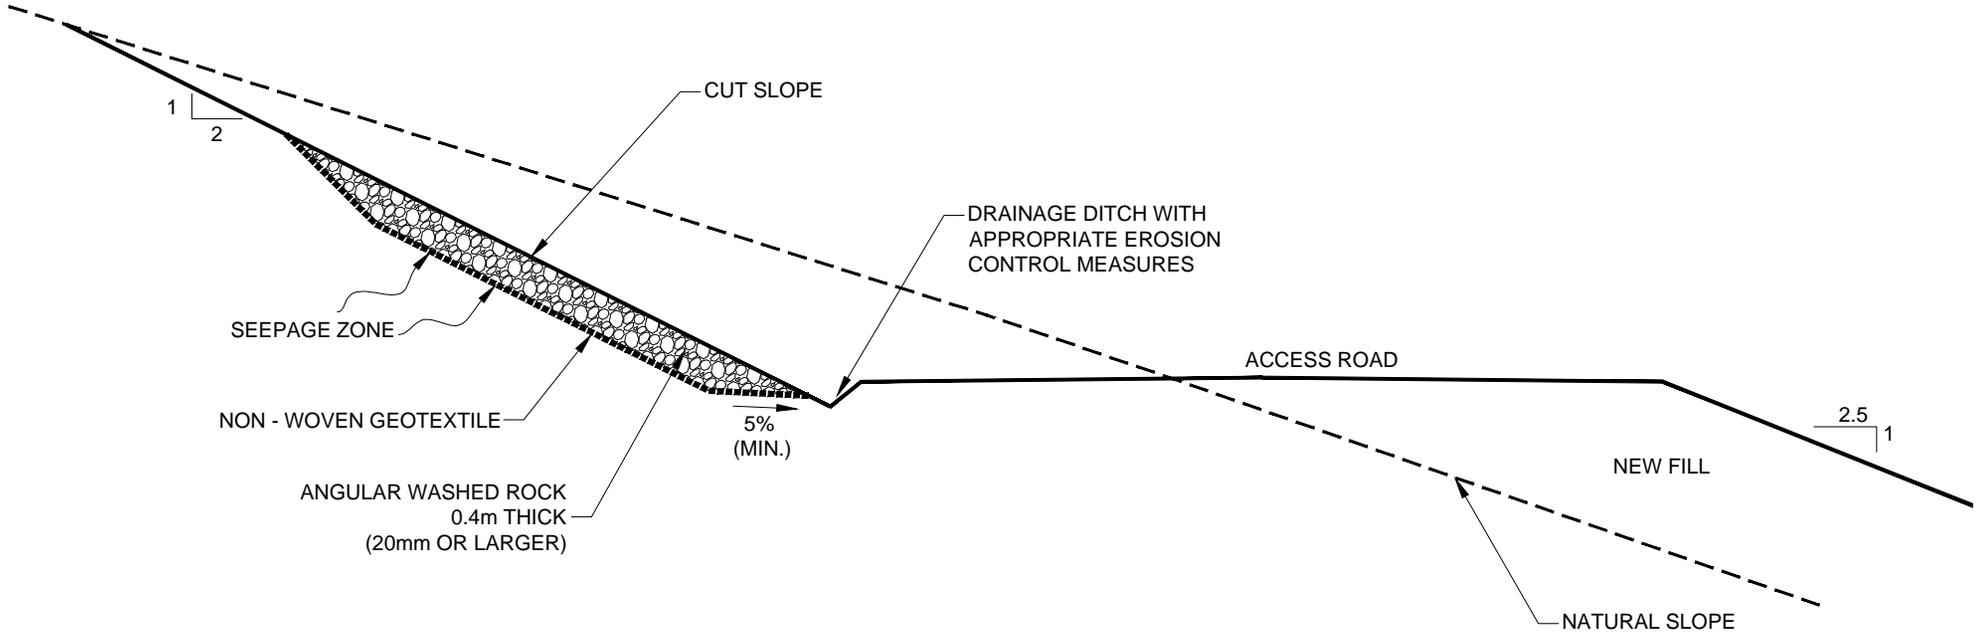
**FIGURE 2**

As discussed in Section 3, test pits TP16-1C through TP16-3C in cut areas were dry. As such, it is anticipated that the factor of safety of the 2H:1V cut slopes should be in the range of 1.3 to 1.4, which is deemed acceptable for the proposed low traffic road. As discussed in our January 2016 report, two natural springs were identified in the general area of the access road, albeit further to the south of the proposed cuts (refer to Drawing 17-123-970-1B). Should springs or seepage zones be present within the cut slopes, they could trigger localized slumping which if, left untreated, could lead to larger instabilities. Areas of seepage should be sub-excavated to a minimum depth of 0.4 m. A heavy non-woven geotextile should be placed on the exposed base and the subcut backfilled using 0.4 m of 20 mm (or larger) washed angular rock. The base of the subcut should be graded towards the drainage swale along the east edge of the road. Figure 2 in Appendix A shows a typical drainage detail for cut situations. In addition, surface features that can promote the collection and accumulation of runoff water on the slope face should be avoided to reduce the rate of surface infiltration.
