CCGS JOHN P TULLY

Project Details	
Our Reference	CCGS JOHN P TULLY/28-Oct-2014
Country	
Location	Vancouver Drydock Company
Survey Date	28-Oct-2014

Vessel Details	
Vessel Name	CCGS JOHN P TULLY
IMO Number	8320420
Vessel Type	
DWT	636
Classification Society	(None)
Built	Unknown Drydock Location
Approximate Age[Years]	30

Paint Inspection Summary

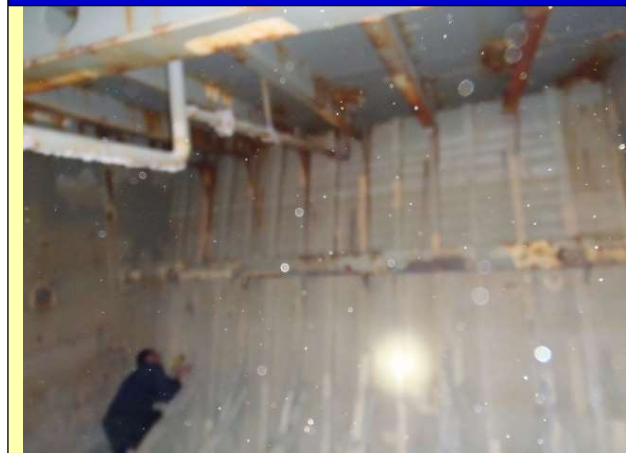
Poor picture quality - but general condition of the tank

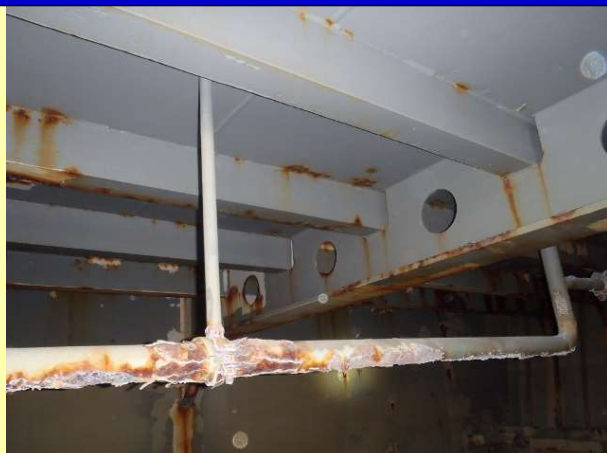
Typical breakdown along the edges and welds, brackets and pipes are also in poor repair

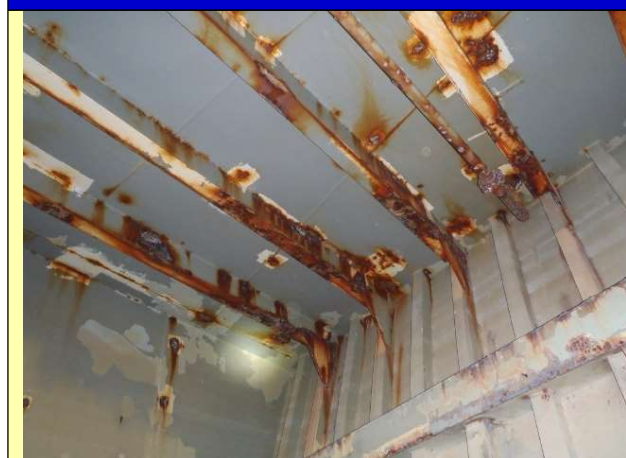
Typical breakdown along the edges and welds, brackets and pipes are also in poor repair. Flat areas are in average condition

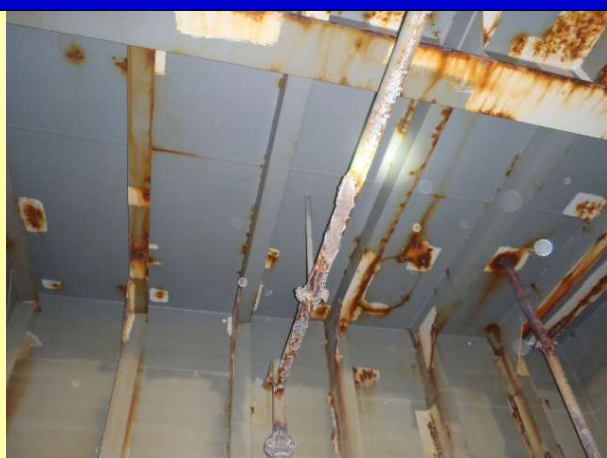
Typical breakdown along the edges and welds, brackets and pipes are also in poor repair. Flat areas are in average condition

#2 Port Ballast Tank		
Corrosion	Due To Mechanical Damage	0.3%
	Due To Low DFT	3% Localised
	Due To Detachment	1% Scattered
Pitting	Type	Active
	Extent	5% Localised
Cracking	Extent	0.1%
	Severity	Light
Blistering	Extent	None
	Size	
	Severity

Tank is in average condition. Typical breakdown on the edges, welds and previous repaired areas. Approx. 5% localized. Tank is heavily stained and did have sludge in the bottom of the tank and could not make an assessment of the condition in those locations.

Tank could be repaired or renewed depending on the condition at time of docking

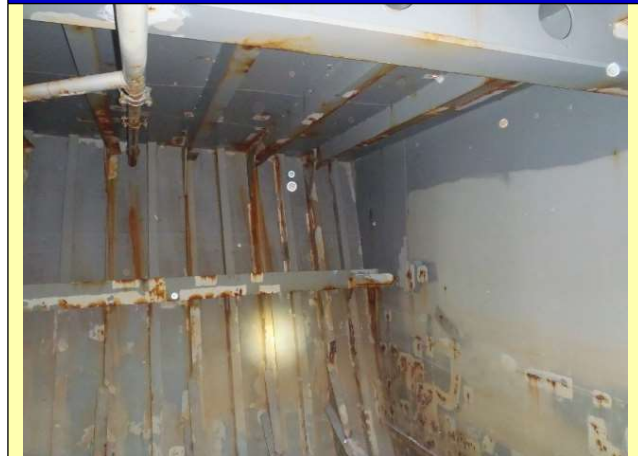
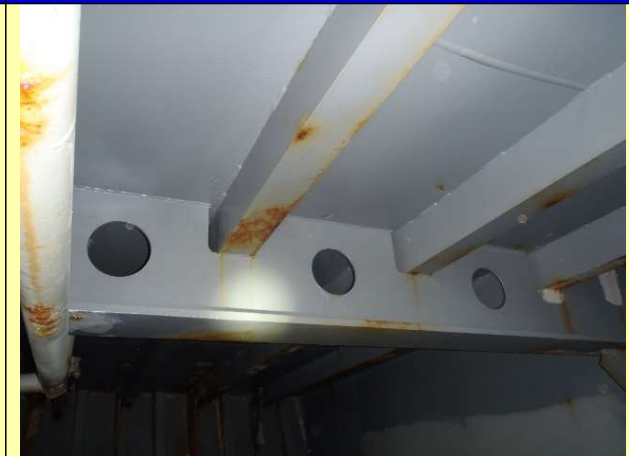
<p>Tank is in average condition. Typical breakdown on the edges, welds and previous repaired areas. Approx. 5% localized. Tank is heavily stained and did have sludge in the bottom of the tank and could not make an assessment of the condition in those locations.</p>	<p>Breakdown on the edges and staining, flats are in average condition</p>

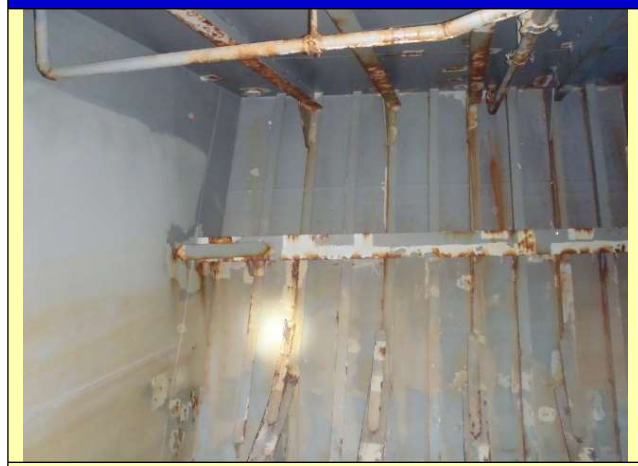
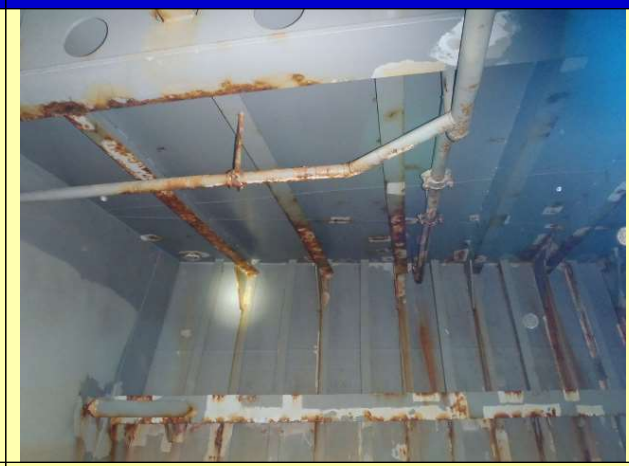
<p>Typical condition with breakdown on the edge and along the welds</p>	<p>Typical condition with breakdown on the edge and along the welds</p>

#2 Starboard Ballast Tank		
Corrosion	Due To Mechanical Damage	1% Scattered
	Due To Low DFT	3% Scattered
	Due To Detachment	1% Scattered
Pitting	Type	Active
	Extent	5% Localised
Cracking	Extent	None
	Severity	
Blistering	Extent	None
	Size	
	Severity	
Detachment	Extent	1% Scattered

Comments and Recommendations	
<p>Tank is in average condition. Typical breakdown on the edges, welds and previous repaired areas. Approx. 5% localized. Tank is heavily stained and did have sludge in the bottom of the tank and could not make an assessment of the condition in those locations.</p>	
<p>Tank could be repaired or renewed depending on the condition at time of docking</p>

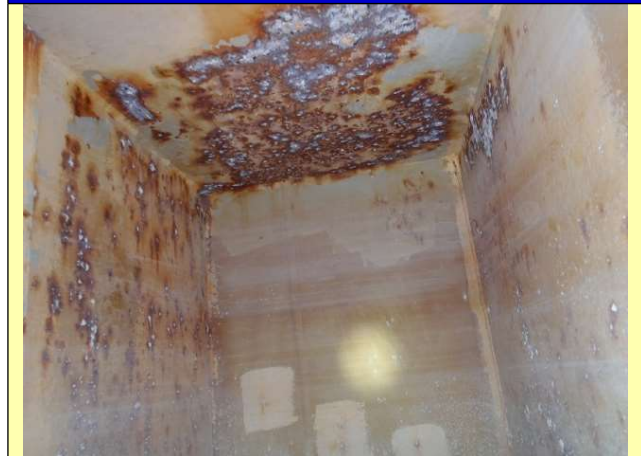
<p>Heavy corrosion and staining typical throughout the tank</p>	<p>Heavy corrosion and staining typical throughout the tank</p>

Corrosion	Due To Mechanical Damage	15% Scattered
	Due To Low DFT	33%
	Due To Detachment	5% Scattered
Pitting	Type	Active
	Extent	33%
Cracking	Extent	None
	Severity	
Blistering	Extent	None
	Size	
	Severity

Detachment	Extent	5% Scattered
Comments and Recommendations		
Tank is in poor condition and needs to be renewed

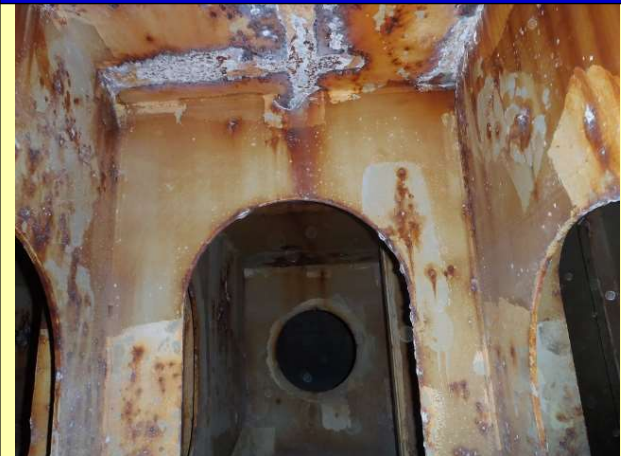
General poor condition	General poor condition

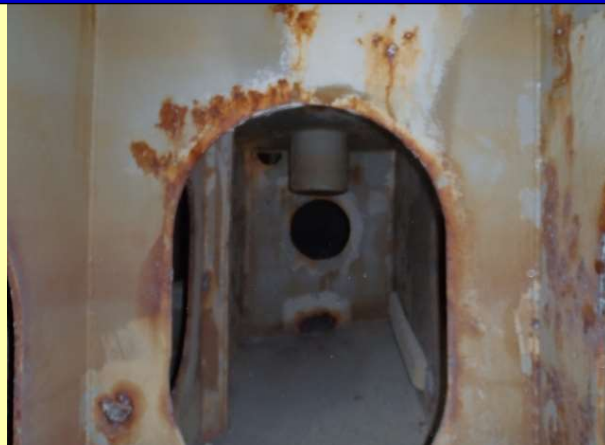
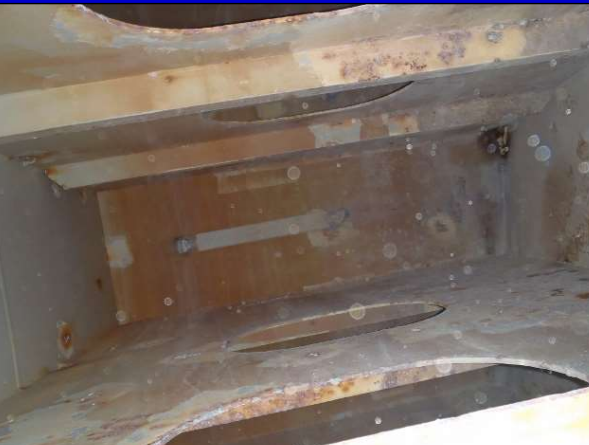
General condition of the tank	Scattered breakdown and breakdown on the edges and repaired areas

#7 Starboard Ballast Tank		
Corrosion	Due To Mechanical Damage	
	Due To Low DFT	
	Due To Detachment	
Pitting	Type	
	Extent	
Cracking	Extent	
	Severity	
Blistering	Extent	
	Size	
	Severity	
Detachment	Extent	
Comments and Recommendations		
Tank is in poor condition and needs to be renewed

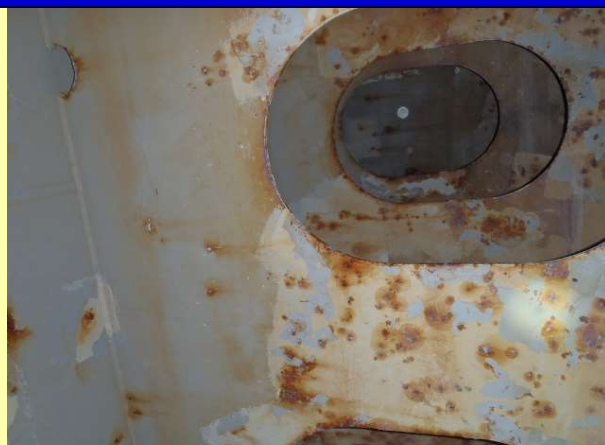
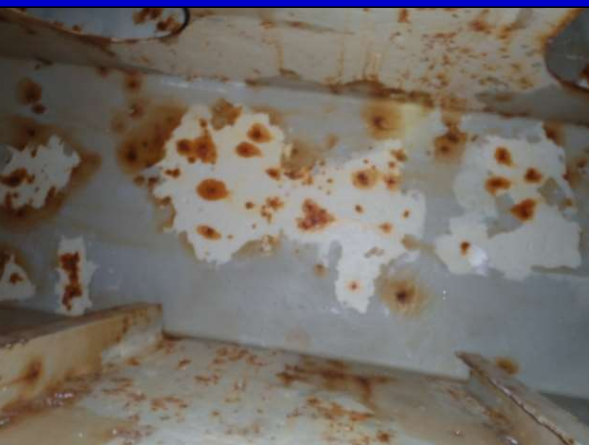
General poor condition	General poor condition

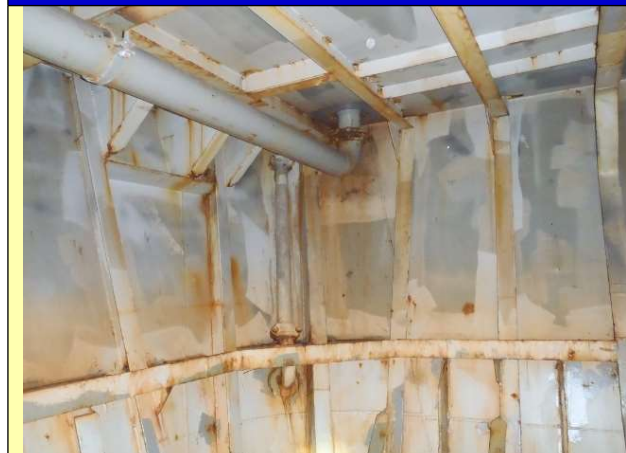
Typical breakdown along the edges and welds, brackets and pipes are also in poor repair. Flat areas are in average condition

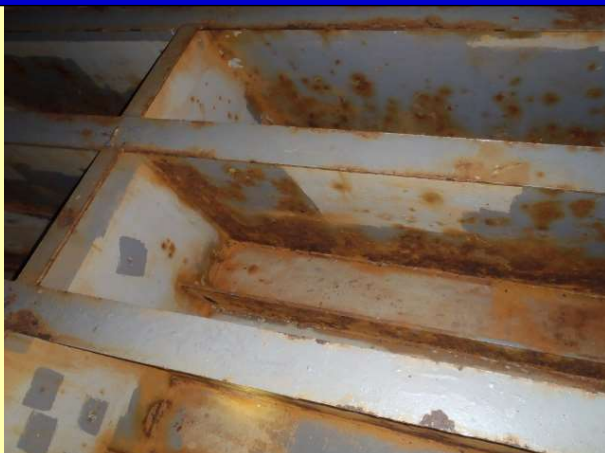
Bilge areas are in poor condition

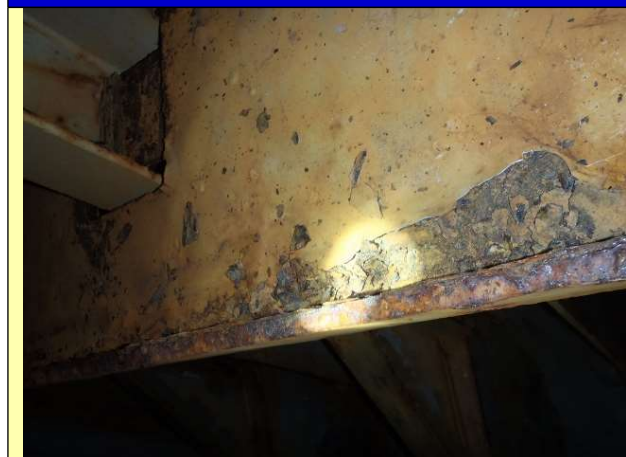
Close up of typical breakdown and steel loss

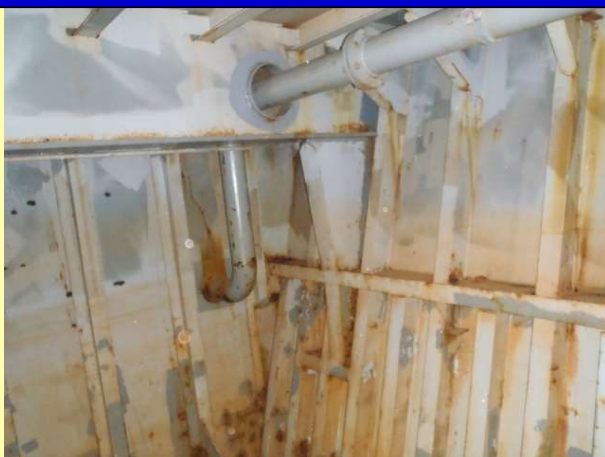
General condition with breakdown on the edges and welds resulting in staining

#10 Port Ballast Tank		
Corrosion	Due To Mechanical Damage	1% Scattered
	Due To Low DFT	10% Localised
	Due To Detachment	0.3%
Pitting	Type	Active
	Extent	10% Localised
Cracking	Extent	None
	Severity	
Blistering	Extent	None
	Size	
	Severity

Tank is in average condition. Typical breakdown on the edges, welds and previous repaired areas. Approx. 10% localized. Tank is heavily stained and did have sludge in the bottom of the tank and could not make an assessment of the condition in those locations.

Tank could be repaired or renewed depending on the condition at time of docking

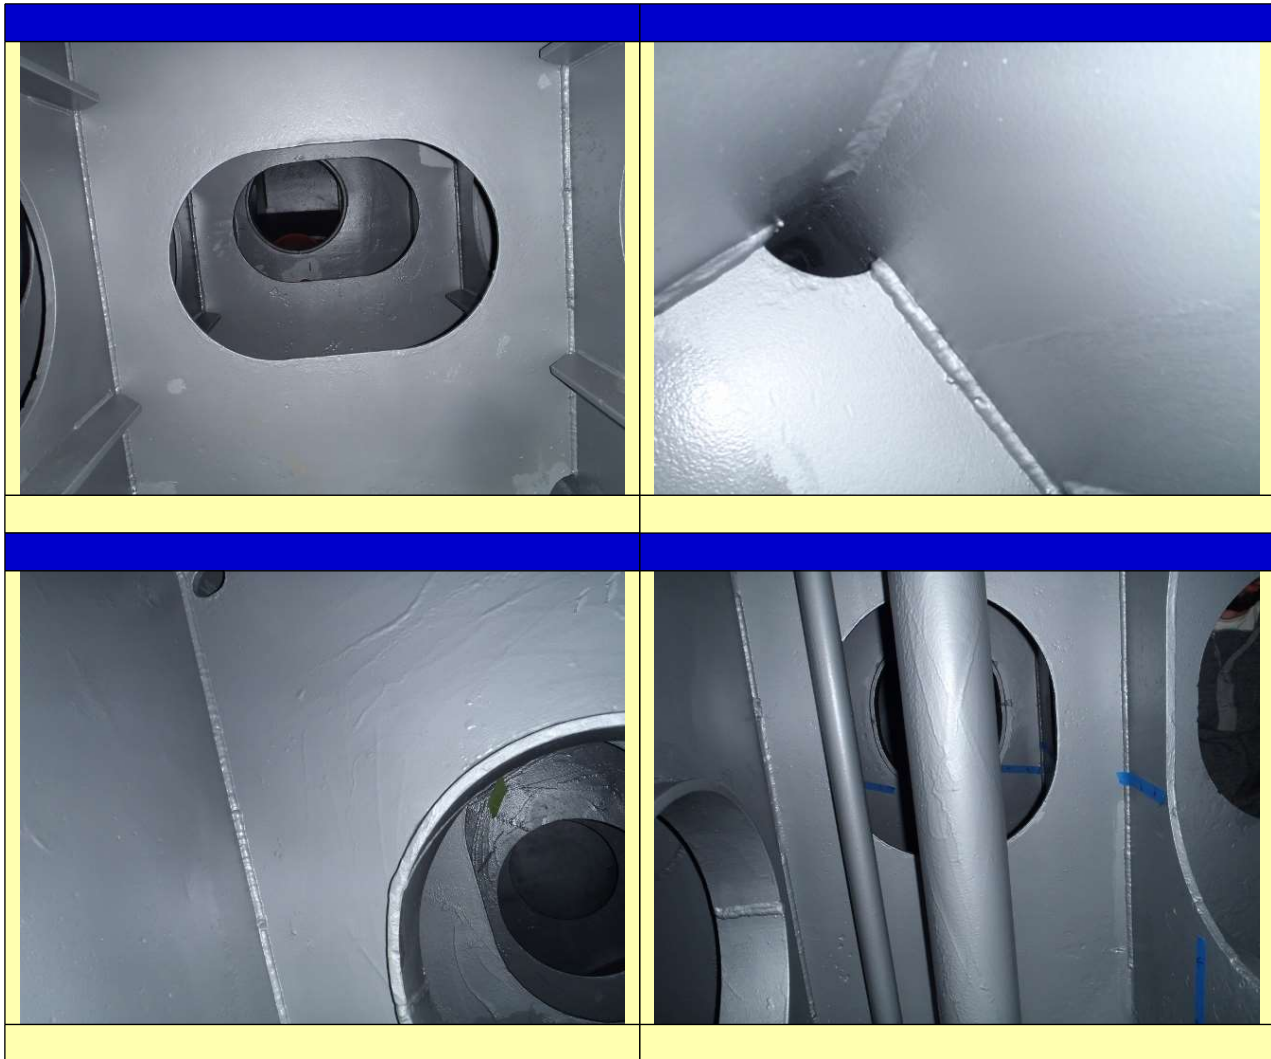
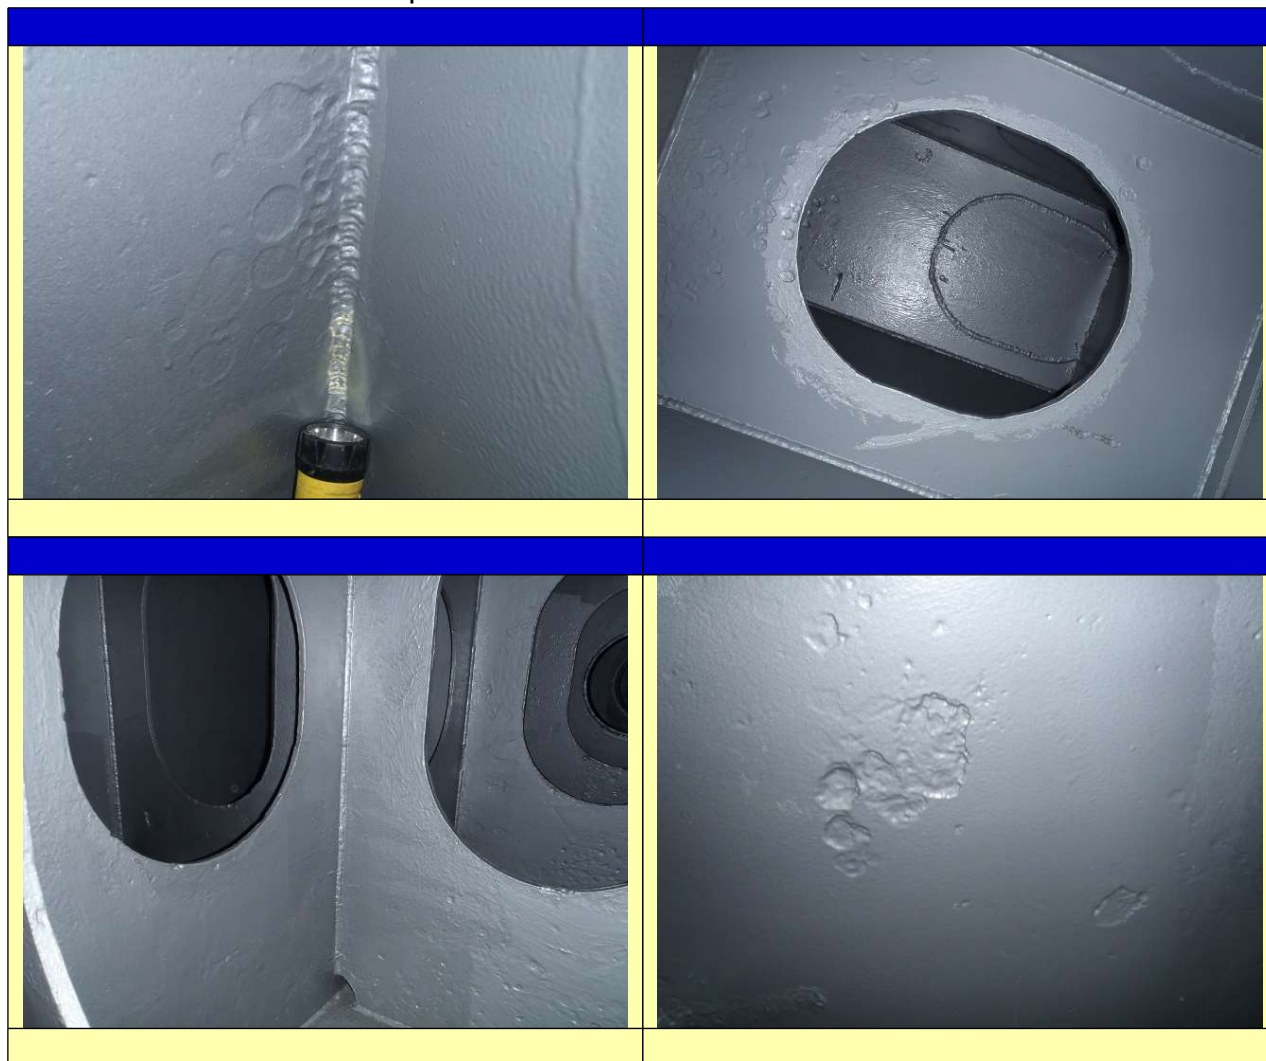
Paint Inspection Details - #6 Centre Ballast Tank

Corrosion	Due To Mechanical Damage	None
	Due To Low DFT	None
	Due To Detachment	None
Pitting	Type	Passive
	Extent	None
Cracking	Extent	None

Severity	
Blistering	Extent	None
	Size	
	Severity	
Detachment	Extent	None
Comments and Recommendations		
Renewed with Intershield 300HS
