# HAZARDOUS BUILDING MATERIALS ASSESSMENT

WABUSH AIRPORT  
WABUSH, NL

**MARCH 2012**  
**REF. NO. 076653 (3)**

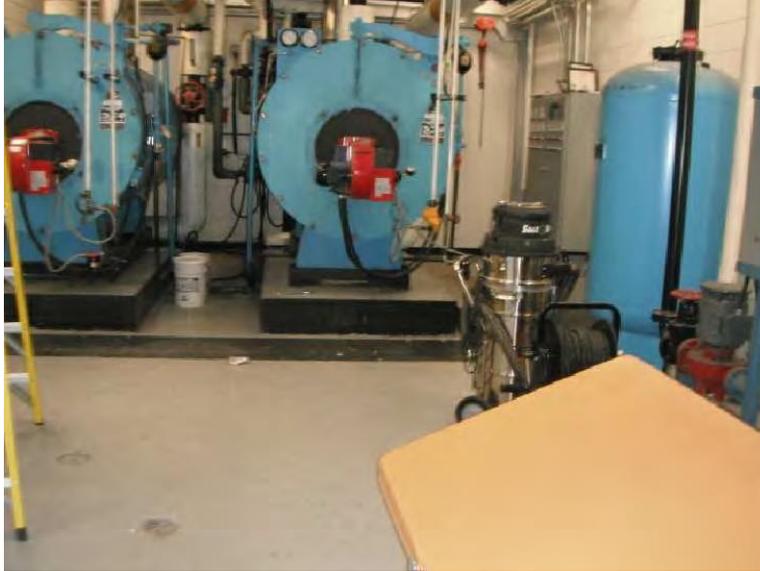
*Mechanical Room in Air Terminal Building – the Pipe Insulation contains Asbestos*

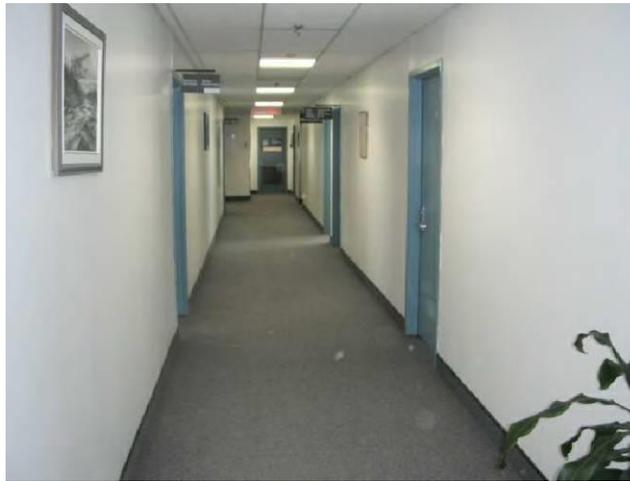
*Hallway on second floor of ATB – drywall plaster may contain asbestos.*

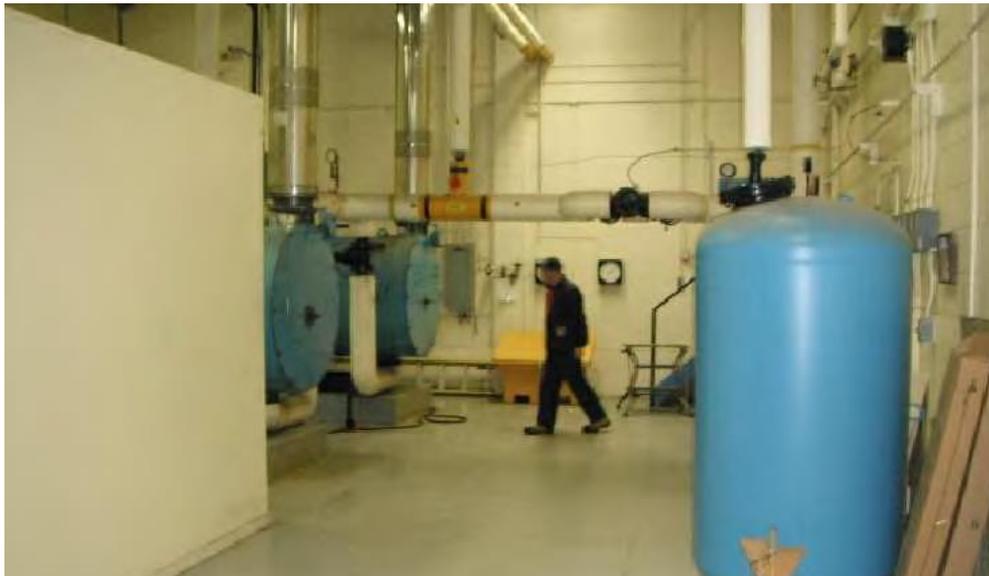
*Mechanical Room in Combined Services Building – the Pipe Insulation contains Asbestos*

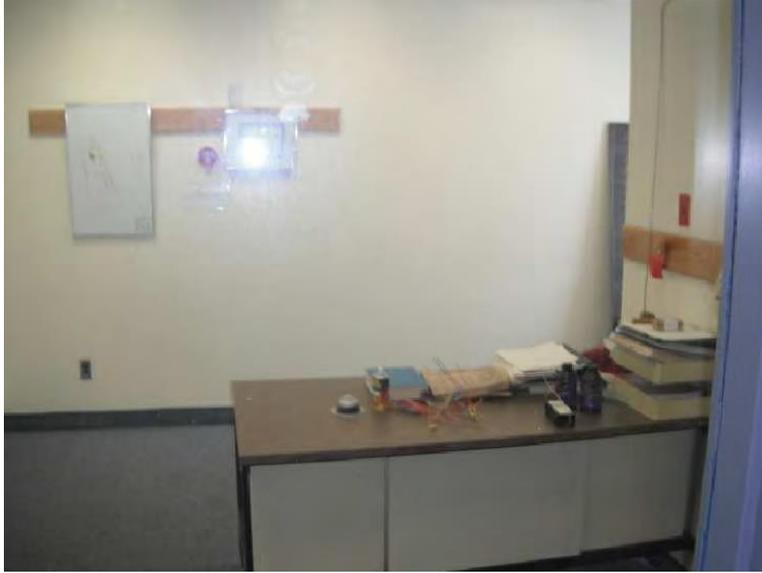
*Office space in Combined Services Building – Floor Tiles contain Asbestos*

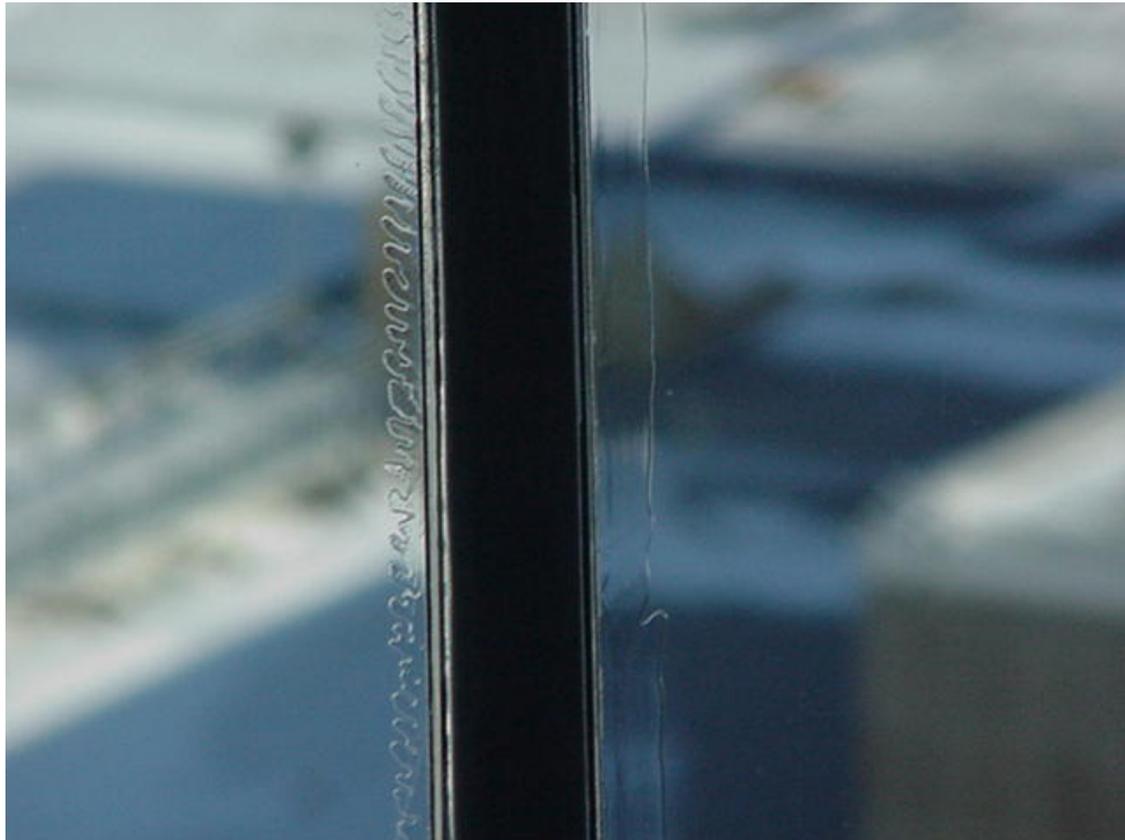
**Photo 1**

Minor defects in areas of the glazings that do not affect the controllers'/specialists' lines-of-sight may be considered acceptable. Replacement is the only way to correct deficiencies as polishing to remove scratches is not usually recommended since it may result in distortions in the glass.
