West Memorial Building Heritage Materials Testing Results for Wood Panelling Dismantle

335 Wellington Street, Ottawa, Ontario

Major Crown Projects – Public Services and Procurement Canada
(West Memorial Building: Asset Integrity Project (R.073422.427))

INVESTIGATION 5: Wall Wood Panelling Dismantle Test

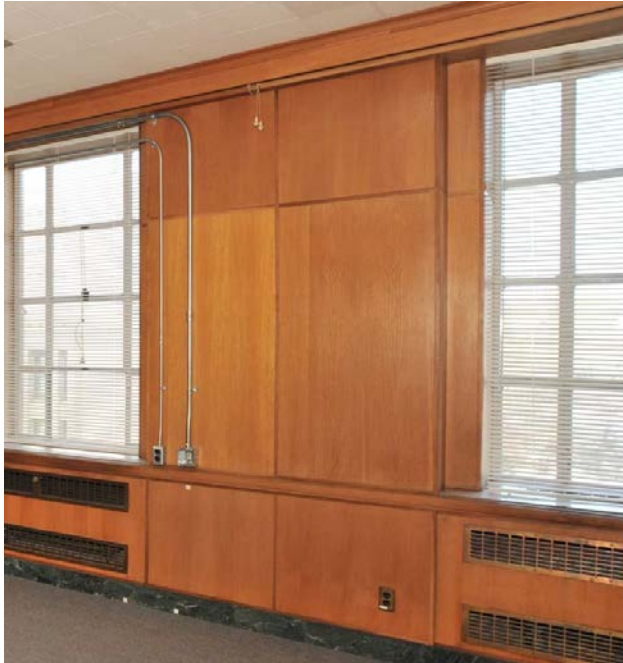
Figure 33: Full wall height wood panelling on interior face of the exterior wall with windows. (Photo: Heritage Conservation Directorate, 2016)

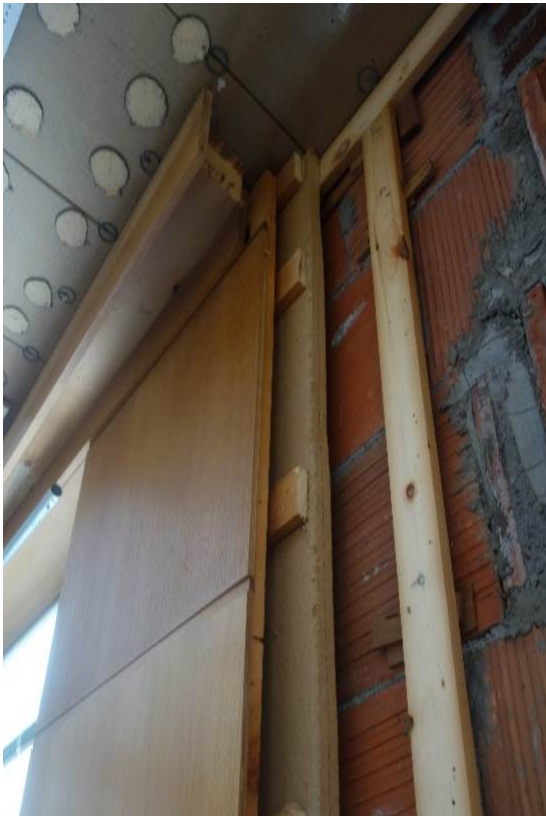
Figure 34: Cross-section of wall and window blind pocket assembly (wood cornice removed) (Photo: Heritage Conservation Directorate, 2016).

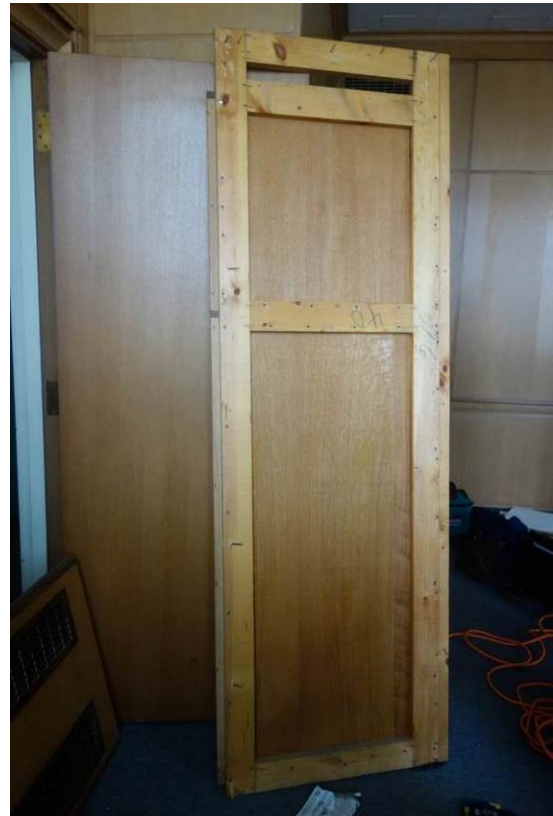
Figure 35: Rear of upper panel (removed) showing backing frame.

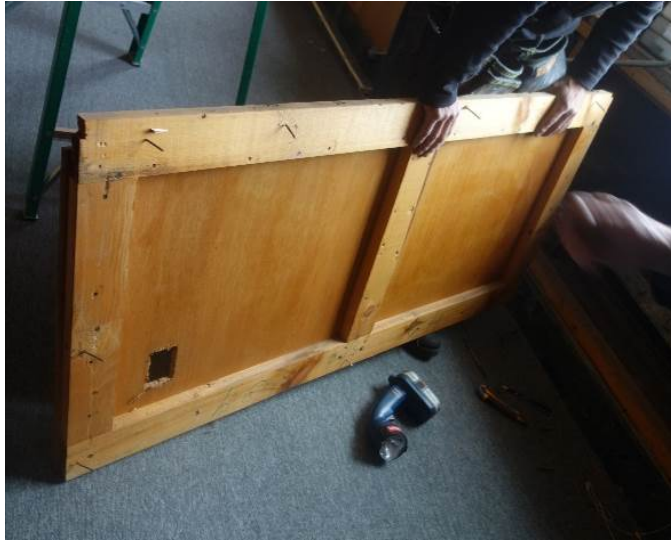
Figure 36: Rear of lower panel (removed) showing backing frame.

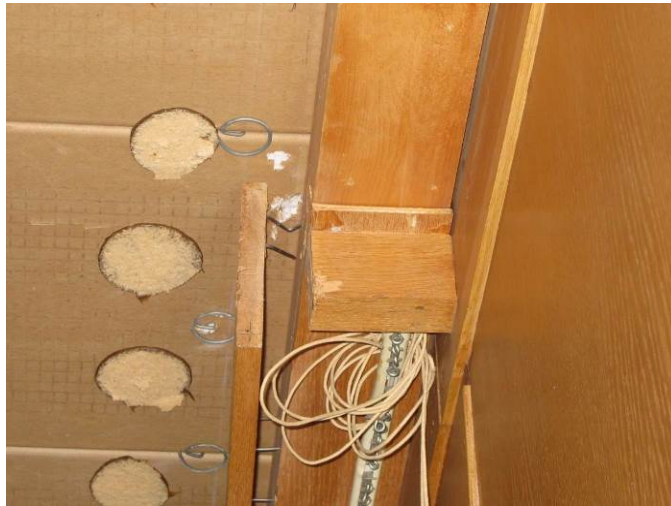
Figure 37: Cross section of window blind pocket assembly.
Note: cornice removed and front face partially pried away.
(photo: Heritage Conservation Directorate, 2016)

3. On exterior walls with windows, the window blind pocket should be disassembled following removal of the wood cornice. All existing blind hardware is removed first. The solid wood front fascia is carefully pried off. Blocks installed at joints are pried off next. The blind pocket upper plate is then pried off, followed by the continuous blocking.

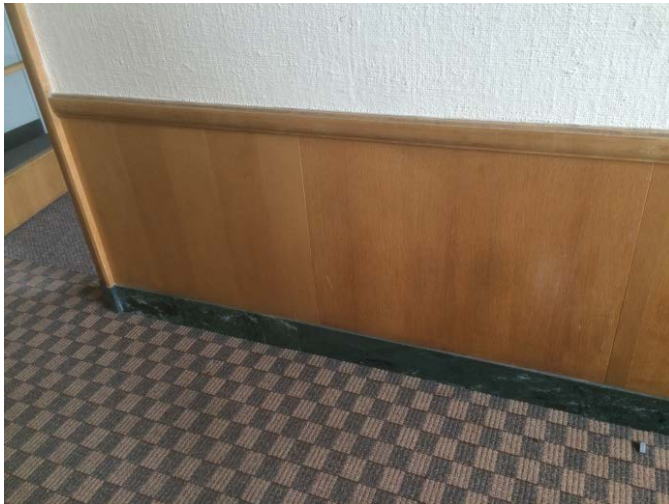
Figure 38: Example of wood wainscoting and chair rail (Room 5014).

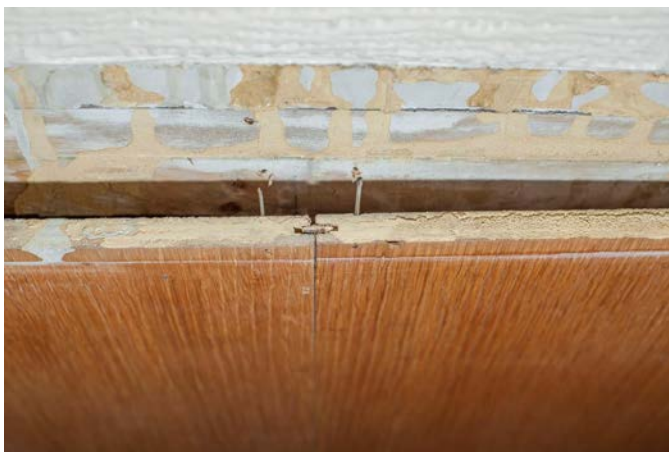
Figure 39: Splined edge joint of panels and attachment to wall by face-nailing (chair rail removed).
