MACHIAS SEAL ISLAND
LIGHTHOUSE
RESTORATION

DETAIL PHOTOS

R.080316.001

A301

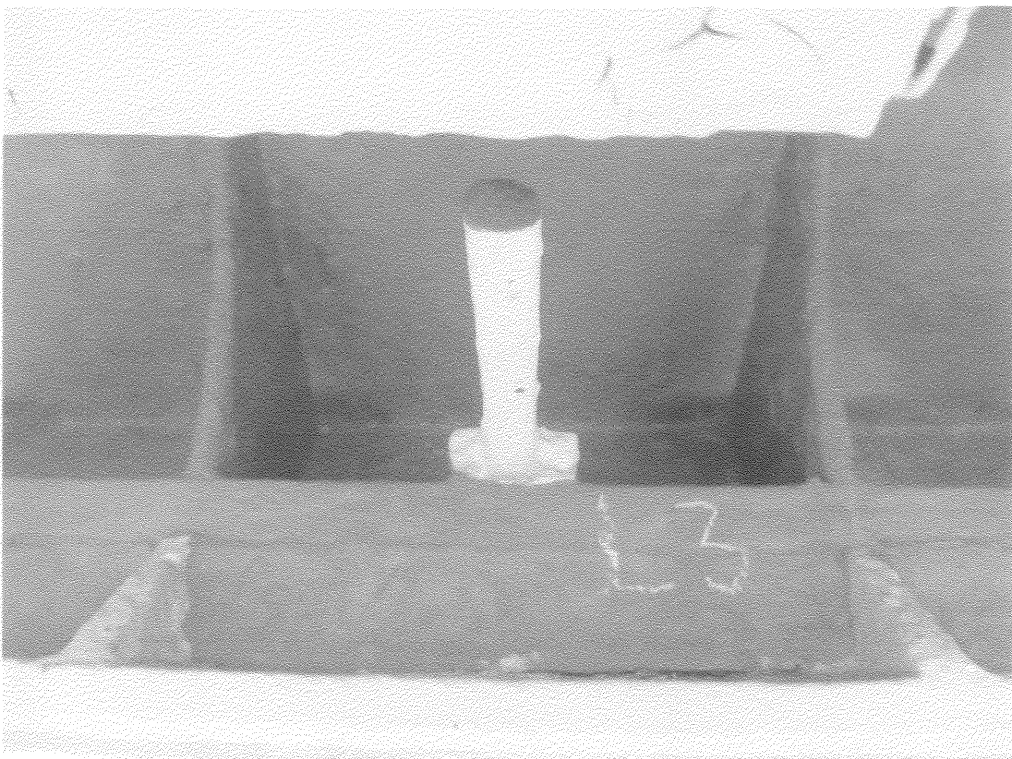
PHOTO 12 - DETAIL VIEW OF INTERIOR LANTERN TIE BAR TO BE REPLACED TO MATCH ORIGINAL. REFER TO STRUCTURAL.

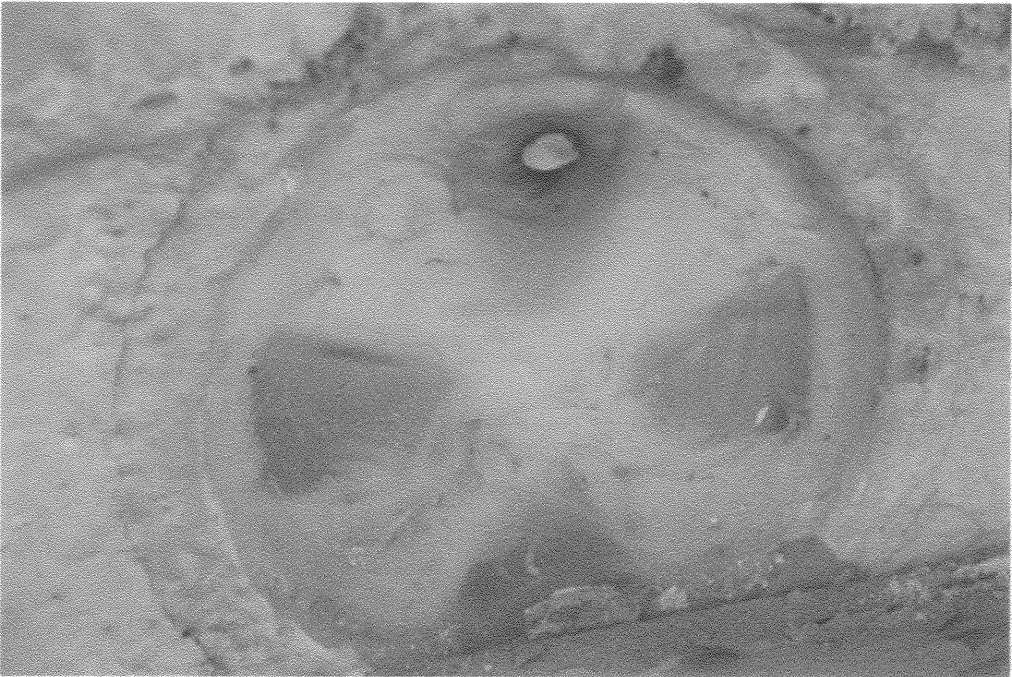
PHOTO 15 - DETAIL OF EXISTING LANTERN VENT WITH FAILED RUBBER SEAL, INTERIOR. REMOVE SEAL, PAINT AND CORROSION. PROVIDE REPLACEMENT CAP WITH GASKET AND INSTALL IN "CLOSED" POSITION. MAKE-GOOD ANY DAMAGE TO CONCRETE SUSTAINED DURING REMOVAL.

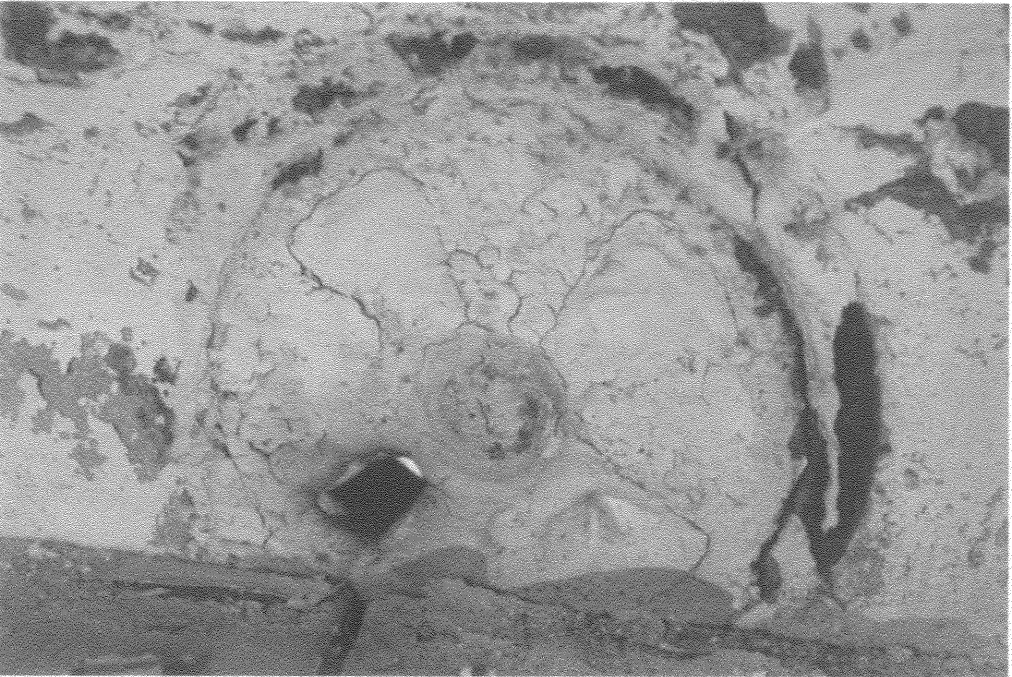
PHOTO 14 - DETAIL OF EXISTING LANTERN VENT, INTERIOR. REMOVE CAP AND REMOVE PAINT AND CORROSION. PROVIDE GASKET FOR SEAL AND REINSTATE CAP IN "CLOSED" POSITION. MAKE-GOOD ANY DAMAGE TO CONCRETE SUSTAINED DURING REMOVAL OF CAP.

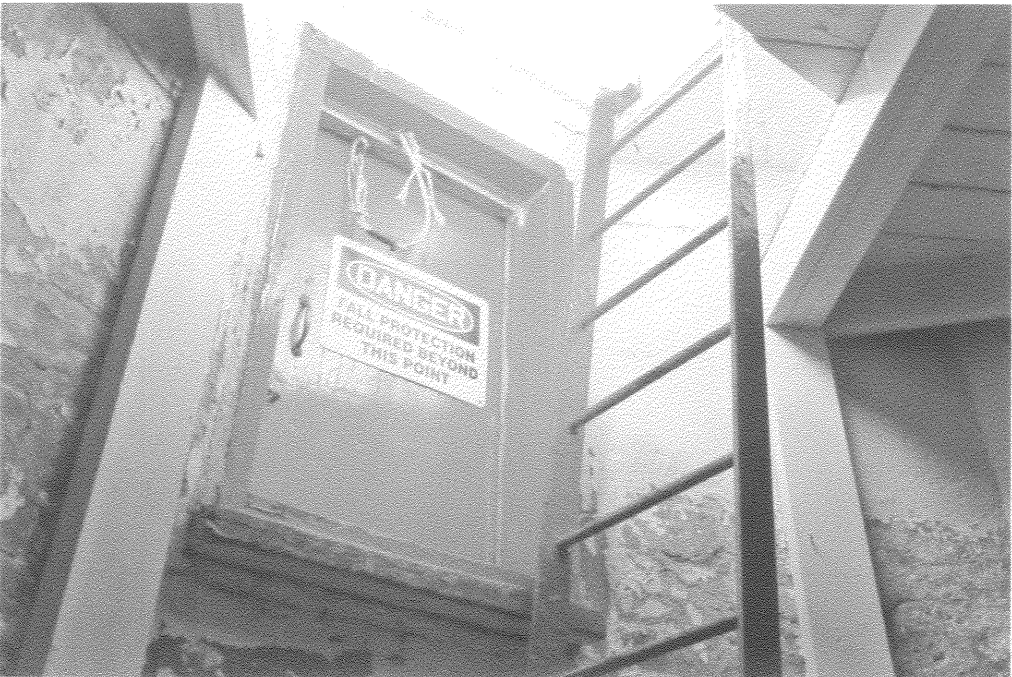
PHOTO 16 - INTERIOR OF GALLERY HATCH. SILL AND HEAD CASING ARE ORIGINAL AND ARE TO BE RETAINED. JAMBS AND DOOR TO BE REPLACED. REFER TO DETAIL 3/A500

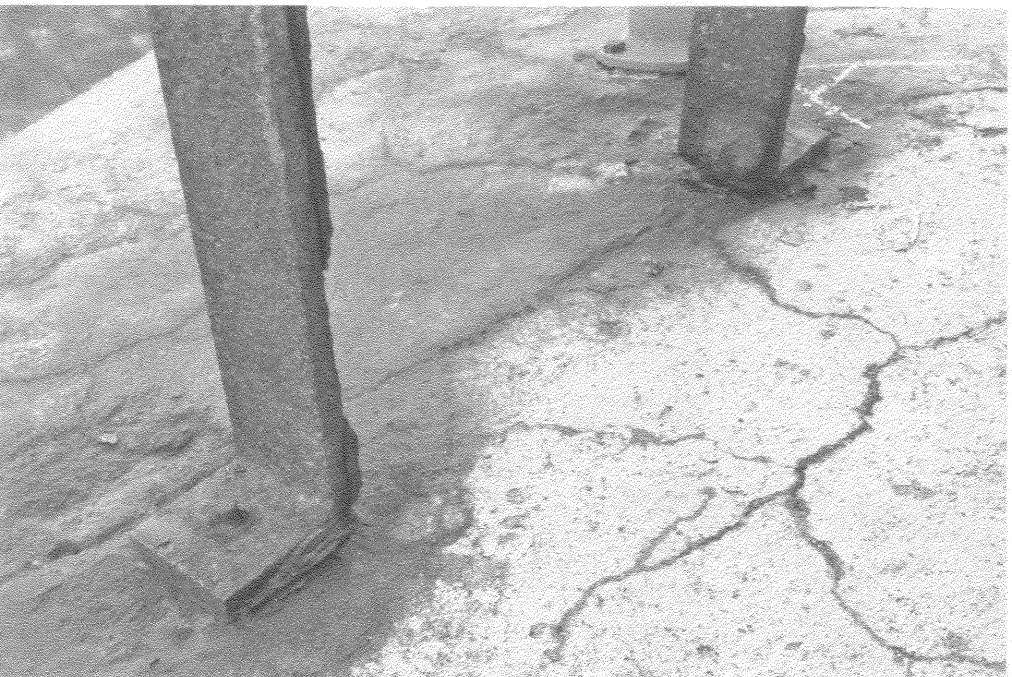
PHOTO 13 - EXTERIOR GALLERY LADDER. PROVIDE NEW METAL BOLTED CONNECTIONS. REFER TO DETAIL 2/A501.
