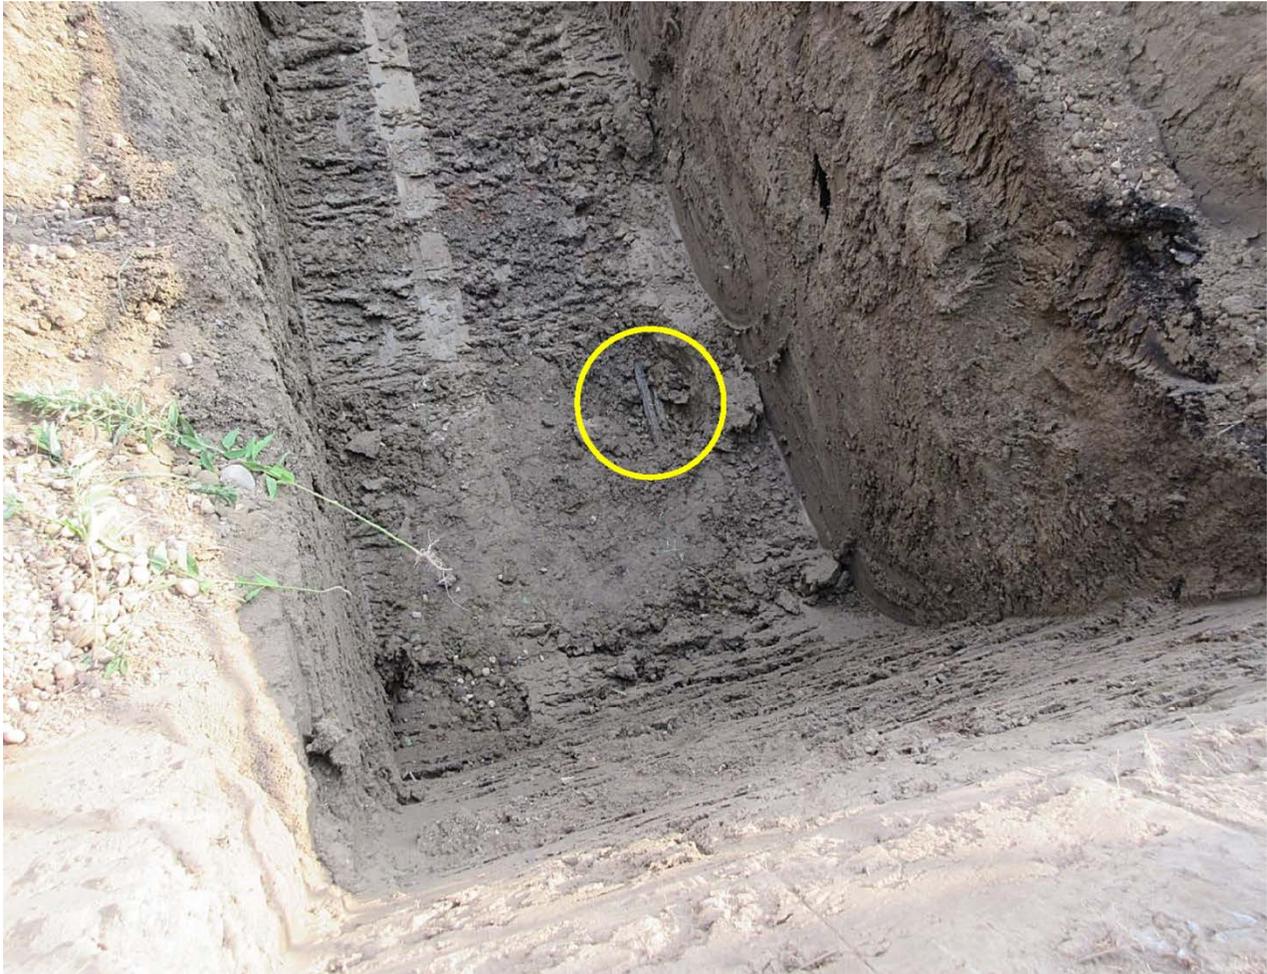
Figure 1: Exposed horizontal waterline. The water line is approximately 8 feet below grade.

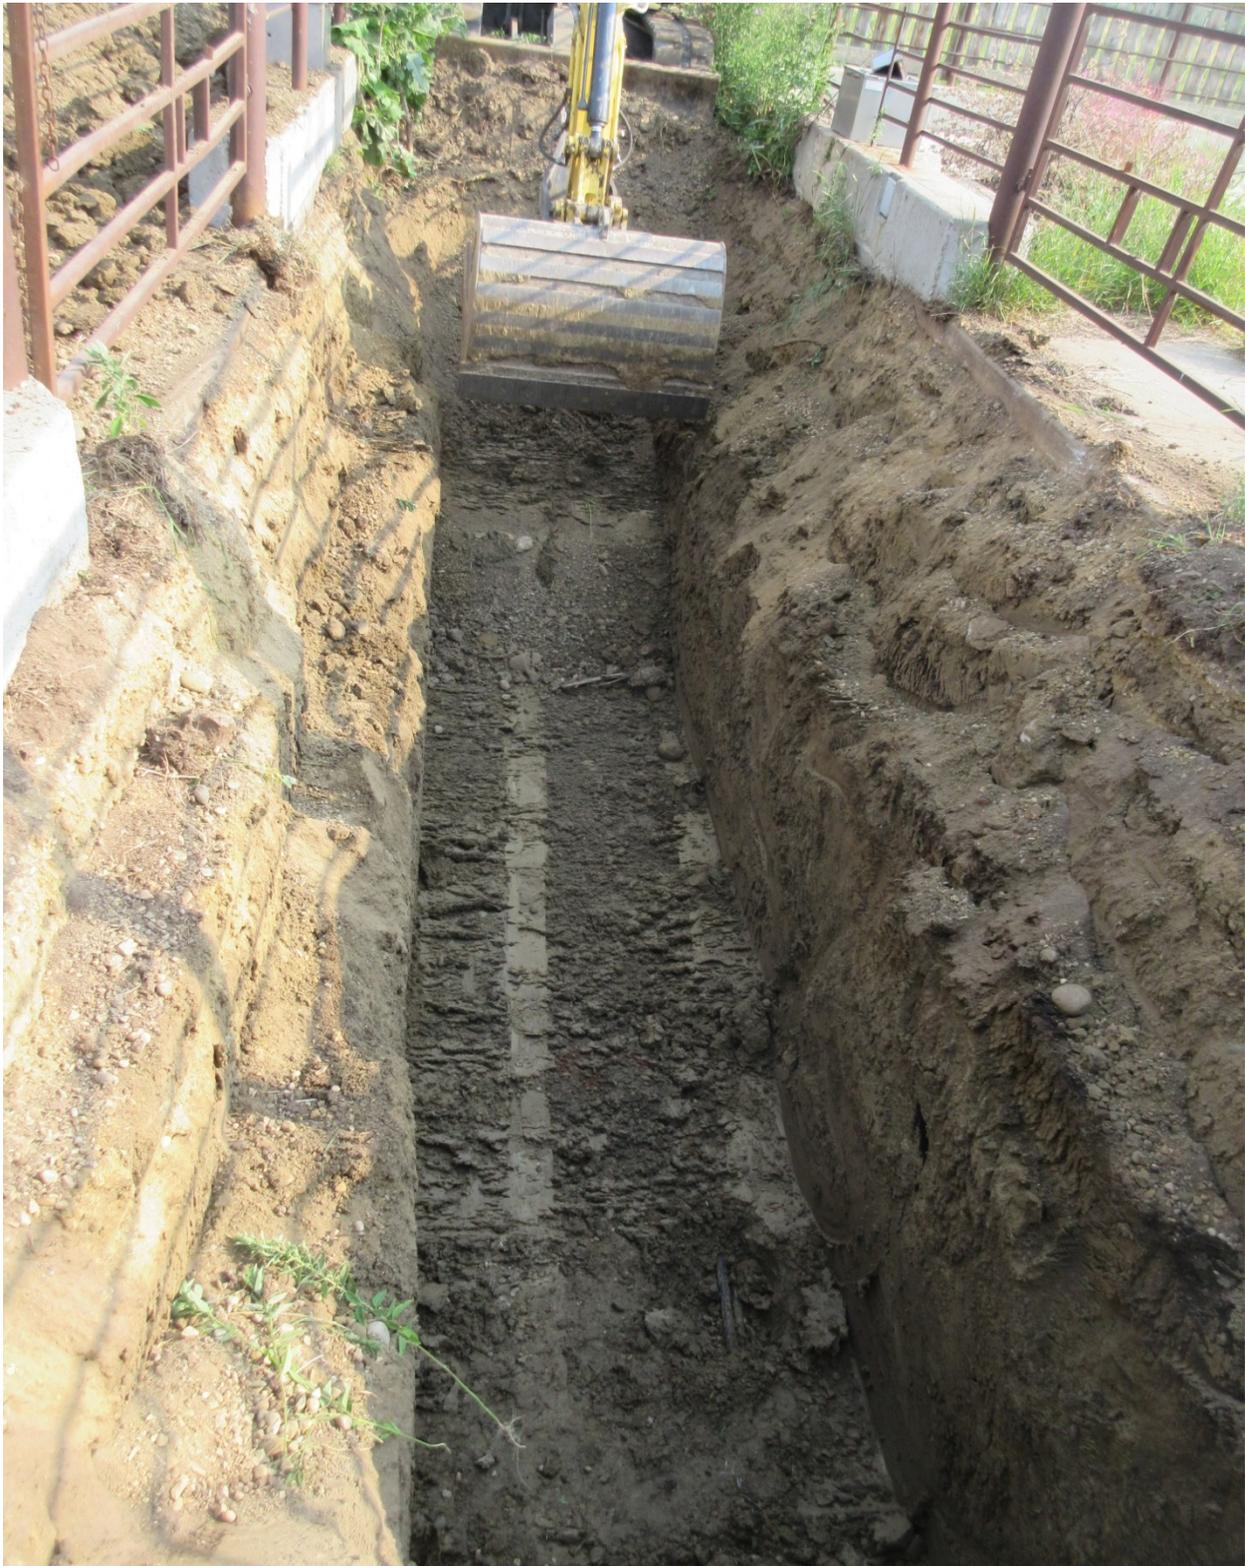
Figure 2: Trench is approximately 40' long x 3+ feet wide, with 8-foot deep sides. The ground is composed of stable clay soils. There is no slumping or water infiltration.

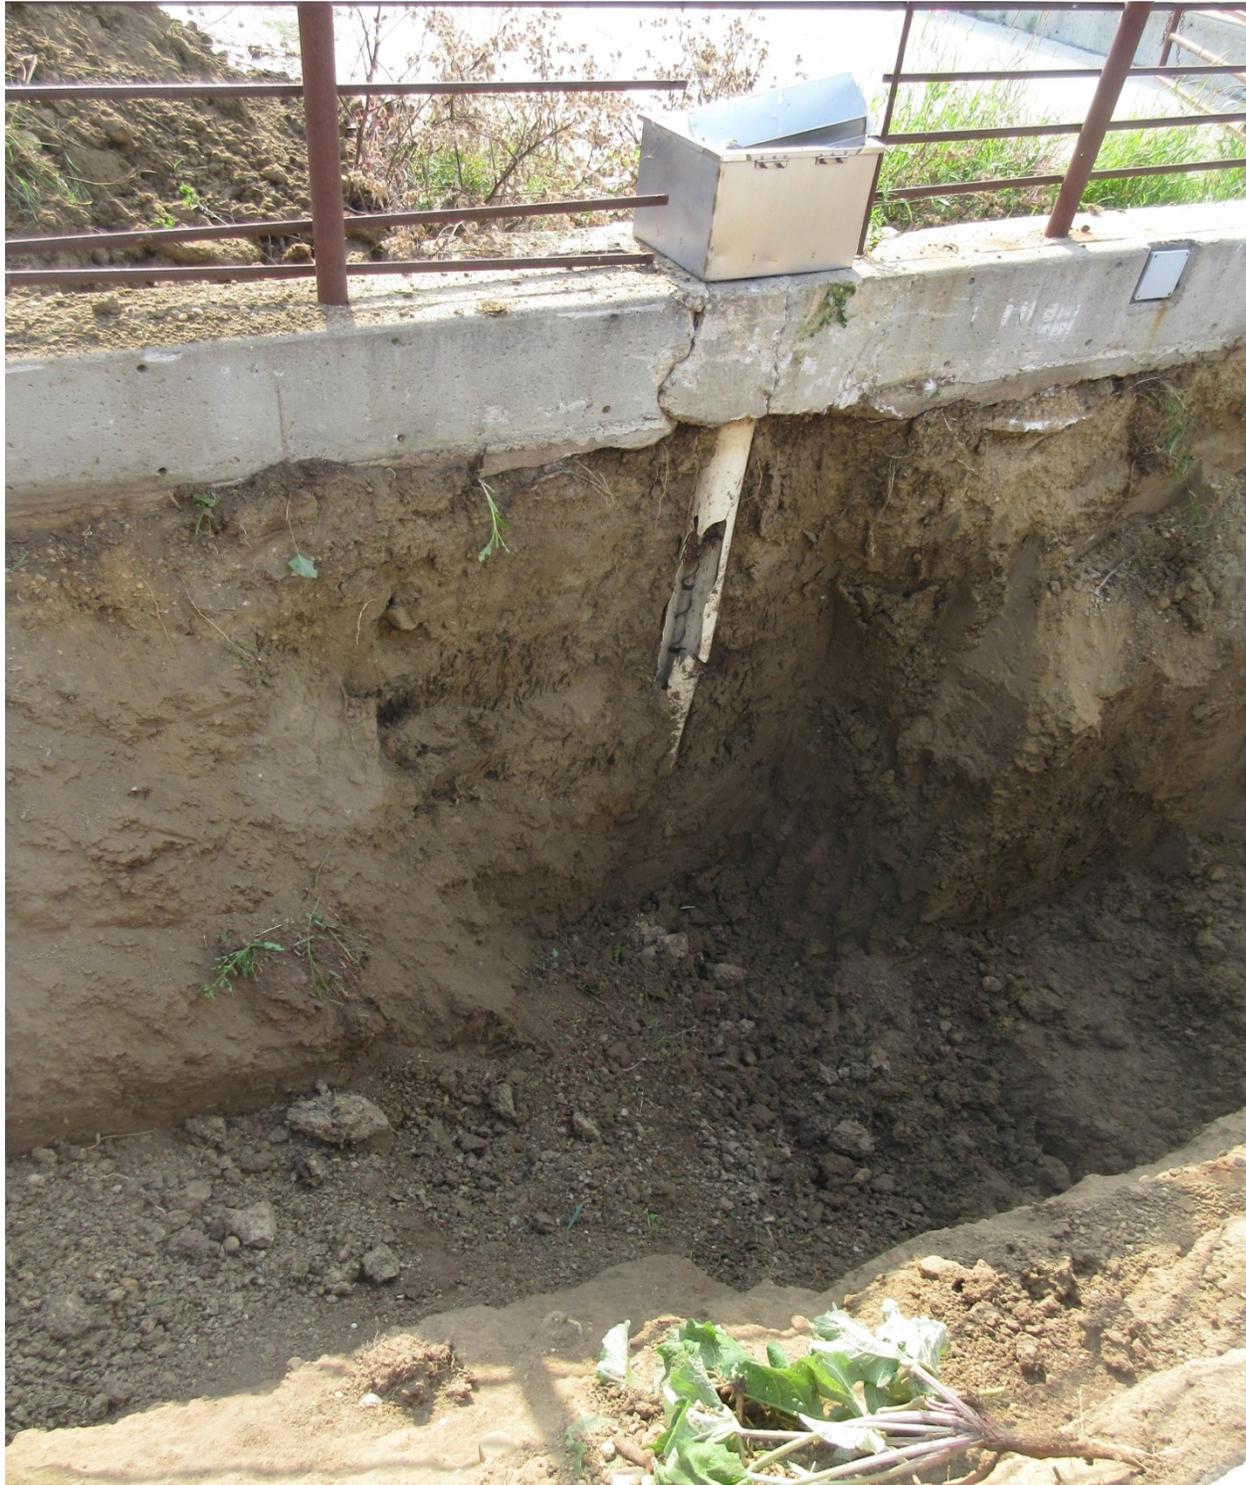
Figure 3: Vertical riser to waterer. Water line curves to upstanding. There are no joints. The riser casing was damaged by excavation work.
