REMOVAL OF VARIOUS SURPLUS INFRASTRUCTURE
AT BACCALIEU LIGHT STATION

BACCALIEU ISLAND, NL
PROJECT NUMBER: F6879-171005

Fisheries and Oceans Canada

Project:	DEMOLITION HAZARDOUS BUILDING MATERIALS ASSESSMENT AND INVENTORY, BACCALIEU ISLAND LIGHTSTATION (DFRP 80521), BACCALIEU ISLAND, NL		
Title:	SITE LOCATION PLAN		
Scale:	1:50,000	Project No.:	TF14076579
		Figure No.:	1.1

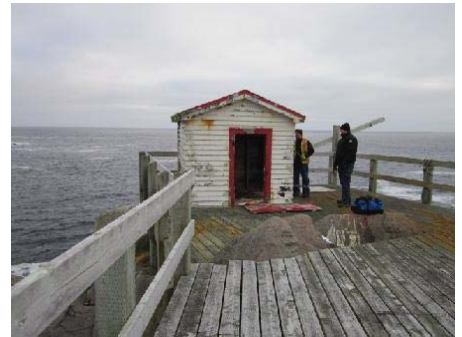
Photo 3: View of upper landing deck and winch house. Note: missing spar and boom.

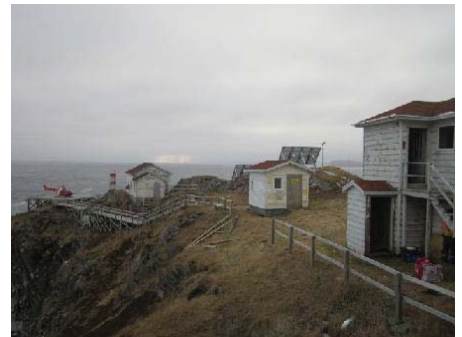
Photo 6: View of damaged fencing near new equipment building.

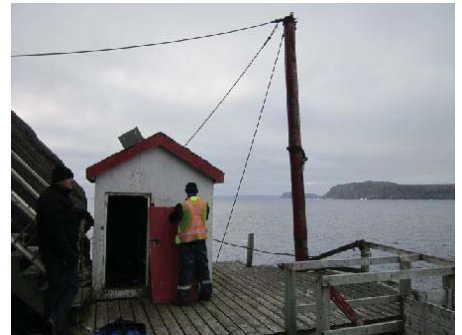
Photo 15: View of lower landing deck, winch house and spar. Note: missing boom.

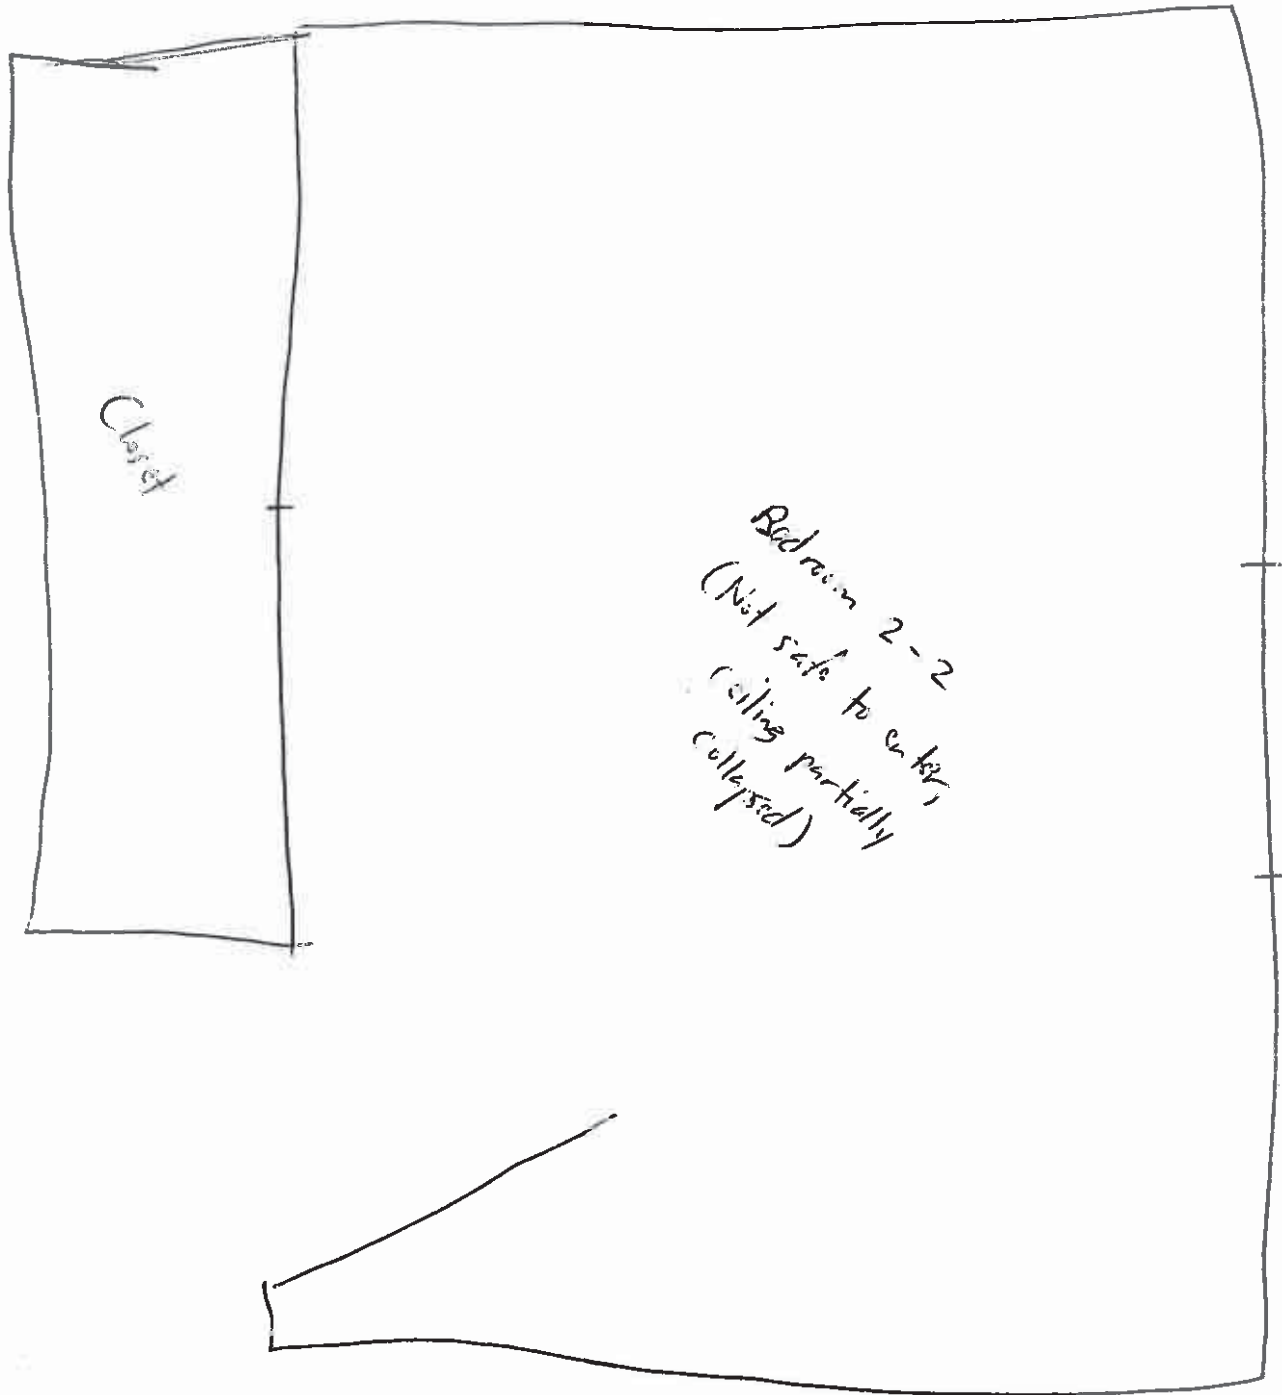
Bedroom 2-2
(Not safe to enter,
ceiling partially
collapsed)
