Hazardous Building Materials Assessment

25 2nd Avenue N,
Ashern, Manitoba

August 10, 2017

Pinchin File: 208339.001

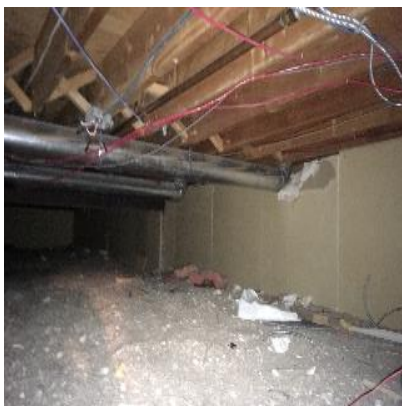
Ducts are either uninsulated or insulated with non-asbestos fibreglass and jacketed with either canvas or foil.

Photo 1: Ductwork in crawlspace. Uninsulated.

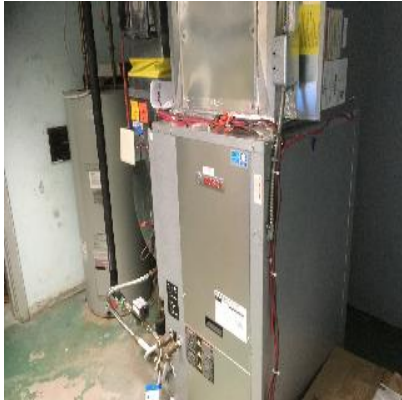
Mechanical equipment is either uninsulated or insulated with non-asbestos fibreglass.

Photo 2: Mechanical equipment uninsulated in basement.

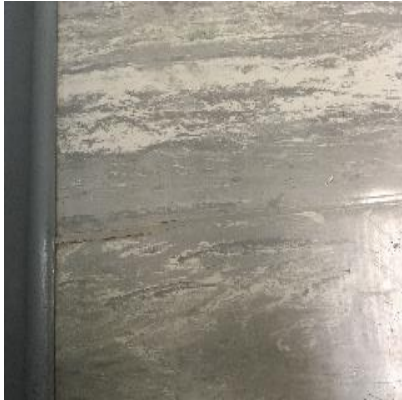
Vinyl sheet flooring is presumed to be non-asbestos based on historical knowledge of the type of flooring (foam) or based on the lack of a paper backing layer (underpad).

Photo 3: Vinyl sheet flooring observed in building.

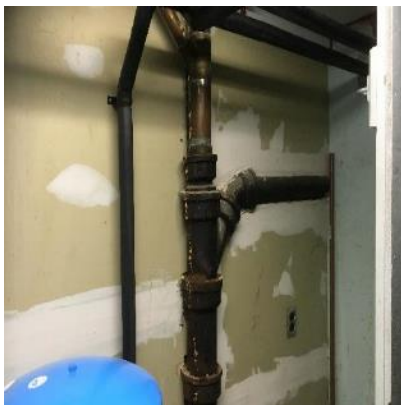
Lead wool or lead caulking is present in bell and spigot fittings on cast iron pipes in the assessed area.

Photo 4: Uninsulated drain pipe with bell and spigot fittings.

Lead-containing items should be recycled when taken out of service or prior to building demolition.
