Hazardous Building Materials Assessment

254 Frontage Road,
Manitou, Manitoba

August 10, 2017

Pinchin File: 208339

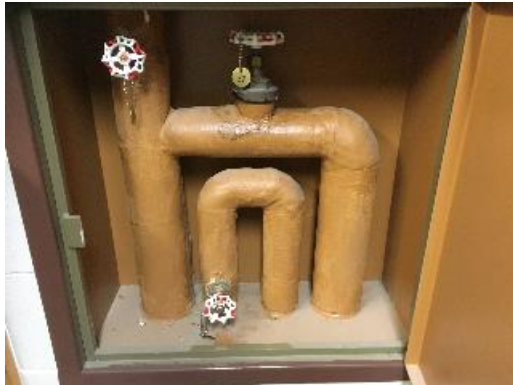
Parging cement is present on pipe fittings (elbows and tees.) on domestic water system lines (Samples 0005A-C). Parging cement was sampled and does not contain asbestos.

Photo 1: Parging cement on elbows of water lines.

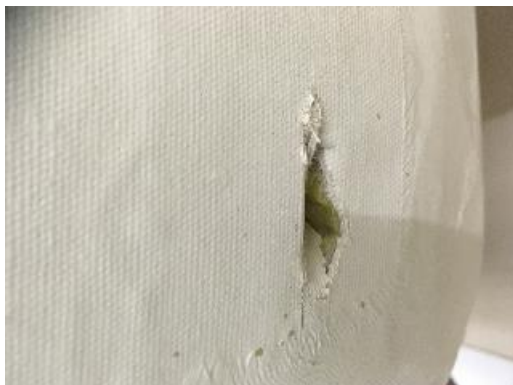
Photo 2: Basement mechanical room. Fibreglass insulation covered with canvas. No parging noted.

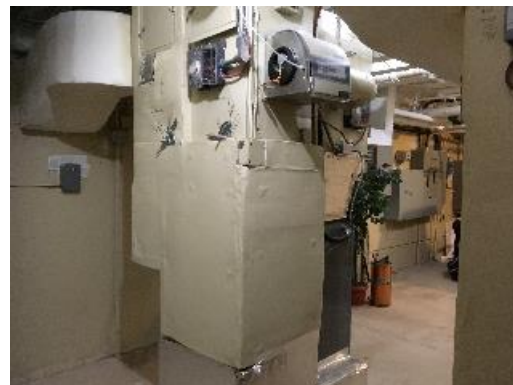
Mechanical equipment is either uninsulated or insulated with non-asbestos fibreglass.

Photo 3: Fibreglass insulation covered with canvas on mechanical equipment. No parging noted.

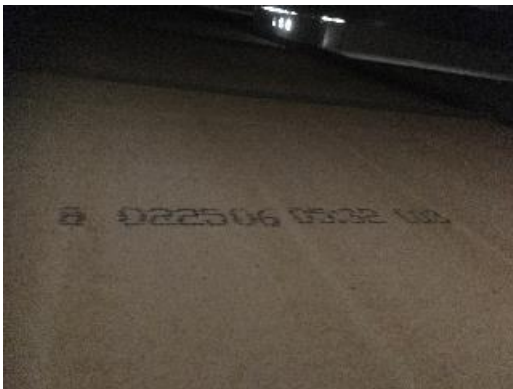
Two distinct types of acoustic ceiling tile are present in the assessed area. One style of ceiling tile is presumed to be non-asbestos based on the date of manufacture determined from the date stamp applied to the top of the tiles. The tiles were manufactured after asbestos stopped being used in acoustic ceiling tiles. The second style of ceiling tile was sampled (0003A-C) and found to be non-asbestos. All ceiling tiles within the assessed area are non-asbestos.

Photo 4: 2006 date code on ceiling tiles.

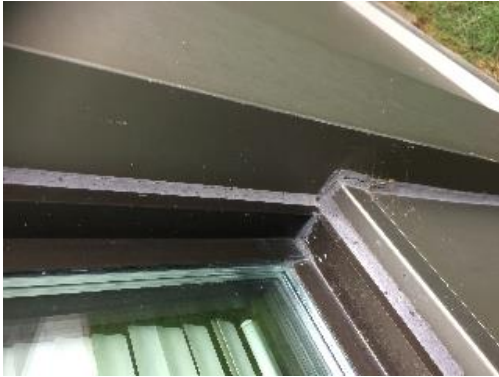
Black caulking at exterior windows and doors contains chrysotile asbestos (Samples 0009A-C). Caulking is non-friable and is in good condition.

Photo 5: Asbestos-containing window caulking (Samples 0009 A-C).

Remove all asbestos-containing materials (ACM) prior to renovation, alteration, maintenance or demolition work or if ACM may be disturbed by the work.

ACM must be disposed of at a landfill approved to accept asbestos waste.

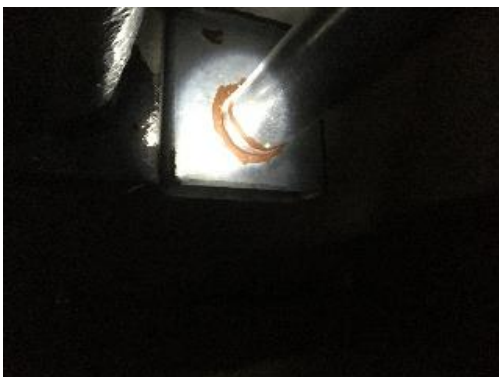
Mastic (brown), applied to joints on ductwork was observed in the crawlspace (Samples 0007A-C). The mastic does not contain asbestos.

Photo 6: Non-asbestos brown mastic applied to joints of ductwork (Samples 0007A-C).

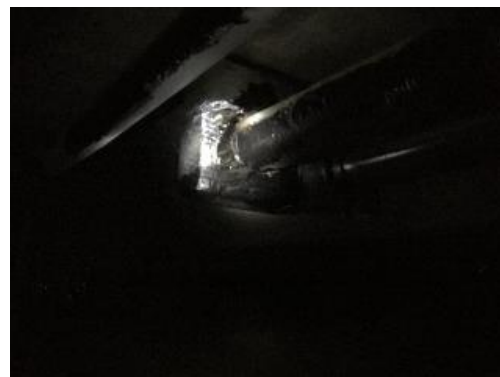
Mastic (black), applied to pins and joints on fibreglass insulation on ductwork was sampled in the assessed area (Samples 0006A-C). Black mastic was also observed on domestic water line seams and elbows in the crawlspace. All black mastic found on fibreglass insulation contains chrysotile asbestos, is non-friable and in good condition.

Photo 7: Asbestos-containing black mastic applied to foil faced fibreglass insulation on ducts throughout work area (Samples 0006A-C).

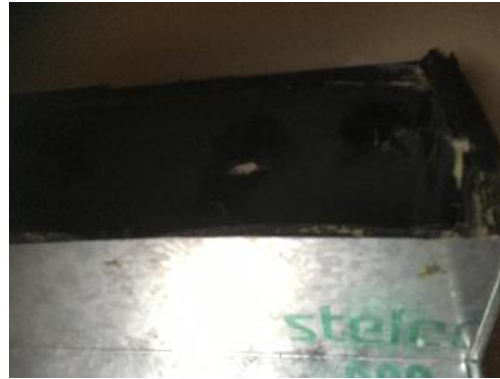
Mastic (black), applied to pins and joints on fibreglass insulation lining ductwork was observed in the NCO Room and was sampled (Samples 0004A-C). The black mastic inside the ductwork contains chrysotile asbestos is non-friable and in good condition.

Photo 9: Asbestos-containing black mastic applied to fibreglass insulation inside duct work observed in the NCO Room (0004A-C).

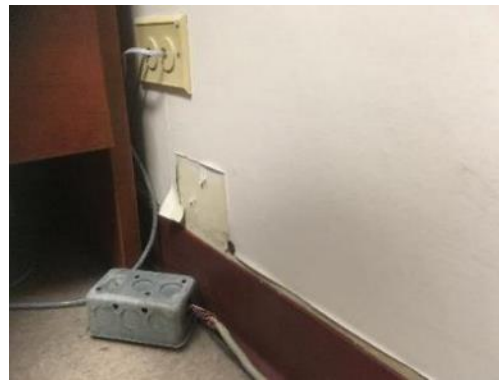
Visible water staining was observed on drywall walls on the east exterior wall in the general office area and in the NCO Office. Water damaged acoustic ceiling tiles were observed adjacent to the damaged drywall.

Photo 11: Water damage observed on drywall in general office area.

Water damage and water staining was noted in areas in the assessed building. Perform an intrusive investigation to determine the source and full extent of water damage. Use appropriate precautions and protect workers during removal using methods that comply with provincial guidelines.

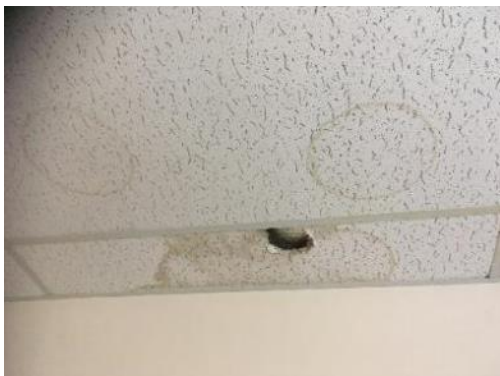
Photo 12: Water damaged acoustic ceiling tiles. General office area.

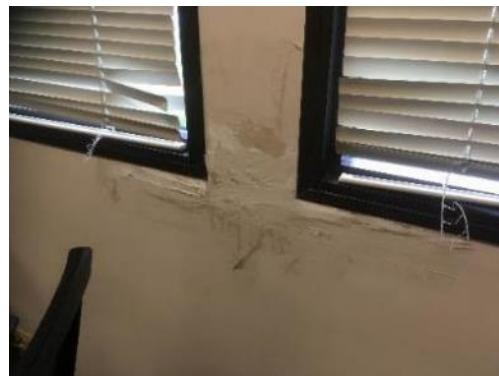
Photo 13: Water damaged drywall adjacent to windows on east exterior wall.
