<b>MSI</b> International (2008) Ltd.	<b>Marine Services</b>	TITLE: <b>CCGS GEORGE R PEARKES W/T DOOR REMOVAL AND REPAIR</b>	DRAWN BY: PAL	DATE DRAWN: OCT. 2016
	197A Major's Path P.O.BOX 29132 St. John's, NL Canada A1A 5B5 Telephone 709 782 2700 Facsimile 709 782 2707 www.msintl.com	CLIENT: <b>D.F BARNES SERVICES</b>	CHECKED BY: MSI	SCALE: N.T.S
		PROJECT NO.: 2830	DRAWING NO.: 2830-01-01	SHEET NO.: 1 OF 7

TITLE: **CCGS GEORGE R PEARKES W/T DOOR REMOVAL AND REPAIR**

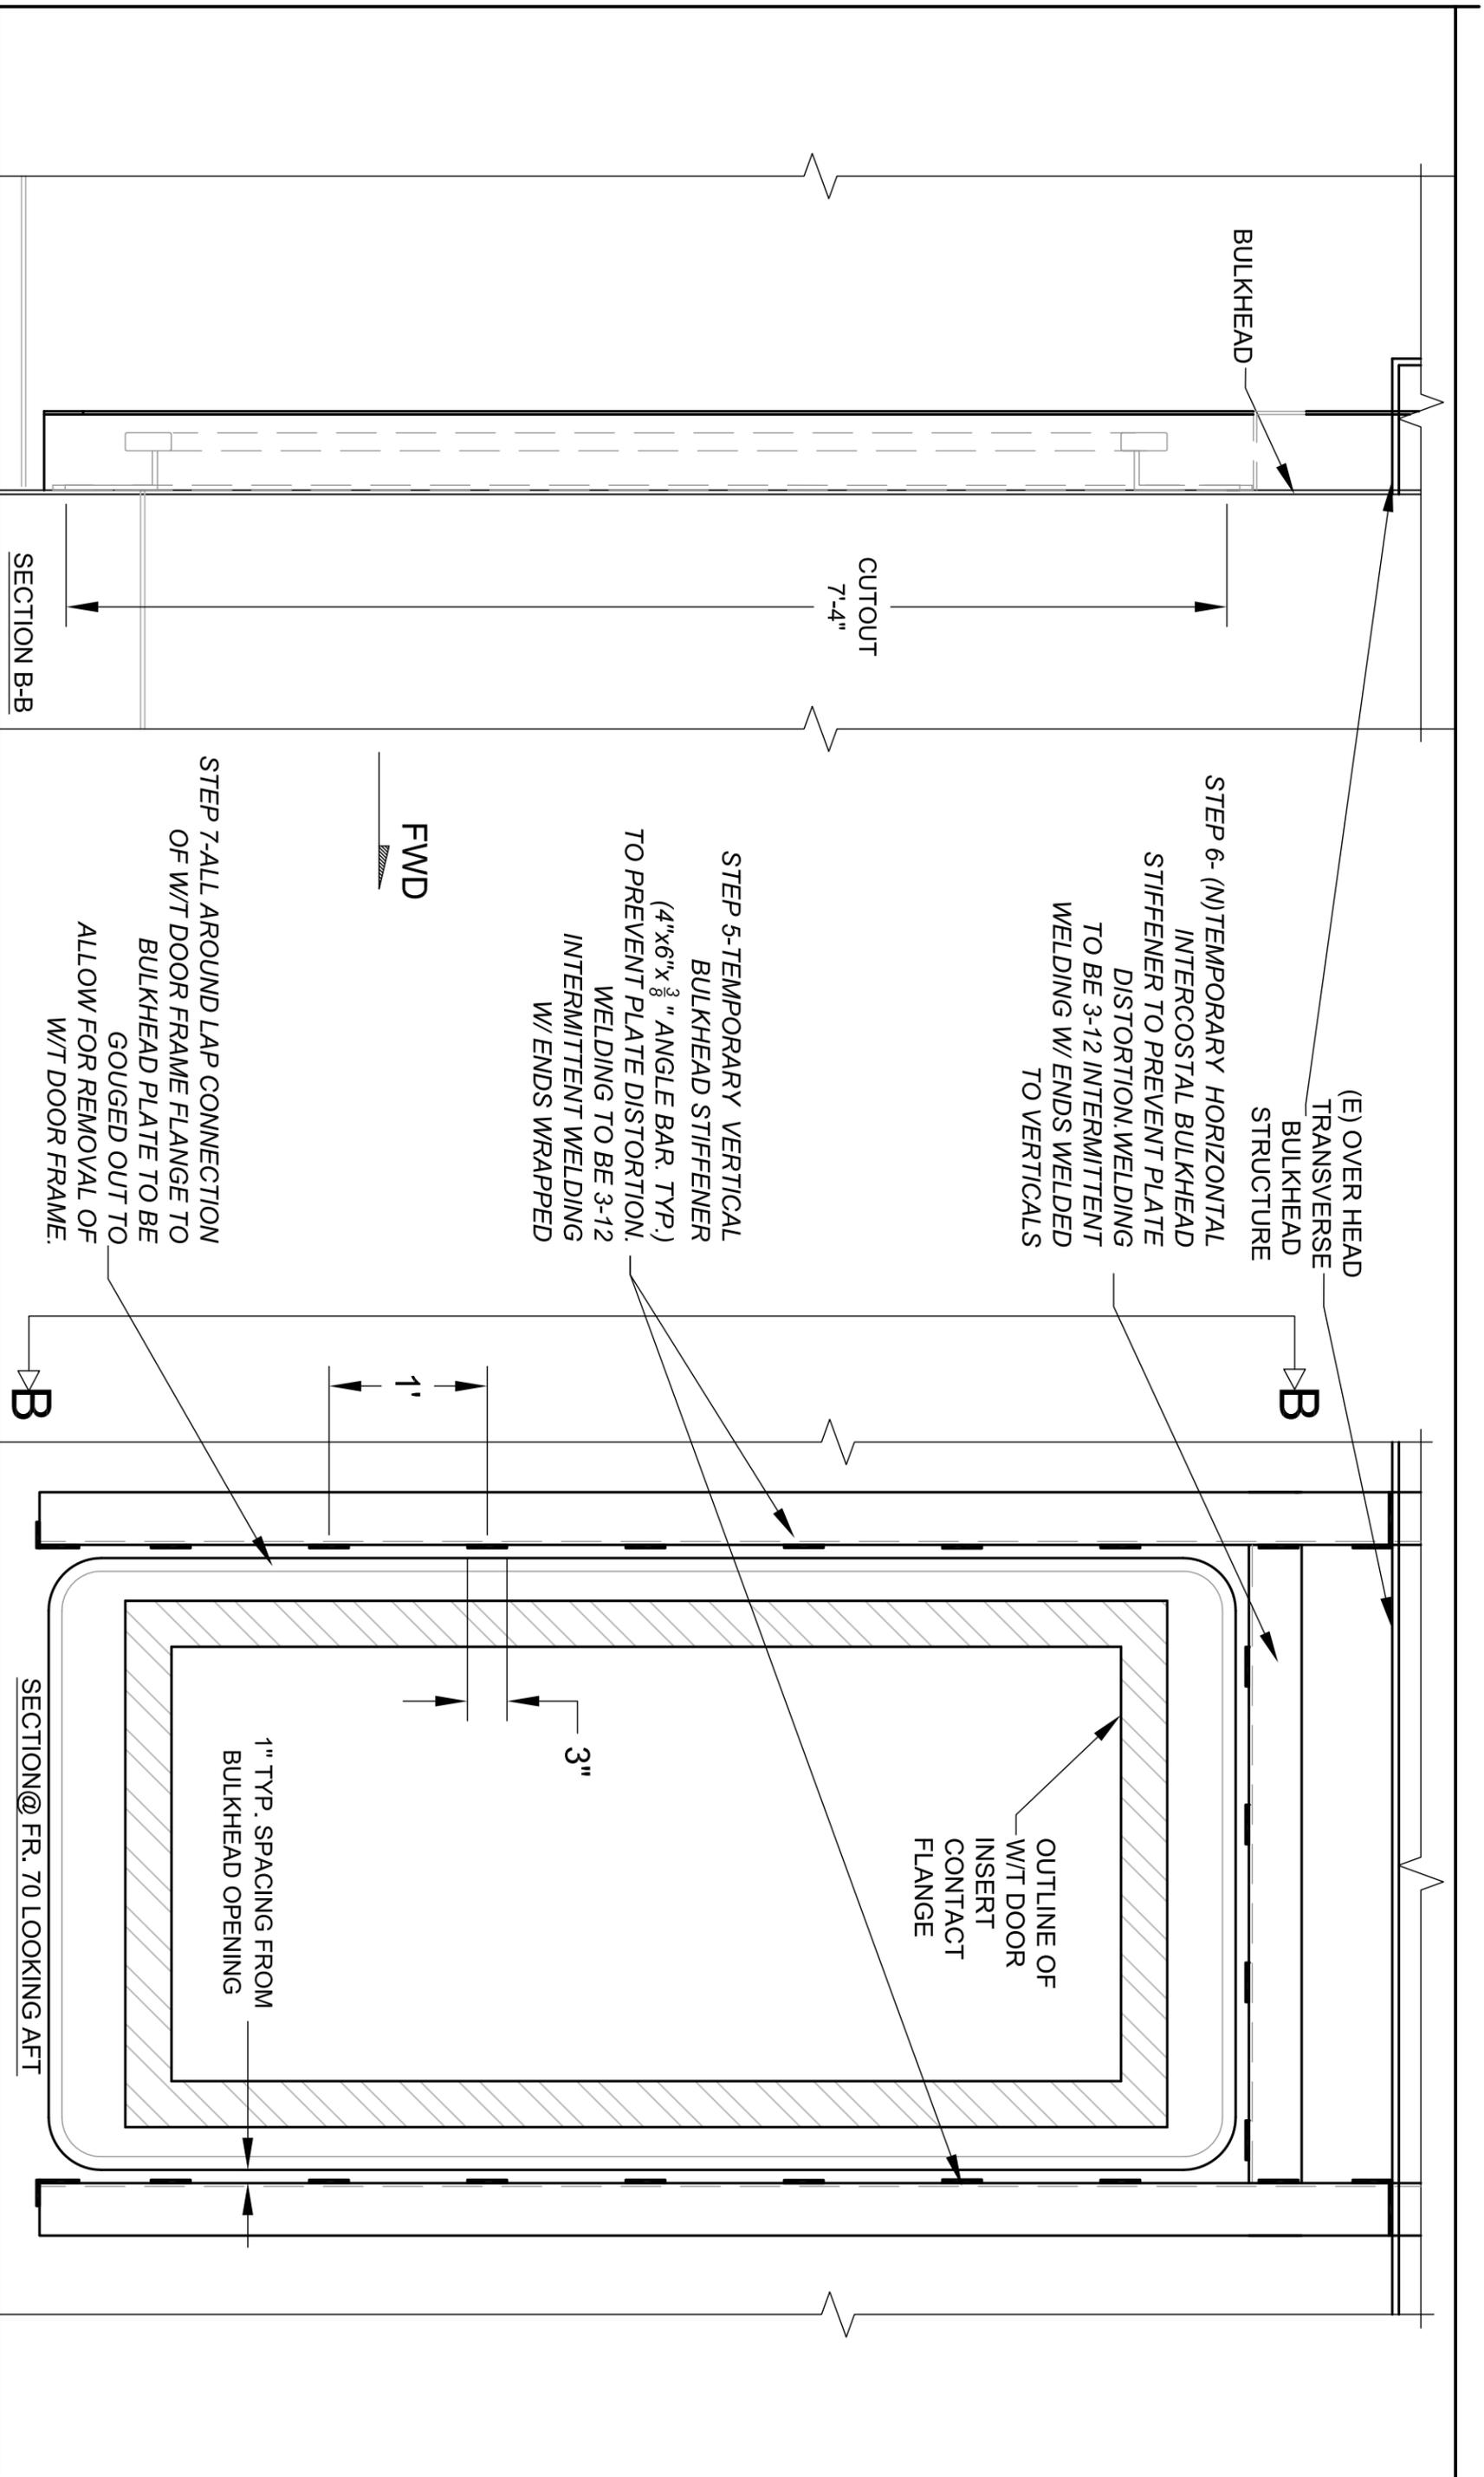
SECTION @ FR. 70 LOOKING AFT

STEP 6- (N) TEMPORARY HORIZONTAL  
INTERCOSTAL BULKHEAD  
STIFFENER TO PREVENT PLATE  
DISTORTION. WELDING  
TO BE 3-12 INTERMITTENT  
WELDING W/ ENDS WELDED  
TO VERTICALS

STEP 5- TEMPORARY VERTICAL  
BULKHEAD STIFFENER  
(4"x6"x 3/8" ANGLE BAR. TYP.)  
TO PREVENT PLATE DISTORTION.  
WELDING TO BE 3-12  
INTERMITTENT WELDING  
W/ ENDS WRAPPED

STEP 7- ALL AROUND LAP CONNECTION  
OF W/T DOOR FRAME FLANGE TO  
BULKHEAD PLATE TO BE  
GOUGED OUT TO  
ALLOW FOR REMOVAL OF  
W/T DOOR FRAME.

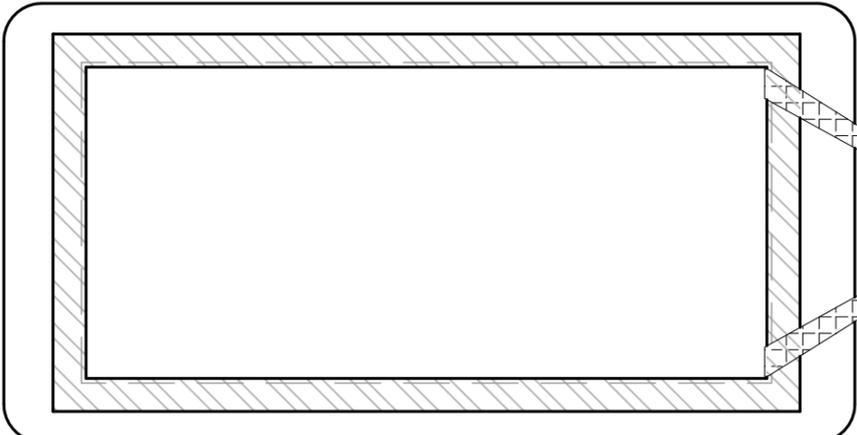
STEP 8 - W/T DOOR FRAME AND DOOR  
REMOVED FROM SHIP.

W/T DOOR  
FRAME TO BE  
ROTATED UPRIGHT  
& BE LIFTED  
ASHORE THROUGH  
GEN. ROOM  
STORES HATCH

W/T DOOR FRAME  
TO BE ROTATED AFT &  
INVERTED TO A  
HORIZONTAL  
POSITION AS SHOWN IN  
GEN. ROOM
