**GEOTECHNICAL EVALUATION & SITE SURVEY  
SUPERINTENDENT'S RESIDENCE  
SAULT CANAL, SAULT STE. MARIE, ONTARIO  
YOUR FILE NO. 6553-0035-52129**

**Project: SO6430G  
Date: January 13, 1995**

January 12, 1995

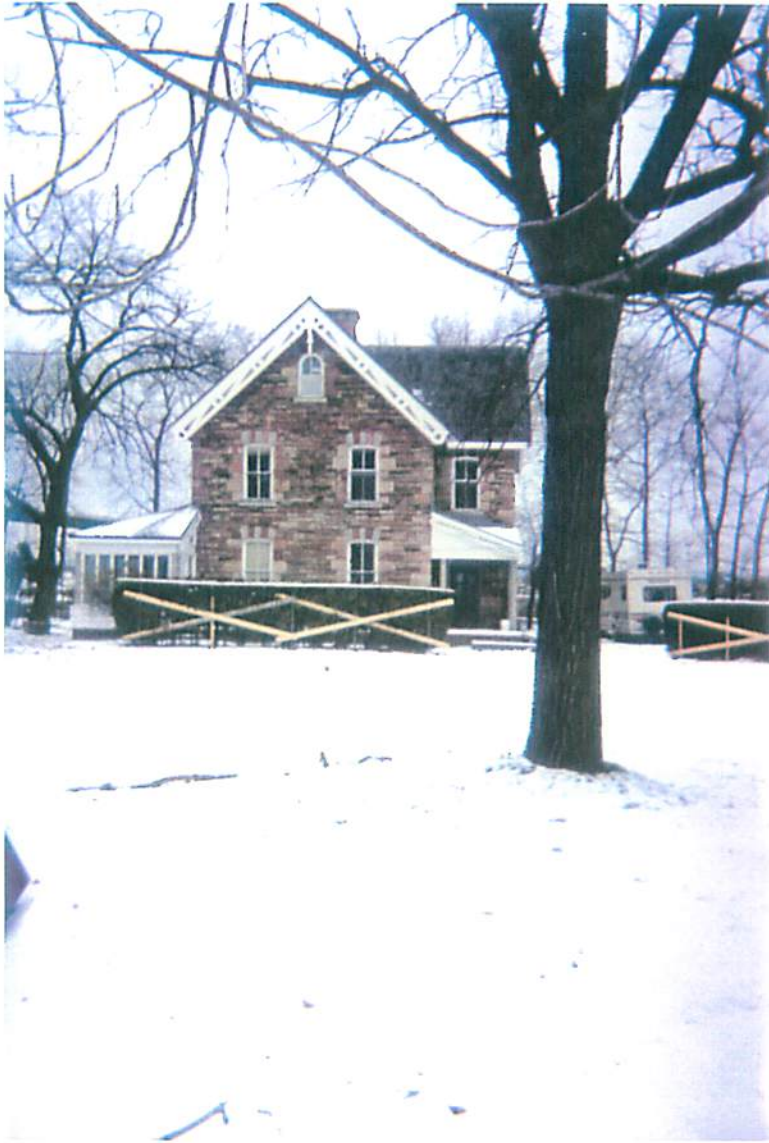
**PHOTOGRAPH #1**

**Superintendent's Residence  
(South end with the main entrance)**

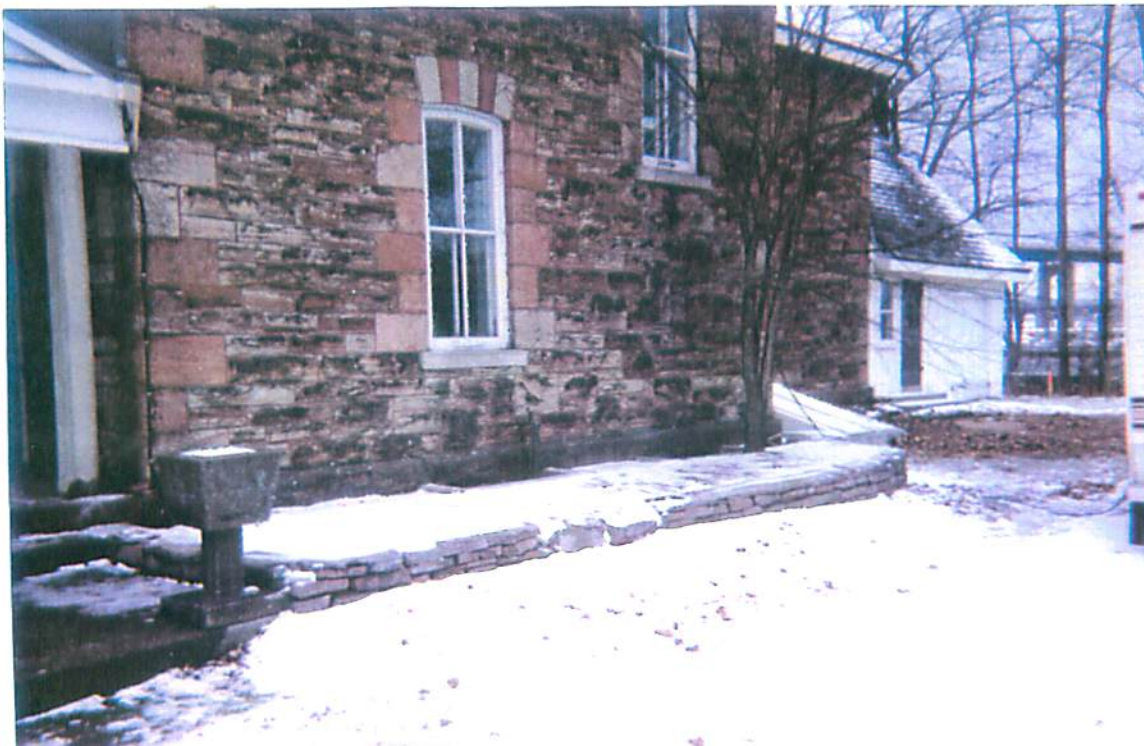
**PHOTOGRAPH #2**

**East Wall of Building**

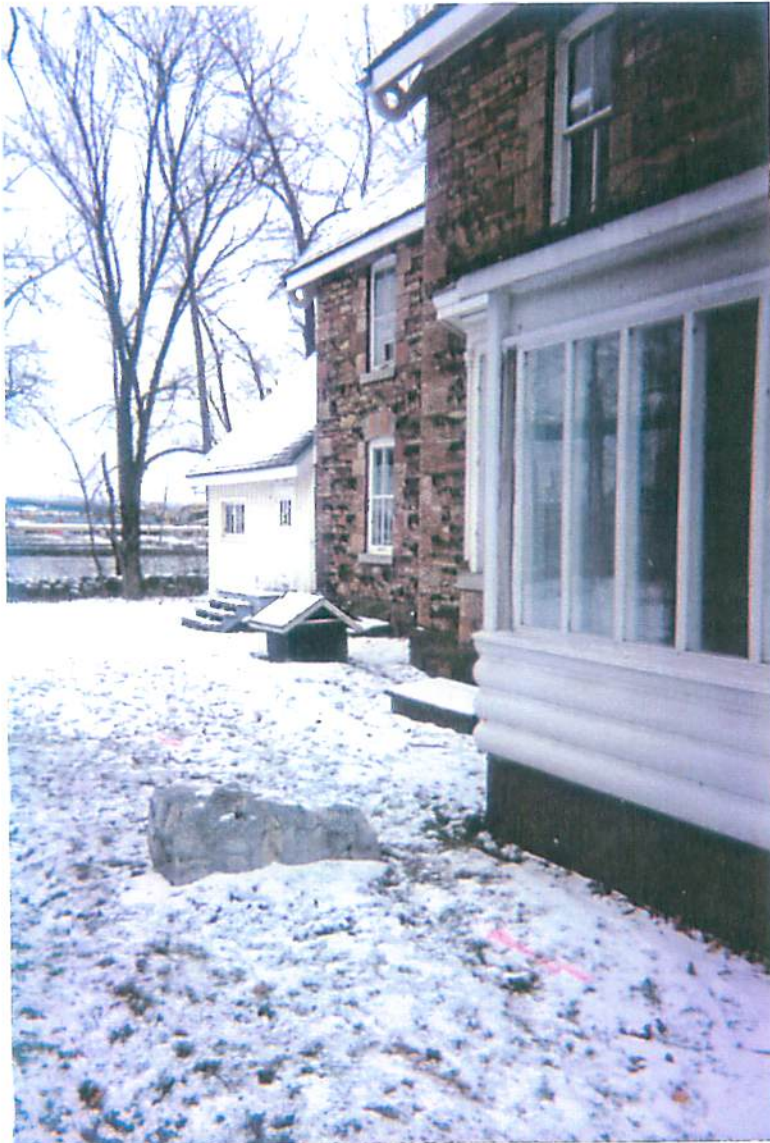
PHOTOGRAPH #3  
West Wall of Building

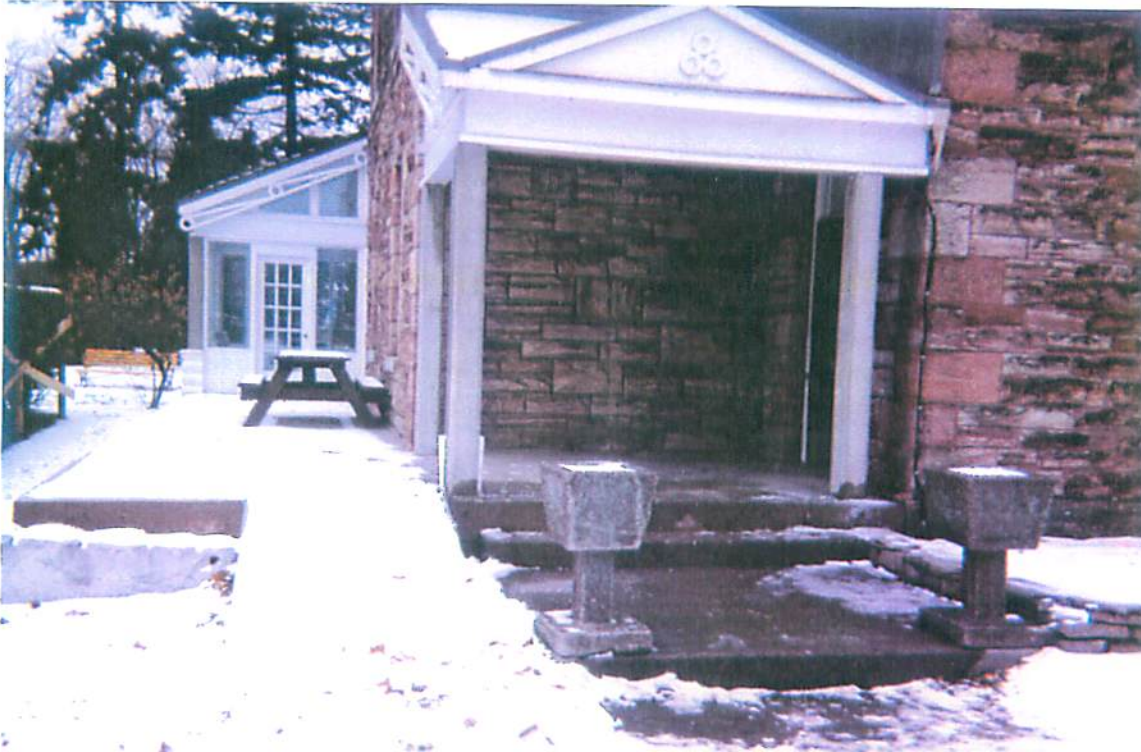
PHOTOGRAPH #4  
The Main Entrance

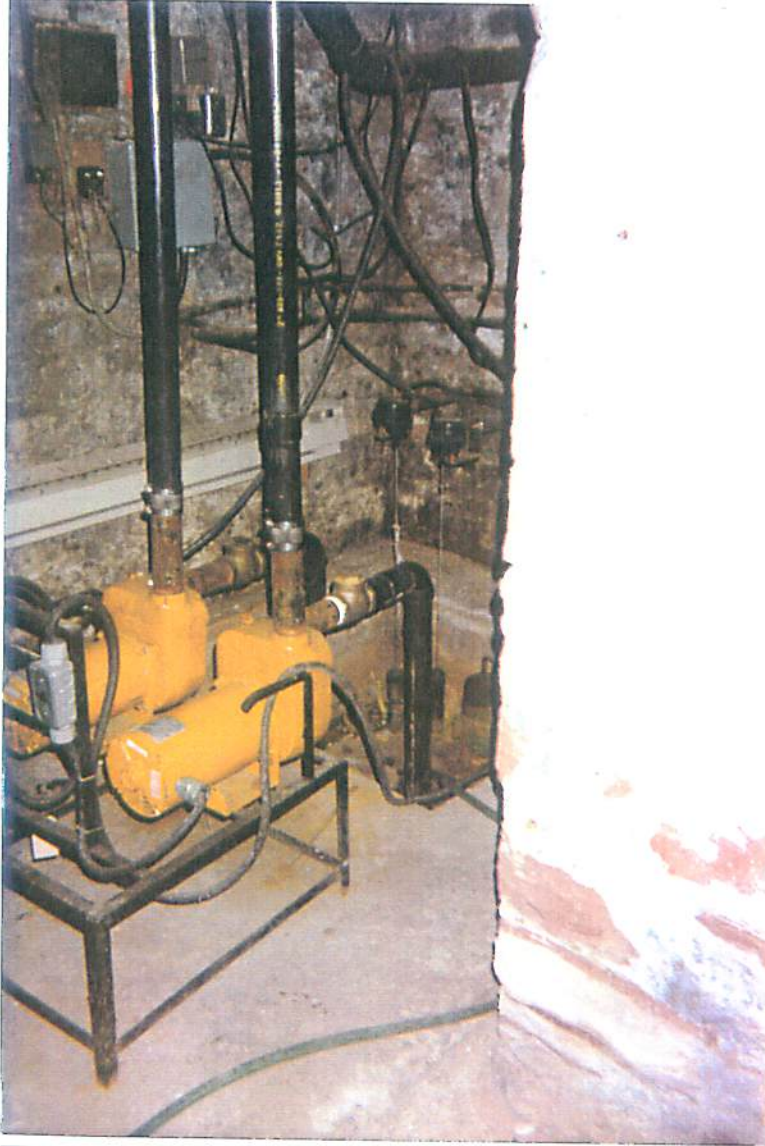
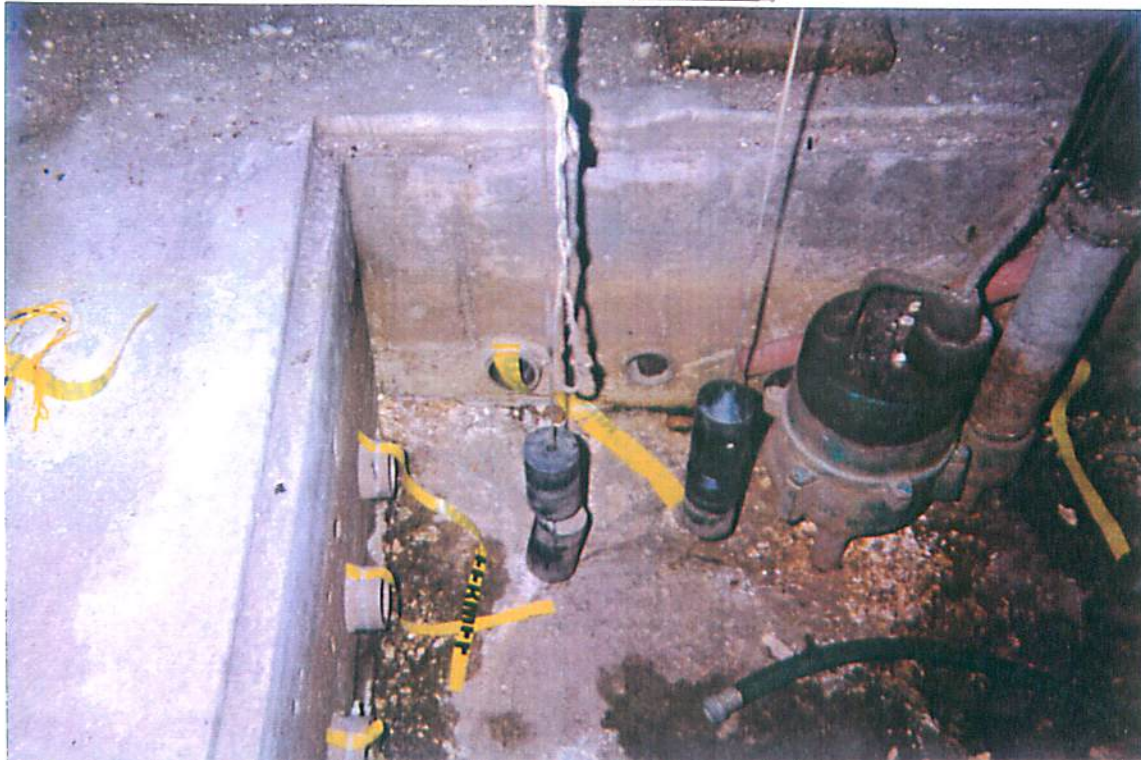
PHOTOGRAPH #5 & #6

Sump #2

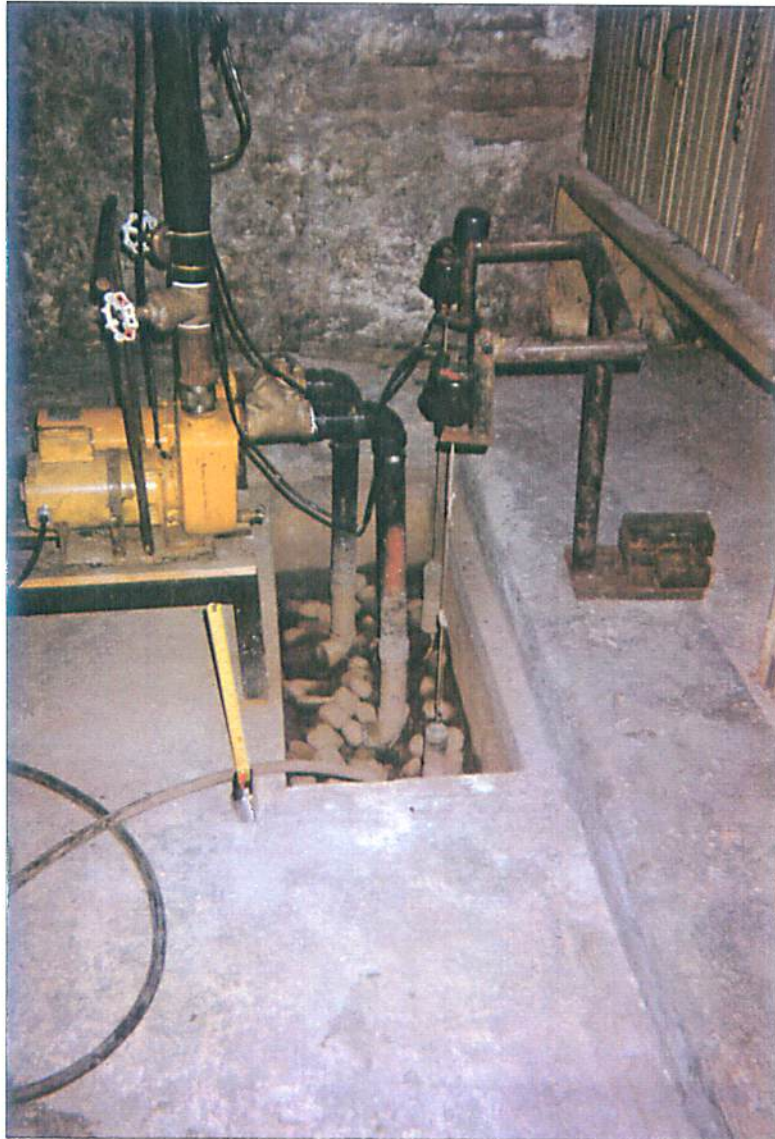
**PHOTOGRAPH #7**

**Sump #1**

**(Note the wet gravel fill at the bottom of the sump)**

Based on our general knowledge of the area and the results of our investigation it is evident, that the water entering into the basement through the sumps is related to the occasional rise of groundwater level mainly from SEICHE effects. In order to curtail the problem it would be necessary to install perimeter and underfloor weeping tile systems around the building and beneath the floor slabs. Such an extensive and costly procedure may, however, be prohibitive in comparison to the assumption that occasional water entering into the basement may be acceptable. It may be more suitable to construct a higher "table" floor in the basement, i.e. above the highest water level at least to the furnace and other facilities.

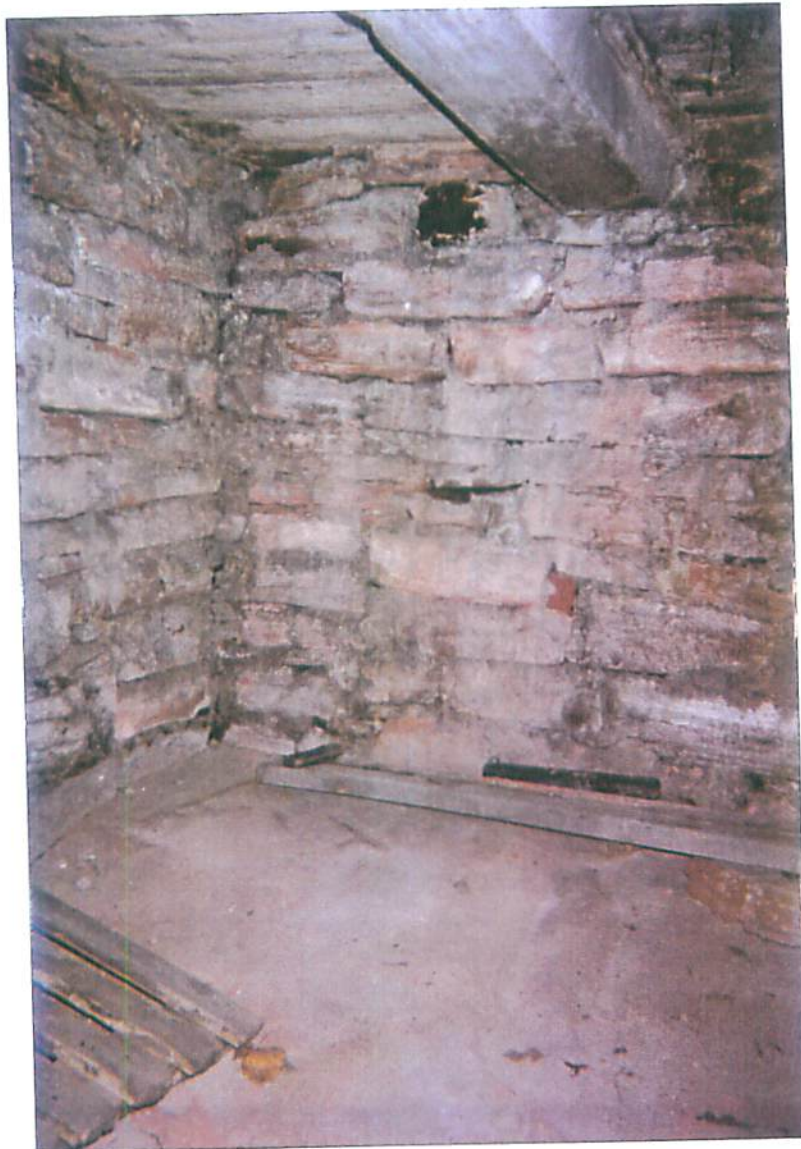
**PHOTOGRAPH #8**

In addition to the rising groundwater, there are visible signs of some minor water seeping through foundation walls in the area of an underground storage space, attached to the west wall of the building (Photograph 8). This seepage is possibly due to lack of damp-proofing behind the foundation walls. Similar signs of water seepage (patches of

**Underground Storage Space "Attached" to the West Side of the Building**

**(Note the result of water seepage on the walls and floor slab)**

With regard to surface water seeping into the basement through the walls at two locations, (exterior stairwell and underground storage place) we would suggest the removal of backfill from behind those walls and then adequate damp proofing and repairs. Alternatively these exterior structures may be demolished and the original foundation walls reinstated.

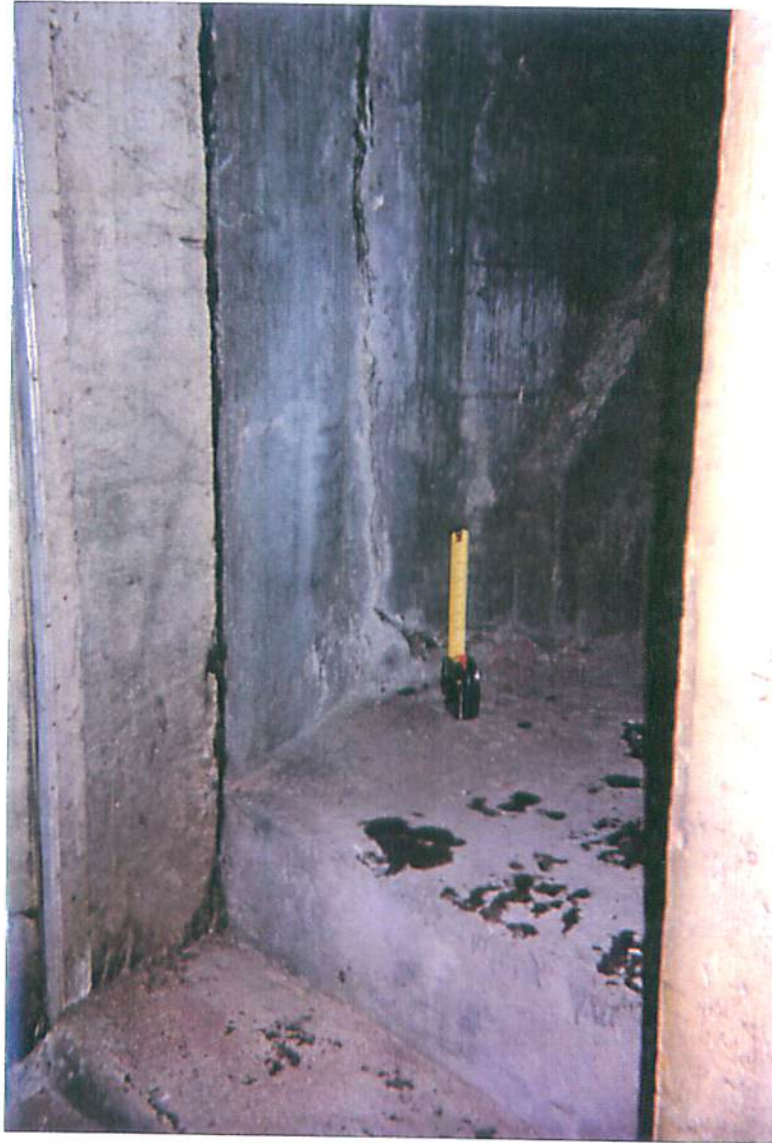
**PHOTOGRAPH #9**

"efflorescence" deposit, a salt residue common in concrete due to the movement of water through the concrete) were noted around the basement's side door, in the previously noted exterior stairwell (Photographs 9 and 10).

**Exterior Stairwell Attached to the East Side of the Building**

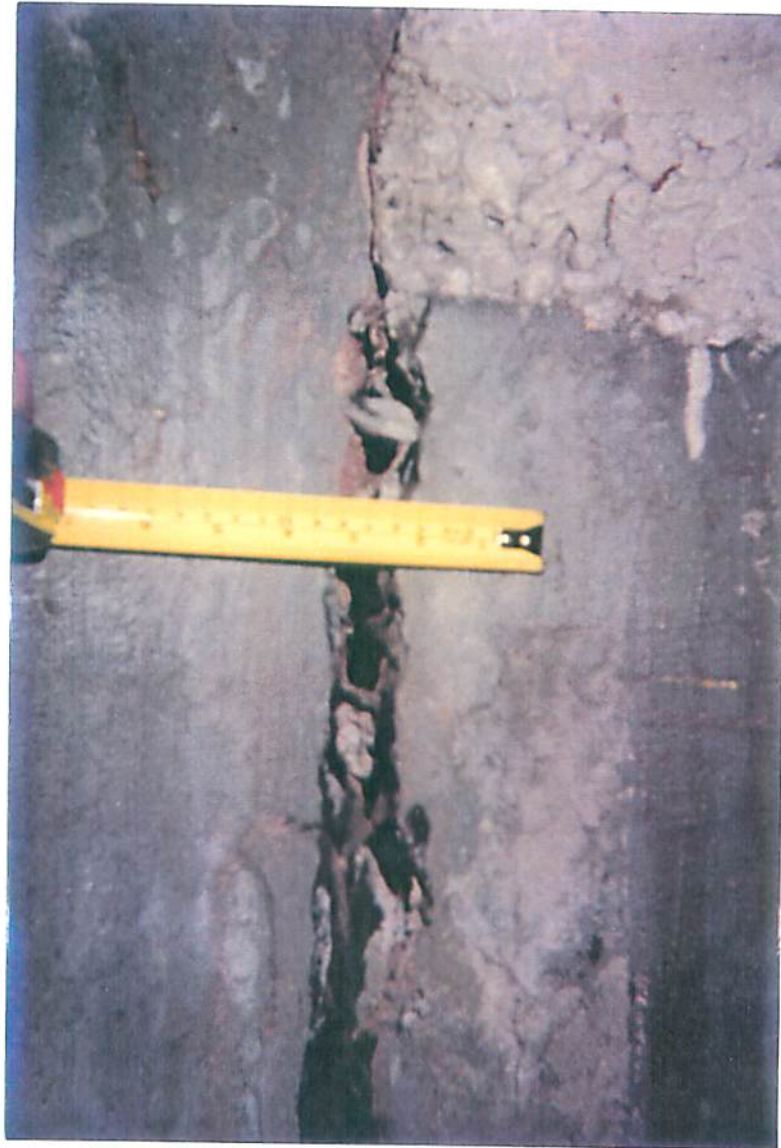
**PHOTOGRAPH #10**

Visual examination of the house indicated, that there are no settlement related cracks on the foundation walls. An "opening" joint, however, exists between the exterior basement stairwell and the house which is probably related to differential movement (see Photographs 9 and 10). A small part of the stairwell had been founded on the bedrock (adjacent to the building), but a major part on the loose backfill. Compression of the fill under the stairwell's weight has probably occurred and resulted in the differential settlement and cracking at the joint.

**Opening of Joint Between the Stairwell Wall and the Building  
as a Result of Differential Settlement**

**(Poor foundation of the stairwell)**

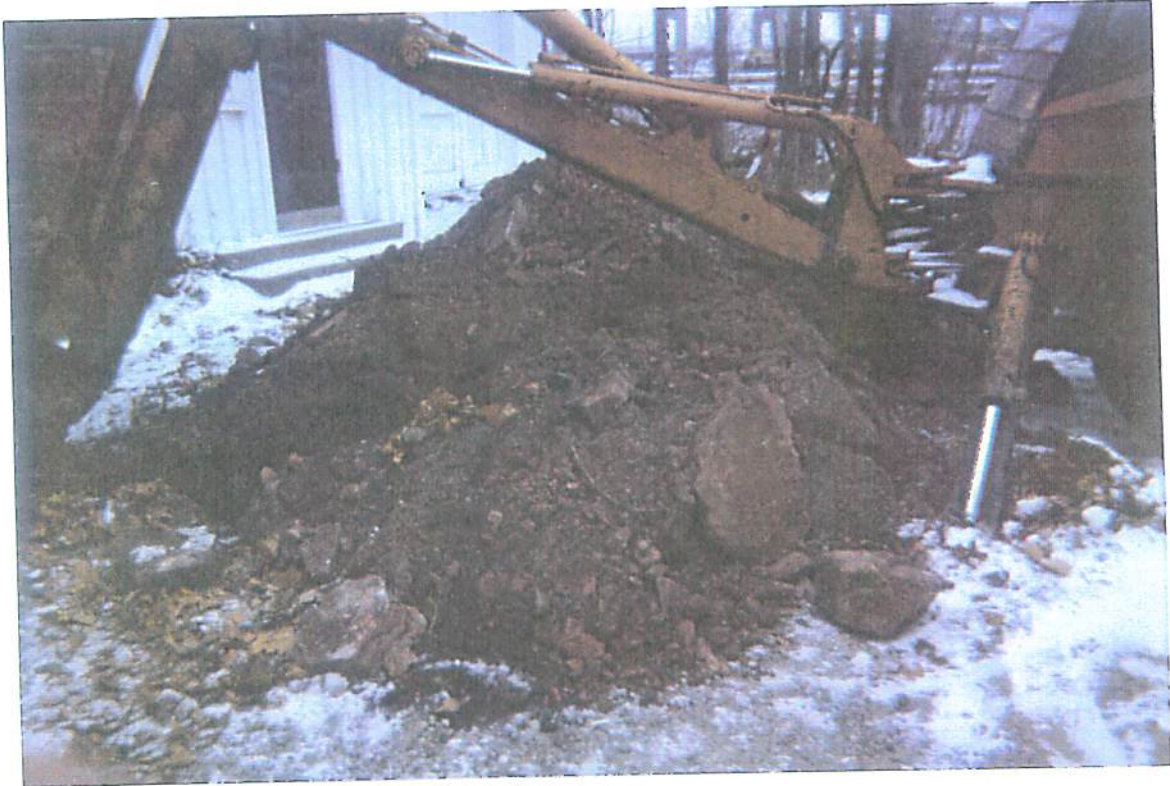
**PHOTOGRAPH #11**

**Excavation of Test Pit Adjacent to the Exterior Stairwell**

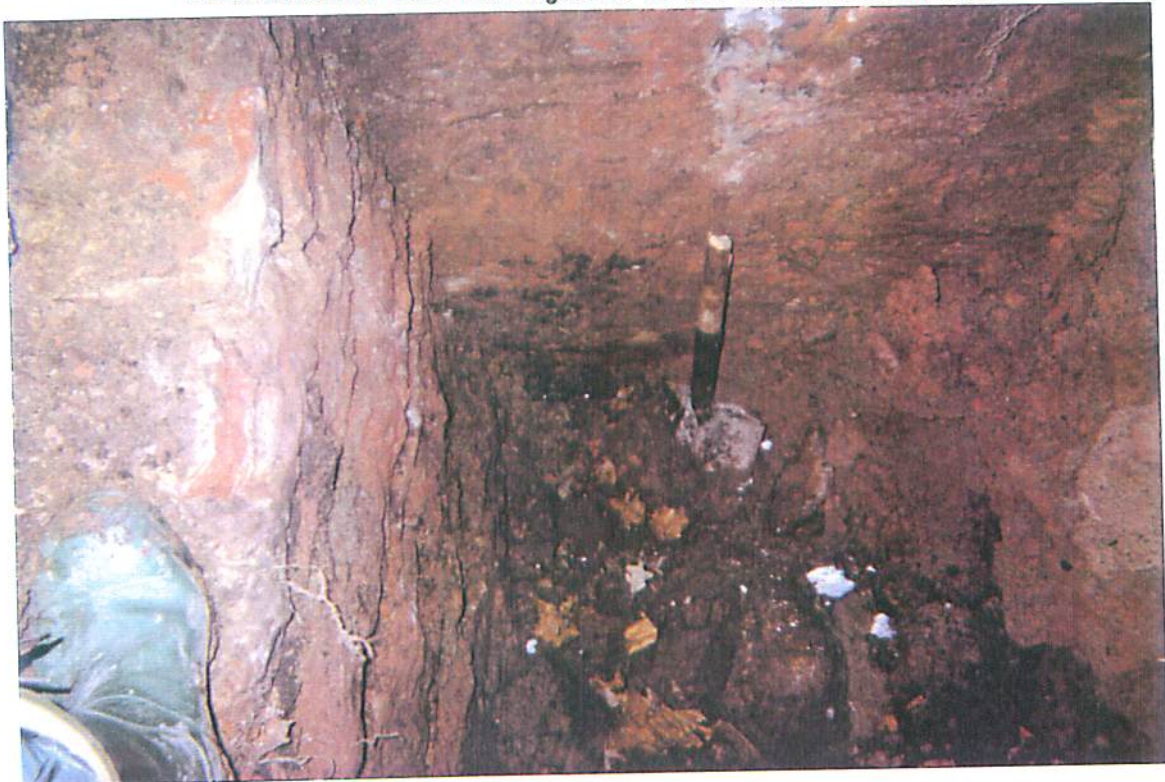
**PHOTOGRAPH #12**

**Test Pit with the Exposed Building's and Stairwell's Foundation Wall**

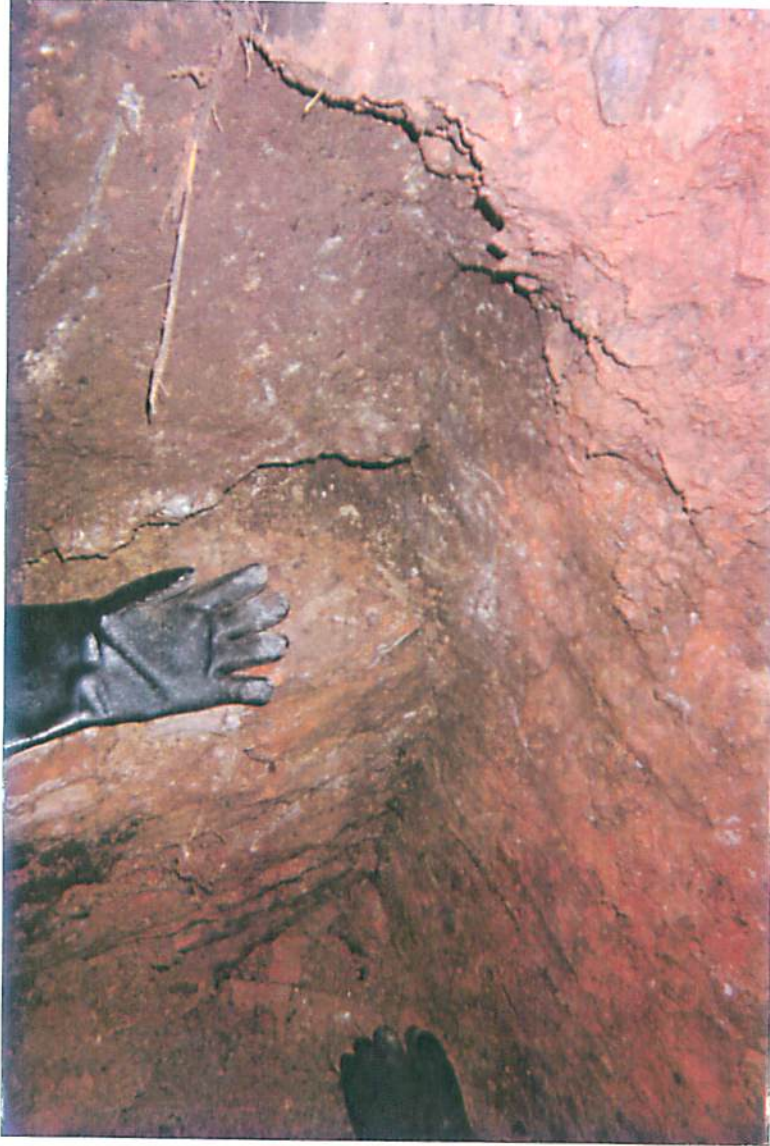
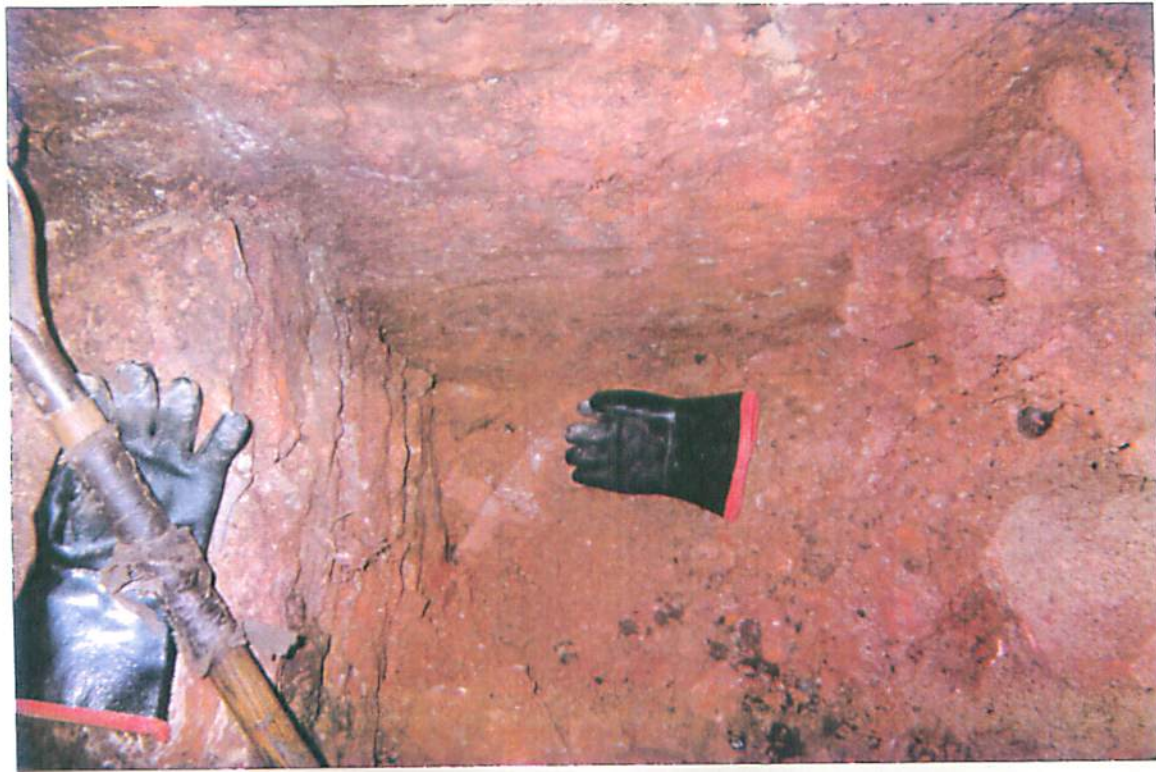
**PHOTOGRAPH #13 & #14**

In the test pit, reddish-brown heterogeneous fill was intercepted, extending down to the foundation level of the building. It is likely, that this fill (comprising silt, clay, sand and rock fragments up to "boulder" sizes) had been dumped around the foundation wall at the time of the construction of the dwelling. Neither weeping tile nor damp-proofing on the foundation wall was encountered. The backfill was wet because of poor drainage conditions around the building. Water seepage was intercepted at the bottom of the test pit, approximately 0.5 m below the basement floor level.

**Test Pit**  
**(Note the water seepage at the bottom of the pit)**

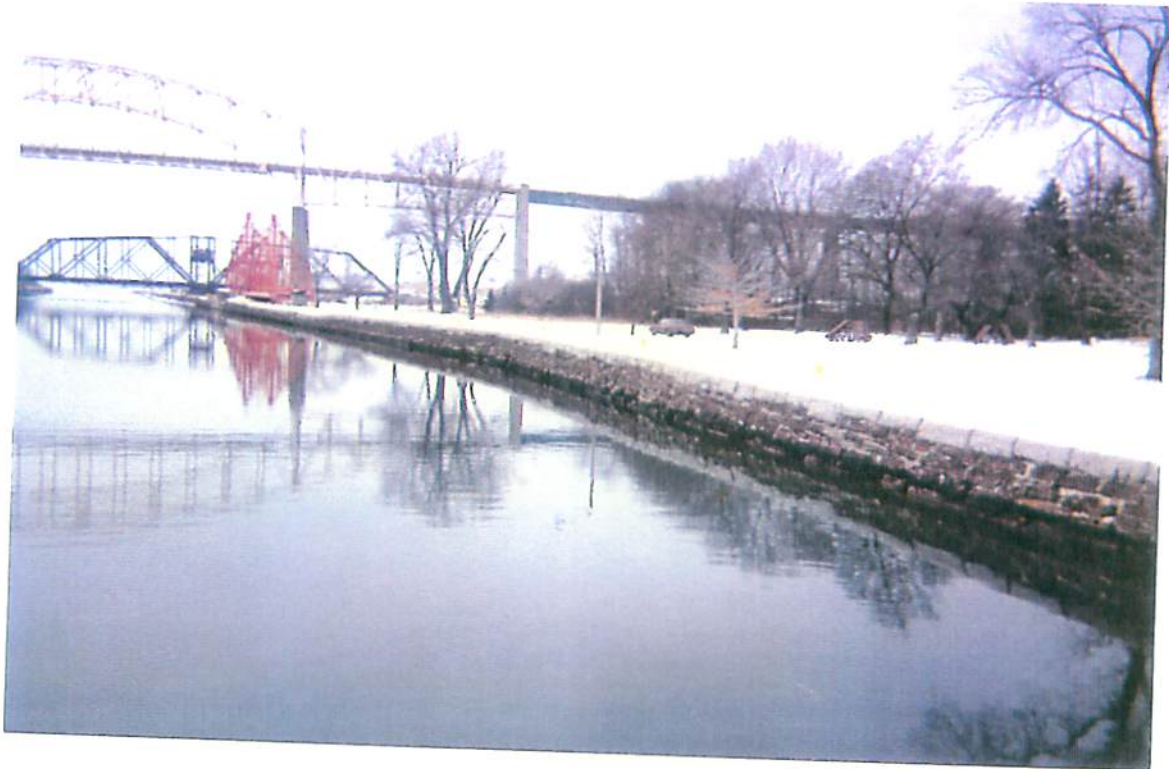
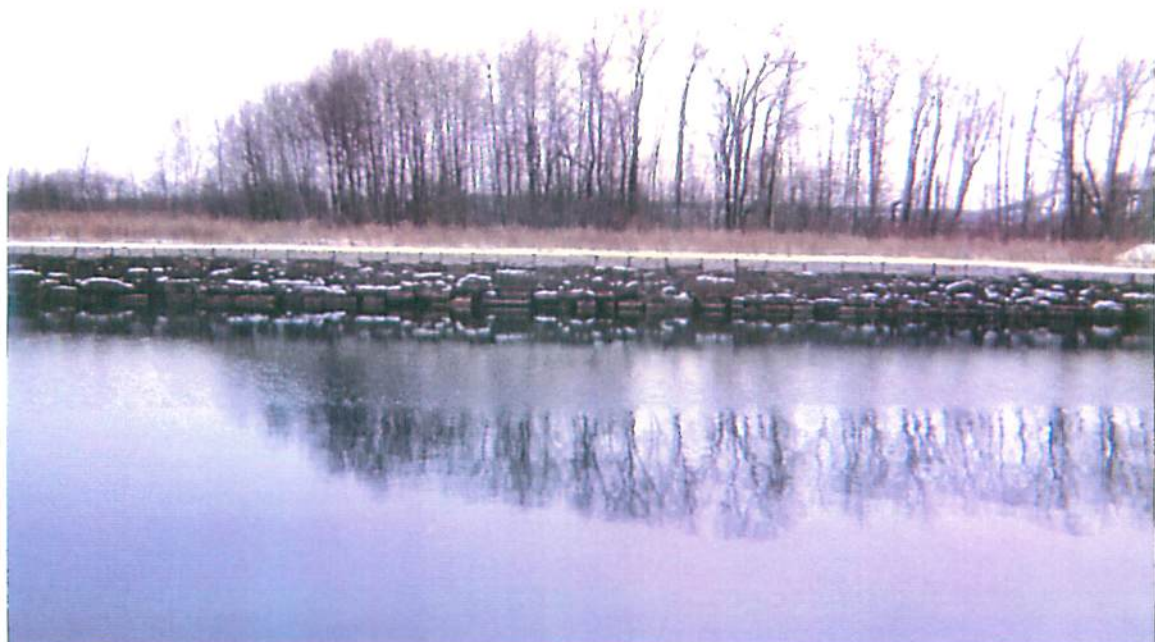
**PHOTOGRAPH #15 & #16**

As is visible on photographs 15 and 16, the water level in the canal may rise approximately 0.5 m above the recently noted elevation. With the higher water level there may be an estimated 0.2 m of water in the basement, which coincides with the reported sporadic water seepage problems.

**Sandstone Masonry Wall along the Canal**

**(Note the damage on the wall around the water level)**

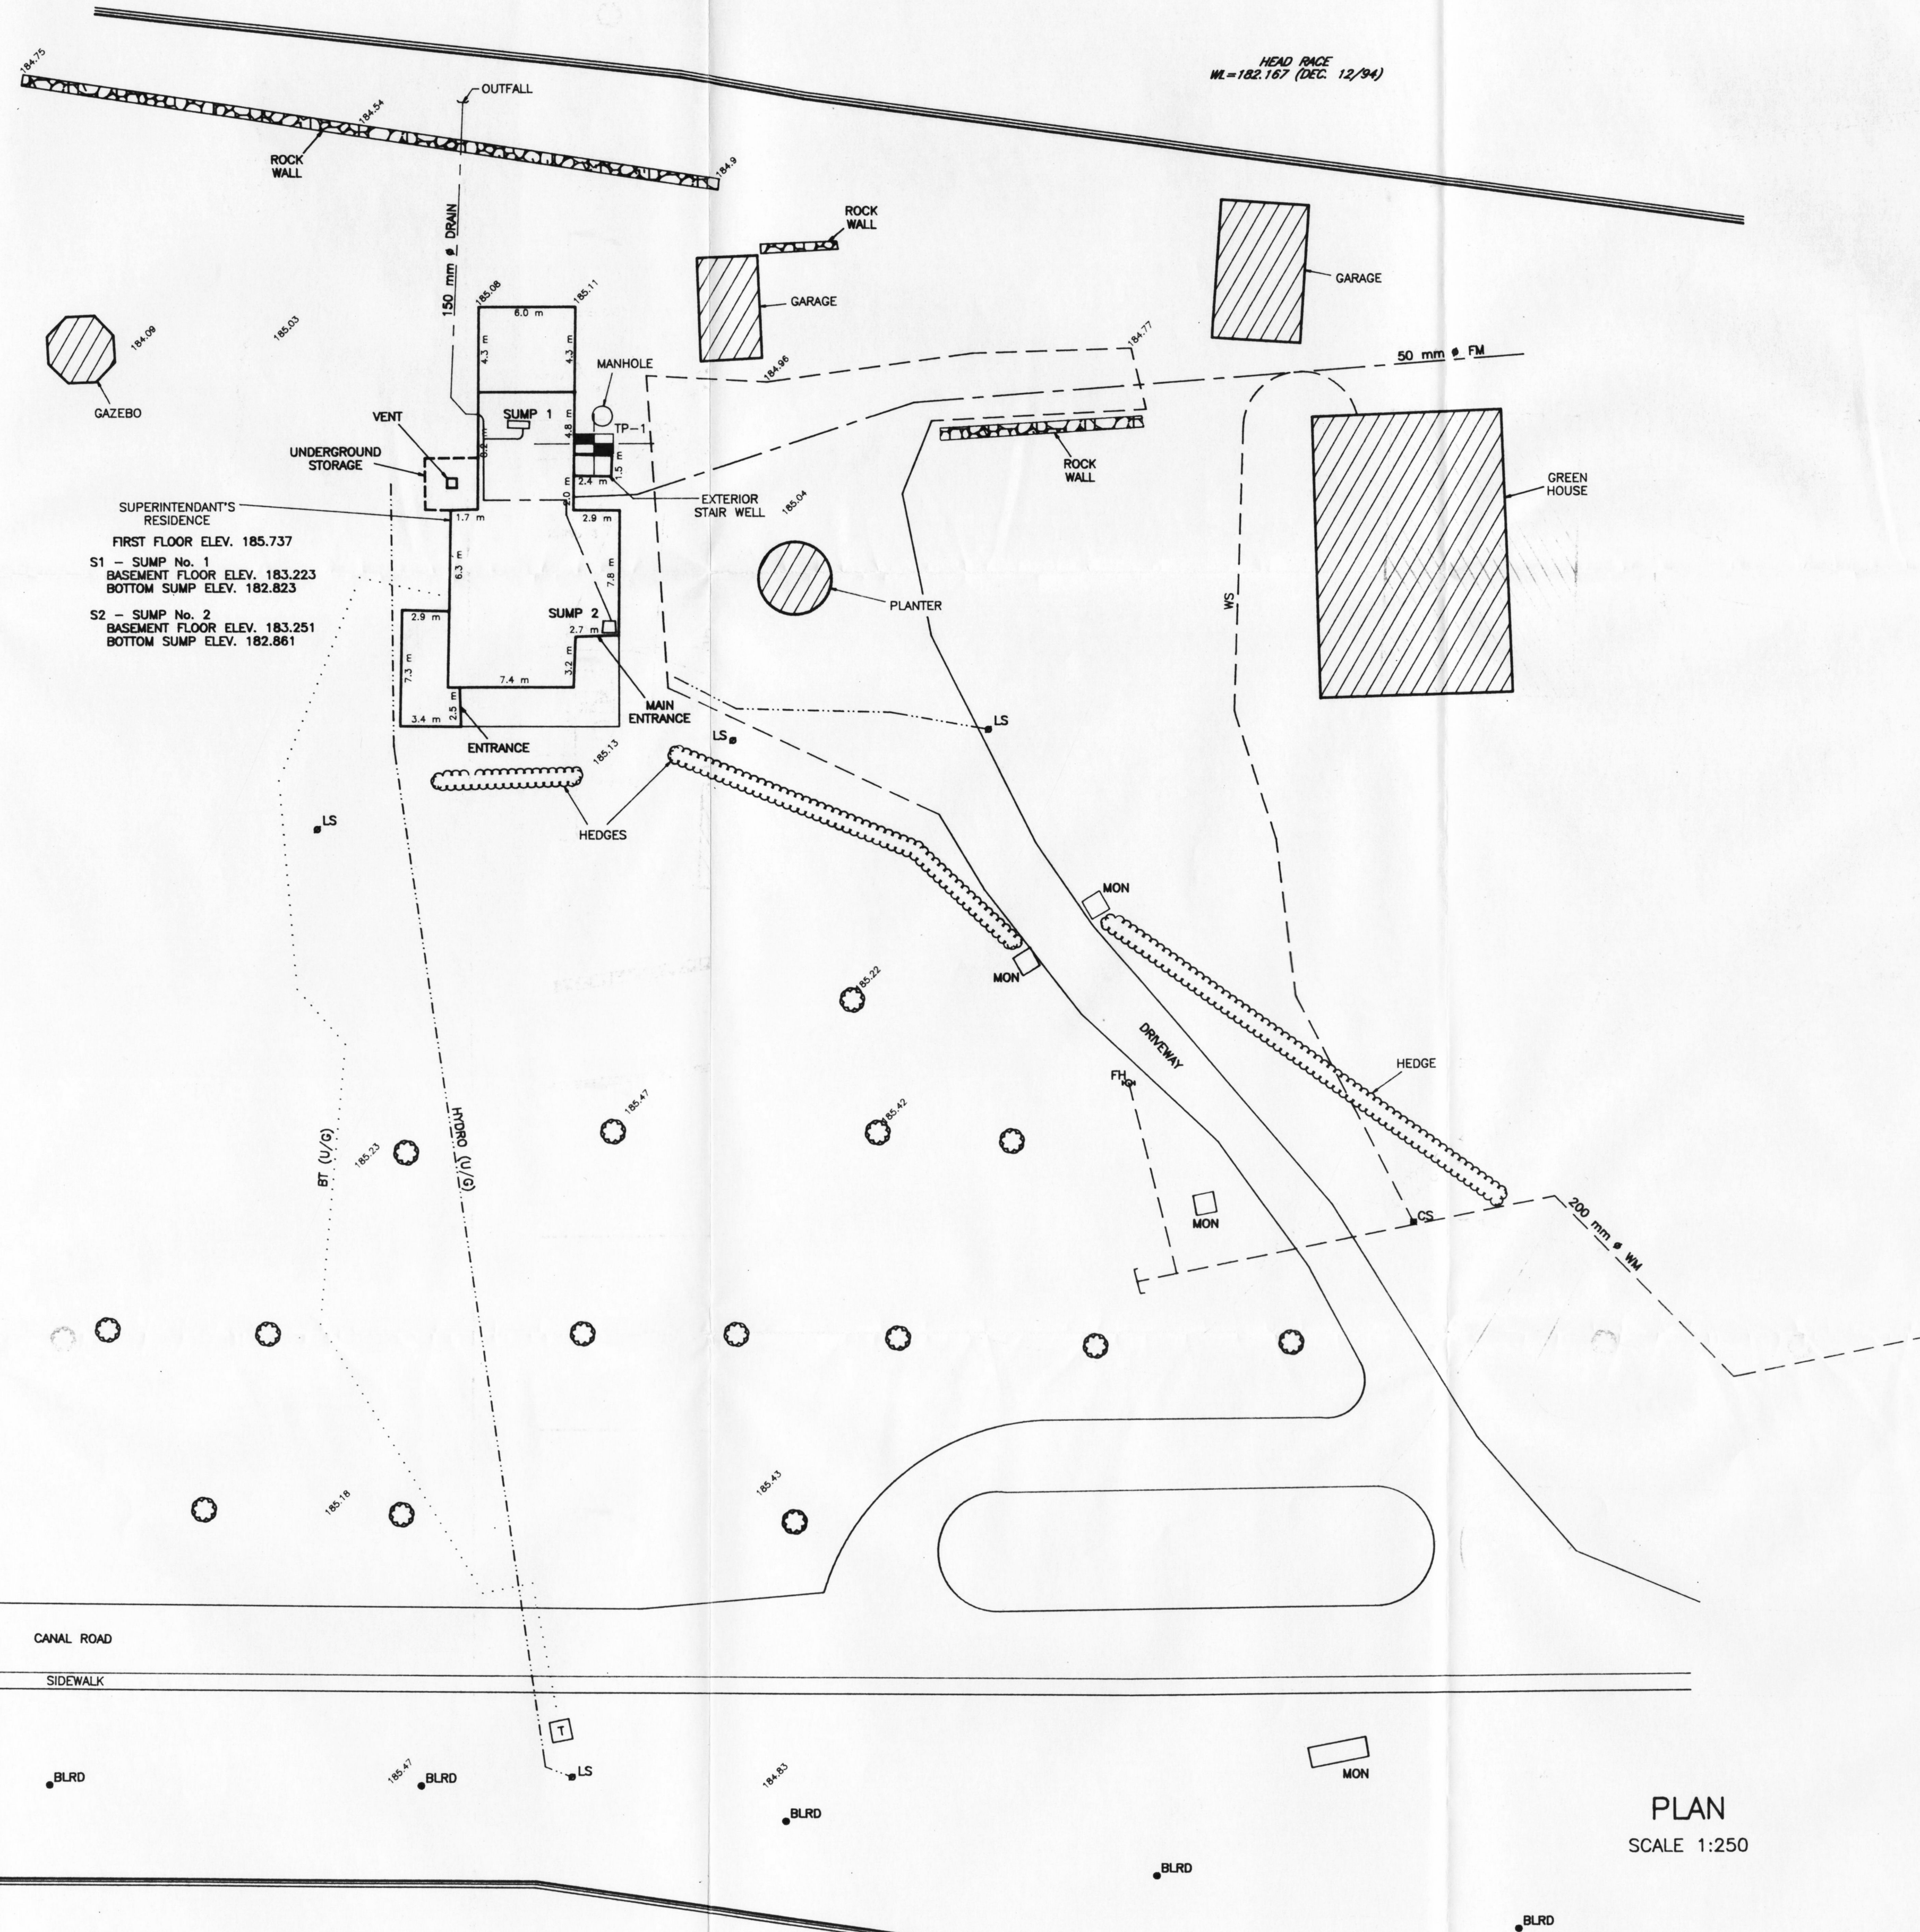
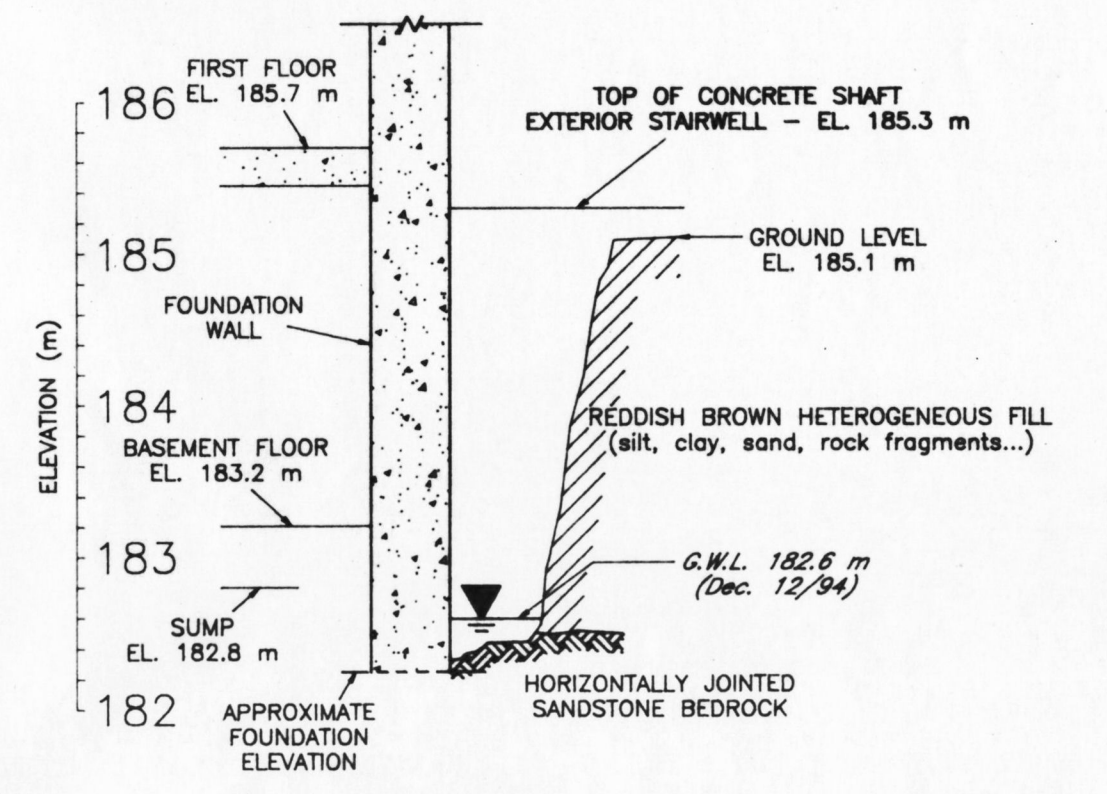
SUPERINTENDANT'S RESIDENCE  
 FIRST FLOOR ELEV. 185.737  
 S1 - SUMP No. 1  
 BASEMENT FLOOR ELEV. 183.223  
 BOTTOM SUMP ELEV. 182.823  
 S2 - SUMP No. 2  
 BASEMENT FLOOR ELEV. 183.251  
 BOTTOM SUMP ELEV. 182.861

HEAD RACE  
 WL=182.167 (DEC. 12/94)

SAULT CANAL  
 WL=182.907 (DEC. 12/94)
