ADDENDUM NO. 2

Project:	PESC Fume Hood Recapitalization	Project / File No:	190001
Project Address:	2645 Dollarton Avenue, North Vancouver, BC	Date:	August 24 th , 2017
Tender Issue Date:	2017-07-28		
Tender Close Date:	2017-08-28	No. of Pages:	Twenty-nine written pages.

PROJECT-SPECIFIC HAZARDOUS BUILDING MATERIALS ASSESSMENT – SITE REVIEW REPORT

Project:	Fume Hood Recapitalization Project		
Client:	Public Services and Procurement Canada	Stantec Project #:	123220871
Stantec Site Assessor:	Keith Irwin	Date of Site Visit:	April 25, 2017
Location:	Pacific Environmental Science Center, 2645 Dollarton Avenue North Vancouver, BC	Issue Date:	May 16, 2017

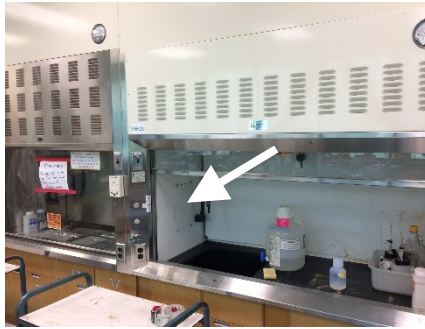
Location	Hazardous Building Material Observations	Photo	Samples collected?	Analytical Results
Main floor - fume hoods 28, 31 and 32	Potential asbestos-containing cement panel lining insides of fume hoods

CP-01	No Asbestos Detected
Mechanical mezzanine	Potential asbestos-containing red duct seam mastic applied to fume hood exhaust ducting

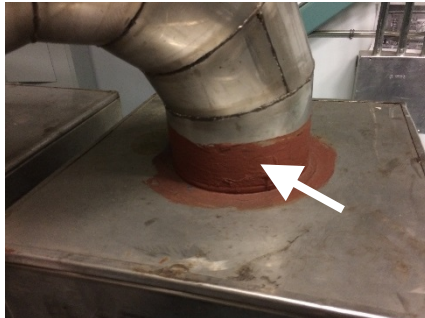
DM-01A DM-01B DM-01C	No Asbestos Detected

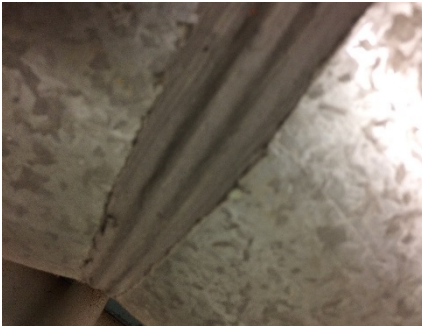
Location	Hazardous Building Material Observations	Photo	Samples collected?	Analytical Results
Mechanical mezzanine	Potential asbestos-containing grey duct seam mastic applied to supply air ducting

DM-02A DM-02B DM-02C	No Asbestos Detected
Roof	Potential asbestos-containing silver duct seam mastic applied to fume hood exhaust ducting

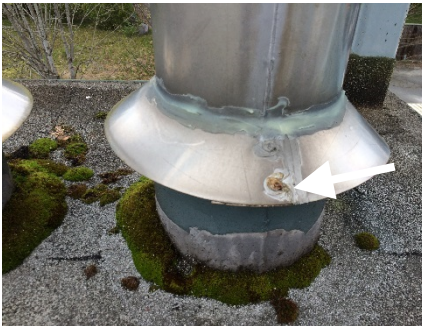
DM-03A DM-03B DM-03C	No Asbestos Detected
Roof	Potential asbestos-containing clear duct seam mastic applied to fume hood exhaust ducting

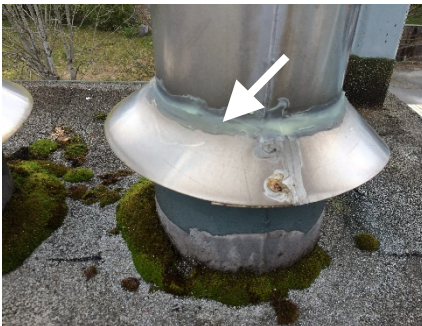
DM-04A DM-04B DM-04C	No Asbestos Detected
Roof	Potential asbestos-containing grey roof sealant applied to the base of fume hood exhaust ducting

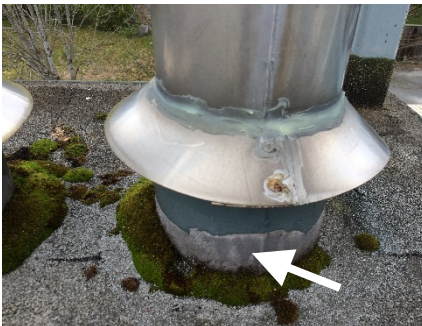
RS-01A RS-01B RS-01C	No Asbestos Detected

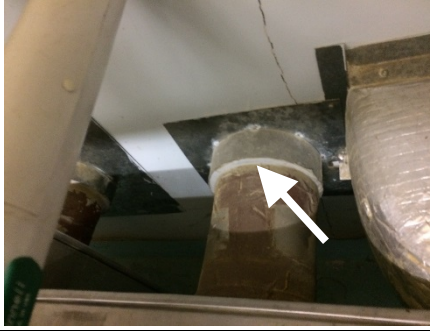
Location	Hazardous Building Material Observations	Photo	Samples collected?	Analytical Results
Mechanical mezzanine	Potential asbestos-containing grey fire stop applied to wall penetrations for fume hood exhaust ducting

FS-01A FS-01B FS-01C	No Asbestos Detected
Mechanical mezzanine	Potential asbestos-containing cream fire stop applied to floor penetration for fume hood 27 exhaust ducting	No Photo Available	FS-02A FS-02B FS-02C	No Asbestos Detected
Main electrical room	Potential asbestos-containing red fire stop applied to wall penetration for sprinkler system piping	No Photo Available	FS-03A FS-03B FS-03C	No Asbestos Detected
Main electrical room	Potential asbestos-containing orange fire stop applied to wall penetration for electrical conduit	No Photo Available	FS-04A FS-04B FS-04C	No Asbestos Detected
Roof	Potential asbestos-containing white/clear roof flashing mastic applied to seams of roof flashing around fume hood exhaust manifold

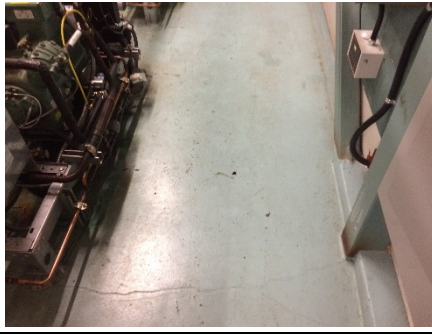
Location	Hazardous Building Material Observations	Photo	Samples collected?	Analytical Results
Mechanical mezzanine	Potential asbestos-containing concrete floor sealant applied to the floor

CFS-01A CFS-01B CFS-01C	No Asbestos Detected
Throughout	Potential asbestos-containing drywall joint compound

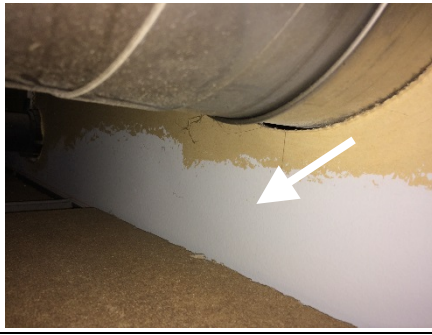
DJC-01A DJC-01B DJC-01C DJC-01D DJC-01E	No Asbestos Detected
Roof -	Potential asbestos-containing bitumen roof membrane on fume hood exhaust manifold

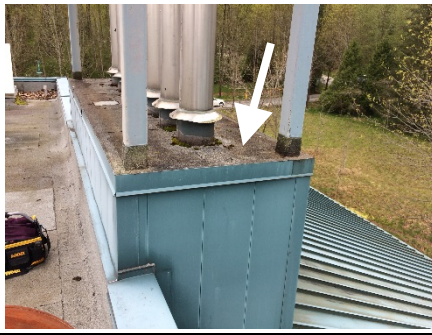
RM-01A RM-01B RM-01C	No Asbestos Detected
Block B – Room 106 laboratory storage cabinet	Previously presumed asbestos-containing cement (“Transite”) panel on the interior areas of the cabinet – no longer present in this location

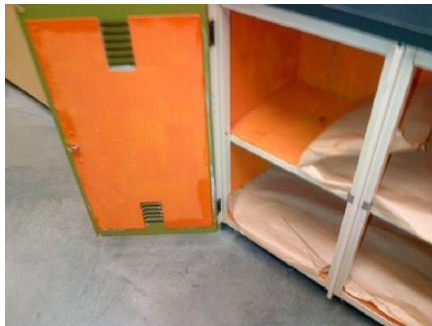
Not sampled in Initial Assessment Report – listed as “presumed ACM”	No longer present

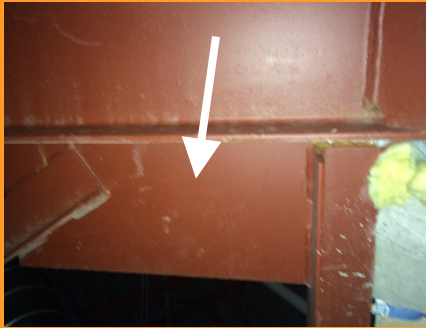
Location	Hazardous Building Material Observations	Photo	Samples collected?	Analytical Results
Throughout	Suspected lead-containing red paint on structural steel beams

P-01	1,900 ppm lead
Mechanical mezzanine	Suspected lead-containing green paint on structural steel bracing and columns throughout

- If LCPs or other lead-containing equipment/materials within the subject building are to be disturbed and/or removed during the Project ensure compliance with the following:

- The transportation requirements of the Federal Transportation of Dangerous Goods Regulation
- Corrective action or remedial work on paint applications containing any concentration of lead should be undertaken in a manner so as to avoid generating fine particulate matter or dust (i.e., avoid sanding). Airborne lead dust or fumes should not exceed the BC Reg. 296/97 eight-hour occupational exposure limit (OEL) of 0.05 mg/m³ during the removal of paints and products containing any concentration of lead. The use of personal protective equipment is recommended to reduce the potential for over-exposure to lead dust.

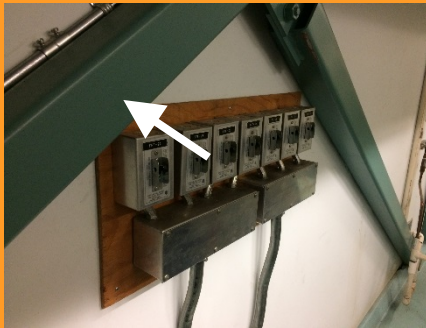
P-02	450 ppm lead (current assessment) 1,800 ppm lead (Initial Assessment Report)
Mechanical mezzanine	Suspected lead-containing yellow paint on structural steel beams, bracing, columns and Q-decking throughout

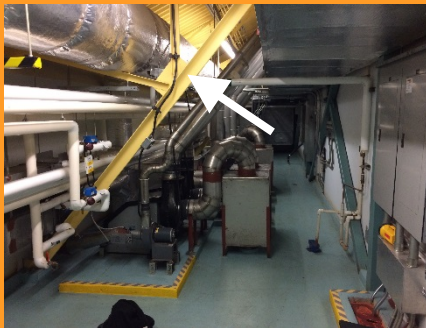
P-03	5,600 ppm lead
Mechanical mezzanine	Suspected lead-containing green paint on concrete floor throughout

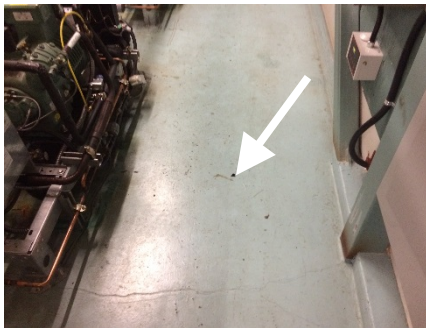
P-04	<90 ppm lead

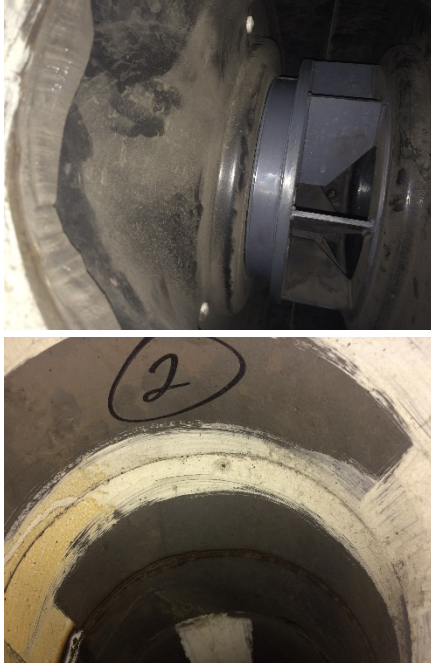
Location	Hazardous Building Material Observations	Photo	Samples collected?	Analytical Results
Throughout subject areas	Lead (presumed) in: <ul style="list-style-type: none"> • Lead-acid batteries used in emergency lighting • Solder used in bell fittings for cast iron pipes and in electrical equipment 	No photo available	Expected to be present within the subject areas; not sampled	N/A
Fume Hoods (general)	Information pertaining to the operations and types of chemicals used in each fume hood was provided by PESC staff, and is attached to this document for reference. Chemicals with potential for "reactive" residues (e.g., picric acid or perchloric acid) do not appear to have been used.			
Mechanical mezzanine – Exhaust fan for fume hood 32	General dust observed on inner ducting surfaces. No particulate consistent with chemical residue/deposits observed Trace amounts of chemical deposits, if present, would not be present in significant quantities to require disposal as "hazardous waste"

- Lead is also presumed to be present in:
 - Lead-acid batteries used in emergency lighting
 - Solder used in bell fittings for cast iron pipes and in electrical equipment

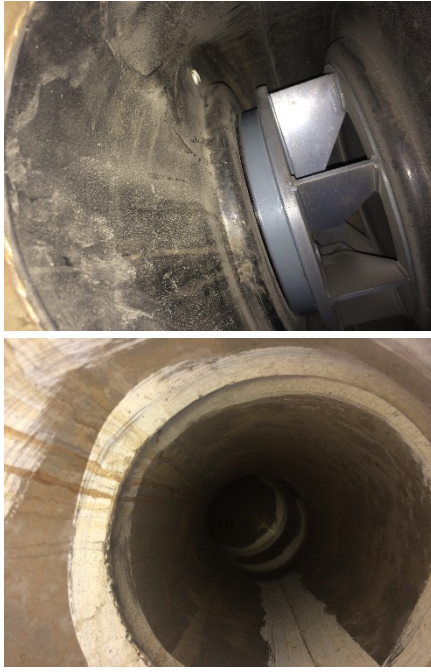
Location	Hazardous Building Material Observations	Photo	Samples collected?	Analytical Results
Mechanical mezzanine – Exhaust fan for fume hood 29	<p>General dust observed on inner ducting surfaces.</p> <p>No particulate consistent with chemical residue/deposits observed.</p> <p>Liquid staining consistent with condensation observed.</p> <p>Trace amounts of chemical deposits, if present, would not be present in significant quantities to require disposal as "hazardous waste"</p>

- Based on a review of information provided by site staff regarding fume hood use and observation of interior conditions of fume hood ducting and exhaust systems chemical residues/deposits do not appear to be present in types, forms or amounts that would require significant special handling or disposal procedures during the Project.

- As a measure of diligence in protecting the health and safety of workers conducting removal of fume hood ducting, and due to the potential for trace hazardous residues to be present on the inside of such ducting, the following should be implemented during dismantling fume hood ducting and exhaust systems:

- Avoid skin contact with duct interior surfaces and/or exhaust system components through the use of disposable, chemically resistant gloves (e.g. rubber or nitrile) while dismantling/handling ducting and other exhaust equipment

- Use of N95 (at minimum) type respirators
 - Wash hands and exposed skin with soap and warm water after handling ducting, and prior to eating, drinking or smoking

- Do not eat, drink or smoke in the work area
