XCG File No. 1-336-191-01
December 2, 2014

**DESIGNATED SUBSTANCES AND
HAZARDOUS MATERIALS SURVEY
CANADA'S COAST GUARD BASE
PARRY SOUND, ONTARIO
R.064667.007**

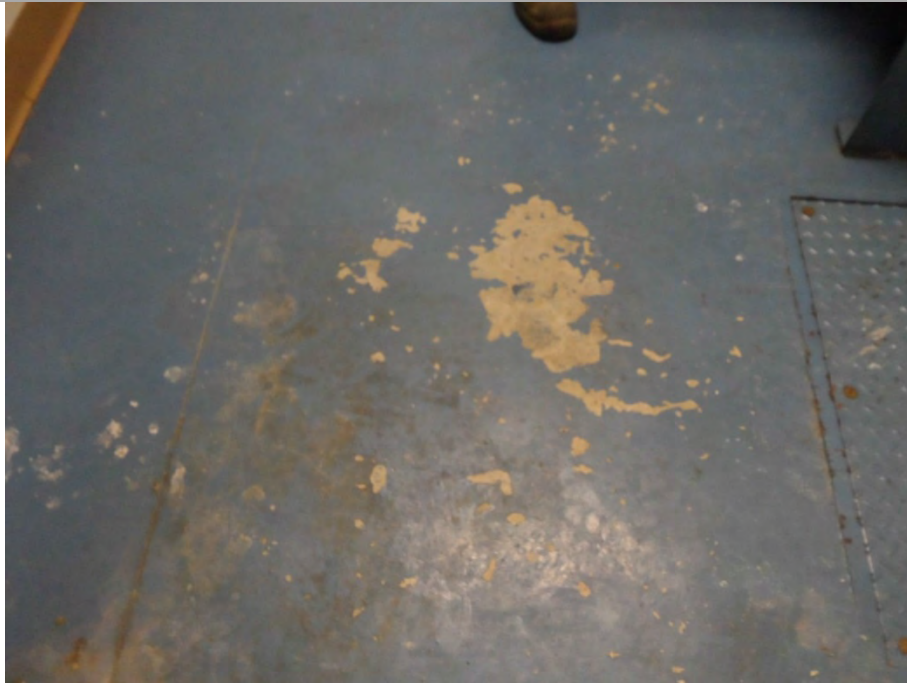
Photo 1: Main Building Room 179 blue interior floor paint – Lead-containing (Sample 179-P-12).

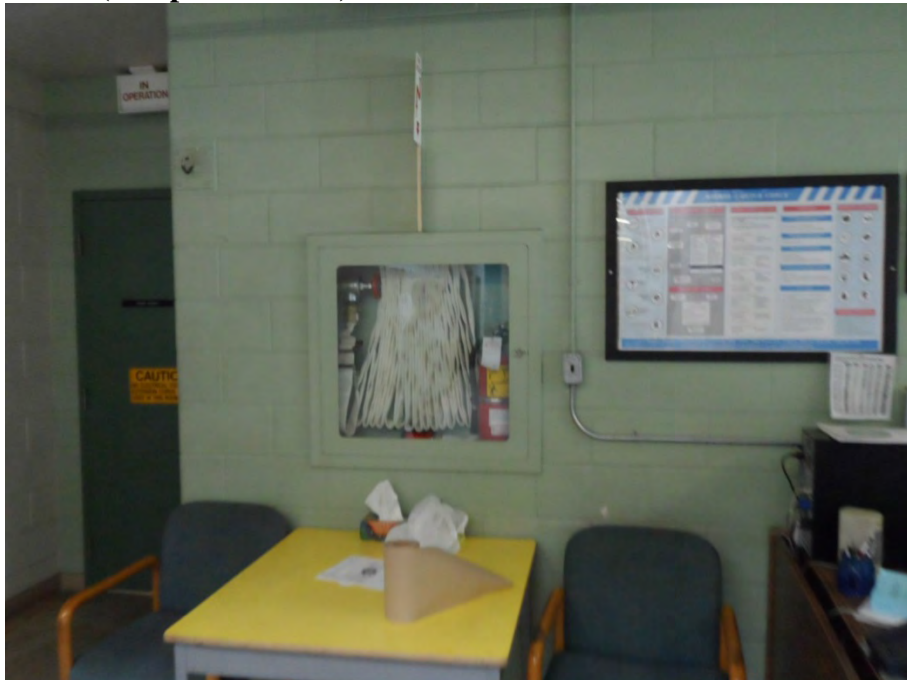
Photo 2: Main Building Room 123 Light green interior wall paint – Lead-containing (Sample 123-P-18).

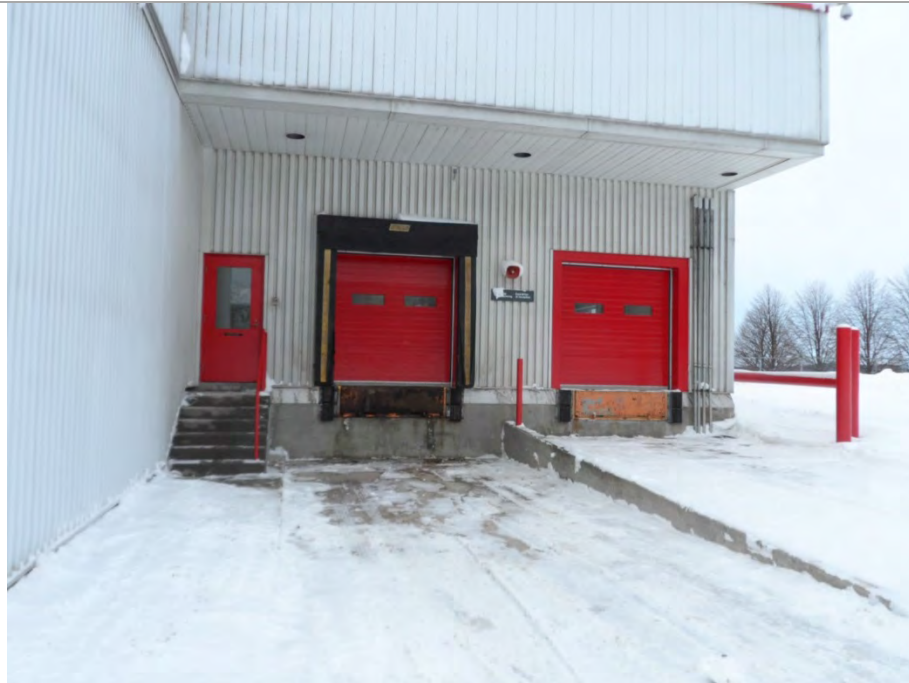
Photo 3: Main Building exterior red trim paint–Lead-containing (Sample Admin-P-29).

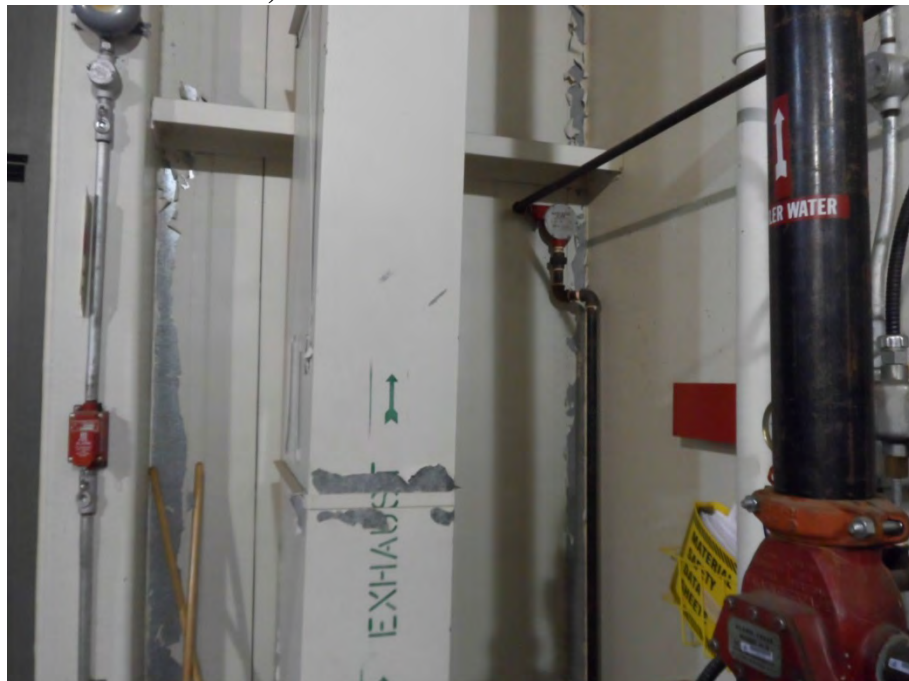
Photo 4: Hazard Storage Building cream interior wall paint – Lead-containing (Sample Haz-P-25).

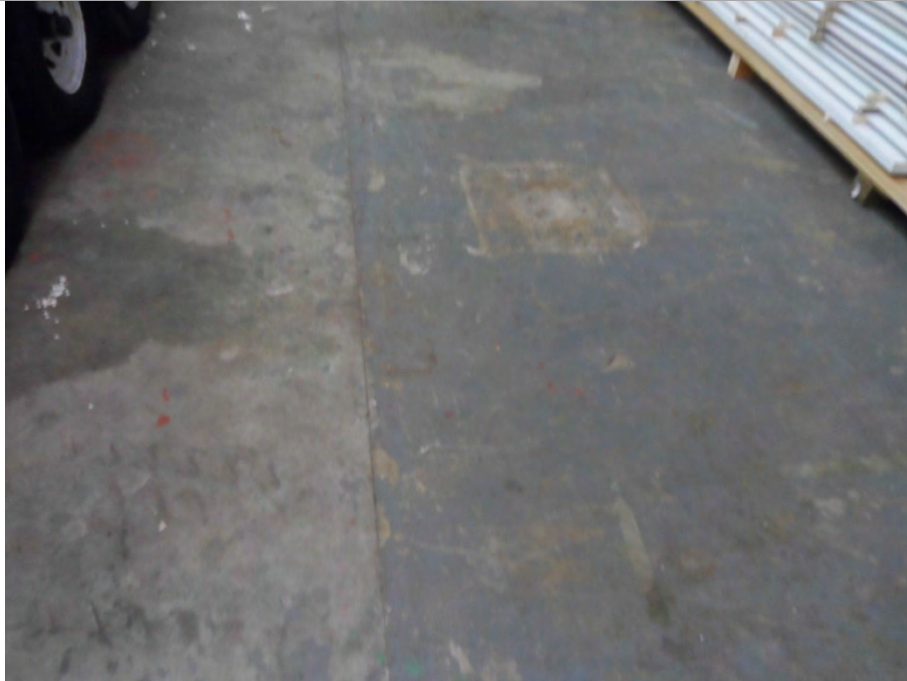
Photo 5: Ship stores grey floor paint – Lead-containing (Sample SHP-P-27).

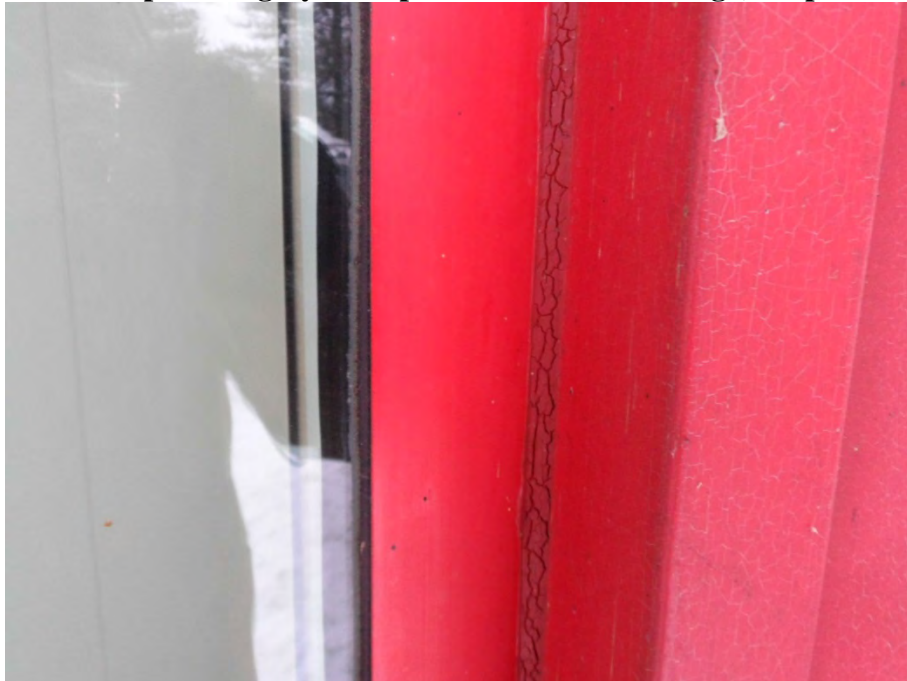
Photo 6: Main Building exterior red siding – Lead-containing (Sample Admin-P-29).

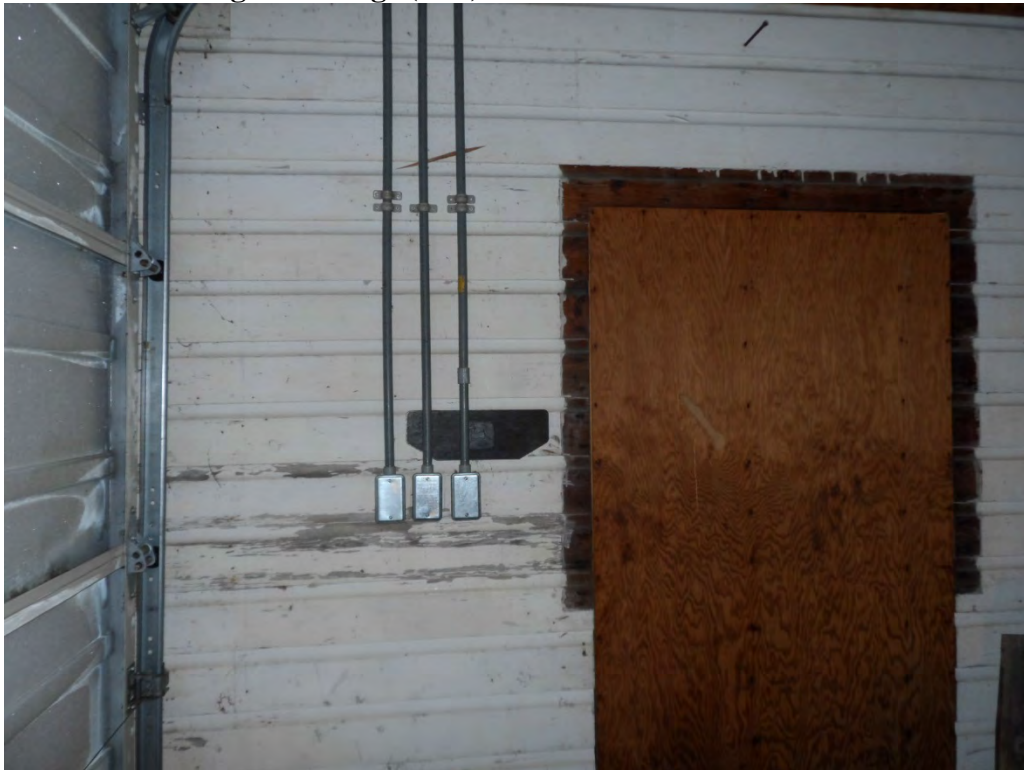
Photo 8: Storage Building (east) white interior siding paint – Lead-containing (Sample STR1-P-31).

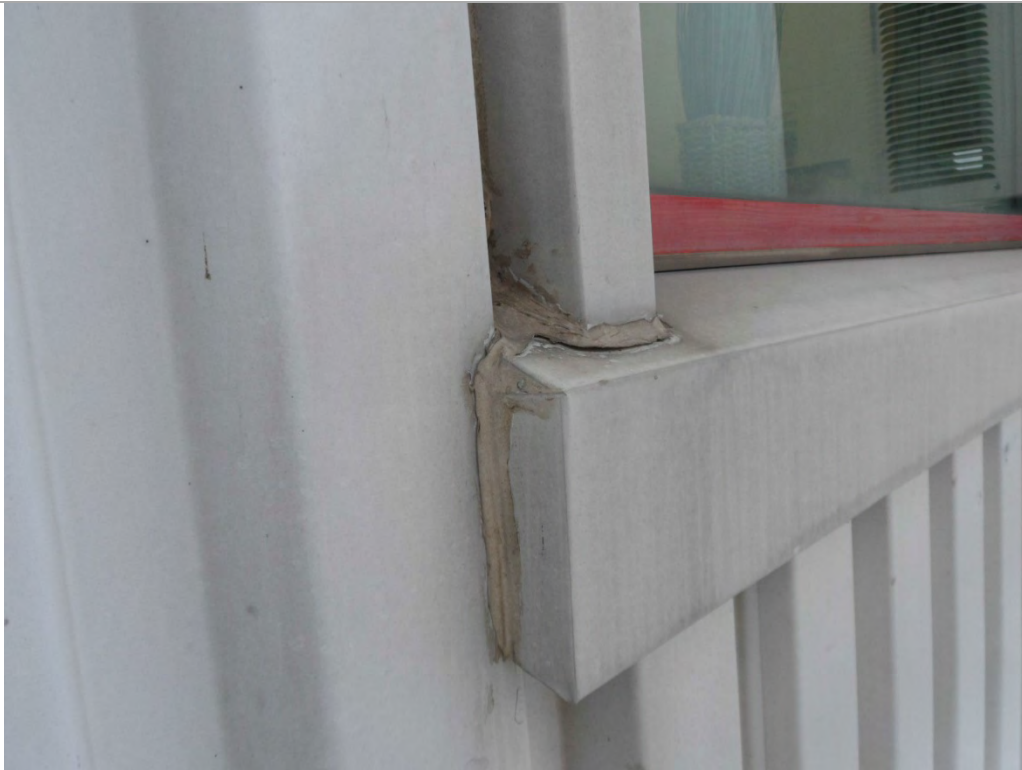
As identified in above Table 4, sample Admin-P-30 was laboratory reported as “Void” due to insufficient sample to analyze. This was due to the extremely thin well adhered factory finish on the grey exterior siding. XCG recommends that the grey exterior siding be treated as lead-containing. In order to collect sufficient sample volume, XCG estimates approximately >2 square metres of paint would need to be removed, which exceeds normal sample collection expectations.

Photo 9: Main Building grey exterior siding paint - Lead-Containing (Sample Admin-P-30).

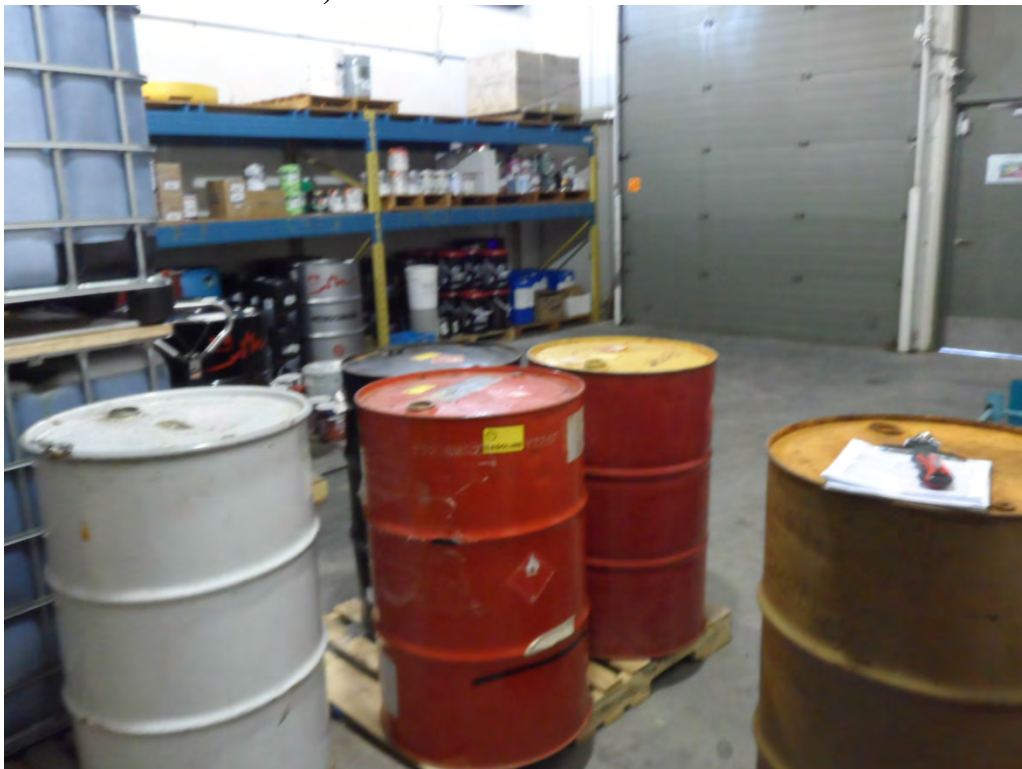
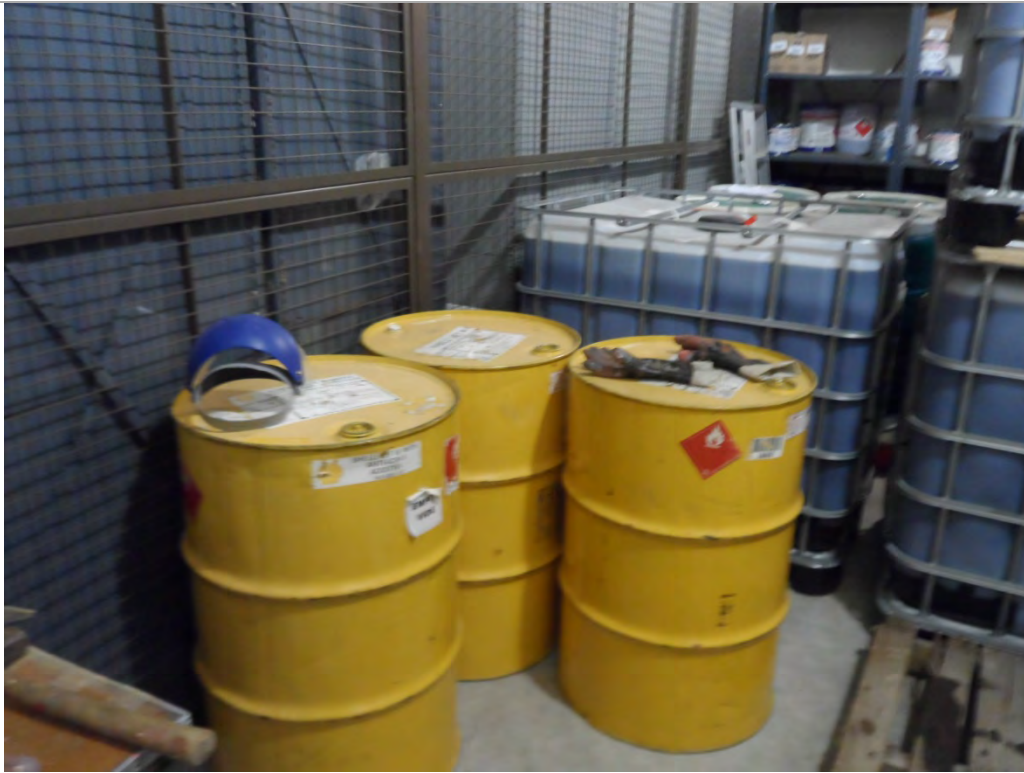
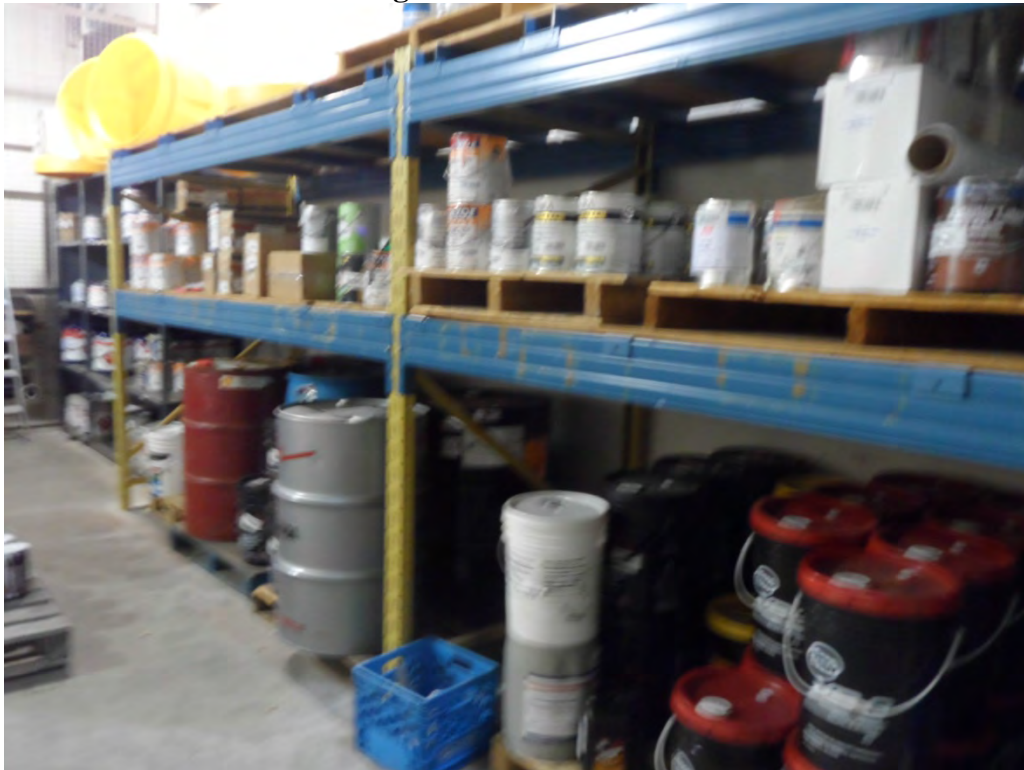
- **Fuel, Oil, and/or Waste Oil Storage and Chemical Storage:** Various chemicals were observed within the Flammable Storage. The chemicals observed included, but were not necessarily limited to: gasoline, fuel, oil, various gases, hydraulic oils, and paints. Two large above ground tanks (ASTs) containing aircraft jet fuels were observed south of the Flammable Storage building. A waste oil storage AST was observed north of the Helicopter Hangar. In addition, other chemicals such as hydraulic oil, injection oil, battery acid, paints, and finishes were observed stored

Based on observations made during the site reconnaissance, no obvious issues/concerns were observed related to the on-site storage of chemicals. It is recommended that an environmental compliance audit be conducted to assess whether the fuel, oil, waste oil and chemicals are being stored and managed in accordance with applicable legislation and federal policies/procedures. This compliance assessment was beyond the scope of this DSHMS.

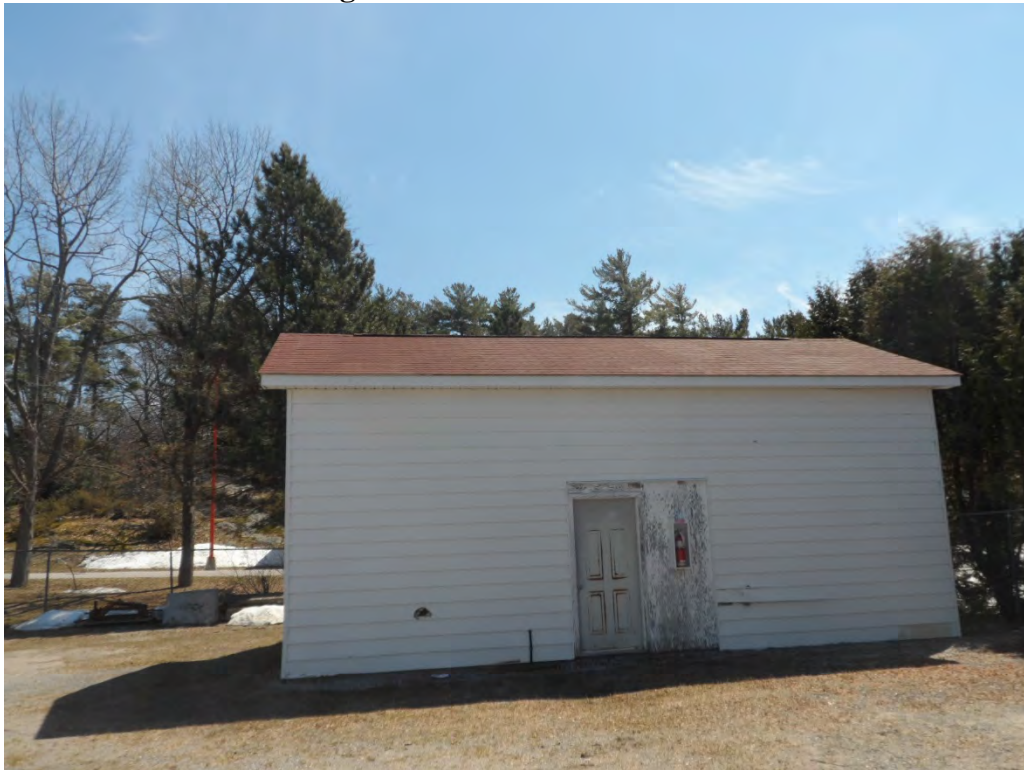
Mould/water damage was observed within the storage building identified as "Garage (Samuel Risley Storage)" located near the entrance to the subject site. The mould/water damage was observed on the underside of the plywood ceiling and was most likely caused by a leaking roof. On-site staff commented that the leaking roof has been repaired. No other evidence of mould/water damage was observed; however, numerous on-site staff commented that the Main building has had reported leaks recently. Based on the comments made by on-site staff, the potential for mould growth exists, even if not observed during XCG's site reconnaissance.

Photo 20: Garage (Samuel Risley Storage) recently replaced shingle roof.

Based on observations made during the assessment, XCG recommends further investigation of the ceiling and attic space of the building identified on-site as “Garage (Samuel Risley Storage).” As a result of historic roof leakage, there was mould growth and significant water staining observed on the underside of the plywood ceiling. The potential for additional mould exists within the attic space.
