# **FINAL Hazardous Building Materials Assessment**

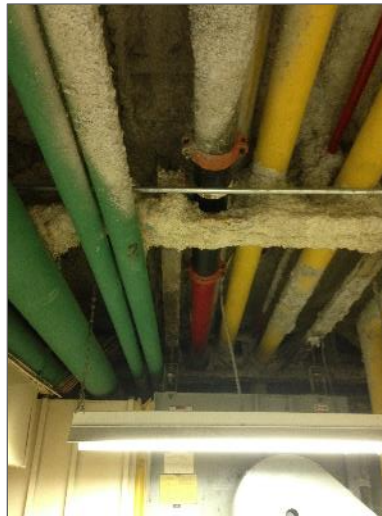
Asbestos was not detected in the fireproofing samples.

Non-asbestos fireproofing present within various mechanical rooms.

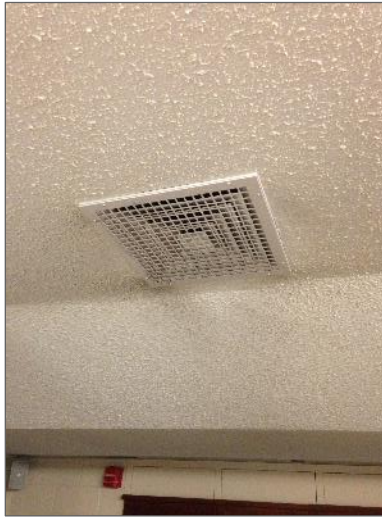
Texture finish is present on drywall ceilings in the Chapel. No asbestos was detected in the texture coat samples.

Non-asbestos texture coat present in the Chapel.

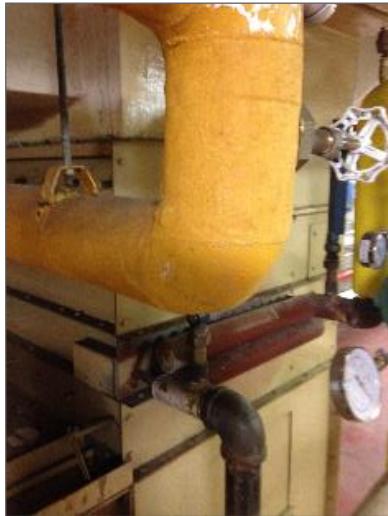
Asbestos pipe elbow in Cell Block Tunnels

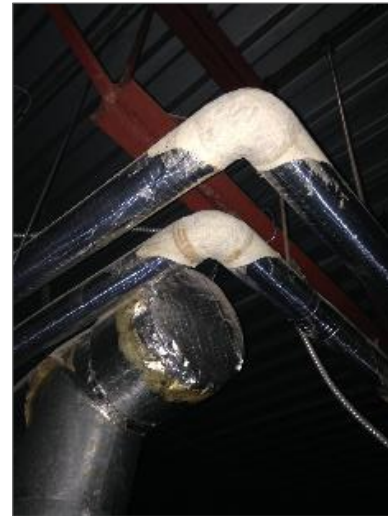
Asbestos pipe elbows in Executive Services

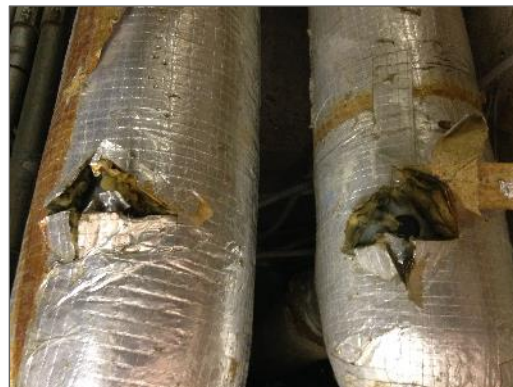
Example of non-asbestos ducting present.

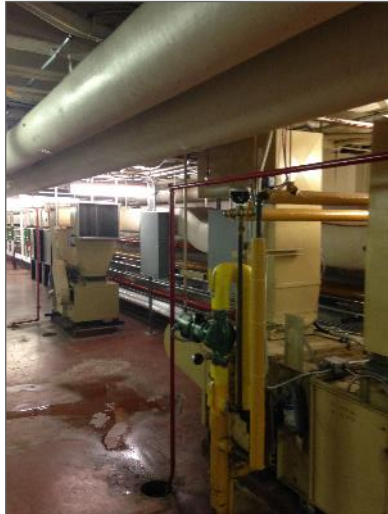
Example of mechanical equipment present.

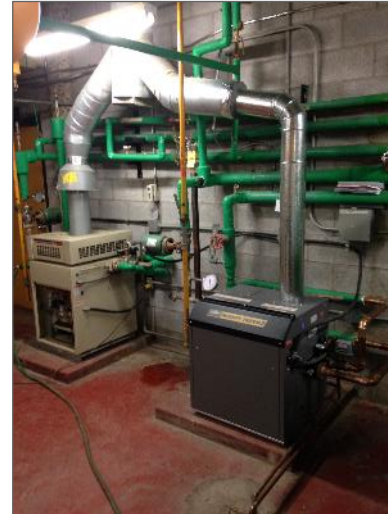
Example of uninsulated mechanical equipment present.

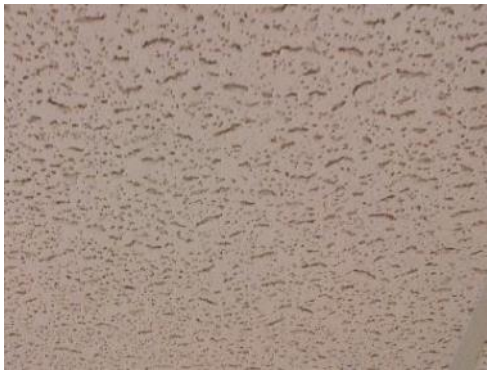
Non-asbestos lay-in ceiling tiles, Sample S0012, Contact Visiting Room.

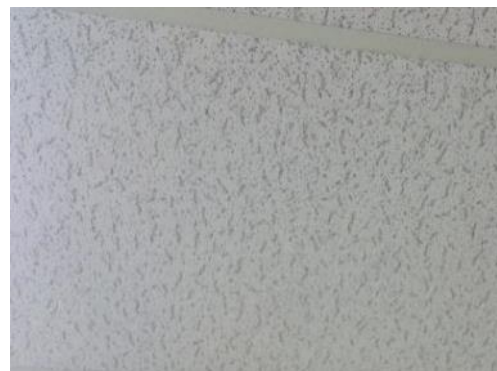
Non-asbestos lay-in ceiling tiles, Sample S0023, Engineering And Maintenance.

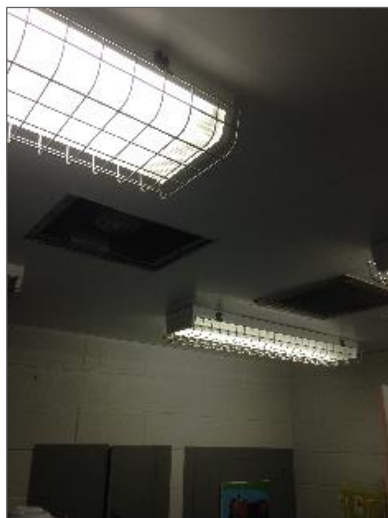
Asbestos containing Drywall Joint Compound in Medication Room

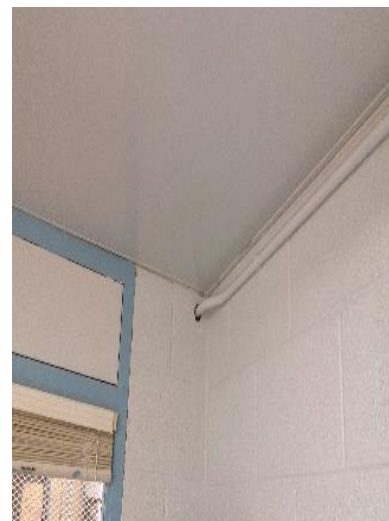
Asbestos containing Drywall Joint Compound in room S22, Engineering and Maintenance

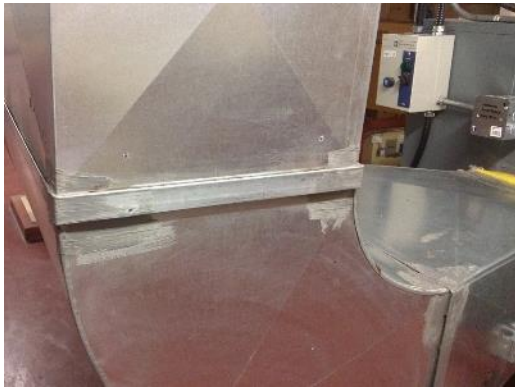
Non-asbestos "silver" mastic, Sample S0006, Southwest Mechanical Room.

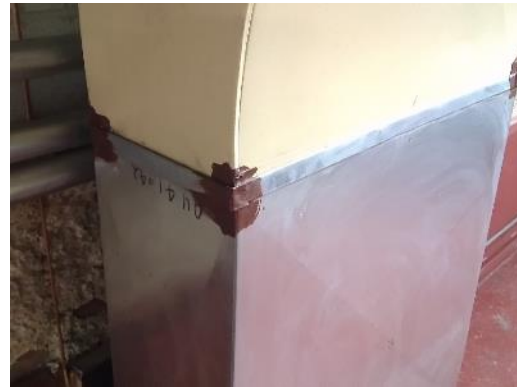
Non-asbestos "red" mastic, Sample S0007, Southwest Mechanical Room.

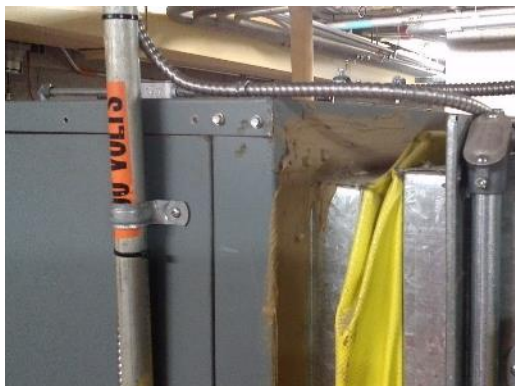
Non-asbestos "brown" mastic, Sample S0008, Southwest Mechanical Room.

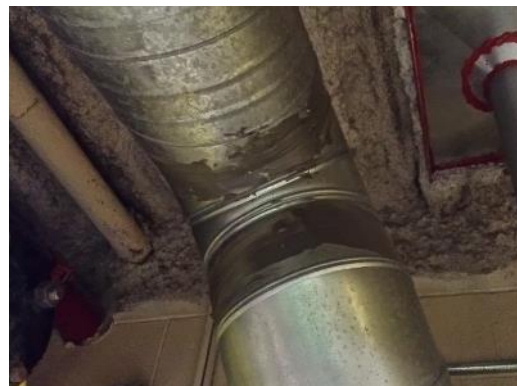
Non-asbestos "grey" mastic, Sample S0016, Segregation Block Mechanical Room.

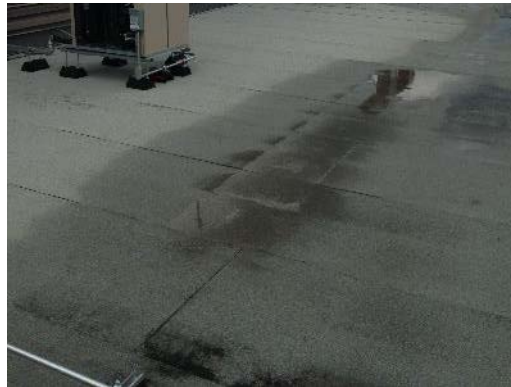
Built-up roofing is present on the roof over the entire assessment areas. The built up roofing materials do not contain asbestos (sample S0020A-H).

Non-asbestos roofing materials.

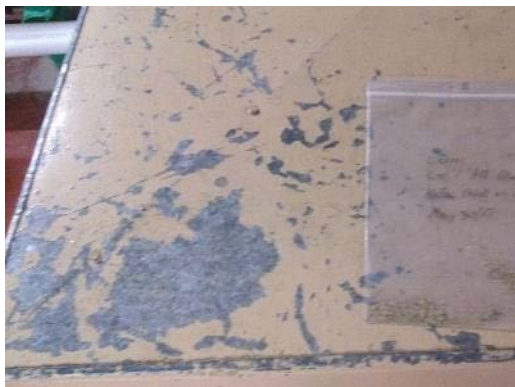
Lead-based "yellow" paint, Sample L0001.

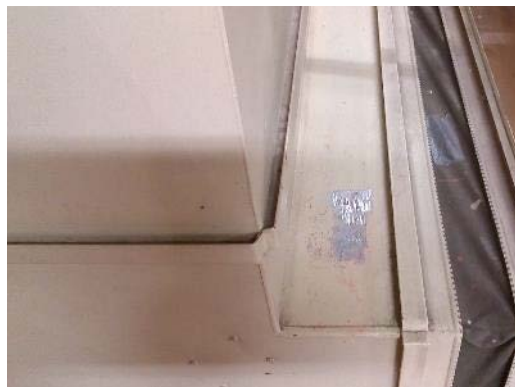
Lead-based "beige" paint, Sample L0002.

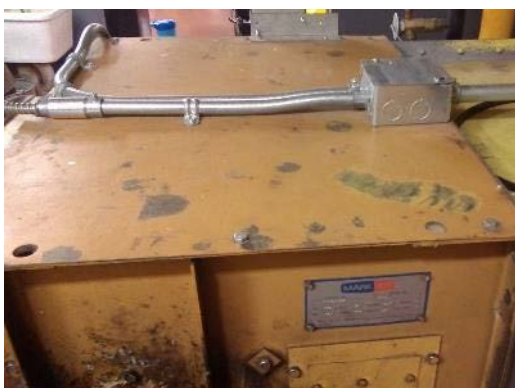
Lead-based "brown" paint, Sample L0003.

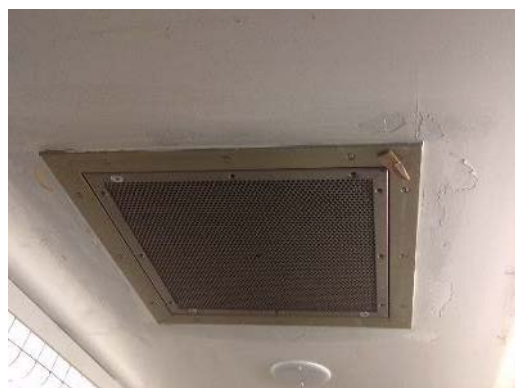
Lead-based "white" paint, Sample L0004.

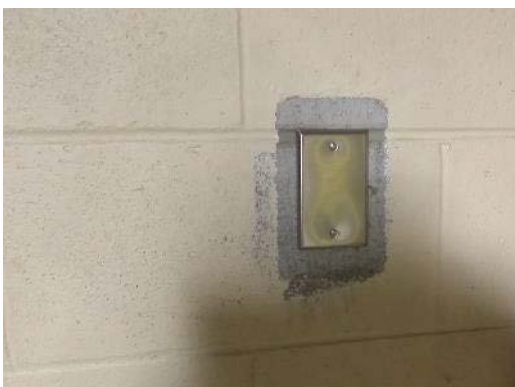
Lead-based "beige" wall paint, Sample L0005.

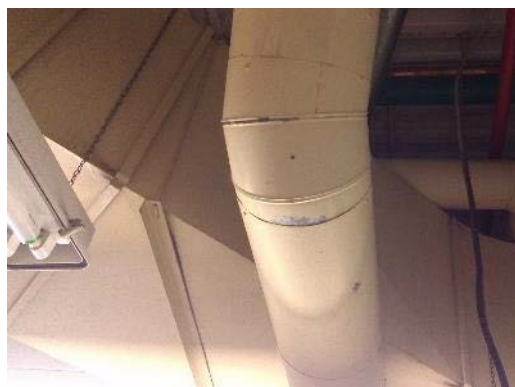
Lead-based "beige" paint, Sample L0006.

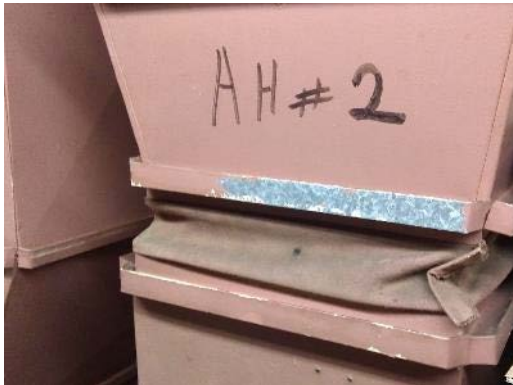
Lead-based "pinkish-brown over beige" paint, Sample L0007.

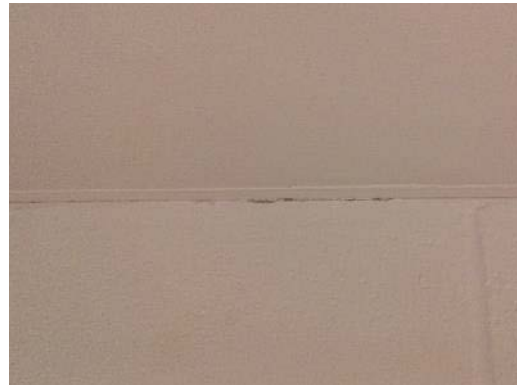
Lead-based "grey" paint, Sample L0008.

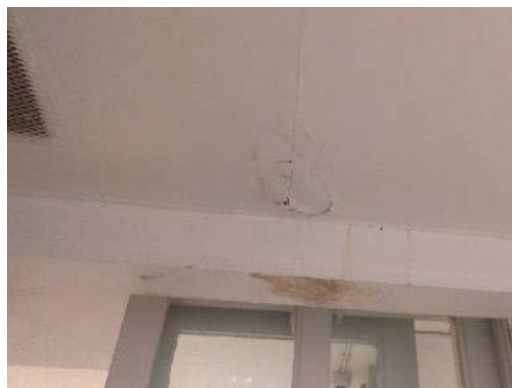
Grey wall and ceiling paint that did not have elevated levels of lead was flaking/peeling in the A and B Cell Blocks, central area:

Peeling non-lead based paint in Cell Block A and B office
