ANNUAL REASSESSMENT OF ASBESTOS-CONTAINING MATERIALS

C.D. HOWE BUILDING

240 SPARKS STREET, OTTAWA, ONTARIO

GEC Project No. 29702

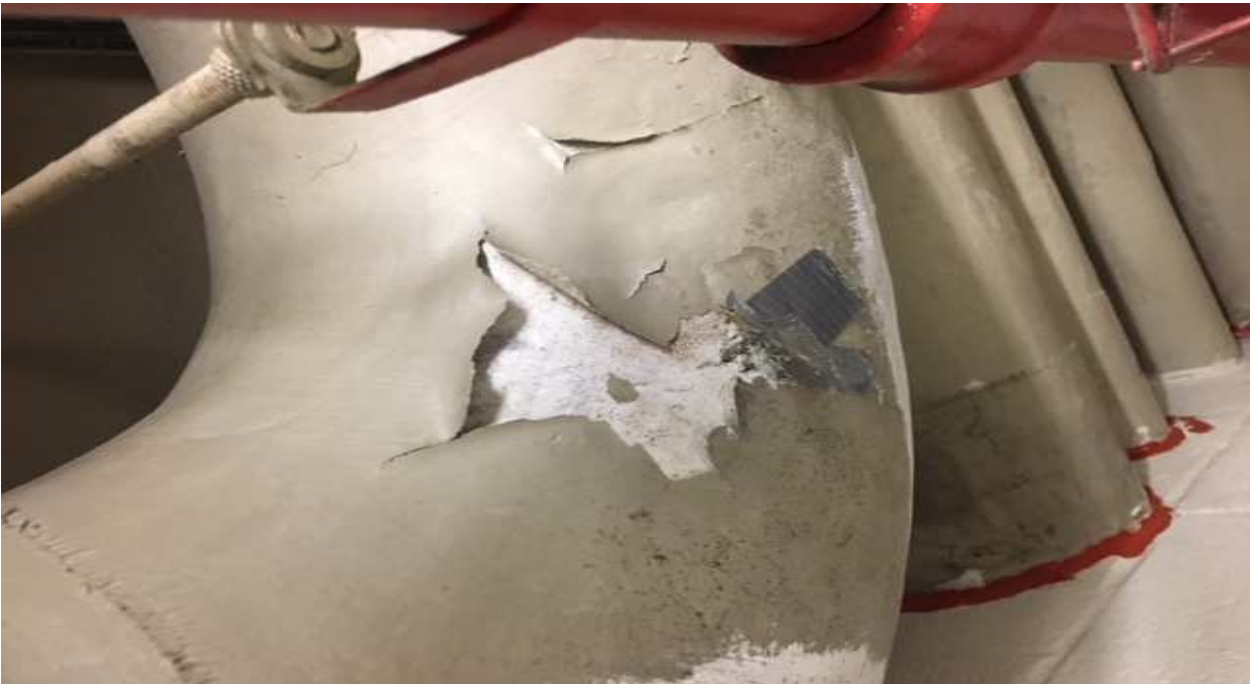
Photo #1. Example of damaged paring cement fitting outside room S-125.

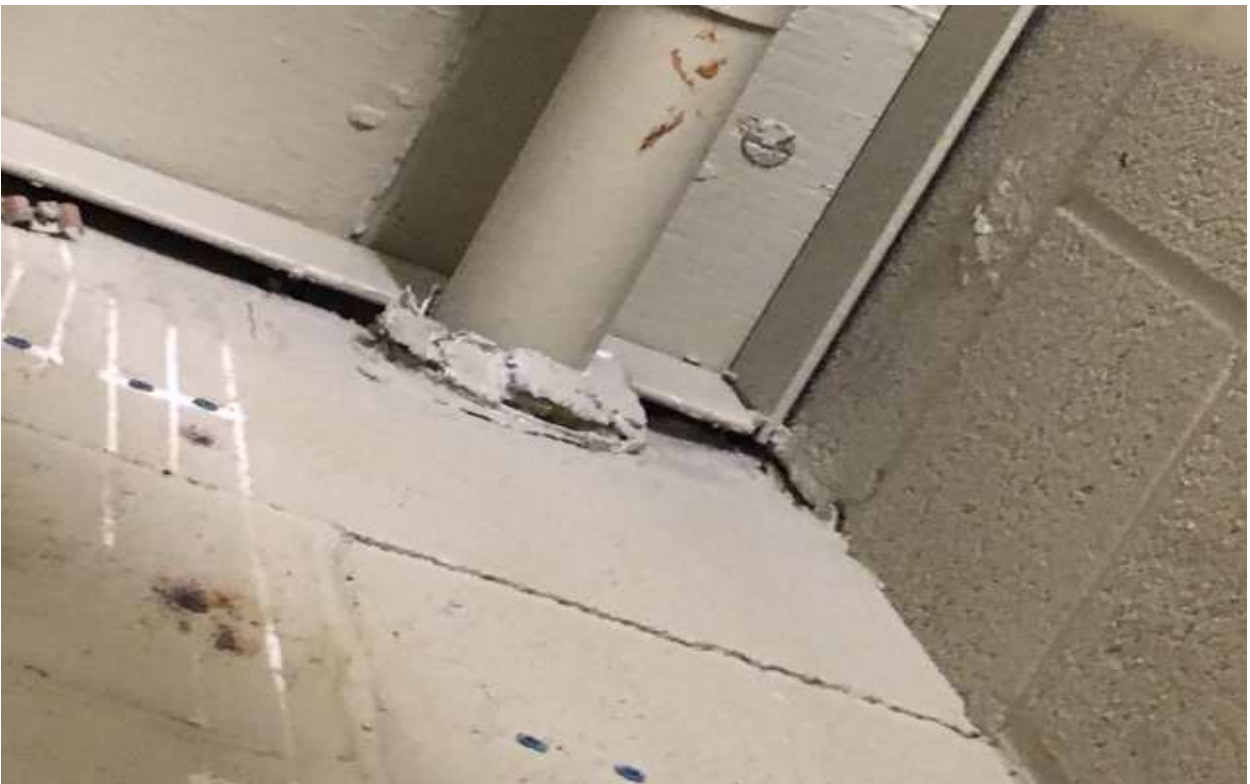
Photo #2. Example of damaged firestop Mechanical Room 331.

* Should BGIS wish to encapsulate Firestop deemed to be in fair condition, ensure the encapsulate material is such that time and temperature will not transform the structure of the material and subsequently further damage the asbestos-containing Firestop (i.e., pull away from wall).

ACMs in FAIR condition observed in various locations throughout the building as indicated in **Table 4** GEC. recommends the repair to be completed by following Type 2 procedures. The required work comprises of encapsulating the noted materials within the building.
