TPSGC/PWGSC

**Building Condition Report - Daniel J. MacDonald Site Charlottetown
P200153A**

161 Grafton
Daniel J. MacDonald Site Charlottetown P200153A
P200153-101-20000522
Charlottetown
Construction Year: 1984
Gross Area (SM): 16,435
Date of Most Recent Assessment: 06/02/17

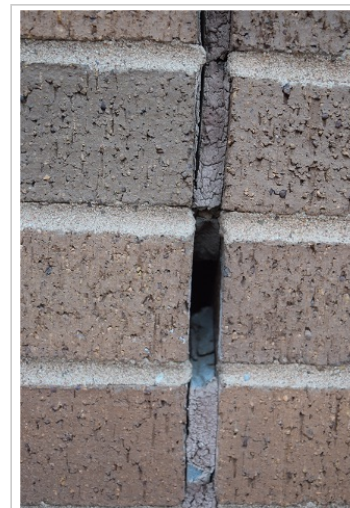
Control Joint Repairs

Moisture infiltration into the wall system; possible damage by insects or other animal pests entering the wall system.

Priority	1- Year 1	Category	I - Reliability
Estimated Cost	\$3,102	FY Action Date	2018

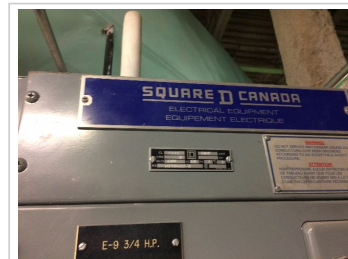
Replace Motor Control Center

Adjustment factor changed to 0.3 as the MCC would cost \$44,000 to replace.

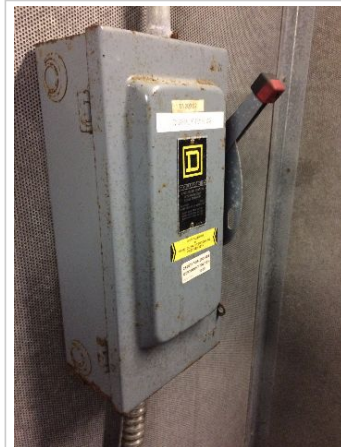
Replace Branch Wiring Devices - 60A Disconnect Switch

Adjust factor changed to 0.5 as a more accurate cost for a 60A disconnect is approximately \$1500.
