Hazardous Building Materials Assessment – 2 Buildings

40 Willow Avenue E, Souris, MB
and 276 1st Street SW,
Minnedosa, MB

February 27, 2017

Pinchin File: 201843

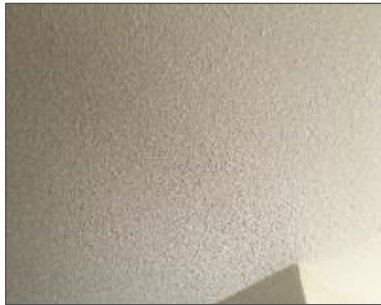
Texture finish is present applied to drywall ceiling in the Souris residence (samples 0003A-C). No asbestos was detected in the texture coat samples.

Photograph No. 1 – Texture coat on the drywall ceilings in the Souris residence.

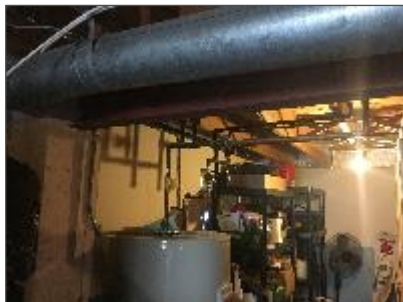
Pipes are either uninsulated or insulated with non-asbestos fibreglass.

Photograph No. 2 – All piping in both building are either uninsulated, or insulated with fibreglass.

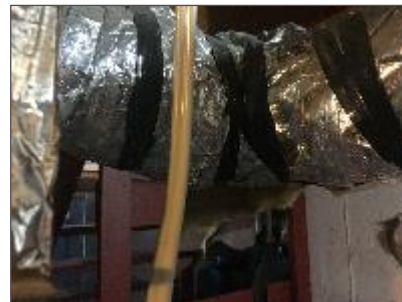
Photograph No. 3 – All piping in both building are either uninsulated, or insulated with fibreglass.

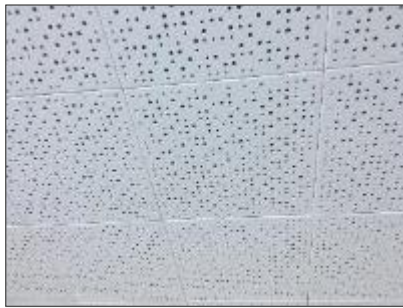
Photograph No. 4 – 12" x 12" wood fibre ceiling tiles in the Souris detachment.

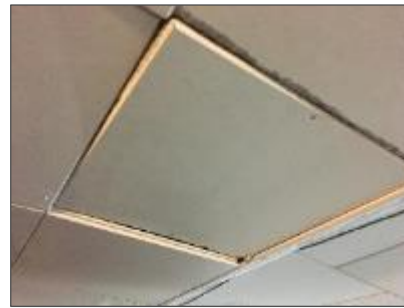
Photograph No. 5 – 12" x 12" ceiling tiles sampled from the basement of the Souris residence.

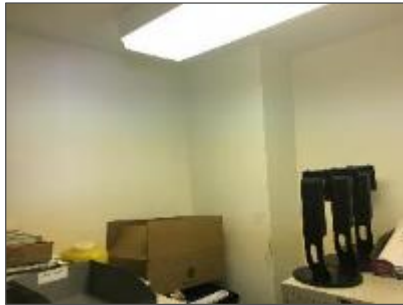
Drywall (gypsum board) and drywall joint compound is present as a wall and ceiling finish in both detachments. Based on the results of the testing (samples 0001A-C, 0005A-C, 0009A-C, and 0011A-C), the drywall joint compound in the Souris detachment, the basement of the Souris residence, the second floor of the Minnedosa detachment, and the main floor of the Minnedosa detachment, contains chrysotile asbestos.

Photograph No.6 – Drywall as a wall finish in the Souris detachment.

Remove all ACM prior to renovation, alteration, maintenance or demolition work or if ACM may be disturbed by the work.

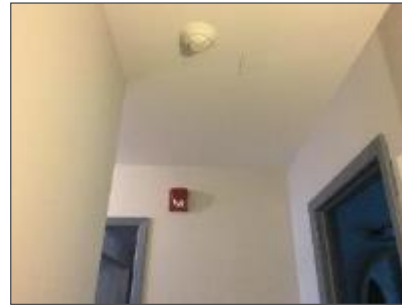
Photograph No. 7 – Drywall as a wall and ceiling finish in the Minnedosa detachment.

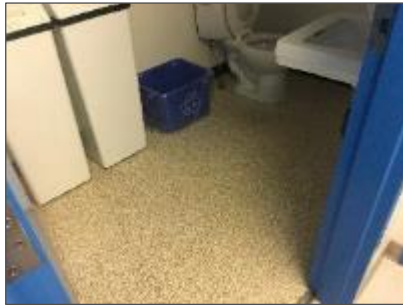
The vinyl sheet flooring is non-friable but can become friable upon removal. Vinyl sheet flooring is in good condition.

Photograph No. 8 – Asbestos-containing tan vinyl sheet flooring present in the Souris detachment.

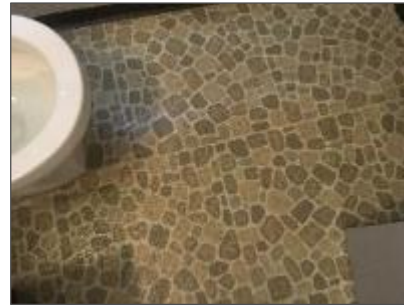
Photograph No. 9 –Asbestos containing vinyl sheet flooring in the 2nd floor bathroom of the Minnedosa detachment.

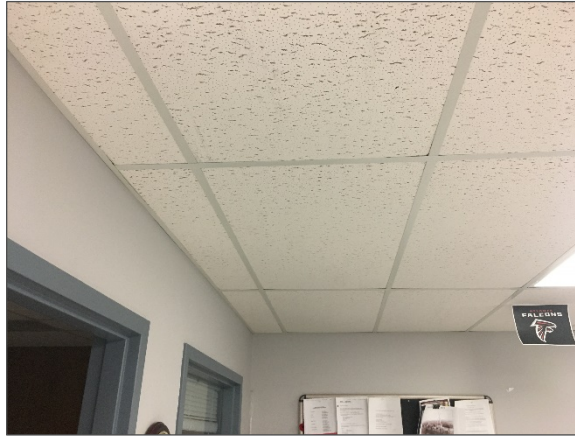
Photograph No. 10 – 24” x 48” acoustic ceiling tiles sampled from the main floor of the Minnedosa detachment (samples 0012A-C).

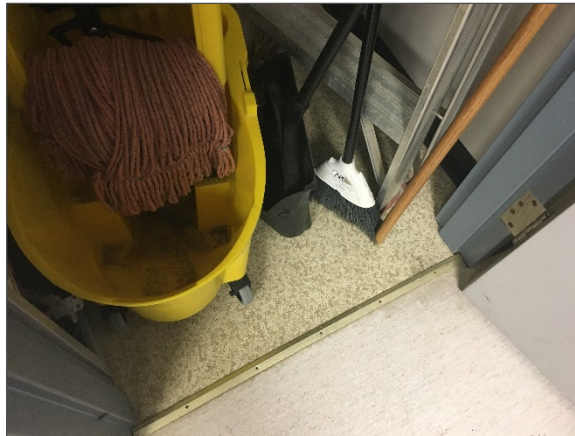
Photograph No. 11 – Vinyl sheet flooring from the main floor janitors closet in the Minnedosa detachment.

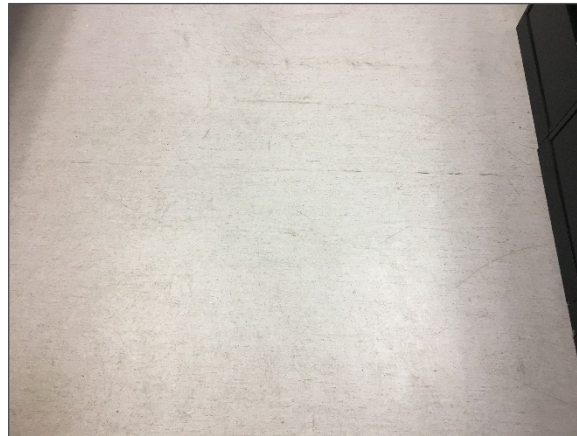
Photograph No. 12 – Recently installed vinyl sheet flooring on the main floor of the Minnedosa detachment.

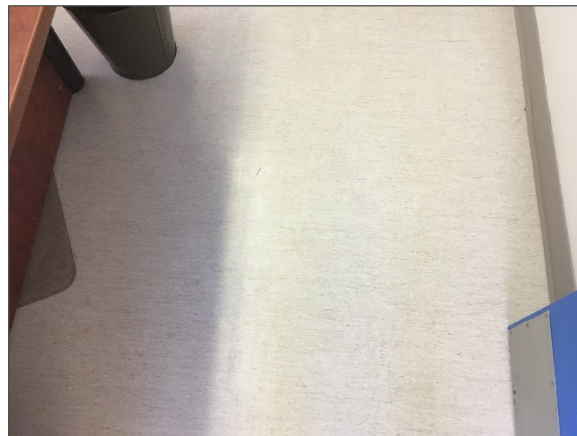
Photograph No. 13 – Recently installed vinyl sheet flooring in the Souris detachment.
