Hazardous Building Materials Assessment

406 Main Street,
Island Lakes, Manitoba

August 29, 2017

Pinchin File: 209290

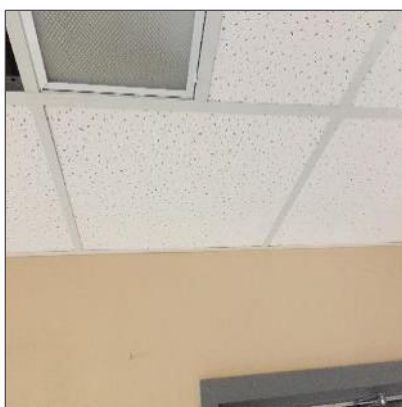
All ceiling tiles were presumed to be non-asbestos based on the date of manufacture determined from the date stamp applied to the top of the tiles (1997) or by surveyors review of the composition of the ceiling tiles (wood cellulose).

Photo # 1 - Non-asbestos acoustic ceiling tiles date stamped 1997 year of production.

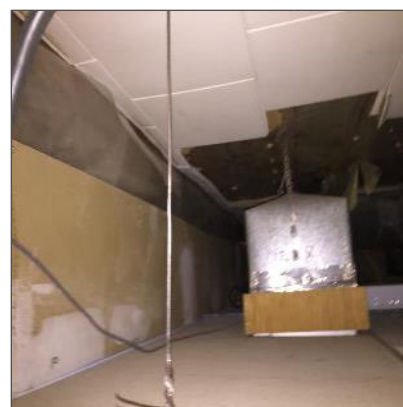
Photo # 2 - Non-asbestos wood cellulose mechanically fastened ceiling tiles present above lay-in tiles.

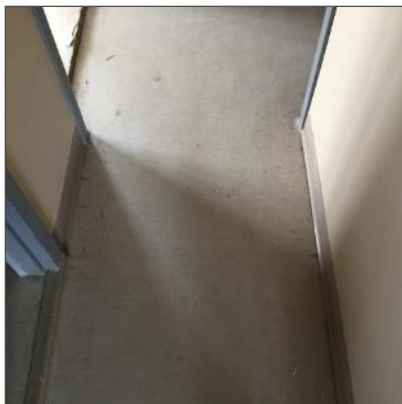
Asbestos if present within vinyl sheet flooring will be identified within the paper backing layer only. Vinyl sheet flooring was presumed to be non-asbestos based on the lack of a paper backing layer (underpad).

Photo # 3 - Non-asbestos vinyl sheet flooring with paper backing.

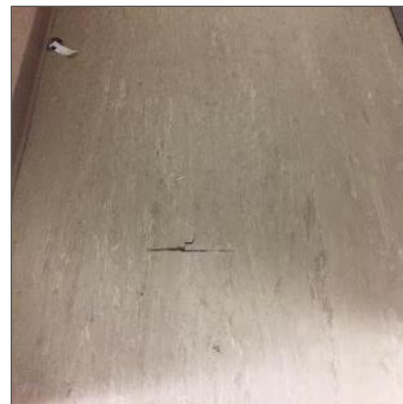
Photo # 4 - Non-asbestos vinyl sheet flooring with paper backing.

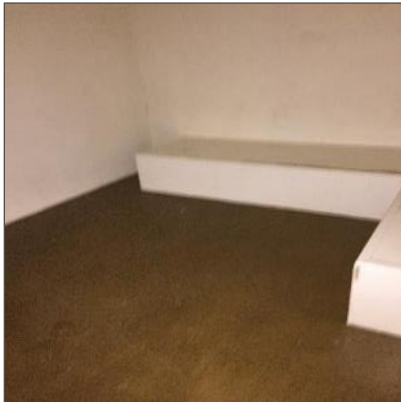
Size, Pattern, Colour and Photo #	Locations (Quantity)	Sample Number	Asbestos Type (tile)
Brown, vinyl composite flooring	Cells and corridor	S0002A-C	Non-asbestos

Photo # 5 - Non-asbestos vinyl composite flooring within the cells and corridor.

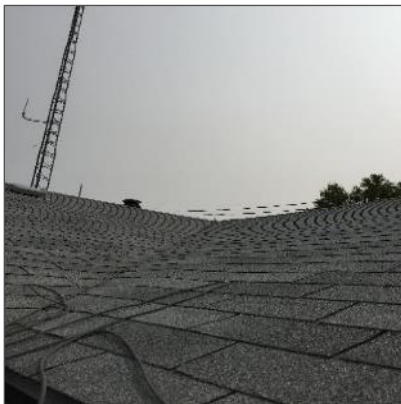
The pitched roof present over the building is covered with non-asbestos asphalt shingles (Samples 0003A-C).

Photo # 6 - Non-asbestos asphalt shingles.

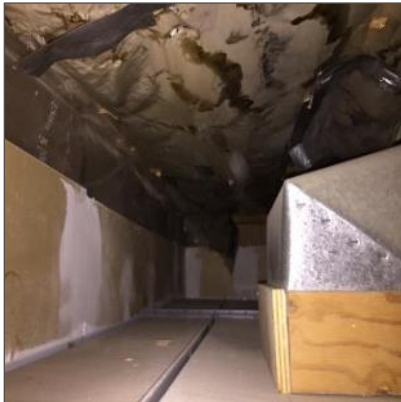
- 30 SF of drywall finish within the kitchen;
- 30 SF of acoustic ceiling tiles within the kitchen;
- 30 SF of fibreglass batting within the kitchen; and
- 8 SF of mouldy ceiling tile finish within the office space.

Photo # 7- Mouldy drywall, ceiling tile, and fibreglass batting within the kitchen.

Mould growth was noted in areas affected by the planned work. Use appropriate precautions and protect workers during removal using methods that comply with provincial guidelines.

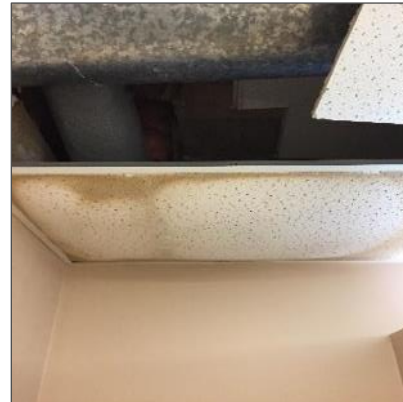
Photo # 8 - Mouldy ceiling tile finish within the office space.
