Hazardous Building Materials Assessment

NE 17-39-20-W3M Highway
374, Scott, Saskatchewan

**Agriculture and Agri-Food
Canada**

October 31, 2017

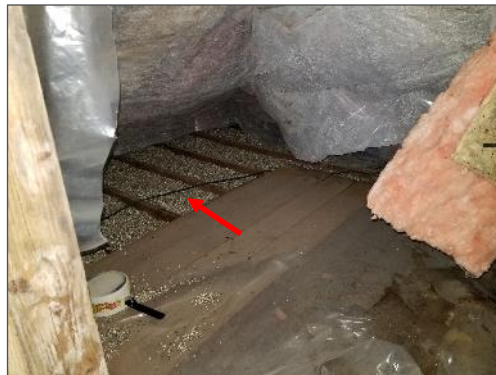
Vermiculite, containing Libby amphibole asbestos, is present as insulation in the attic space (samples S0012A-C). Vermiculite is a friable material. Vermiculite debris, containing Libby amphibole asbestos, may be present in void spaces within wood framed walls and other void spaces however this was not observed during the assessment.

Photo 1. Vermiculite insulation between floor joists in the attic.

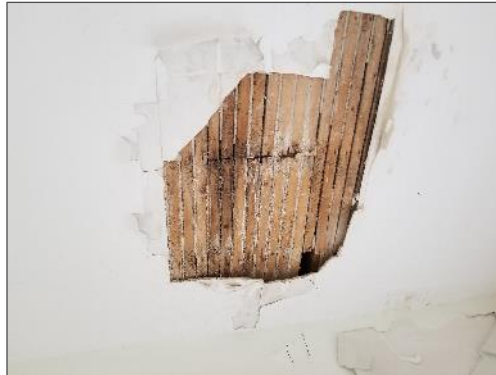
Plaster throughout the house was found to not contain asbestos (samples S0003A-E).

Photo 2. Non-asbestos containing plaster that has fallen away from the wood lath.

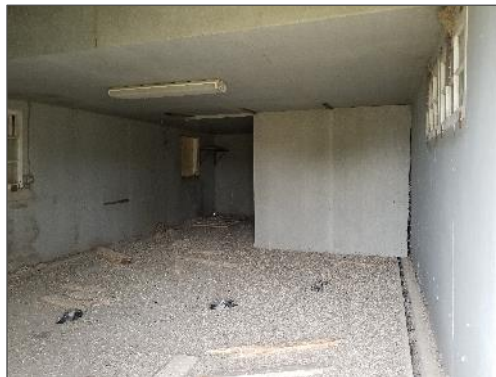
Transite board, presumed to contain asbestos based on visual observation, is present as the walls and ceiling in the pigeon shack. Transite is non-friable and is in good condition.

Photo 3. Transite board used for the walls and ceilings of the pigeon shack.

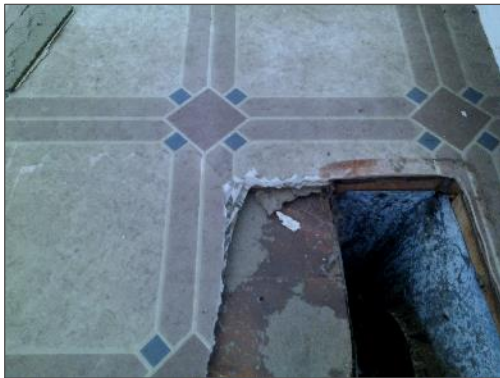
The vinyl sheet flooring is non-friable but can become friable upon removal. Vinyl sheet flooring is in good condition.

Photo 4. Asbestos-containing multi layered vinyl sheet flooring in the Kitchen (Loc. 3).

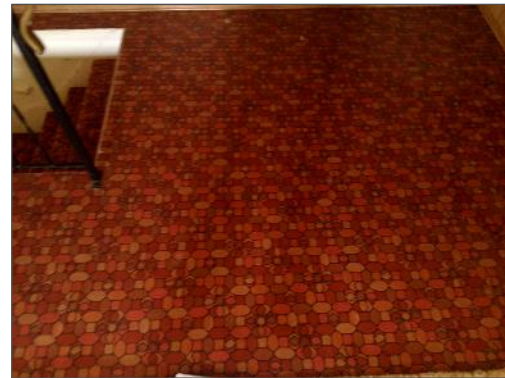
Photo 5. Asbestos-containing red vinyl sheet flooring on the 2nd floor (Loc. 9).

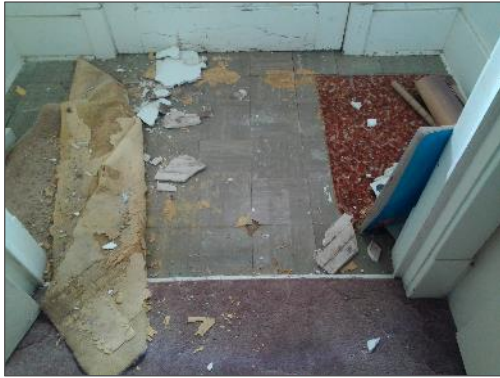
The vinyl floor tiles and mastic are non-friable and are in good condition.

Photo 4. Grey with white streaks vinyl floor tile in the back entrance (Loc. 5).

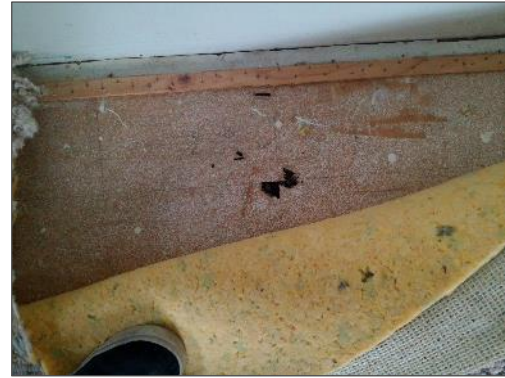
Photo 5. Tan floor tile under carpet in the east bedroom (Loc. 6).

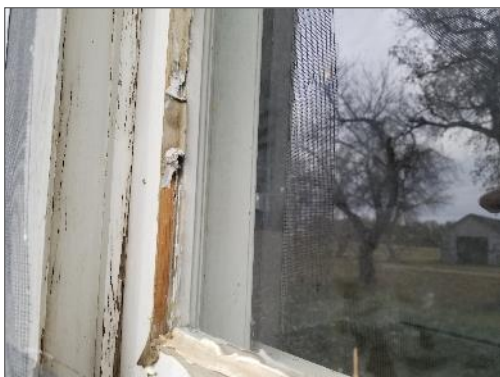
White caulking, containing chrysotile asbestos, is present around exterior window frames (sample S0002). Caulking is non-friable and is in good condition.

Photo 6. Asbestos-containing white caulking around exterior window frames.

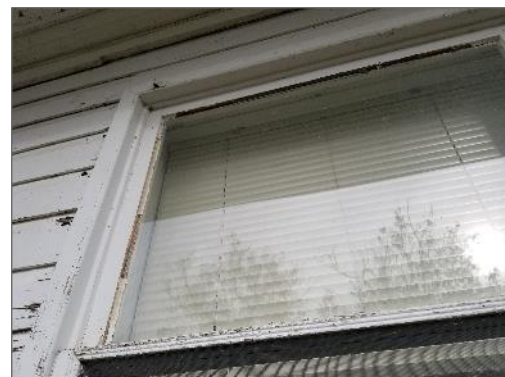
Grey caulking at exterior window frames does not contain asbestos (samples S0001).

Photo 7. Non-asbestos containing grey caulking around exterior window frames.

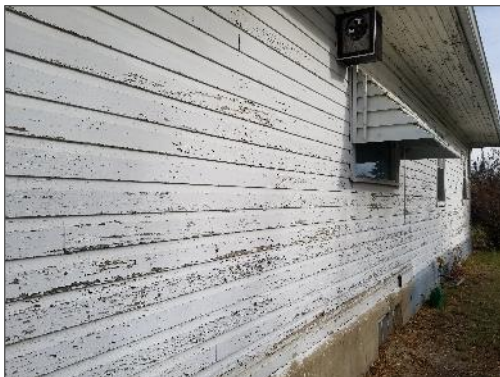
Photo 8. White, lead-containing exterior flaking white wall paint.

Items painted with paints containing elevated levels of lead may be a hazardous waste. Test lead-painted materials for leachable lead and other metals prior to disposal.

Dispose of painted non-metallic materials exceeding the criteria for leachable lead as hazardous waste. Well adhered paints containing elevated levels of lead on metal substrates do not require leachable lead analysis as the materials can be recycled with the paint intact.

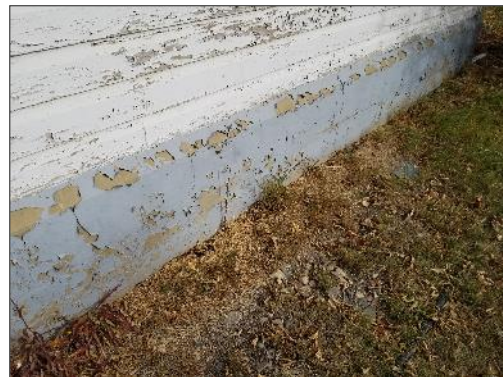
Photo 9. Grey, lead-containing exterior flaking foundation paint.

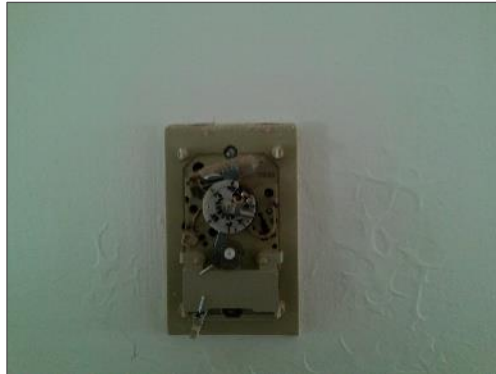
Mercury is present as a liquid in thermostats ampules.

Photo 10. Thermostat in the hallway (Loc. 5) which contains mercury.

Do not break lamps or separate liquid mercury from components. Recycle and reclaim mercury from fluorescent lamps and thermostats when taken out of service. Liquid mercury is classified as a hazardous waste and must be disposed of in accordance with local regulations.

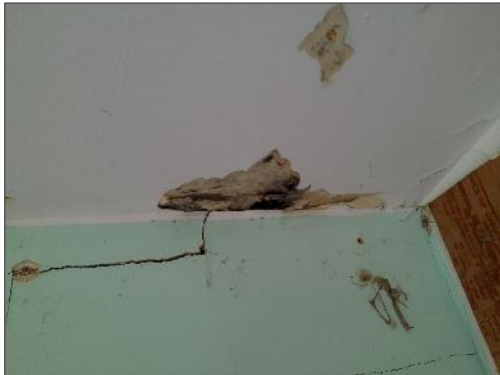
Visible mould growth and water staining is present on drywall ceiling (50 ft²) in the entrance (Loc. 2), on ceiling plaster and wall wood (15 ft²) in the east bedroom (Loc. 6), on ceiling plaster (5 ft²) in the west bedroom (Loc. 8), and on ceiling fibrous board (80 ft²) in the basement (Loc. 10). There is approximately 150 ft² of visible mould growth.

Photo 11. Ceiling mould in the front entrance (Loc. 2).

Mould growth was noted in areas affected by the planned work. Use appropriate precautions and protect workers during removal using methods that comply with provincial guidelines.

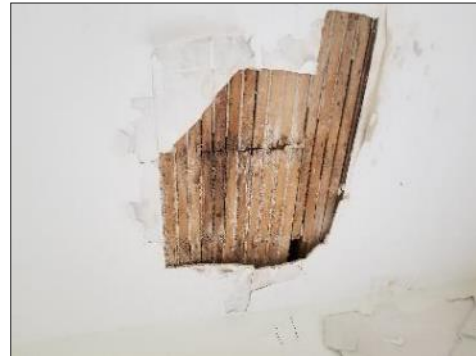
Photo 12. Ceiling mould and water damage on wood and plaster in the east bedroom (Loc. 6).

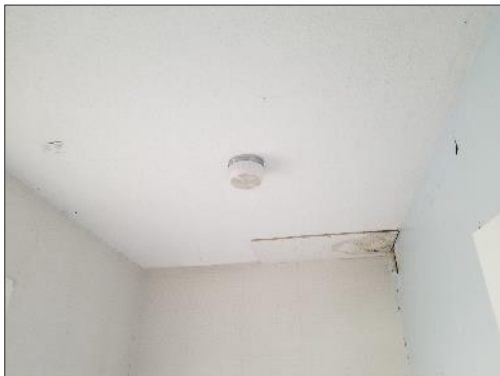
Photo 11. Ceiling mould in the west bedroom (Loc. 8).

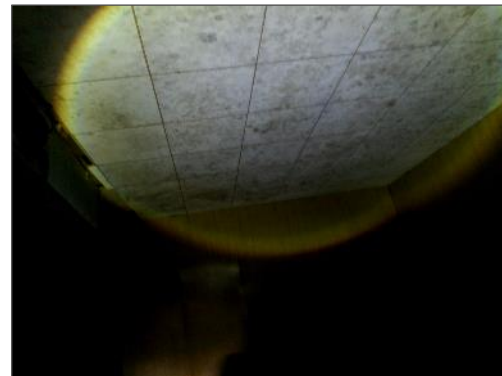
Photo 12. Ceiling mould on fibrous ceiling board in the basement (Loc. 10).
