HAZMAT REPORT

L-4.0 FINDINGS—OPERATIONS BUILDING

FLOOR PLAN SHOWING HAZARDOUS BUILDING MATERIALS AND BULK SAMPLE LOCATIONS

FORT LANGLEY NATIONAL HISTORIC SITE OF CANADA, FORT LANGLEY

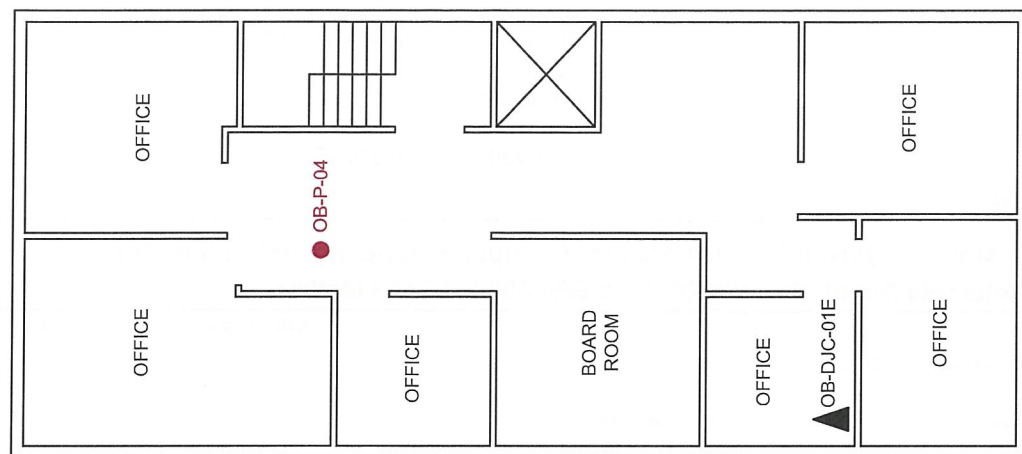
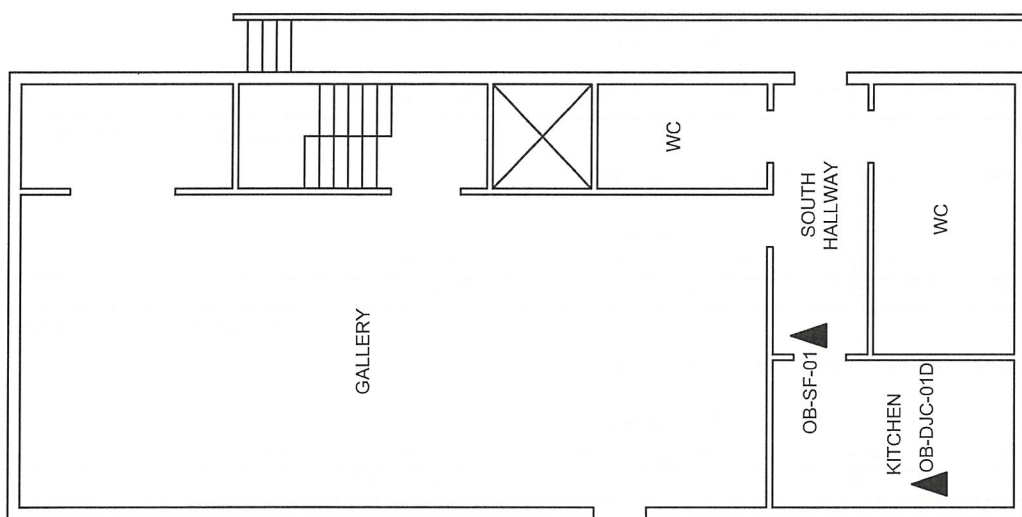
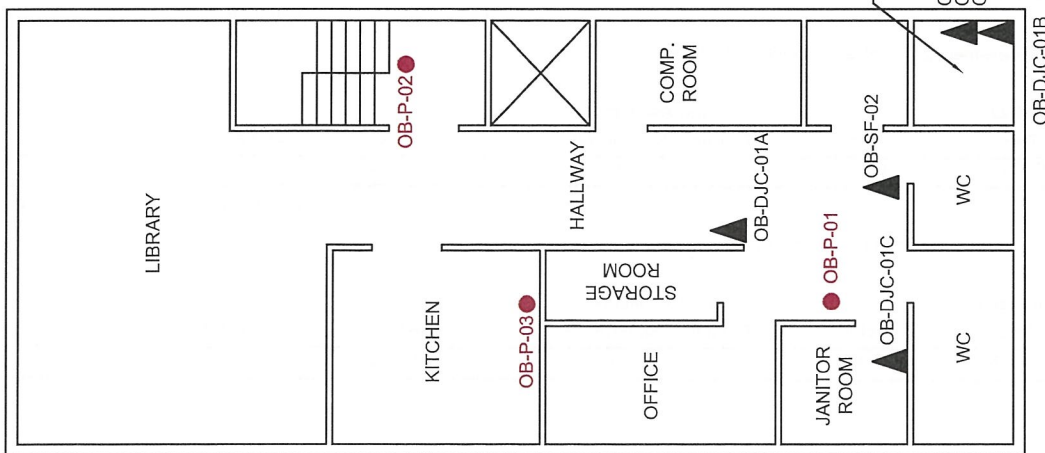
Floor plan drawings, which include locations of the samples collected during this assessment and locations of identified hazardous building materials (where practical), are attached to this Appendix.

Based on our observations of building construction (estimated vintage of interior finishes and uniformity of building material use) and on our interpretations of suspected ACM sample analytical results, no ACMs were identified.

Based on our observations and on our interpretations of suspected LCP sample analytical results, no LCPs were identified.
