**GEOTECHNICAL ENGINEERING REVIEW AND ASSESSMENT
OPERATION BUILDING KITCHEN UPGRADE**

**FORT LANGLEY NATIONAL HISTORIC SITE OF CANADA
LANGLEY, BC**

JOB No.: 217P553

DATE: AUGUST 10, 2017

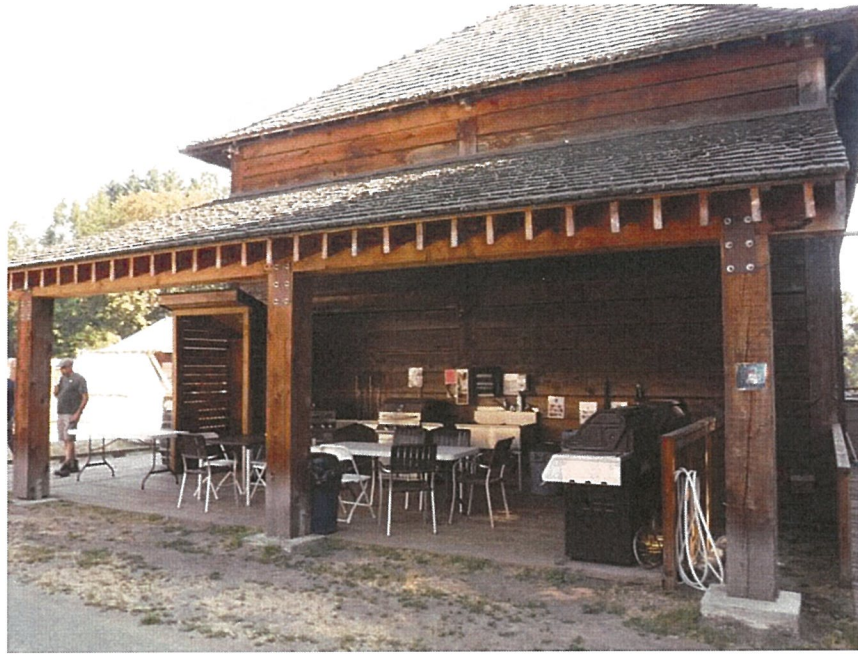
A canopy covered timber deck is situated at the south outside the building. The canopy is supported by existing external building wall and 3 nos. of columns at about 4 m. \pm from the wall as shown in Photo No.1. The columns are found on shallow footing as shown in Photo No.2. It is understood that the Kitchen upgrade will involve area within the covered timber deck at south side of the building as shown in Figure 4 - Proposed Building Addition (Main Floor). The covered timber deck is an at-grade deck found on existing grade.

Photo #1: External Wall and Canopy at Proposed Building Renovation

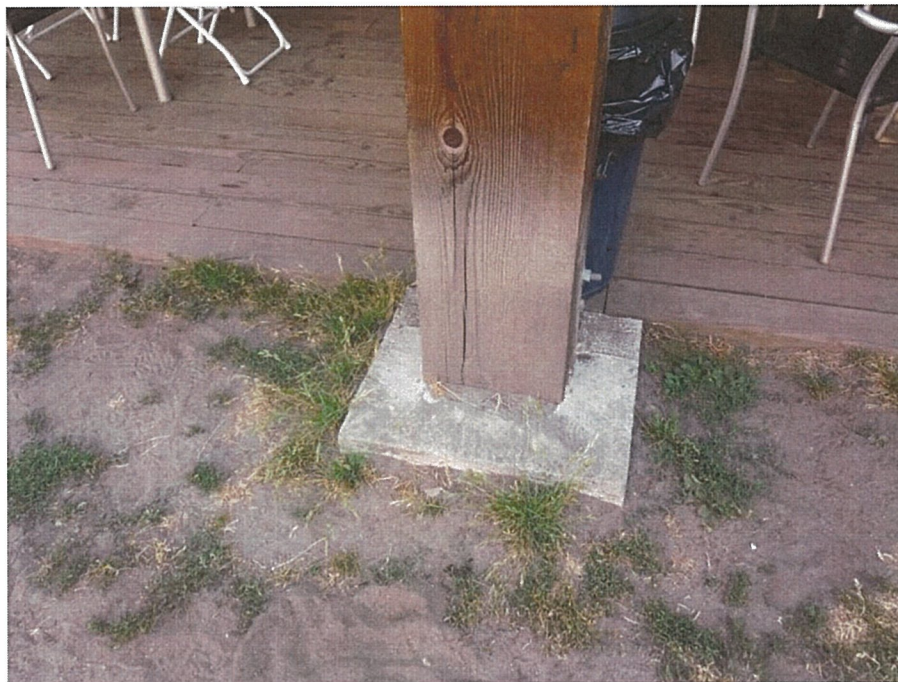
Photo #2: Shallow Foundation for Column supporting existing Canopy

A 2 m. ± wide, 3 m. ± deep trench excavation can be done by typical timber trench shoring for new foundation construction. The shoring will avoid disturbance of existing canopy footings which are likely found on shallow pad footings.

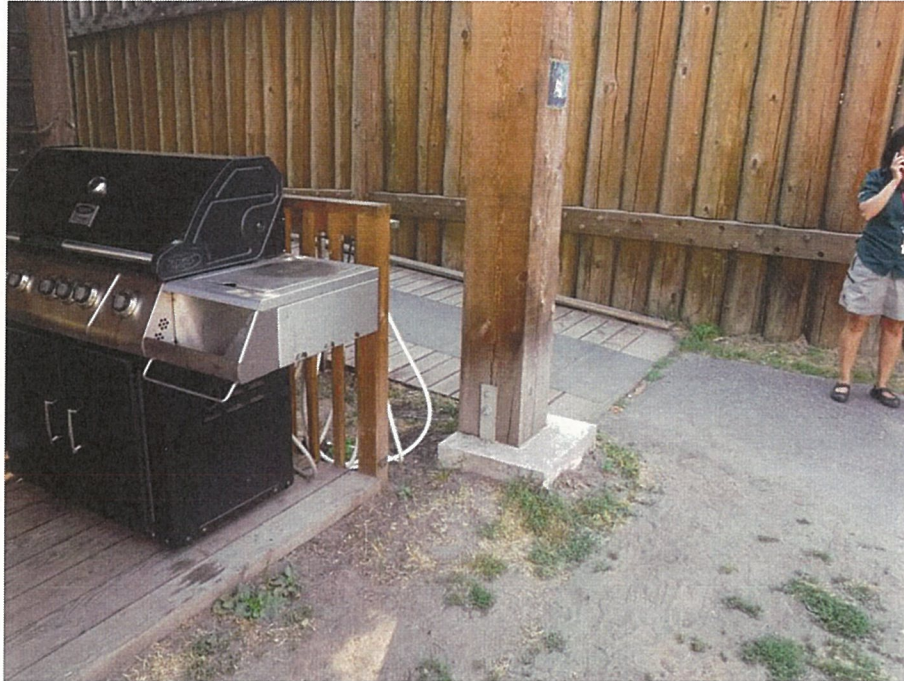
Photo #3: Log Palisade and Timber Deck in adjacent east to Building

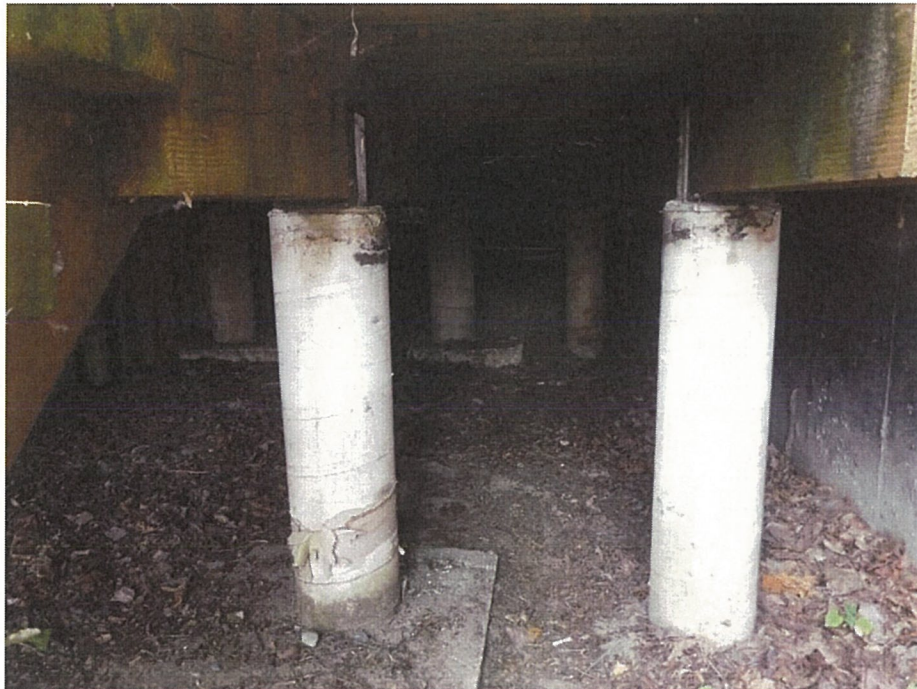
The site topography around the building is slightly sloping up from north to south along the building. It can be assessed by a gravel path to the main entrance at the east of the building. A suspended timber deck and a Log Palisade wall is observed in adjacent east of building as shown in Photo No.3. The deck is a suspended deck supported by concrete sonnet tube as shown in Photo No.4. Access to the basement can through doors along the deck.

Photo #4: Sonnet Tube supporting the timber deck

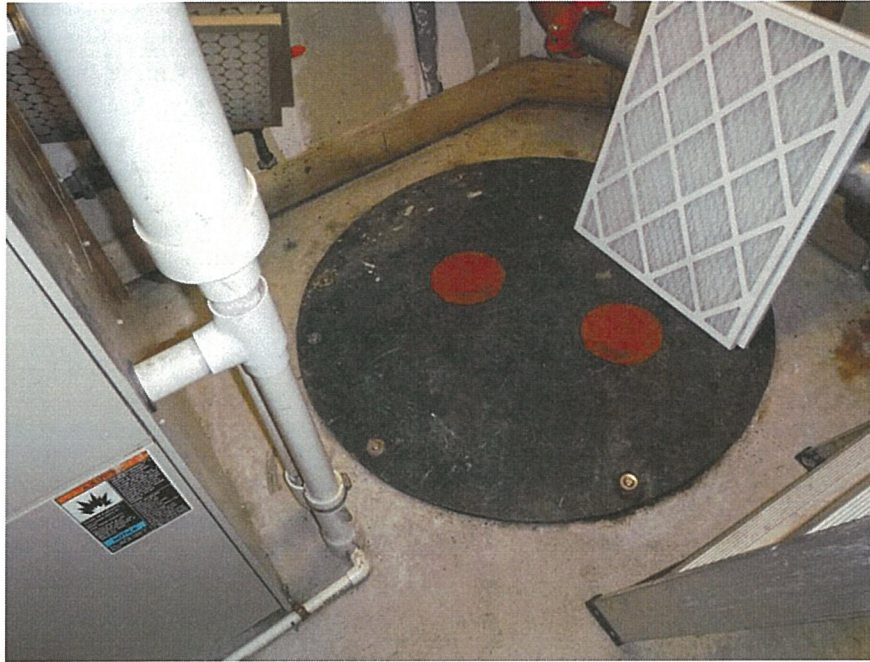
The basement at the south side of the existing building is occupied by washrooms and a Mechanical Room as shown in Figure 5 - Existing Basement Plan. A sump is noticed in the Mechanical Room as shown in Photo No. 5. JCI was informed by Park staff that flooding in the basement occur when the pump went malfunction. JCI was also informed that the sump will be removed and replace by a future drainage system operating by gravity fall to a new drainage system at the area.

Photo #5: A sump is located inside Mechanical Room at South eastern corner of building

For precaution purpose, it is recommended that foundation drainage composed of 4 in. perforated pipe can be installed new foundation subgrade to protect existing basement from moisture migration. The foundation drainage can hook up to the new drainage system by gravity fall. Foundation drainage should be protected by embedded in minimum 100 mm. thick 19 mm. clear crushed gravel covering all around the pipe. **Roof drainage must not connect to foundation drainage directly and must be drained by a separate solid PVC pipe to the anticipated new drainage system.**

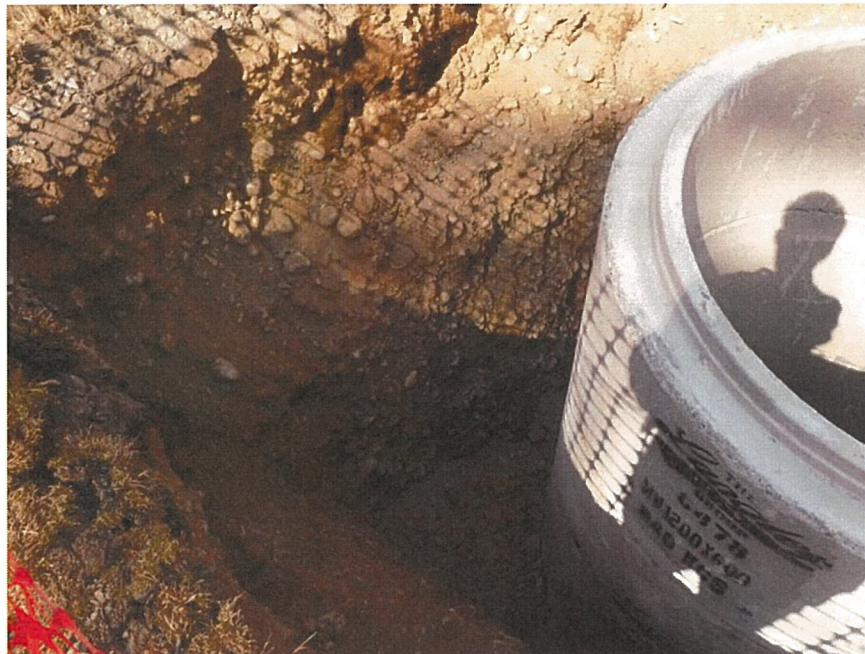
Our site reconnaissance observe an excavation for a manhole construction nearby the site. The excavation is about 2.5 m \pm depth with a Yellowish brown, dense, SAND and Gravel with pebbles occur immediate depth below existing grade. No groundwater was observed during the time of site visit.

Photo #6: Nearby Drainage Construction identify dense SAND and Gravel in Excavation

JEC TH recommends an Allowable Bearing Capacity of 2,000 psf. for SLS Design and 3,000 psf. for ULS Design for footing found on the dense native SAND and Gravel. Frost protection is not a concern if footing step down to native soil at basement grade.
