UNDERWATER SERVICE REPORT BRIGADIER MG "ZALINSKI" OIL REMOVAL OPERATION

March 26 – April 6, 2015

Ref# 35058

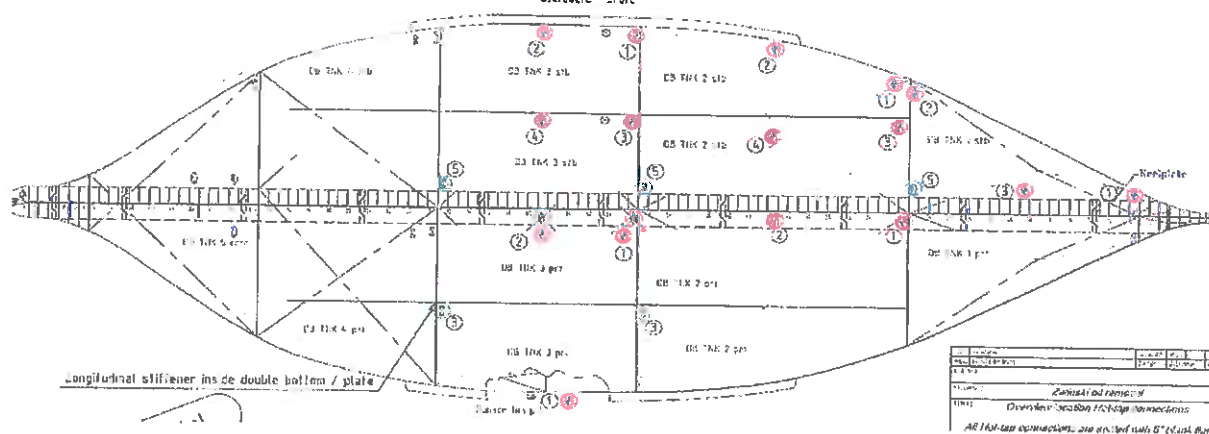
HULL VALVE PLACEMENT DRAWING

All hot-tap connection sealed with 6" blank flange!

Valves presently missing handles:

- Port tank 3: Valve 1
- Stbd tank 1: Valve 1
- Stbd tank 1: Valve 3

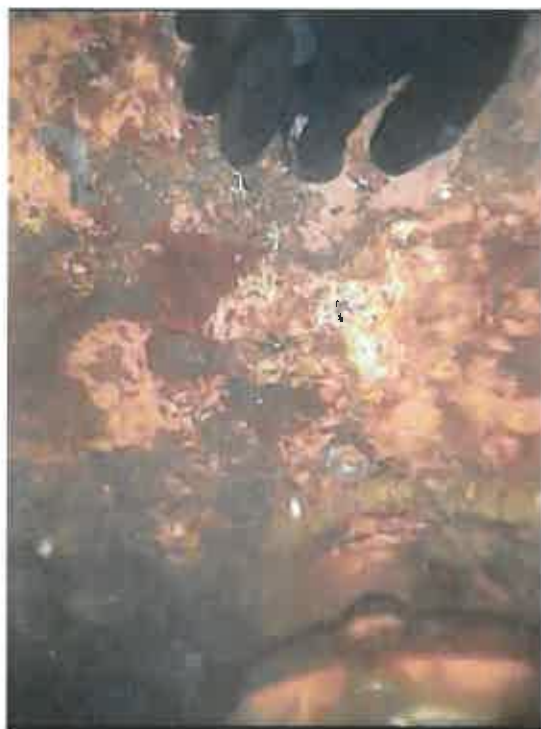
Bottom plate

- Bottom plating was covered in soft and hard marine growth with no signs of large holes from corrosion.
- Plating was still relatively solid as no hole developed while working throughout the pumping process with a series of tap tests performed periodically by diver.
- One small 5mm hole was observed approx 1 meter aft of Stbd tank 1: valve 3. This hole was covered with a two part epoxy.
- All other epoxy patches previously applied that were sighted remained intact.

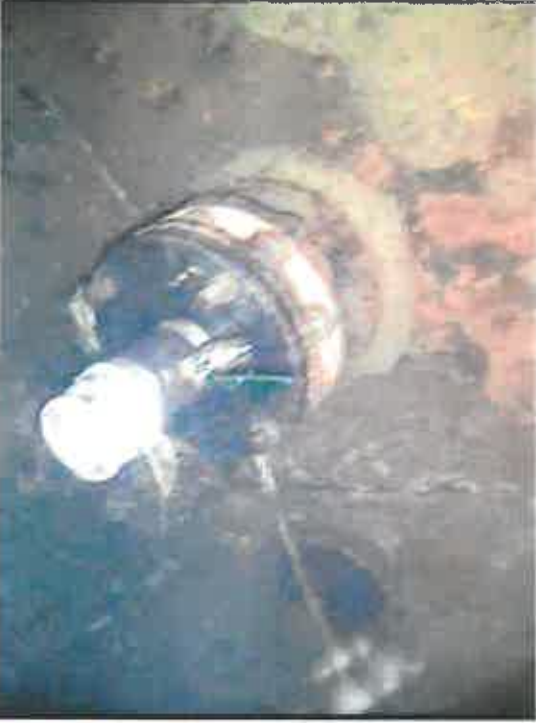
Nipple cam lock flange fitted

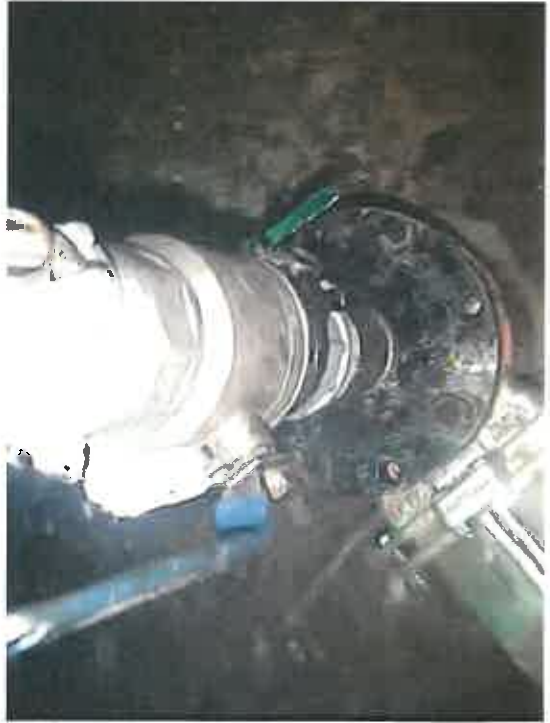
Suction hose valve fitted while pumping

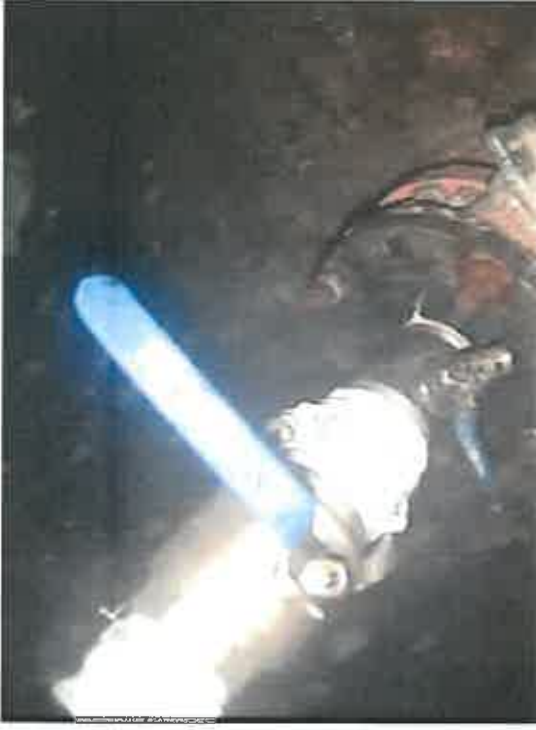
Flange fitted with a blanking valve

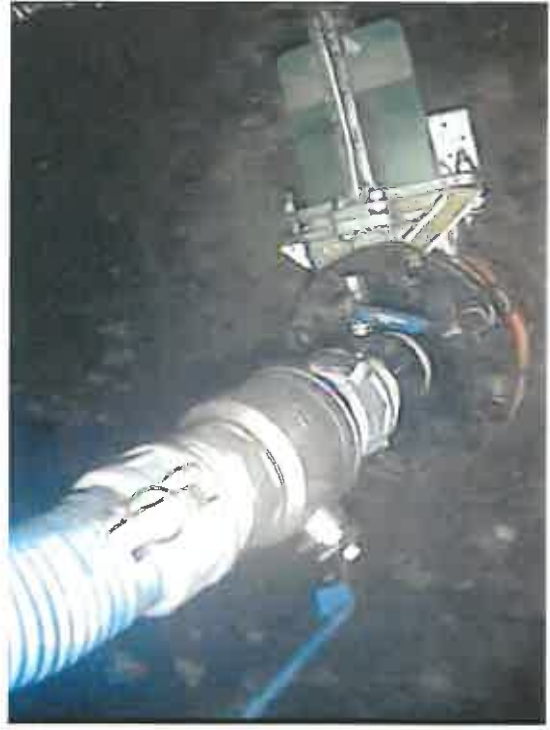
Pumping hose connected

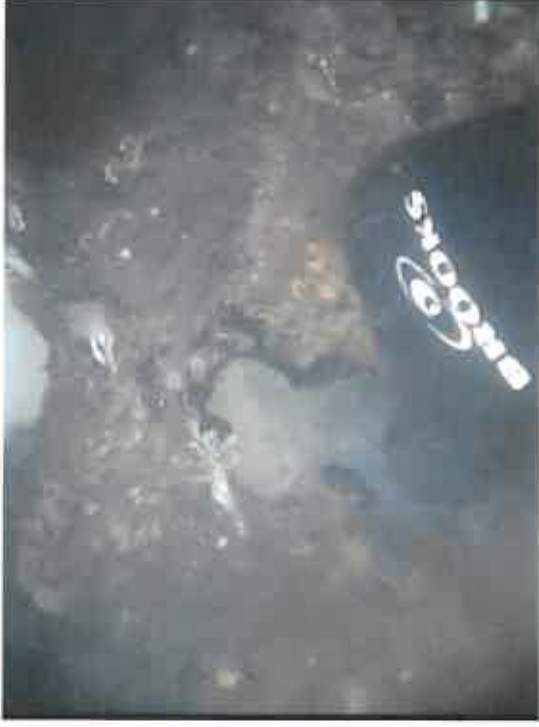
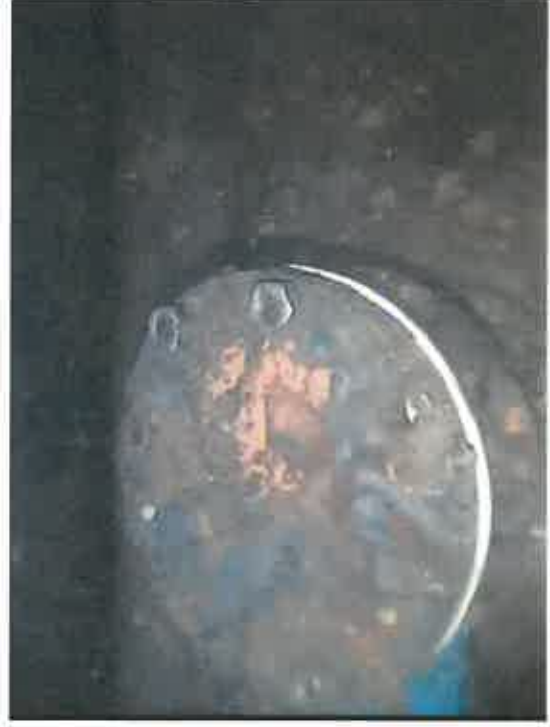
Newly applied epoxy to a small hole
Tank valve caps re installed

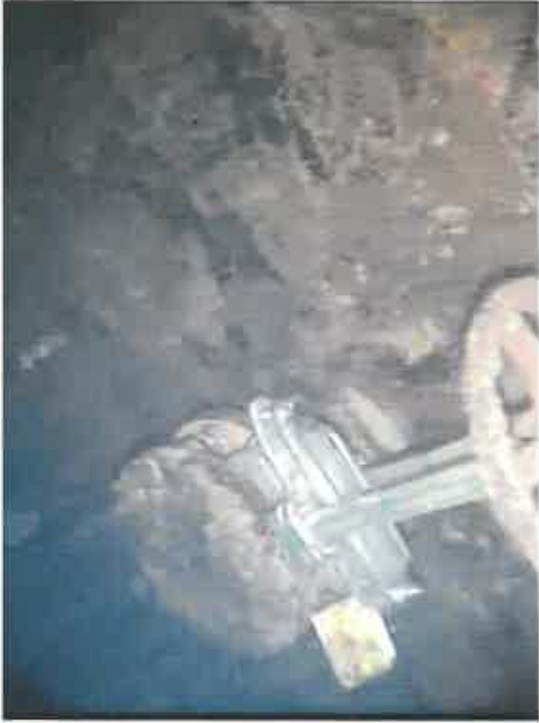
Intact valve with handle

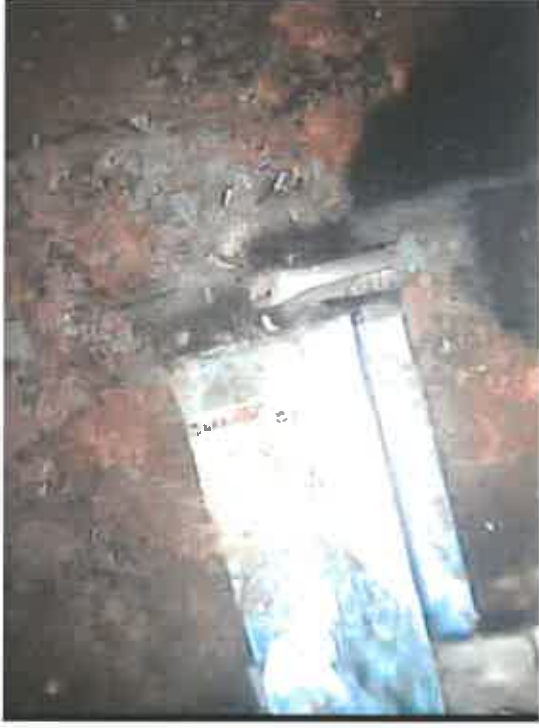
Valve with missing handle
