ASBESTOS SURVEY REPORT

CANADIAN COAST GUARD BASE, 401 KING
STREET WEST, PRESCOTT, ONTARIO

MARCH 2017

WSP Project no: 171-00836-00
PSPC Project no: R.087220.001
Date: March 2017

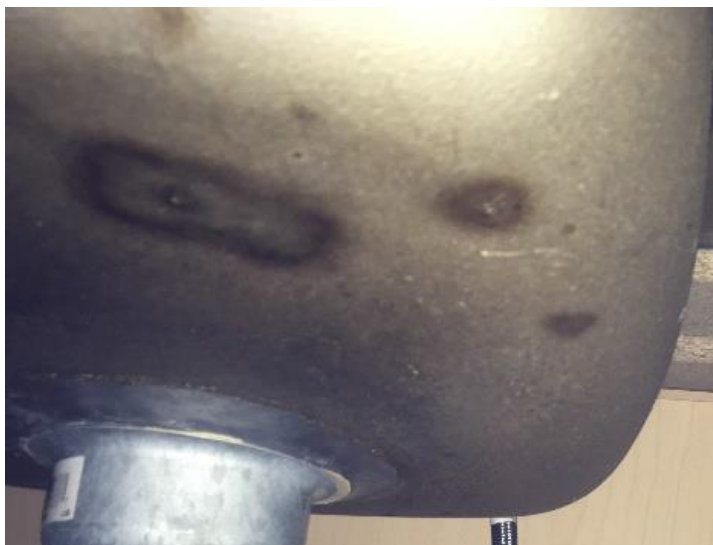
MATERIAL DESCRIPTION & LOCATION	ASSESSMENT	ACTION ¹	PHOTO ²
Gold Sink Acoustic Coating 1 sink observed in the Kitchen located on the Administration Level.	Sample ID: MB-GSA-A to C Concentration: 2% Chrysotile Material: Non-friable Accessibility: A (Areas of the building within reach, from ground level, of all building users. Activities of the building users may result in disturbance of ACM). Condition: Good	Action 7 Routine surveillance of ACM in good condition. Prior to demolition activities which may disturb this material, remove the material following: Type 1 abatement procedures – if the material is wetted and the work is done using non-powered hand tools.	1
12"x12" Vinyl Floor Tile - White Approximately 6 square metres (m ²) was observed within the Display Case located in the East Mezzanine.	Sample ID: MB-VFT6-A to C Concentration: 2% Chrysotile Material: Non-friable Accessibility: A (Areas of the building within reach, from ground level, of all building users. Activities of the building users may result in disturbance of ACM).	Action 7 Routine surveillance of ACM in good condition. Prior to demolition activities which may disturb this material, remove the material following: Type 1 abatement procedures – if the material is wetted and	2

View of asbestos-containing gold sink acoustic undercoating observed within the kitchen of each Residential Unit located at the subject buildings.

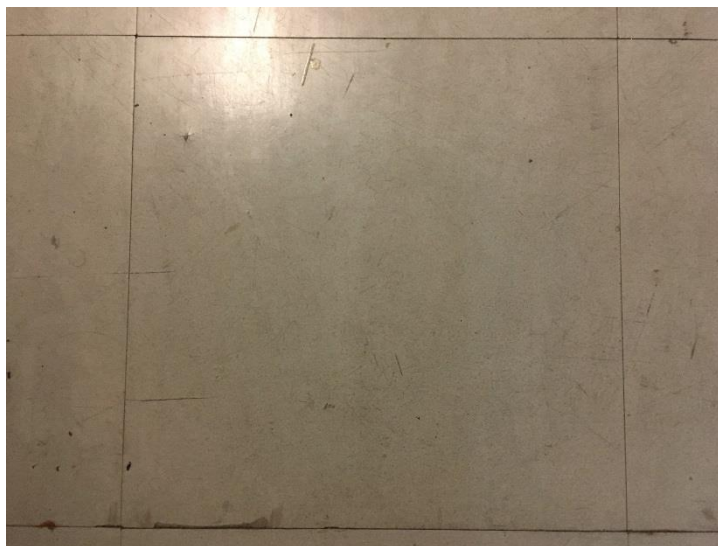
MB-VFT6-A to C

MATERIAL DESCRIPTION & LOCATION	ASSESSMENT	ACTION ¹	PHOTO ²
	Condition: Good	the work is done using non-powered hand tools.	
12"x12" Vinyl Floor Tile – Blue with White Streaks Approximately 25 m ² was observed within the Office located in the West Mezzanine; Approximately 50 m ² was observed on the Administration Level; and Approximately 300 m ² was observed on the Ground Floor.	Sample ID: MB-12-VFT1-A to C ³ Concentration: 19.9% Chrysotile Material: Non-friable Accessibility: A (Areas of the building within reach, from ground level, of all building users. Activities of the building users may result in disturbance of ACM). Condition: Good	Action 7 Routine surveillance of ACM in good condition. Prior to demolition activities which may disturb this material, remove the material following: Type 1 abatement procedures – if the material is wetted and the work is done using non-powered hand tools.	3

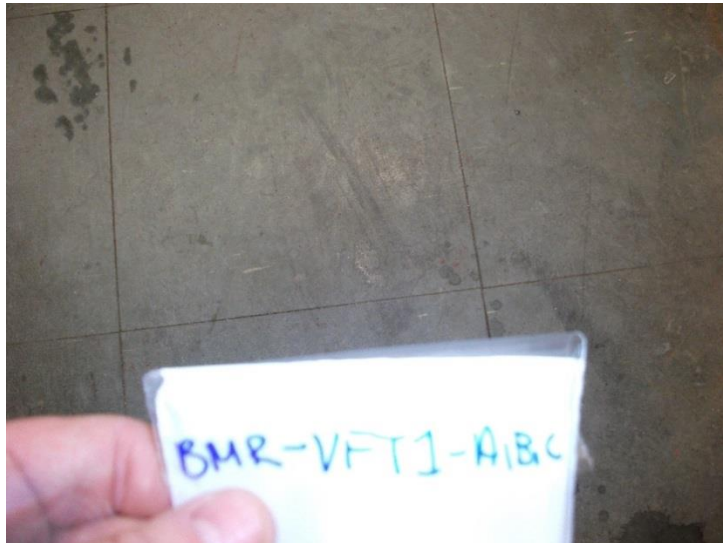
MATERIAL DESCRIPTION & LOCATION	ASSESSMENT	ACTION ¹	PHOTO ²
12"x12" Vinyl Floor Tile – Grey (incl. mastic) Approximately 5 m ² was observed in Hall between Shower and Work Area.	Sample ID: BMR-VFT1-A to C ³ Concentration: 14.2% Chrysotile Material: Non-friable Accessibility: A (Areas of the building within reach, from ground level, of all building users. Activities of the building users may result in disturbance of ACM). Condition: Good	Action 7 Routine surveillance of ACM in good condition. Prior to demolition activities which may disturb this material, remove the material following: Type 1 abatement procedures – if the material is wetted and the work is done using non-powered hand tools.	1

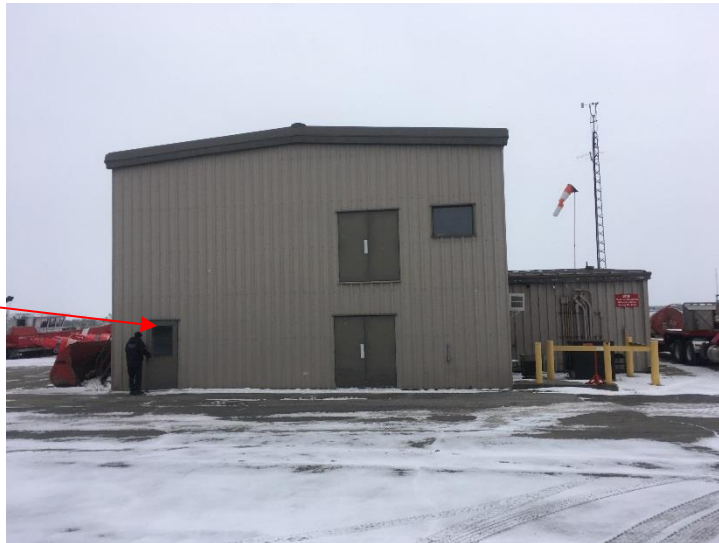
HH-GLZ-A to C

View of asbestos-containing grey exterior window glazing.

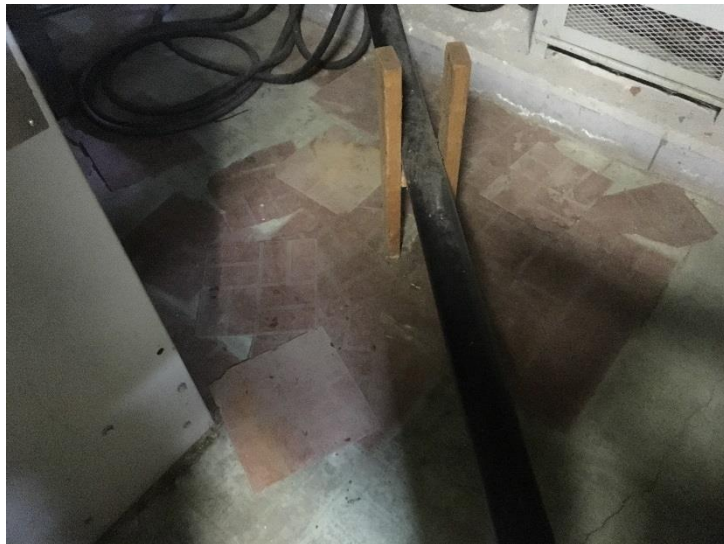
HH-VFT1-A to C

View of asbestos-containing 12x12-inch vinyl floor tile – red. ACM was observed to be in poor condition.

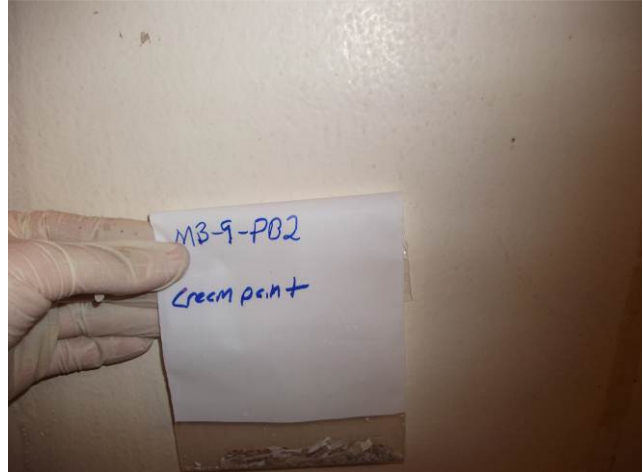
Photograph 2: Main Building- PB2 – Lead-Based Cream Paint Undercoat Throughout Main Building

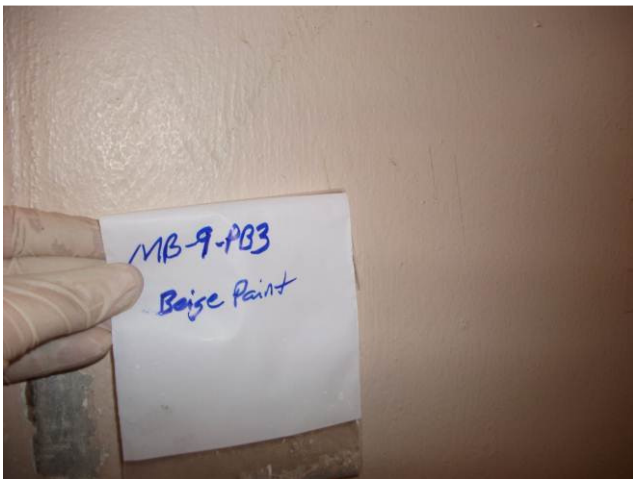
Photograph 3: Main Building- PB3 – Lead-Based Beige Paint Undercoat Throughout Main Building

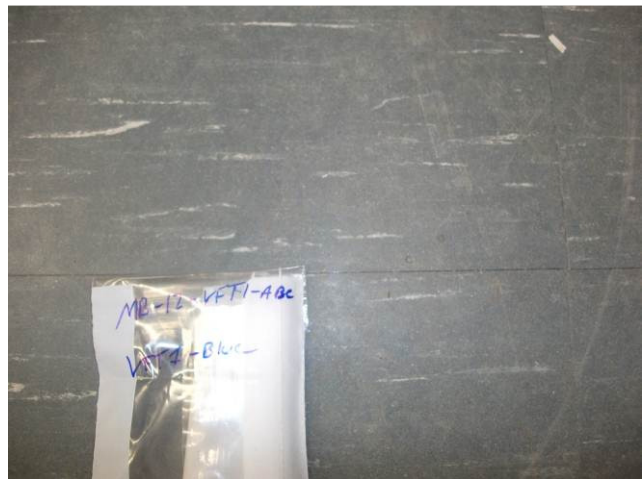
Photograph 4: Main Building – ACM (VFT1) Blue With White Streak 12" X 12" Vinyl Floor Tile

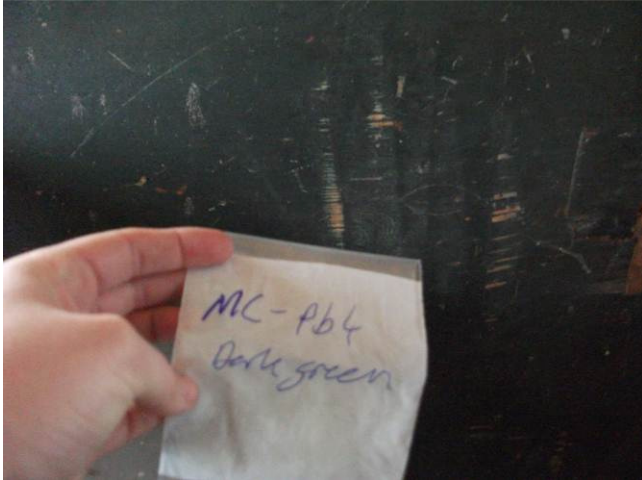
Photograph 9: Metal Clad Storage Building – Lead-Based Dark Green Wall Paint

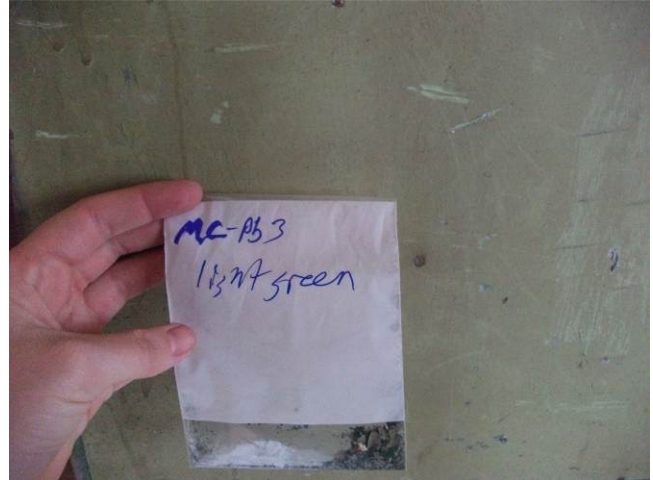
Photograph 10: Metal Clad Storage Building – Lead-Based Light Green Wall Paint

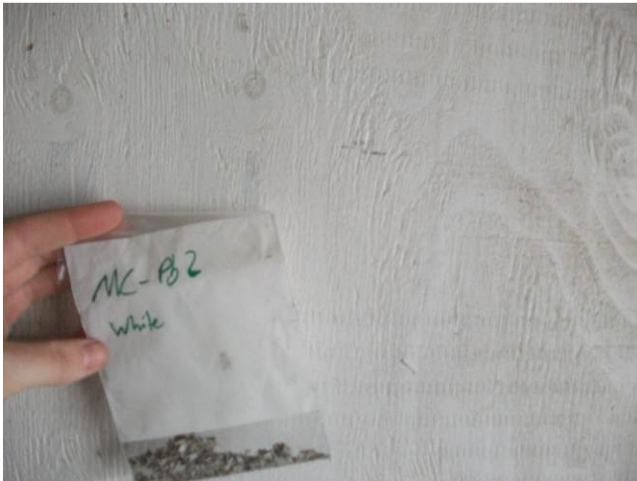
Photograph 11: Metal Clad Storage Building – Lead-Based White Wall Paint

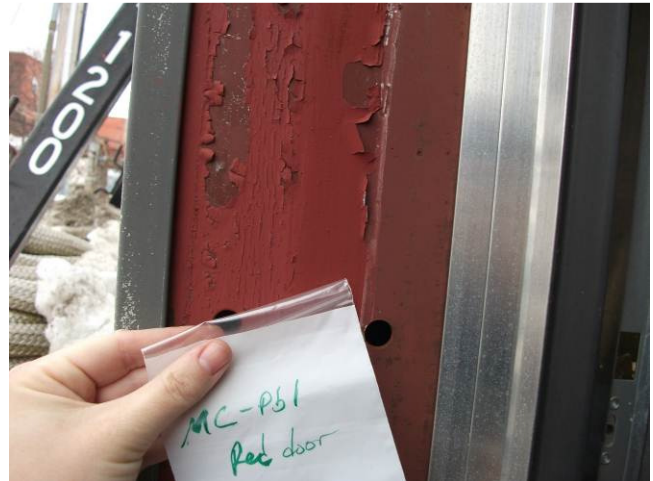
Photograph 12: Metal Clad Storage Building – Lead-Based Red Door Paint

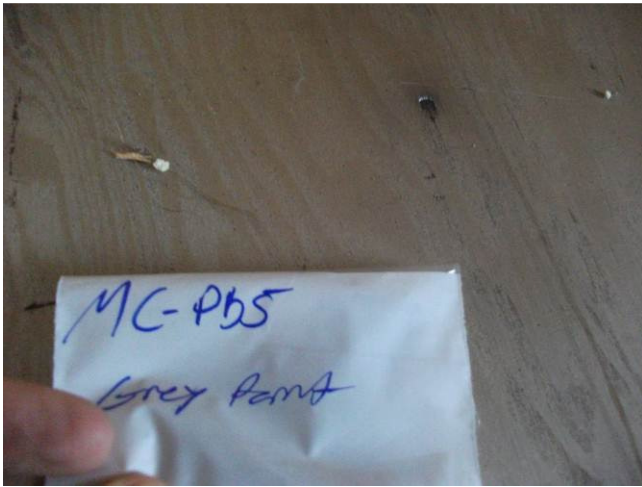
Photograph 13: Metal Clad Storage Building – Lead-Based Grey Wall Paint

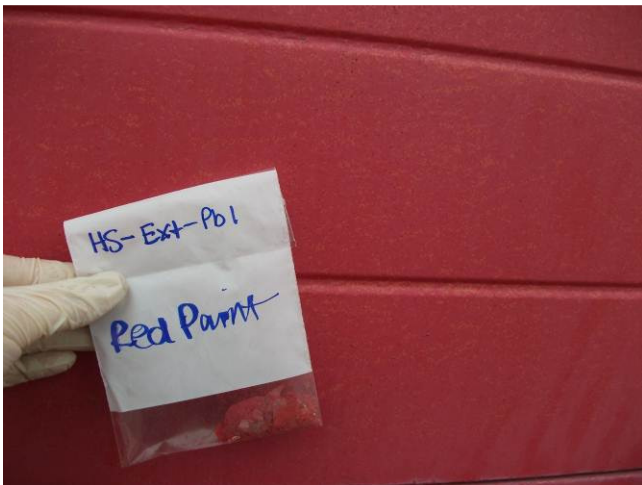
Photograph 15: Heated Storage Building – Lead-Based Red Door Paint

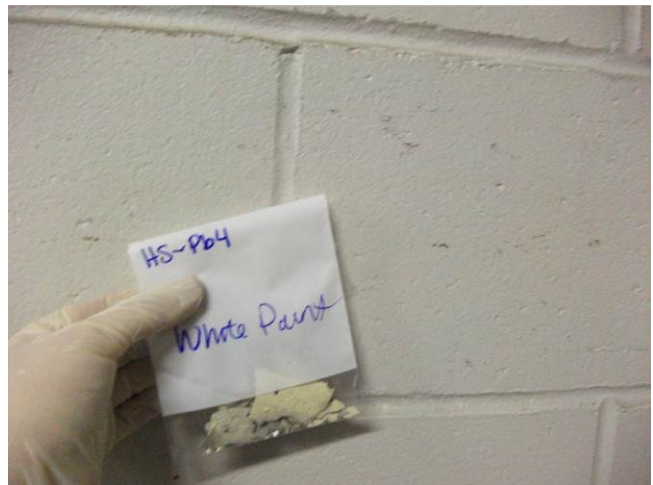
Photograph 16: Heated Storage Building – Lead-Based White Wall Paint

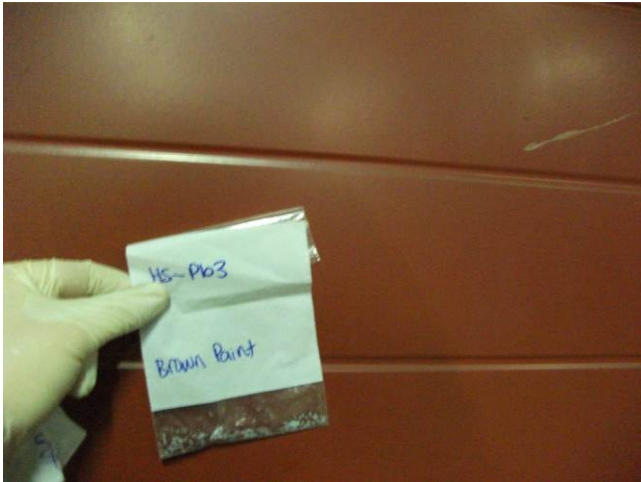
Photograph 17: Heated Storage Building – Lead-Based Brown Door Paint

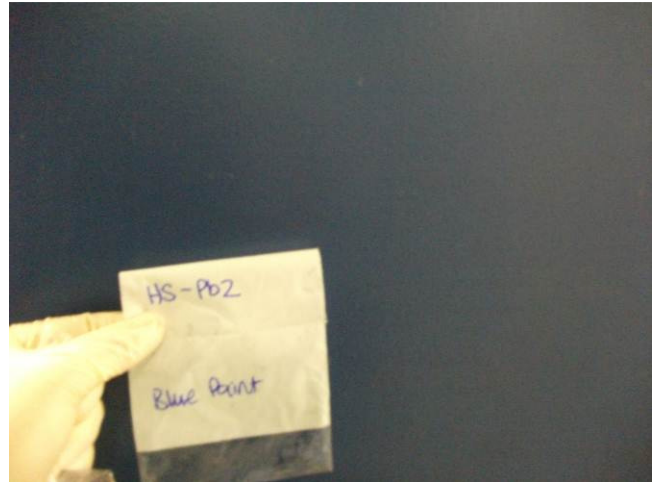
Photograph 18: Heated Storage Building – Lead-Based Blue Wall Paint

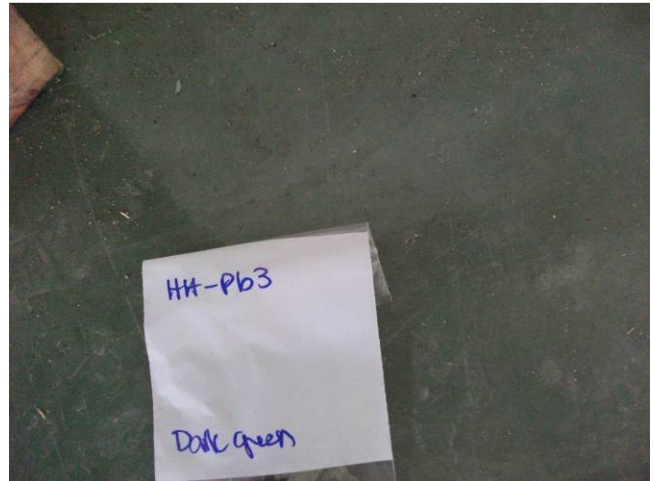
Photograph 20: Helicopter Hangar Building – Lead-Based Dark Green Floor Paint

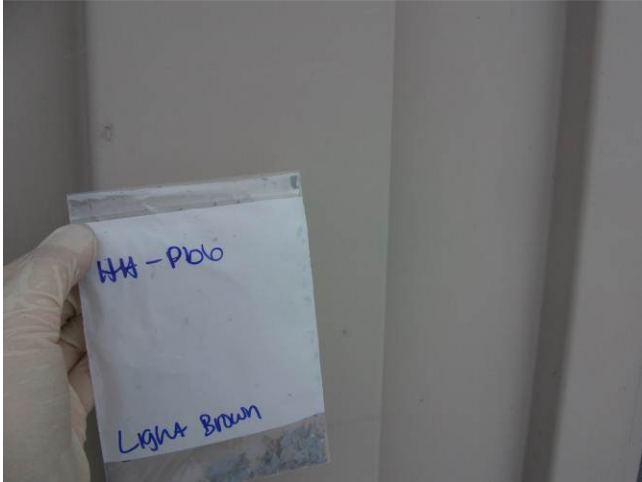
Photograph 21: Helicopter Hangar Building – Lead-Based Light Brown Exterior Wall Paint

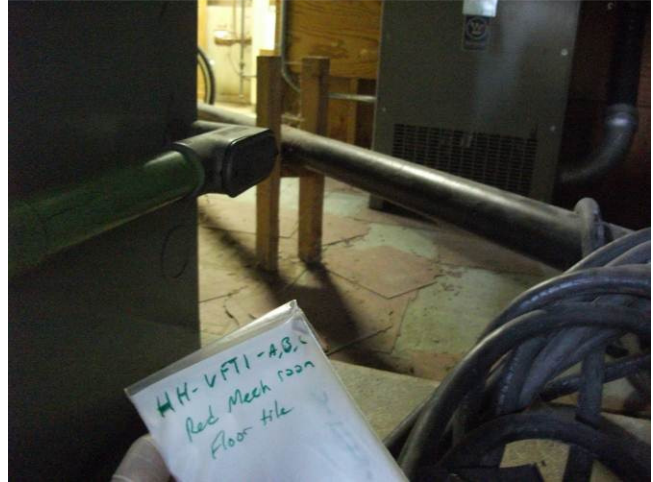
Photograph 22: Helicopter Hangar Building – ACM (VFT1) 12" X 12" Red Vinyl Floor Tile

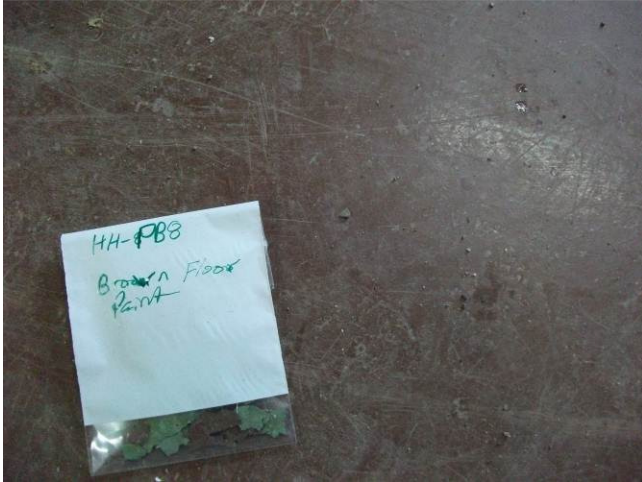
Photograph 25: Helicopter Hangar Building – Lead-Based Brown Floor Paint

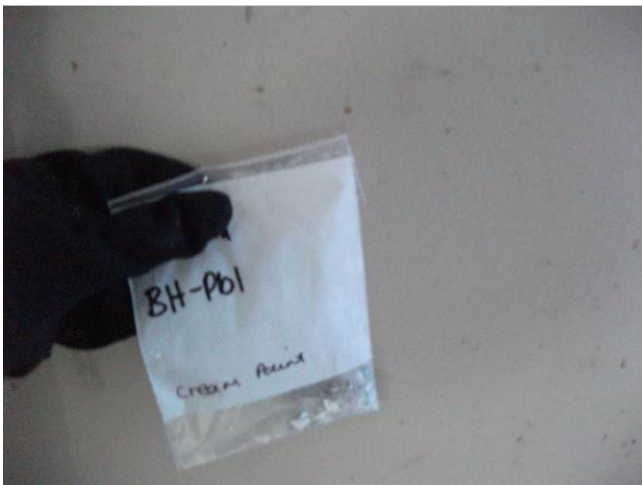
Photograph 27: Boat House Building – Lead-Based Cream Wall Paint

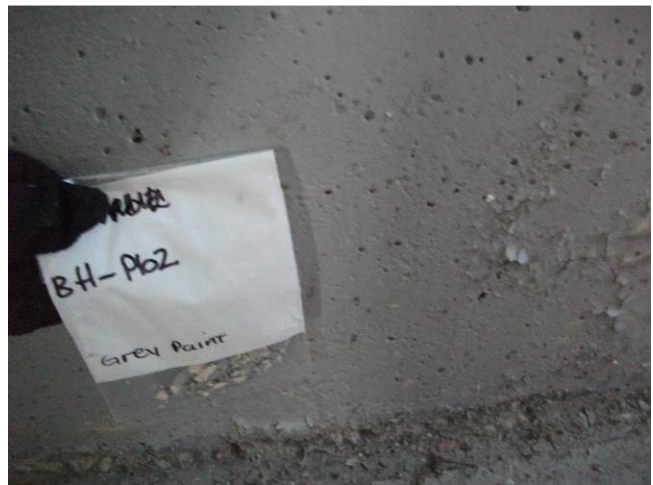
Photograph 28: – Boat House Building – Lead-Based Grey Floor Paint

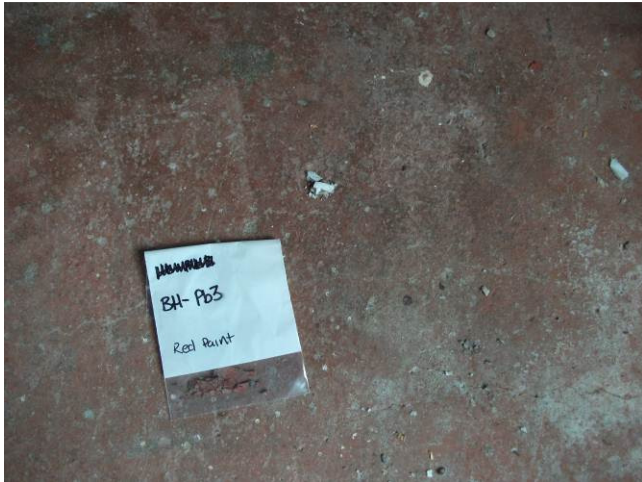
Photograph 29: Boat House Building – Lead-Based Red Floor Paint

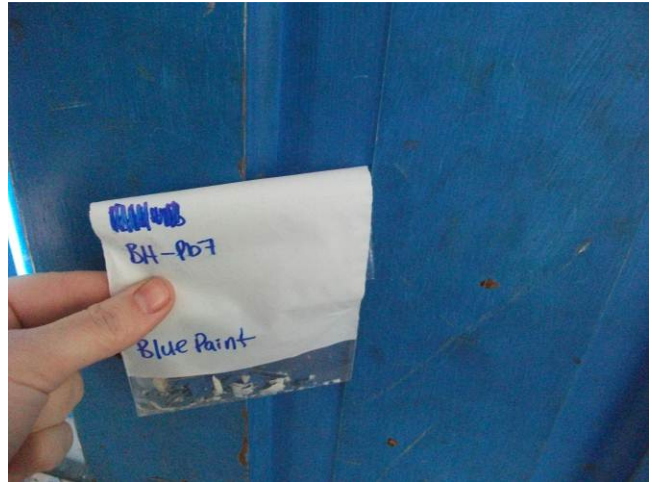
Photograph 30: Boat House Building – Lead-Based Blue Wall Paint

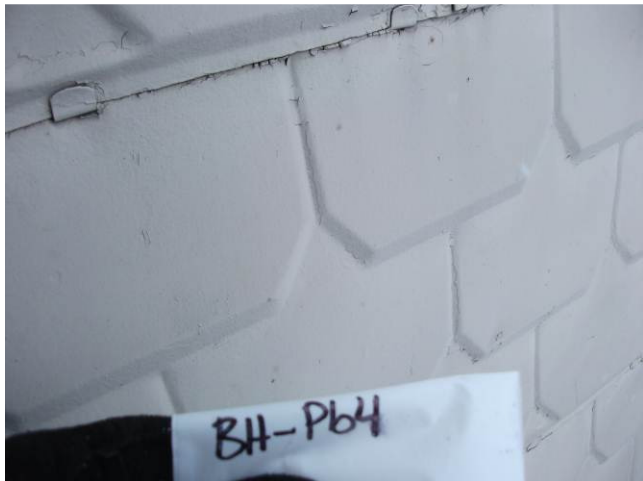
Photograph 31: Boat House Building – Lead-Based Beige Exterior Wall

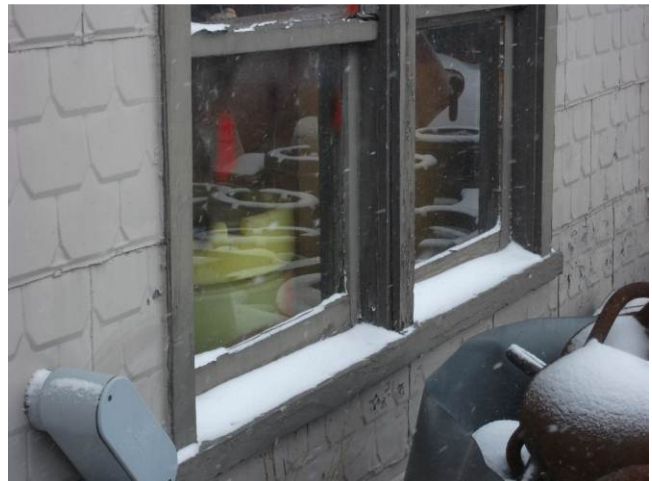
Photograph 32: Boat House Building – Lead-Based Green Exterior Window Paint

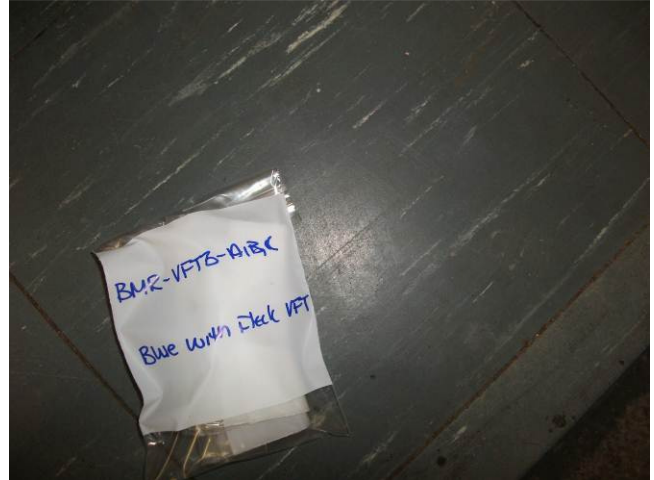
Photograph 34: Buoy Maintenance Building – ACM (VFT3) Blue With White Streak 12" X 12" Vinyl Floor Tile

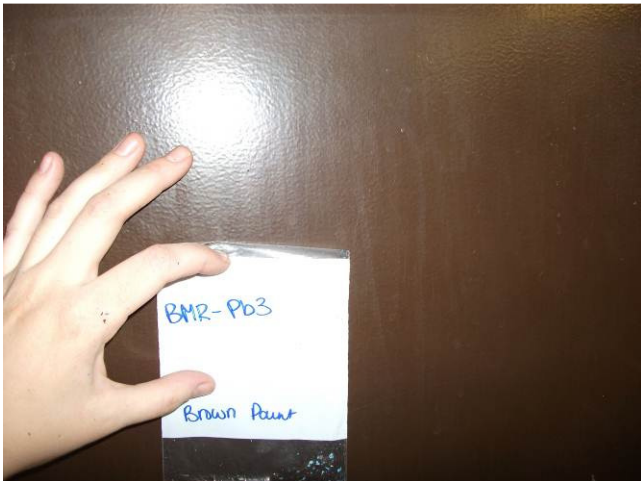
Photograph 35: Buoy Maintenance Building – Lead-Based Brown Exterior Paint

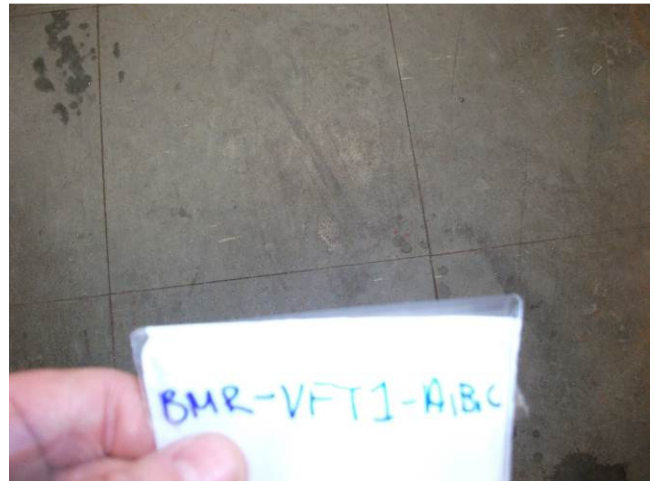
Photograph 36: Buoy Maintenance Building – ACM (VFT1) Blue With White Streak 12" X 12" Vinyl Floor Tile

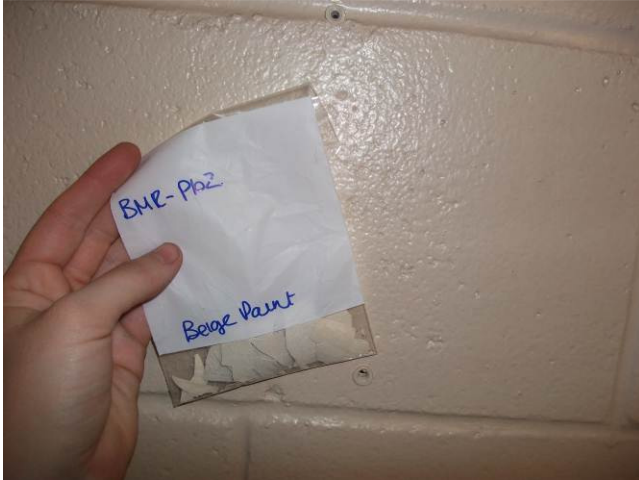
Photograph 37: Buoy Maintenance Building – Lead-Based Beige Undercoat Paint
