**ST. ANTHONY  
SAR STATION  
REFURBISHMENT  
P/N: R.089934.001**

## UPDATED PHASE I ENVIRONMENTAL SITE ASSESSMENT

St. Anthony MCTS Centre (DFRP#01728)

**UPDATED PHASE I ENVIRONMENTAL SITE ASSESSMENT  
ST. ANTHONY MCTS (DFRP #01728)  
ST. ANTHONY  
NEWFOUNDLAND AND LABRADOR**

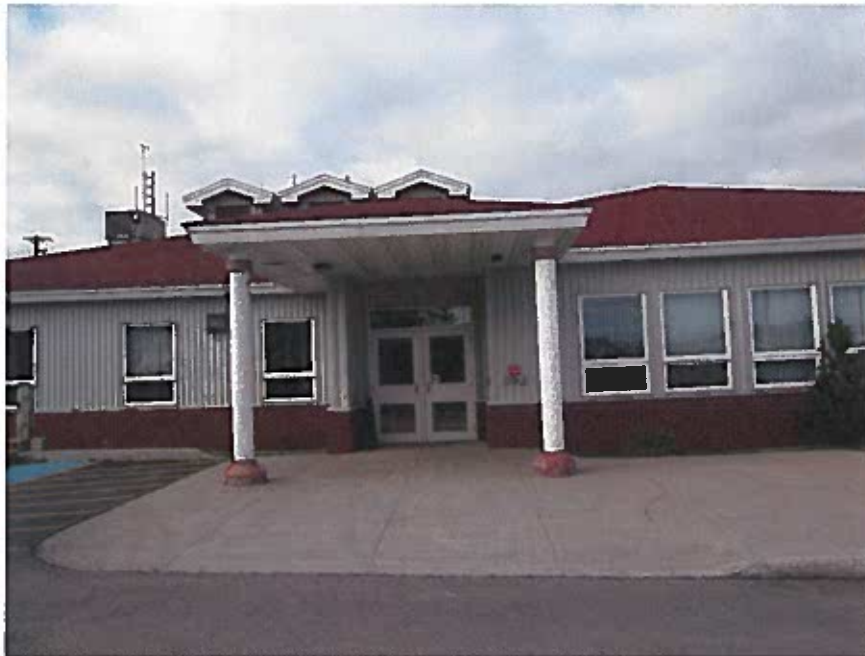
The St. Anthony MCTS (DFRP #01728) and associated warehouse were constructed in 1996 and are owned by Canadian Coast Guard. The MCTS office building and warehouse are in good condition both structurally and on the exterior (see Appendix B, Photos 1 through 4).

**Photo 1: View of main entrance to MCTS office, facing north.**

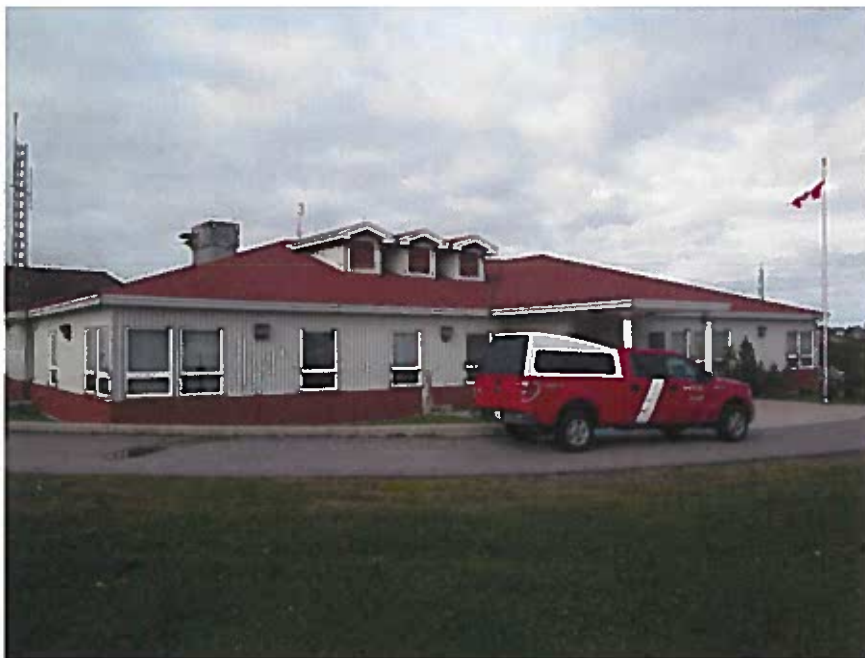
**Photo 2: View of MCTS office, facing northeast.**

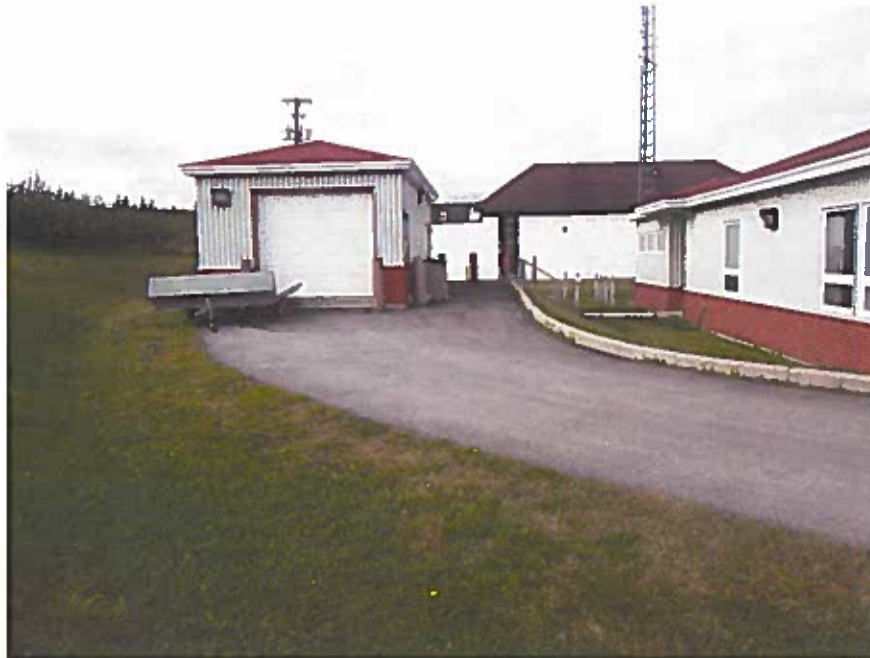
**Photo 3: View of warehouse with Scotiabank in the background, facing north.**

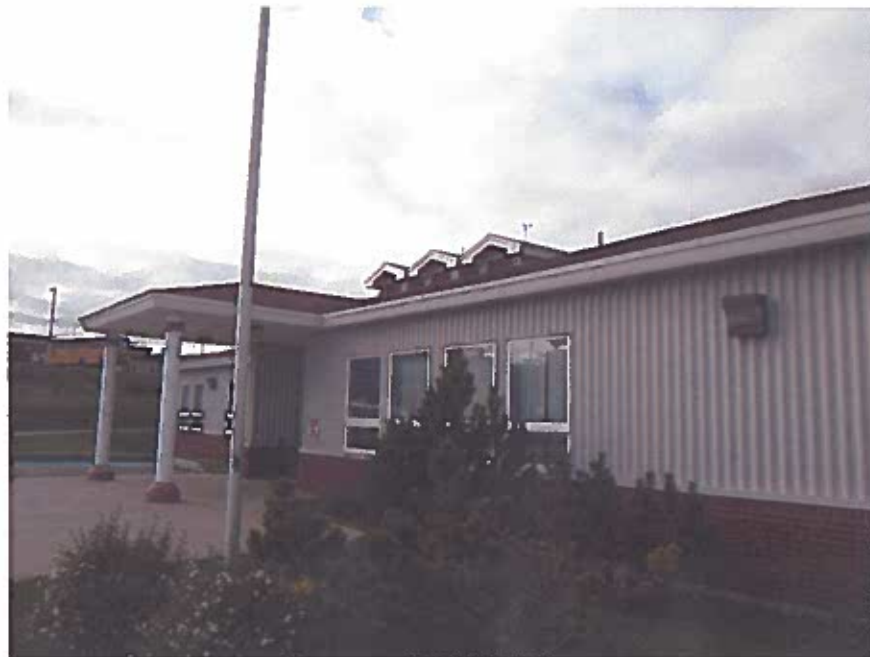
**Photo 4: Alternate view of the MCTS building, facing northwest.**

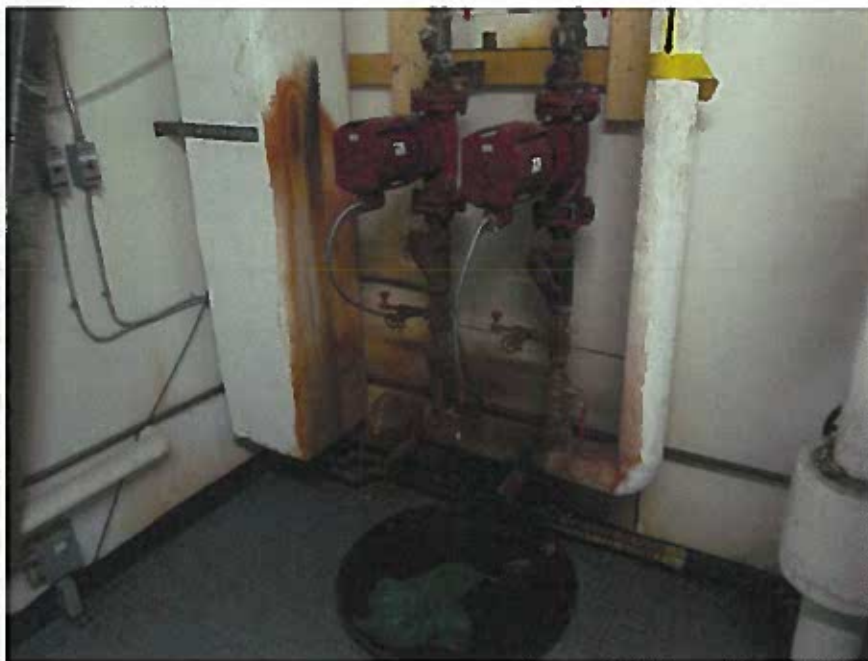
Staining approximately 1 m<sup>2</sup> in area was observed on the floor and walls of the MCTS office building adjacent to the furnace fuel lines (refer to Appendix B, photo 10).

**Photo 10: Fuel lines adjacent to furnace in MCTS building.**

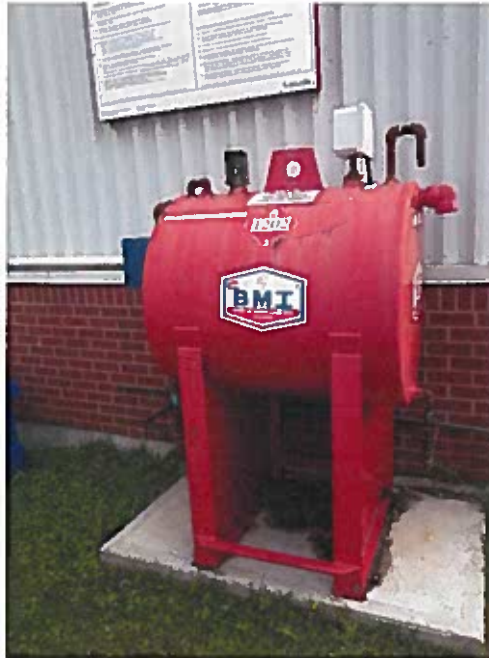
However, during the visit, an AST was observed outside the warehouse and a UST was located adjacent to the warehouse.

Photo 13: 40 gallon AST.

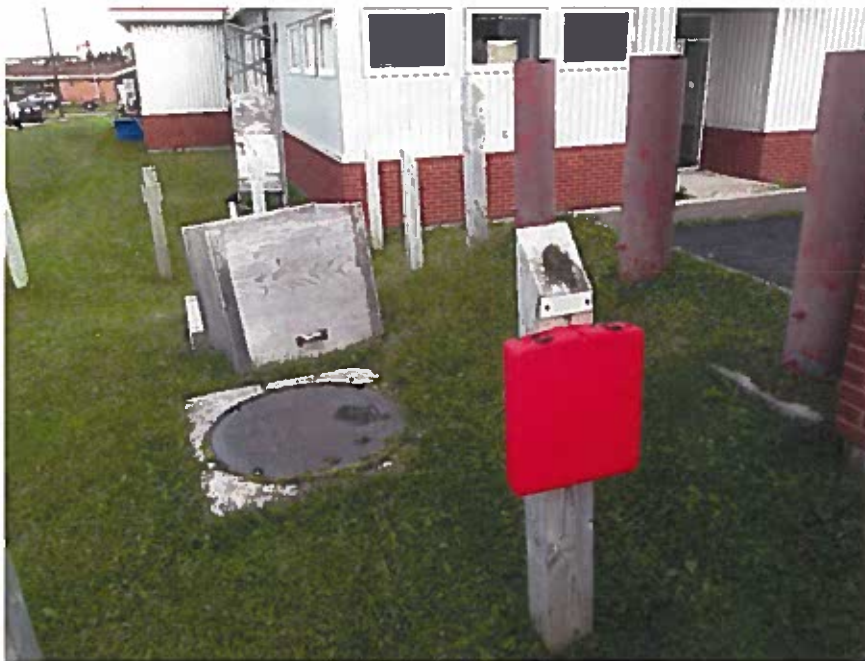
Also, Mr. Smith stated that there is a 455 L AST located inside the warehouse, in the emergency power unit room. This AST is connected to a 4540 L UST located outside the building between the St. Anthony MCTS (DFRP #01728) and the warehouse adjacent to the MF tower. Mr. Smith indicated the 4540 L UST was installed in 1996 and inspected in 2007-2008.

Photo 14: Filling cap and access to 4540 L UST.

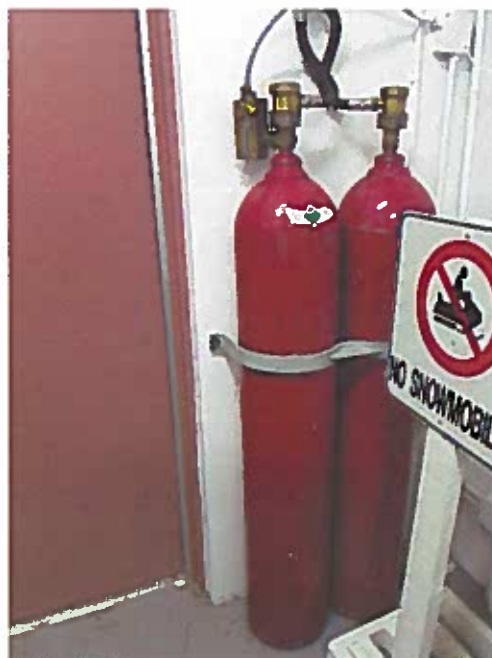
Two full cylinders of CO<sub>2</sub> were observed inside the Emergency Power Unit of the MCTS warehouse, as part of a fire suppression system (see Appendix B, Photo 15).

Photo 15: CO2 fire suppression system tanks.

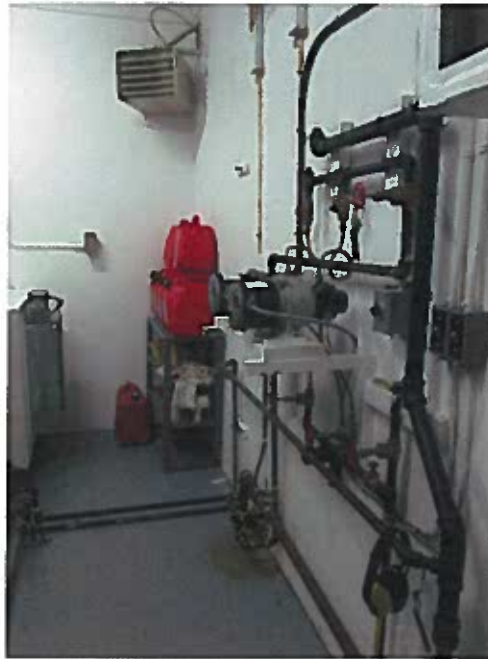
Small fuel storage containers and paint containers were noted within the warehouse itself. Various cleaning supplies were noted inside the MCTS office building.

**Photo 17: Fuel storage containers.**
