Kouchibouguac National Park
186 Route 117, New Brunswick

Hazardous Materials Assessment – FINAL REPORT

Outdoor Theatre, Kelly Building, Ryan Building &
Administration/ VRC Building

File No. TF196450-0000-CD10-RPT-0001

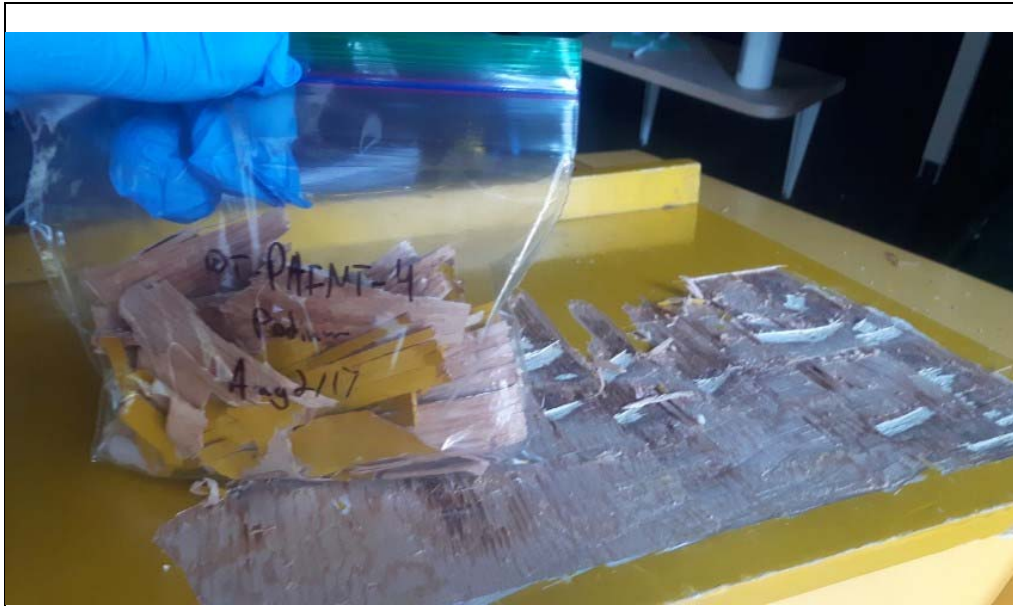
Photo 2:
OT-Paint-4,
Podium in Main
Theatre Building

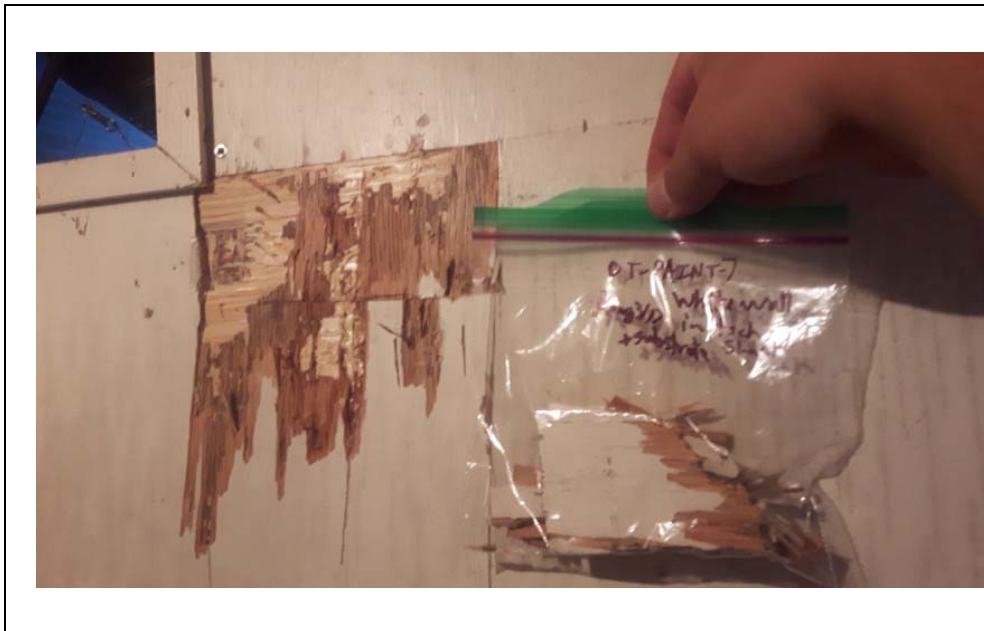
Photo 4:
OT-Paint-7, Indoor
Walls of Reel
Building

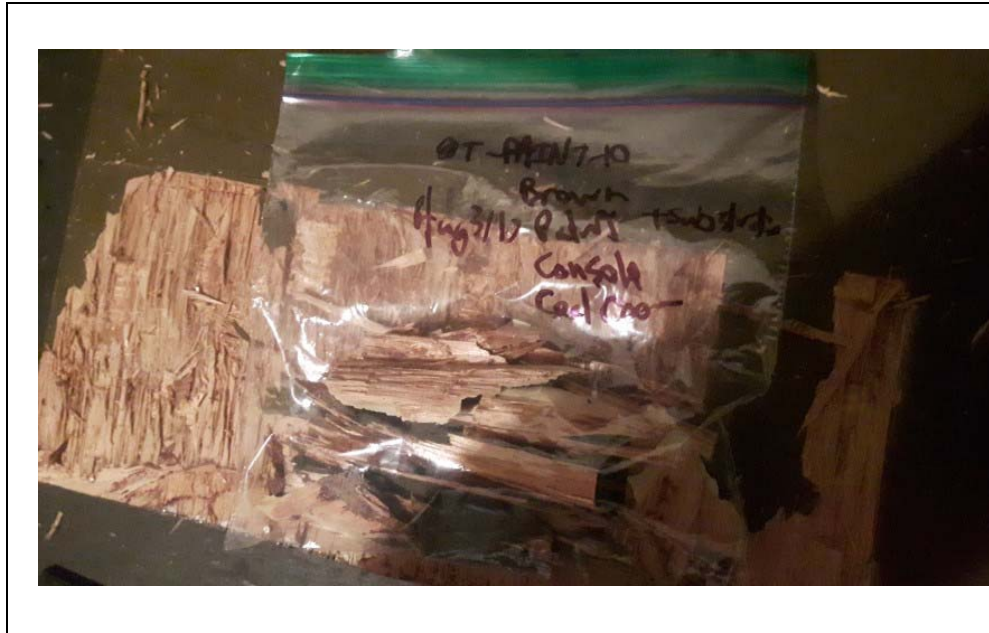
Photo 5:
OT-Paint-10,
Console/counter in
Reel Building

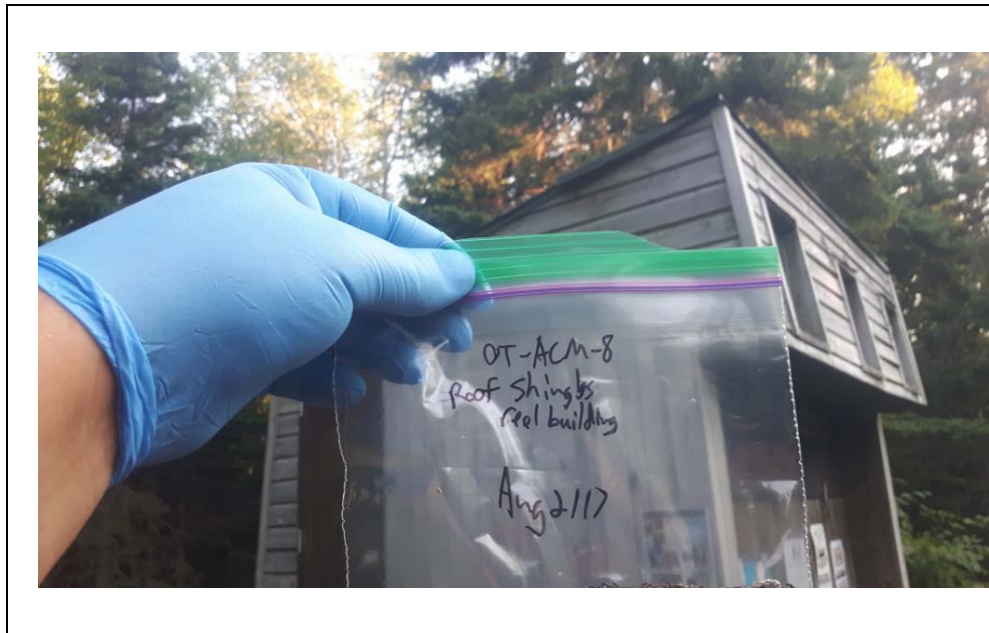
As indicated in Table 1, of the 36 samples submitted, 3 samples had chrysotile asbestos detected. Asbestos was detected in the roof shingles (1.1%) of the Reel Building, the exterior caulking (1.1%) of Kelly's Building, and the gypsum board joint compound (3%) in the Mechanical Room of Ryan's Building. All gypsum board with associated joint compound located in Ryan's Building must be assumed to contain asbestos. Photos of these samples are provided in Attachment A.

Photo 6:
OT-ACM-8, Reel
Building Roof
Shingles

Based on the findings of the investigation, and as shown in Table 1, three samples collected contained asbestos. It is our understanding that these structures are planned for renovation activities; therefore, it is recommended that the known ACMs be removed according to Regulation 92-106 (*Code of Practice for Working with Materials Containing Asbestos in New Brunswick*). The Westmorland-Albert Regional Solid Waste Corporation (RSWC) located in Berry Mills, New Brunswick accepts friable and non-friable asbestos. It is recommended that the removal of ACMs be conducted by a certified contractor trained in the removal and disposal methods. Prior to disposal, the material is required to be bagged in nine (9) millimetre (mm) thick bags and labelled accordingly. The RSWC required 24 hour notice and the approximate disposal cost is \$70/cubic metre (m³).

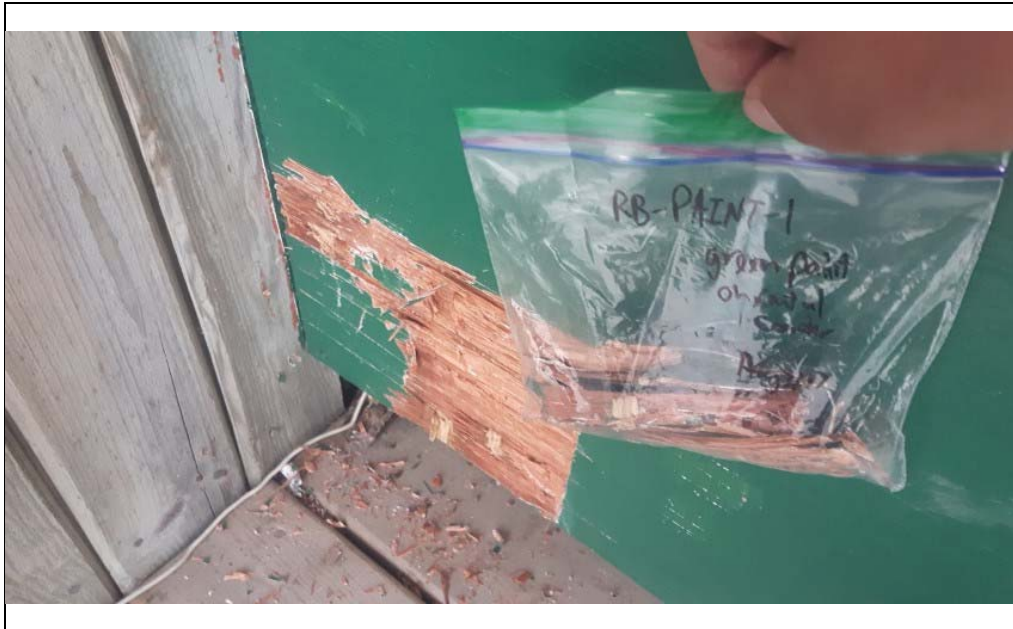
Photo 10:
RB-Paint-1, Front
of rental booth

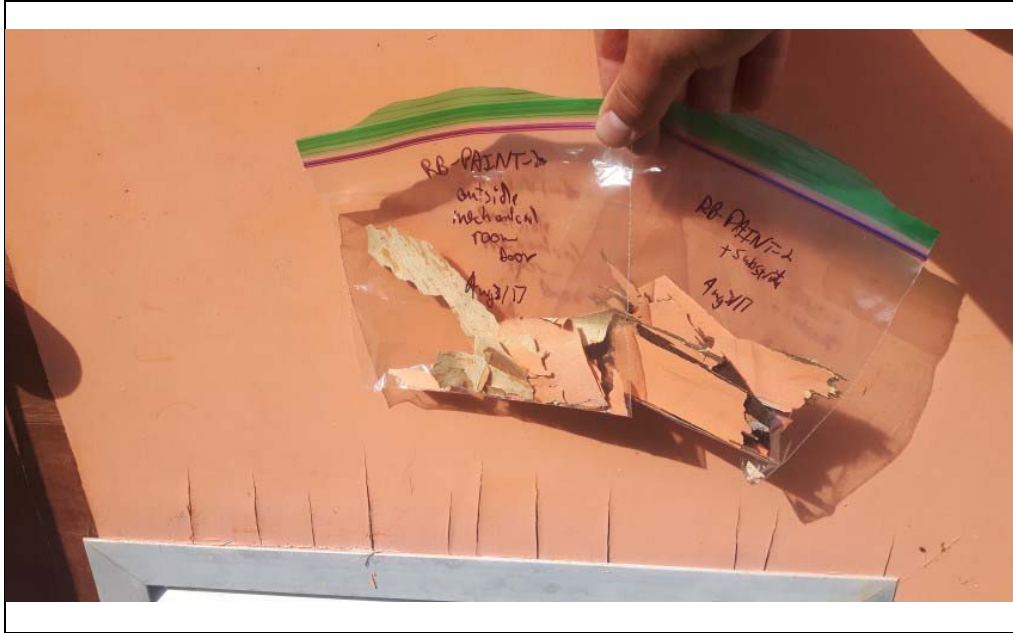
Photo 11:
RB-Paint-2,
Exterior
Mechanical Room
door

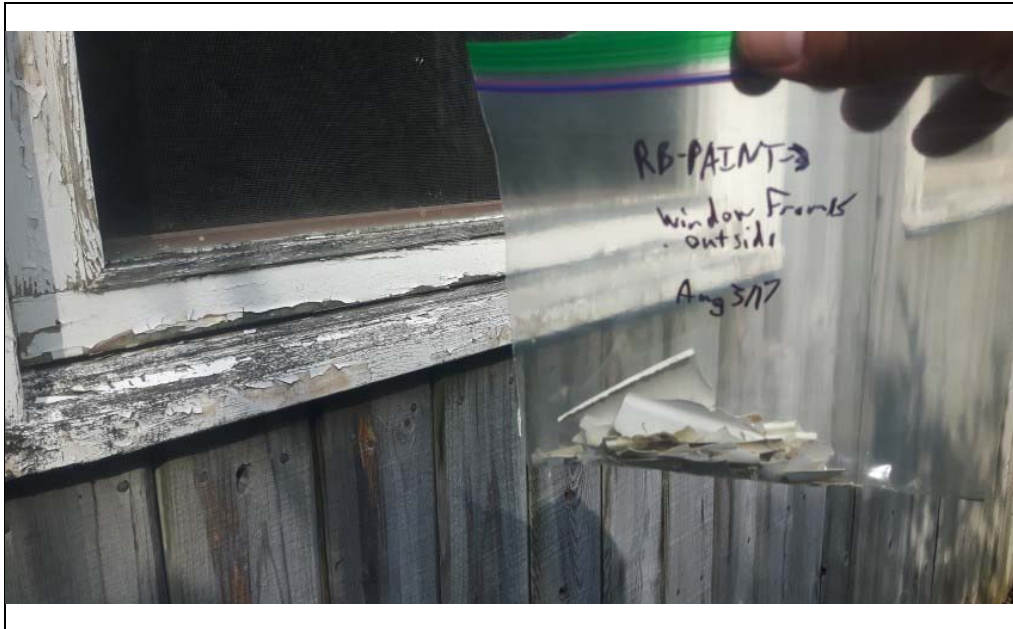
Photo 12:
RB-Paint-3,
Exterior window
trim

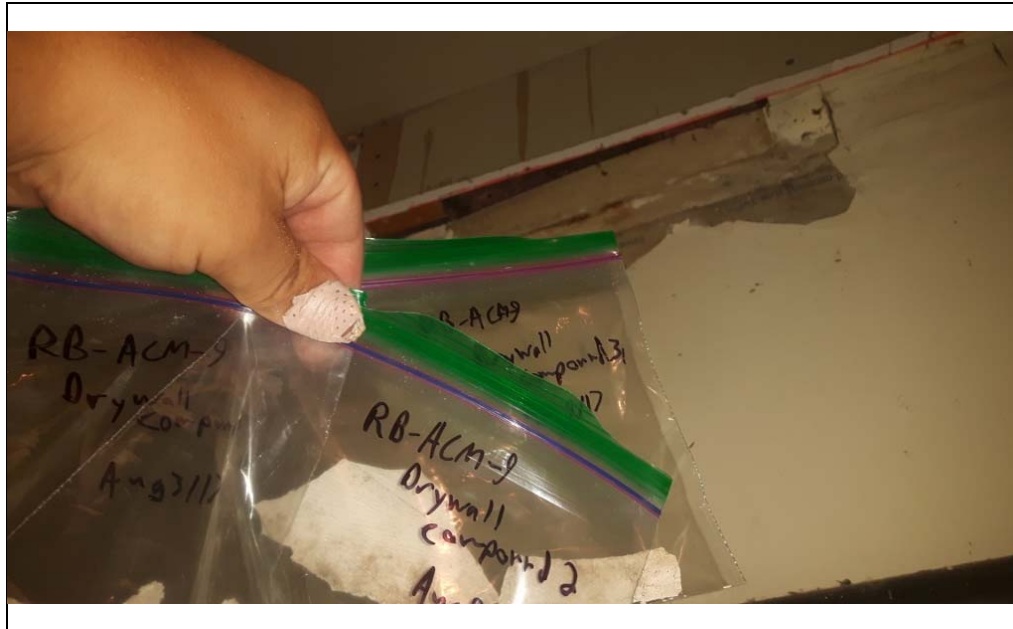
Photo 14:
RB-ACM-9, joint
compound in
Mechanical Room

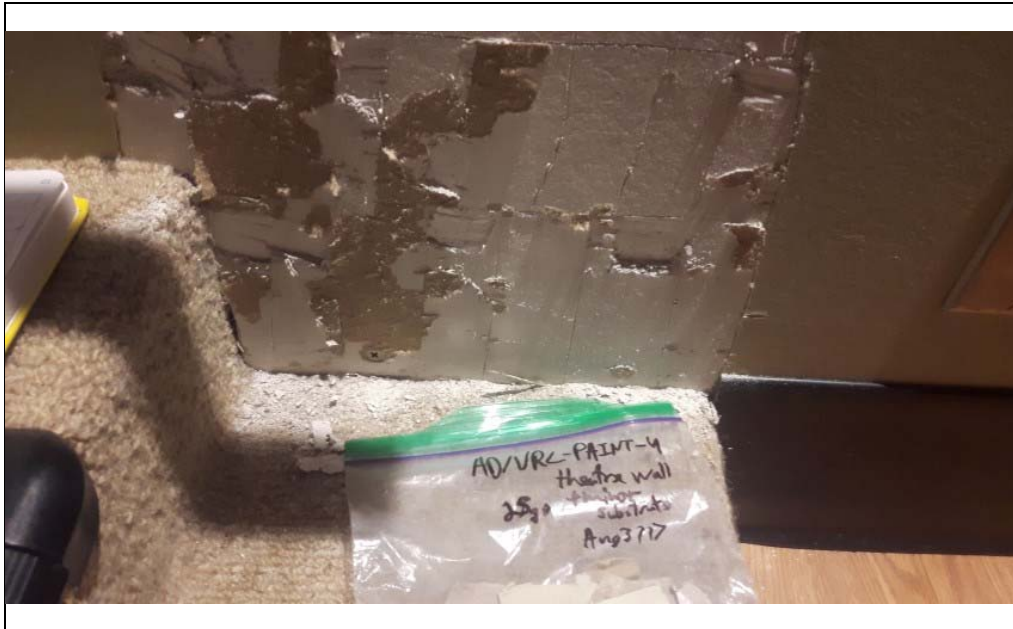
Photo 16:
AD/VRC-Paint 4,
Interior Wall of
Theatre in
Admin/VRC
Building
