Kouchibouguac National Park

Hazardous Materials Assessment – FINAL REPORT

Washroom/ Shower Buildings A Thru F and
Kitchen Shelters K1 & K2

File No. TF196450-0000-CD10-RPT-0002

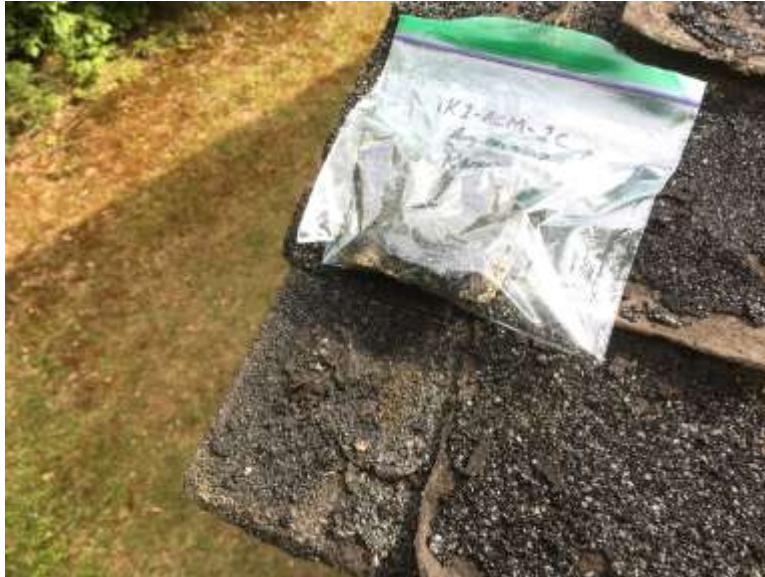
Photo 13:
K1-ACM-1C
Roof tile

| Building | Sample Identification | Location | Description | Results |
|---|---|---|---|---|
| Exterior | K1-ACM-1C | Roof | Roof shingle | 1.9% Chrysotile |

As indicated in Table 1, of the 79 samples submitted, 5 samples had chrysotile asbestos detected. Asbestos greater than 1 % was detected in the roof shingles (1.9%) of Service Kitchen 2. Photos are provided in Attachment A.

Based on the findings of the investigation, and as shown in Table 1, one sample collected contained asbestos. It is our understanding that these structures are planned for renovation activities; therefore, it is recommended that the known ACMs be removed according to Regulation 92-106 (*Code of Practice for Working with Materials Containing Asbestos in New Brunswick*). The Westmorland-Albert Regional Solid Waste Corporation (RSWC) located in Berry Mills, New Brunswick accepts friable and non-friable asbestos. It is recommended that the removal of ACMs be conducted by a certified contractor trained in the removal and disposal methods. Prior to disposal, the material is required to be bagged in nine (9) millimetre (mm) thick bags and labelled accordingly. The RSWC required 24 hour notice and the approximate disposal cost is \$70/cubic metre (m³).
