DESIGNATED SUBSTANCES AND HAZARDOUS MATERIALS SURVEY

BEAVER CREEK INSTITUTION, GRAVENHURST, ON

FEBRUARY 21, 2018

PROJECT NO.: 181-02088-00
DATE: FEBRUARY 2018

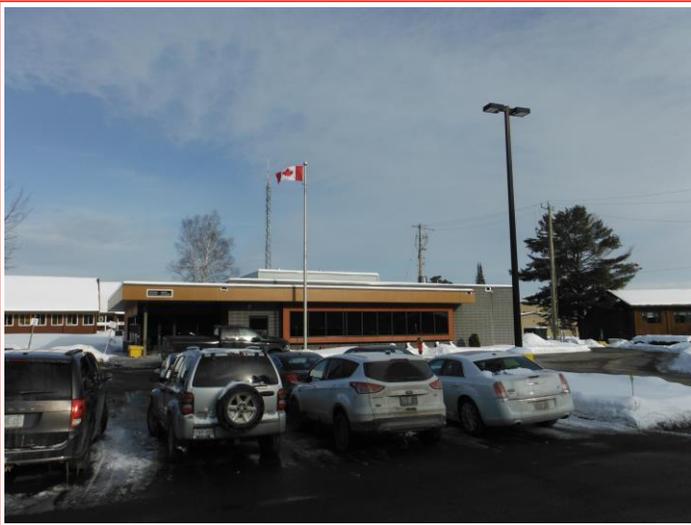
Photo #1: View of Building BC55 (Principle Entrance).

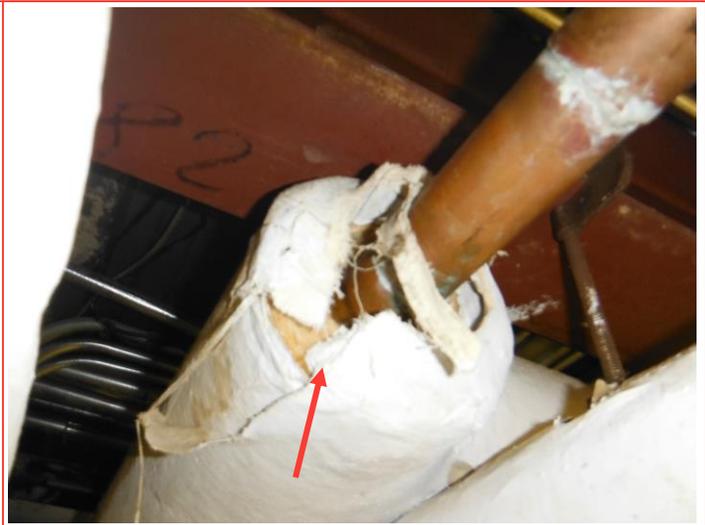
Asbestos-containing paring cement on pipe fittings was previously identified by Oakhill Environmental within buildings BC12 and BC13. WSP's site observations indicated that asbestos abatement previously took place in some locations; however, asbestos-containing pipe fittings are presumed to be present in other concealed areas of the subject buildings (ie. ceiling & wall cavities). One (1) asbestos-containing pipe fitting was observed to be in poor condition in the basement mechanical room (B01) of Building BC13 (see Appendix B – Site Photographs). This material should be removed following Type 2 (glovebag) procedures in order to comply with the requirements of *O. Reg. 278/05* and the *PSPC Asbestos Management Standard*.

Photo #2: View of asbestos-containing parging cement located on pipe in the basement mechanical room (B01) in Building BC13 (Heath Services and SIS Building).

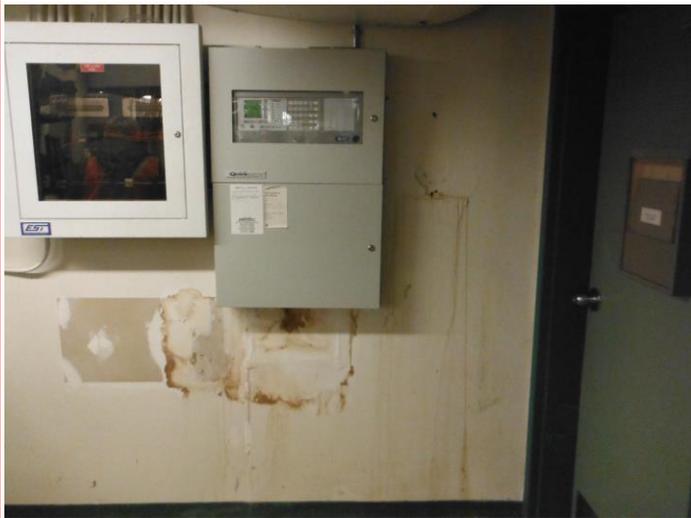
Photo #3: View of typical fire panel and water damage on drywall in the mechanical room of Building BC25 (Accommodation Unit #2).

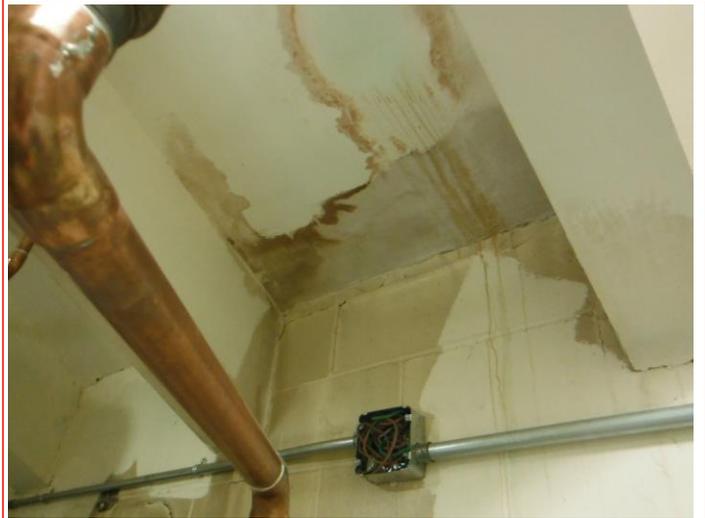
Photo #4: View of water damage on drywall in the mechanical room of Building BC14 (Accommodation Unit #1).
