CCGS Amundsen

# Condition Assessment Report

June 2013

| 16. Summary<br><p><b>This report details a Condition Assessment for the CCGS Amundsen undertaken to determine the current condition of the ship hull structure. Hull Renovation Scheme level 2SS standard was used as a basis for assessment of the current condition and in identifying likely hull elements that will require maintenance for the remaining life of the ship.</b></p> <p><b>The report and supporting surveys concluded that the ship's hull and tanks were generally found in good condition, and at a standard comparable to a classed ship of similar type and age.</b></p> | | | |

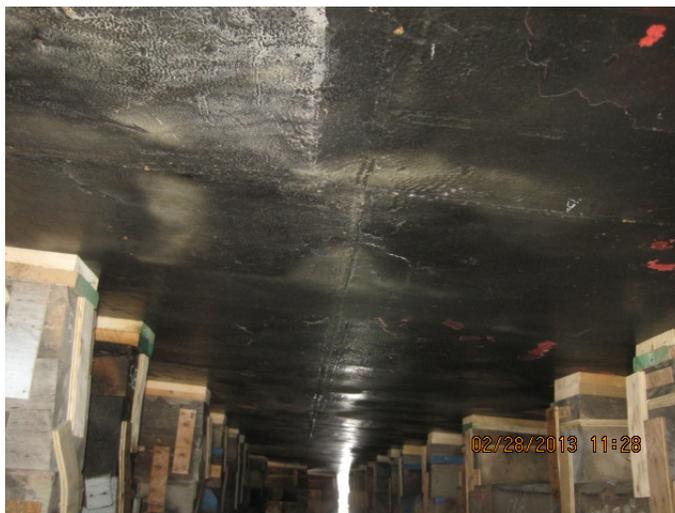
4.1 Bottom Plating

General condition of shell plating	GOOD
Type of coatings	Epoxy
General condition of coatings	GOOD
<p><b>Limit of Inspection</b> A visual examination carried out to full area</p> <p><b>Condition of the hull plating, including sea chests on flat bottom.</b> Good condition No obvious defects found to tank bottom plug openings, neither to echo sounder and other sensor areas.</p> <p><b>Indents (location, extent and effect on the structure)</b> Slight indents found in No.2 stbd D.B. F.O. tank area at Fr.99-100</p> <p><b>Damage (location extent and effect on the structure)</b> No damage found</p> <p><b>Visible loss of thickness (including grooving of welds)</b> No visual thickness loss found</p> <p><b>Other defects</b> None noted</p>

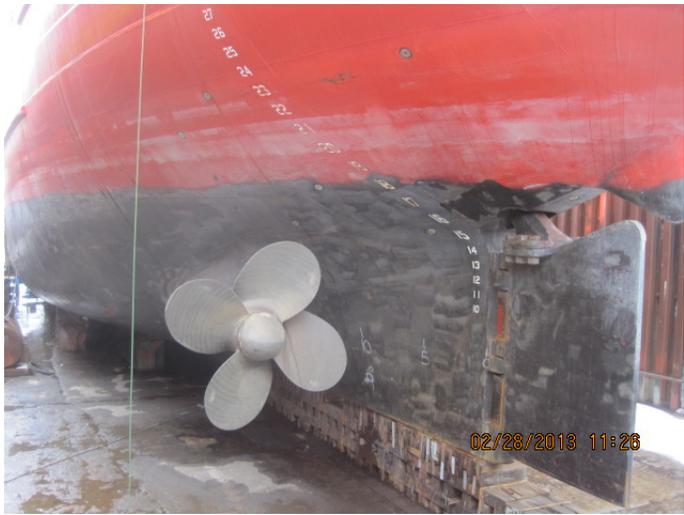
4.2: Port Side Stern

General condition of shell plating	GOOD
Type (not maker) of coatings	Epoxy
General condition of coatings	GOOD
<p><b>Limit of Inspection (including drafts if afloat)</b> Visual examination carried out of the full area</p> <p><b>Condition of the hull plating, appendages</b> Good condition, except for Port and Stbd fwd and aft end hull welding seams found eroded. The seams are lower than side shell plating surface in various depths. Details as follows:</p> <ol style="list-style-type: none"> <li>1.both vertical and horizontal welding seams affected</li> <li>2.covered with rust/scale and/or fouling (marine growth) in places</li> <li>3.of hole type in some seams, especially in butt welds between stern tube and side shell plating</li> <li>4. in some areas coating looks well if viewed from a distance, but corrosion present underneath.</li> <li>5. erosion at aft port side found heavier compared to those at stbd side</li> <li>6.stem eroded to varying degree, including welds between stem and fwd side shell</li> </ol> <p>All sea chests conditions found good and anodes in sea chests found in various breaking down conditions</p> <p><b>Indents (location, extent and effect on the structure)</b> No indents found</p> <p><b>Damage (location extent and effect on the structure)</b> No damage found</p> <p><b>Visible loss of thickness (including grooving of welds)</b> No visible thickness loss found</p>

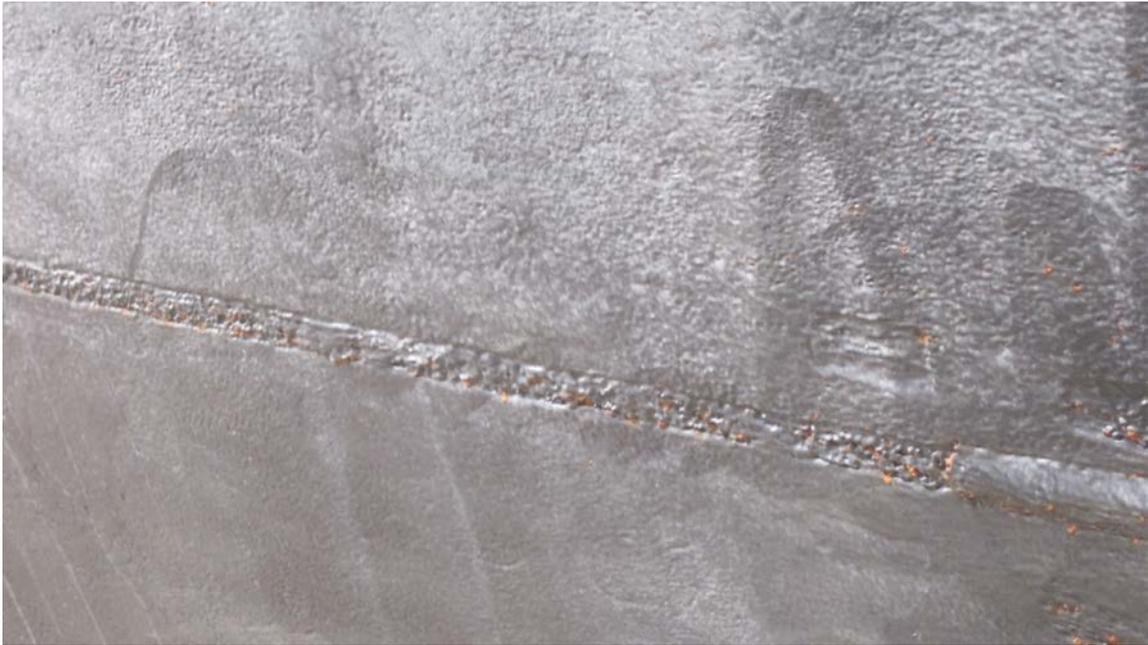
Item No.	Tank / Space	Findings and Recommendations
1	Hull	Welds at the forward and aft extremes show signs of erosion. May require repairs at the next drydocking.
2	No.2 DBFO Tk Stbd	Bottom plating pitting at various locations. Quite a few individual pits look deep, further examination by thickness measurement inspector to be carried out in order to confirm whether necessary to have immediate repair. (Post-survey update: TM did not indicate severe wastage, repairs can be postponed until next opportunity)  Bilge brackets buckled at F99,107 and 112; 500-1500mm in length and 40-90mm in depth. F116 floor buckled 500mm in length and 40mm in depth between 1 <sup>st</sup> and 2 <sup>nd</sup> girder from outboard. No immediate repair is needed.
3	No.3 DBFO Tk Stbd	Bottom pitting at F61-65 extreme inboard was marked - to be repaired by welding. Repairs can be postponed until next opportunity.  Bottom plate dent at F61-71, no immediate repair is needed.  Bottom floor and bottom angle bar bent at F61-71, between 1 <sup>st</sup> and 2 <sup>nd</sup> girder from inboard. Floor bent at approx 38mm in depth and 300x150mm in area, no immediate repair is needed.

4.3: Port Side Hull Fwd Half – Eroded Weld

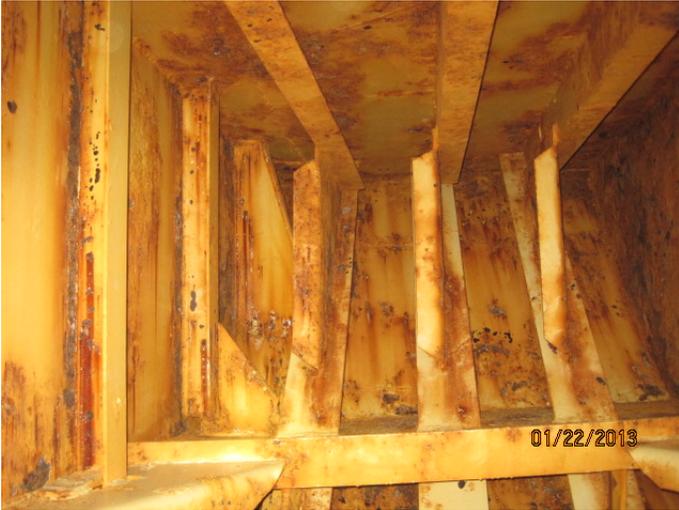
4.11: Fwd Trimming tank F176-183 - ship side

General condition of structure		GOOD	
General condition of cathodic protection		N/A	
General condition of coatings		FAIR,SEE NOTE BELOW	
Type of coatings:	Intertuf JBA 016	Extent	FULL
<p><b>Limit of Inspection</b> Full Visual inspection of tank Located between Frames 176-183, Cleanliness was satisfactory except for bottom plating to be cleaned</p> <p><b>Deckhead</b> Tank top found in good condition no corrosion noted</p> <p><b>Transverse Bulkheads</b> Found satisfactory no damage noted. Welds brackets &amp; stiffeners all found satisfactory</p> <p><b>Deck or Space bottom</b> Found satisfactory no damage noted</p> <p><b>Internal structure</b> Found satisfactory no damage noted</p> <p><b>Other structure</b> None noted</p> <p><b>Coating Details</b> Upper part 15-20% broken down Middle part 10-15% broken down Lower part 10-20% broken down Coating near welding or at not easy access corner found poor</p>

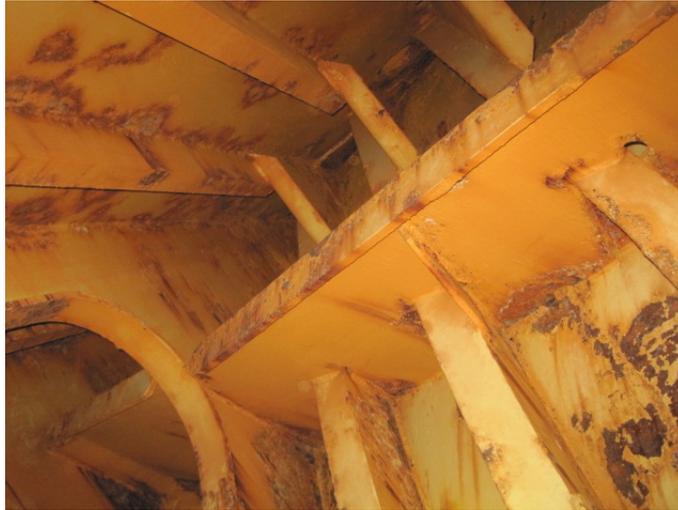
4.14: Aft Trimming Tank - Deck and Side Shell

General condition of structure		GOOD	
General condition of cathodic protection		N/A	
General condition of coatings		FAIR see details below	
Type of coatings:	Intertuf JBA016	Extent	FULL
<p><b>Limit of Inspection</b>  Frame 0-18  Cleanliness was satisfactory</p> <p><b>Deckhead</b>  No obvious defects found, structure was in good condition.</p> <p><b>Transverse Bulkheads</b>  No obvious defects found, structure was in good condition.</p> <p><b>Deck or Space bottom</b>  No obvious defects found, structure was in good condition.</p> <p><b>Internal structure</b>  No obvious defects found, structure was in good condition.</p> <p><b>Other structure</b>  None noted</p> <p><b>Coating details</b>  Generally coating in way of upper part is good and fair in the lower part</p>

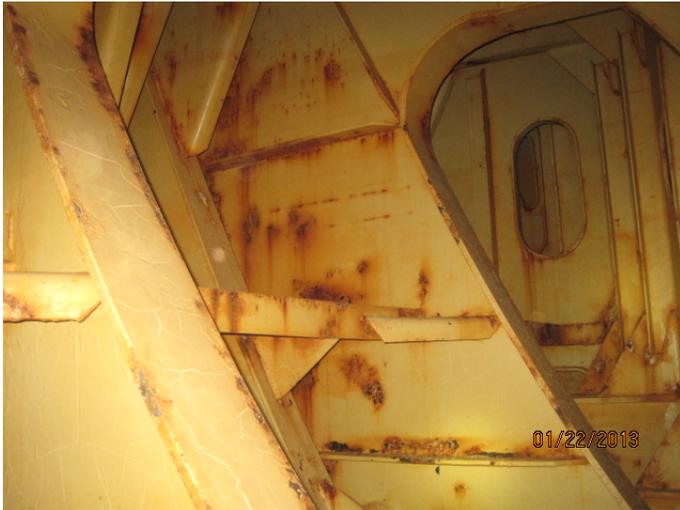
4.17: FPT Side Shell & Structure

General condition of structure		GOOD	
General condition of cathodic protection		N/A	
General condition of coatings		SEE DETAILS BELOW	
Type of coatings:	Intertuf JBA016	Extent	FULL
<p><b>Limit of Inspection</b>  Frame 183-210  Space under chain lockers to be examined after chain locker cleaning  Cleanliness was satisfactory</p> <p><b>Deckhead</b>  Good condition</p> <p><b>Transverse Bulkheads</b>  Good Condition</p> <p><b>Deck or Space bottom</b>  Good condition</p> <p><b>Internal structure</b>  Center longitudinal bulkhead F191-193 buckled at openings, approx. 12mm in depth.</p> <p><b>Other structure</b>  None noted</p> <p><b>Coating details</b>  Stbd lower part F191-200 coating 20% broken down  Port aft and other areas coating 10-15% broken down  Stbd F183-191 coating 5-10% broken down  Center longitudinal bulkhead F191-203 coating 20% broken down</p>

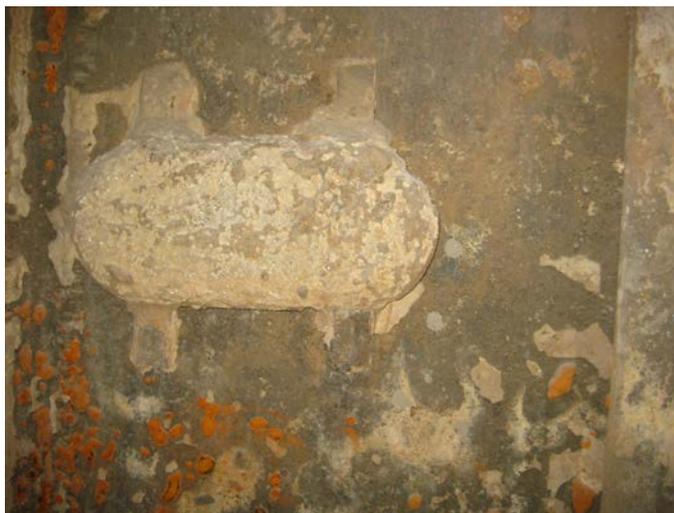
4.20: Sea Bay Motor Propulsion Room-Fwd Bulkhead

General condition of structure		GOOD	
General condition of cathodic protection		FAIR	
General condition of coatings		Poor, SEE DETAILS BELOW	
Type of coatings:	cement	Extent	FULL
<p><b>Limit of Inspection</b>  Visual inspection of tank located between frames 55-61. Bottom plate covered with ice approx. 1 inch thick.</p> <p><b>Deckhead</b>  Good condition</p> <p><b>Transverse Bulkheads</b>  Good condition</p> <p><b>Deck or Space bottom</b>  Bottom plate covered with ice.</p> <p><b>Internal structure</b>  Good condition</p> <p><b>Other structure</b>  None noted</p> <p><b>Coating details</b>  Cement broken down approx 30%.</p> <p><b>Anode condition</b>  Anode wasted approx. 15%.</p>

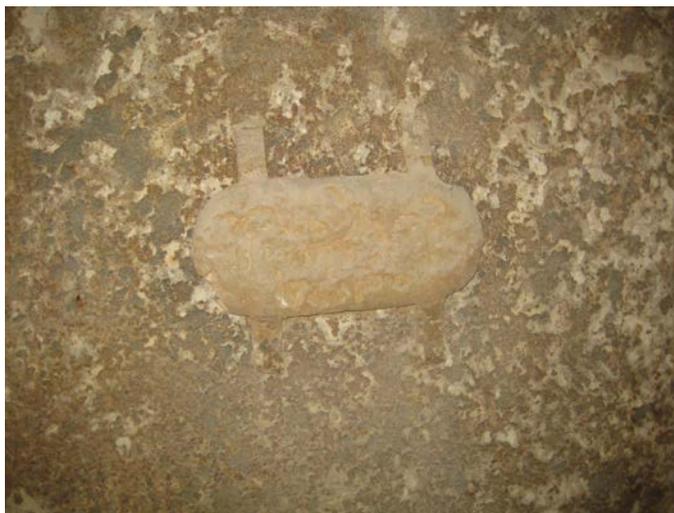
4.22: Aft Sea Bay - Aft Bulkhead

General condition of structure		GOOD	
General condition of cathodic protection		FAIR	
General condition of coatings		POOR, SEE DETAILS BELOW	
Type of coatings:	cement	Extent	FULL
<p><b>Limit of Inspection</b>  Visual inspection of tank located between frames 93-95. Stbd access blocked by vertical pipes, access not possible. Cleanliness was satisfactory</p> <p><b>Deckhead</b>  Good condition</p> <p><b>Transverse Bulkheads</b>  Good condition</p> <p><b>Deck or Space bottom</b>  Good condition</p> <p><b>Internal structure</b>  Good condition</p> <p><b>Other structure</b>  None noted</p> <p><b>Coating details</b>  Cement broken down more than 50%.</p> <p><b>Anode condition</b>  Anode wasted approx 20%.</p>

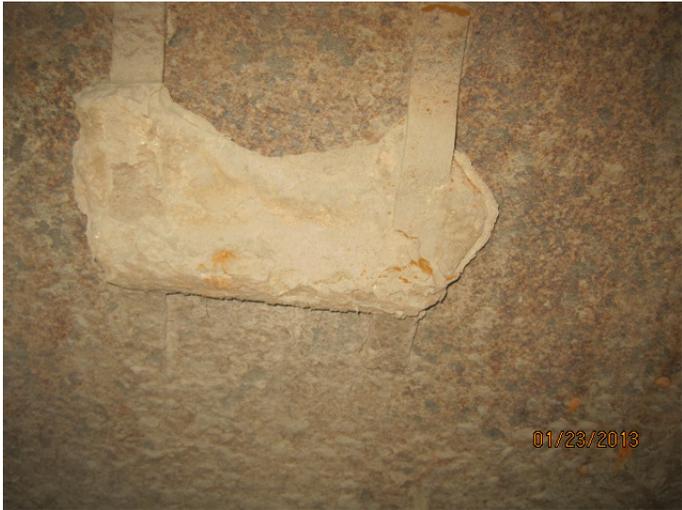
General condition of structure		GOOD	
General condition of cathodic protection		Fair	
General condition of coatings		FAIR see details below	
Type of coatings:	cement	Extent	FULL
<p><b>Limit of Inspection</b>  Frame 95-97. Stbd part not inspected - manhole not opened. Cleanliness was satisfactory.</p> <p><b>Deckhead</b>  No obvious defects found, structure was in good condition.</p> <p><b>Transverse Bulkheads</b>  No obvious defects found, structure was in good condition.</p> <p><b>Deck or Space bottom</b>  No obvious defects found, structure was in good condition.</p> <p><b>Internal structure</b>  No obvious defects found, structure was in good condition.</p> <p><b>Other structure</b>  None noted</p> <p><b>Coating details</b>  Cement coating generally fair.  Anodes wastage at various levels: 5-40%.</p>

4.24: Fwd Sea Bay (Port Side) - Anode

Sacrificial zinc anodes which have little material left should be replaced at the next opportunity.

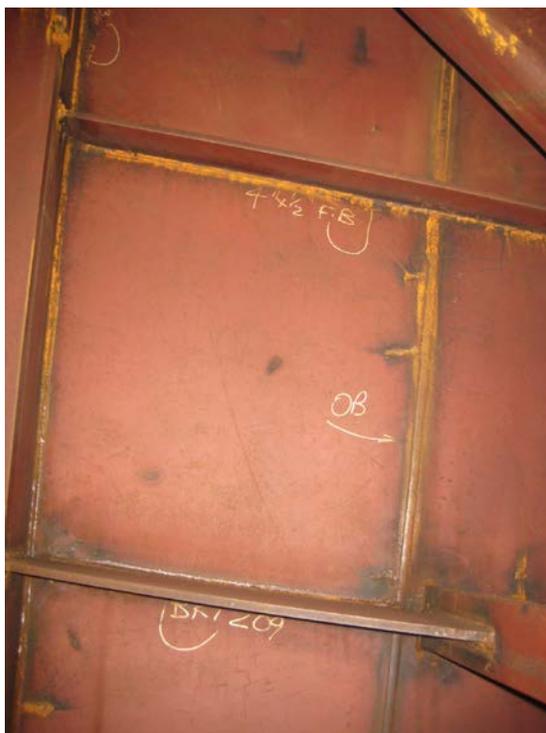
4.37: F.O. Settling Tank - Upper Level Fwd Bulkhead

General condition of structure		GOOD	
General condition of cathodic protection		N/A	
General condition of coatings		N/A	
Type of coatings:	N/A	Extent	FULL
<p><b>Limit of Inspection</b>  Visual inspection of tank located between frames 123-127. Cleanliness was satisfactory</p> <p><b>Deckhead</b>  Good condition</p> <p><b>Transverse Bulkheads</b>  Good condition</p> <p><b>Deck or Space bottom</b>  Good condition</p> <p><b>Internal structure</b>  Good condition</p> <p><b>Other structure</b>  None noted</p> <p><b>Coating details</b>  Bottom plate primer broken around 50%. In general, coating broken down at welds.</p>

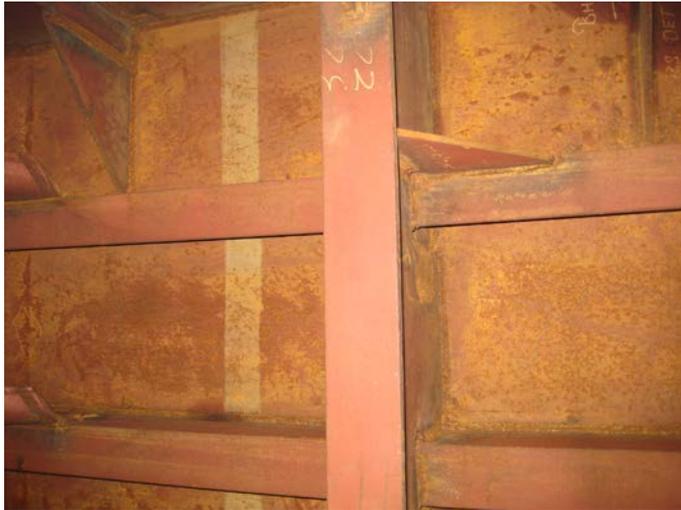
4.39: Fwd Engine Room Wing Tank Port - Upper Level - Aft Bulkhead

General condition of structure		GOOD	
General condition of cathodic protection		N/A	
General condition of coatings		N/A	
Type of coatings:	N/A	Extent	FULL
<p><b>Limit of Inspection</b>  Visual inspection of tank located between frames 95-123  Cleanliness was satisfactory</p> <p><b>Deckhead</b>  Good condition</p> <p><b>Transverse Bulkheads</b>  Good condition</p> <p><b>Deck or Space bottom</b>  Good condition</p> <p><b>Internal structure</b>  Good condition.</p> <p><b>Other structure</b>  None noted</p> <p><b>Coating details</b>  Aft bulkhead plate primer broken around 30%. In general, coating broken down at welds.</p>

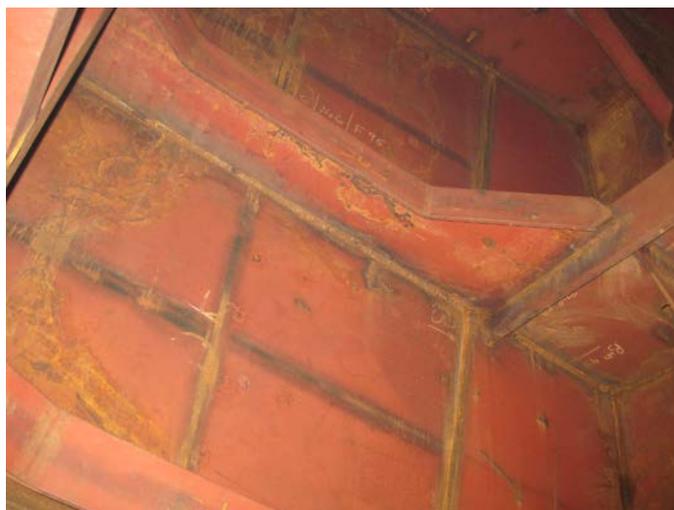
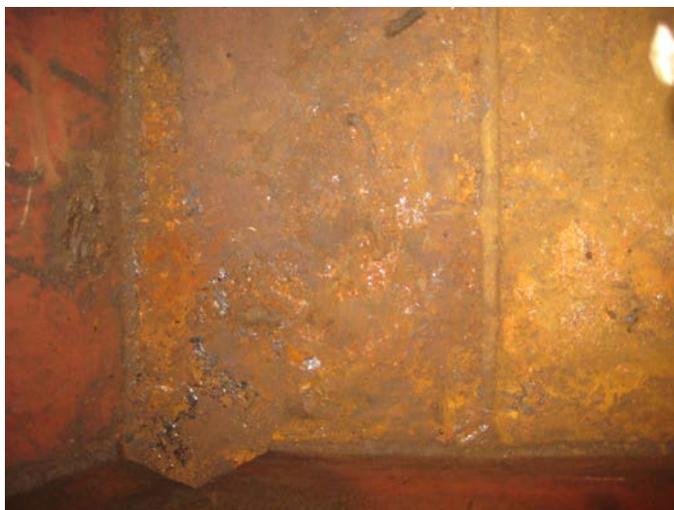
General condition of structure		GOOD	
General condition of cathodic protection		N/A	
General condition of coatings		N/A	
Type of coatings:	N/A	Extent	FULL
<p><b>Limit of Inspection</b>  Visual inspection of tank located between frames 95-123  Cleanliness was satisfactory</p> <p><b>Deckhead</b>  Good condition</p> <p><b>Transverse Bulkheads</b>  Good condition</p> <p><b>Deck or Space bottom</b>  Good condition</p> <p><b>Internal structure</b>  Good condition.  Side shell and attached structures was cut previously for machinery removal and is now closed. New welds examined visually and found satisfactory.</p> <p><b>Other structure</b>  None noted</p> <p><b>Coating details</b>  Aft bulkhead plate primer broken around 25%. In general, coating broken down at welds.</p>

4.41: Fwd Engine Room Wing Tank Starboard - Upper Level

4.42: Fwd Engine Room Wing Tank Starboard - Typical Corrosion At Lower Level

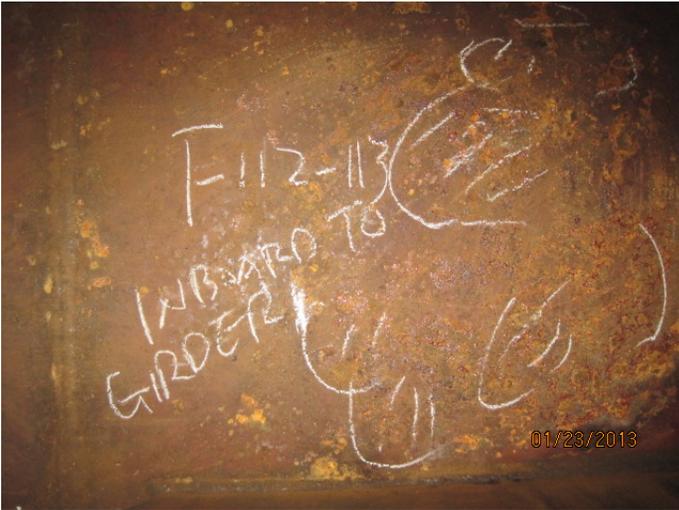
4.65: No.2 D.B.F.O.Tank Stbd - Bottom Pitting

Areas with current diminution in excess of 1SS levels and those with pronounced pitting, see Table 3-1, should be inspected annually, and when possible through enhanced thickness measurement programme. Fine-grid measurements are recommended for all such areas.

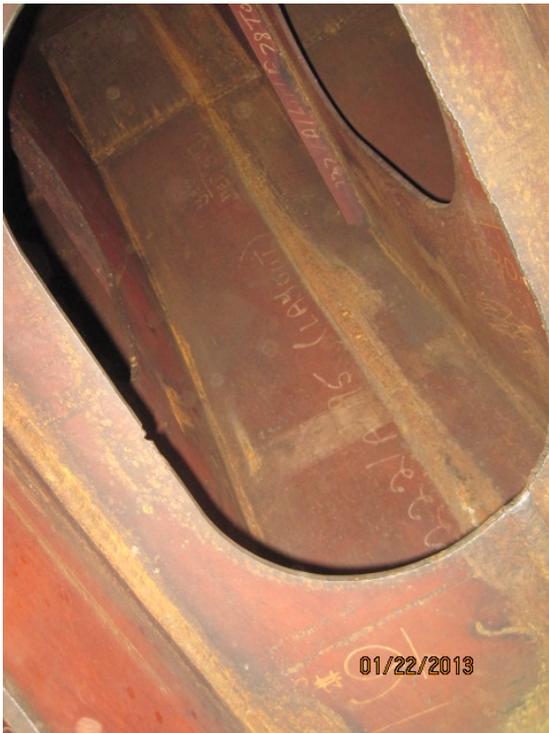
4.69: No.3 D.B.F.O.Tank Starboard - Side Shell

General condition of structure		UNSATISFACTORY	
General condition of cathodic protection		N/A	
General condition of coatings		GOOD (Primer only)	
Type of coatings:	N/A	Extent	FULL
<p><b>Limit of Insection</b>  Frame 61-93  Cleanliness was satisfactory</p> <p><b>Deckhead</b>  Good condition</p> <p><b>Transverse Bulkheads</b>  Good condition</p> <p><b>Deck or Space bottom</b>  Slight pitting initiated at a few spots  Bottom pitting at F61-65 extreme inboard was marked/to be repaired by welding  Bottom plate dent at F61-71, no immediate repair is needed.</p> <p><b>Internal structure</b>  Bottom floor and bottom angle bar bent at F61-71, between 1<sup>st</sup> and 2<sup>nd</sup> girder from Inboard. Floor bent at approx 38mm in depth and 300x150mm in area, no immediate repair is needed.</p> <p><b>Other structure</b>  None noted</p>

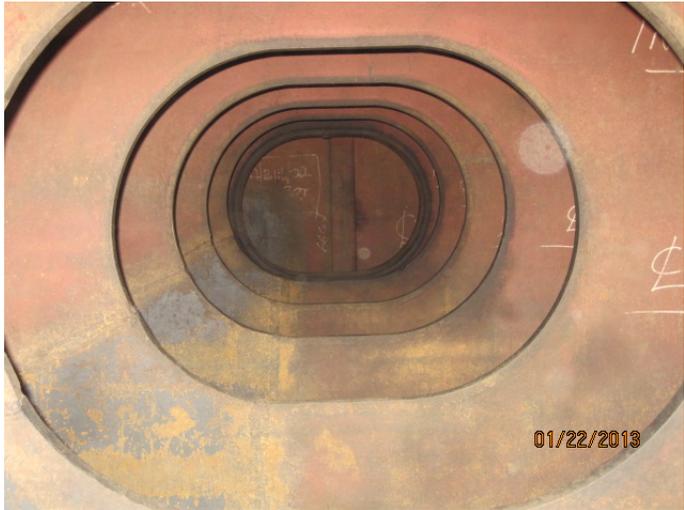
4.71: No.4 D.B. Bilge Tank Port – Structure and Fwd Bhd

4	No.4 DB Bilge FO Tk Port	Pronounced pitting found along bottom plate longitudinal butt seam, especially at scallop cut. Areas marked for TM/repair. (Post-survey update: TM did not indicate severe wastage, repairs can be postponed until next opportunity)
5	Various	Coating in cofferdams and sea water tanks is breaking down to various degrees. No immediate repair is required but the condition should be monitored annually.

General condition of structure		SATISFACTORY	
General condition of cathodic protection		SATISFACTORY	
General condition of coatings		FAIR,SEE DETAIL BELOW	
Type of coatings:	N/A	Extent	FULL
<p><b>Limit of Inspection</b>  Frame39-55  Ship side space is too narrow to enter for inspection  Cleanliness was satisfactory</p> <p><b>Deckhead</b>  Good condition</p> <p><b>Transverse Bulkheads</b>  Good condition</p> <p><b>Deck or Space bottom</b>  Very shallow pitting initiated at 1-5%  Scar pitting developed along bottom plate longitudinal welding butt seam, especially at scallop cut.  Marks were made for TM/repair to be done.</p> <p><b>Internal structure</b>  Good condition</p> <p><b>Other structure</b>  None noted</p> <p><b>Coating details</b>  Bottom plate primer almost gone</p>

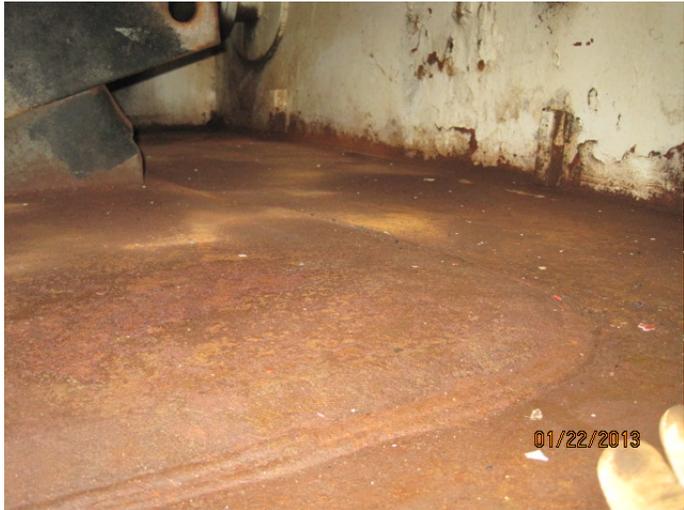
4.87: Aft Void Space Port - Tank Top

General condition of structure		GOOD	
General condition of cathodic protection		N/A	
General condition of coatings		SEE DETAILS BELOW	
Type of coatings:	EPOXY	Extent	FULL
<p><b>Limit of Inspection</b> Frame30-39</p> <p><b>Deckhead</b> Good condition</p> <p><b>Transverse Bulkheads</b> Good condition</p> <p><b>Deck or Space bottom</b> Bottom plate dented slightly at F34-37, between side longitudinal bulkhead and girder.</p> <p><b>Internal structure</b> Good condition</p> <p><b>Other structure</b> None noted</p> <p><b>Coating details</b> Bottom plating coating locally broken down 5-20%.</p>

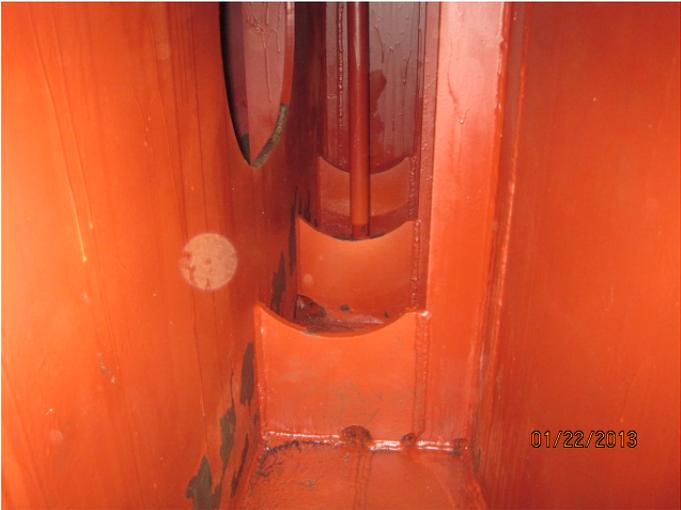
4.89: Aft Void Space Stbd - Side Bhd and Fwd Bhd

General condition of structure		GOOD	
General condition of cathodic protection		N/A	
General condition of coatings		FAIR, SEE DETAILS BELOW	
Type of coatings:	EPOXY	Extent	FULL
<p><b>Limit of Inspection</b>  Frame 31-39  Cleanliness was satisfactory</p> <p><b>Deckhead</b>  Good condition</p> <p><b>Transverse Bulkheads</b>  Good condition</p> <p><b>Deck or Space bottom</b>  Good condition</p> <p><b>Internal structure</b>  Good condition</p> <p><b>Other structure</b>  None noted</p> <p><b>Coating details</b>  Between longitudinal bulkhead and girder, F35-37 overhead coating gone  F31-39 bottom plate coating gone  F31-33 floor coating broken down at approx 150mm from bottom</p>

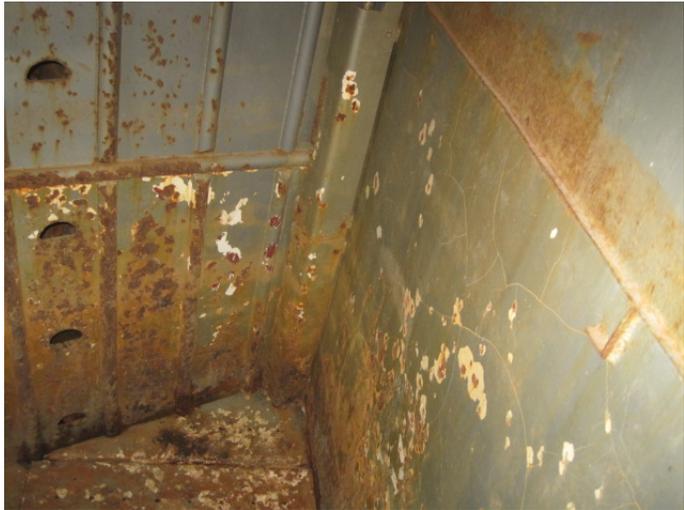
4.91: Port Chain Locker - Fwd Wall

General condition of structure		GOOD	
General condition of cathodic protection		N/A	
General condition of coatings		See details below	
Type of coatings:	EPOXY	Extent	FULL
<p><b>Limit of Inspection</b>  Frame 183-191  Cleanliness was satisfactory</p> <p><b>Deckhead</b>  No obvious defects found, structure was in good condition.</p> <p><b>Transverse Bulkheads</b>  No obvious defects found, structure was in good condition.</p> <p><b>Deck or Space bottom</b>  No obvious defects found, structure was in good condition.</p> <p><b>Internal structure</b>  No obvious defects found, structure was in good condition.</p> <p><b>Other structure</b>  None noted</p> <p><b>Coating details</b>  Upper area coating found good and lower part coating found poor</p>

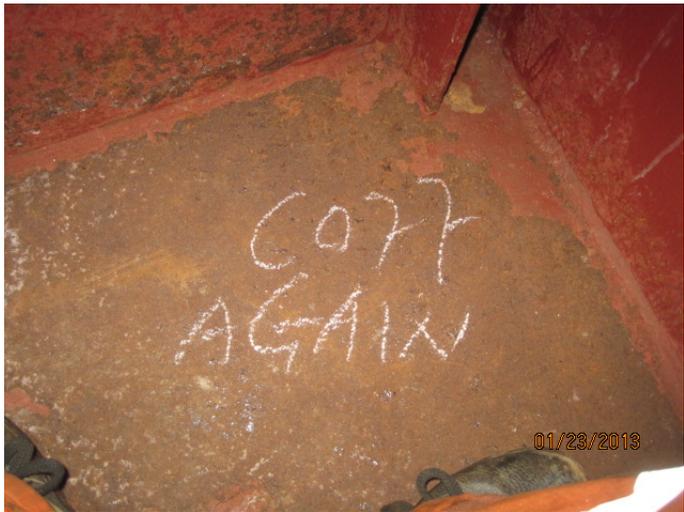
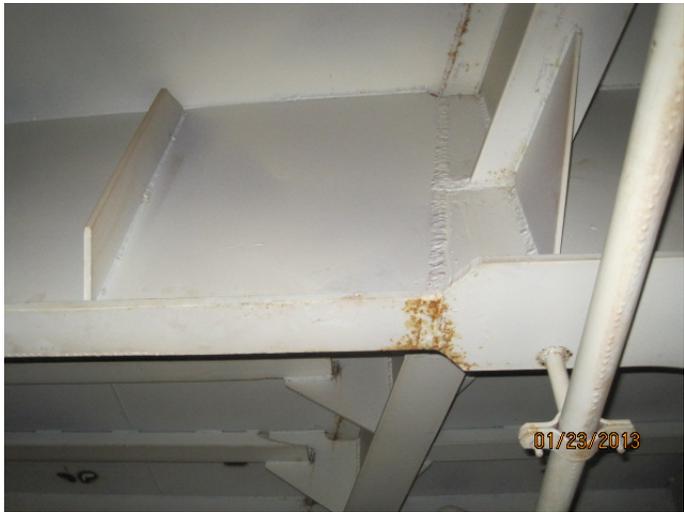
General condition of structure		GOOD see limit of inspection below	
General condition of cathodic protection		N/A	
General condition of coatings		FAIR see details below	
Type of coatings:	EPOXY	Extent	FULL
<p><b>Limit of Inspection</b>  Frame 0-14  Both side areas covered with insulation - not inspected  Cleanliness was satisfactory</p> <p><b>Deckhead</b>  No obvious defects found, structure was in good condition.</p> <p><b>Transverse Bulkheads</b>  No obvious defects found, structure was in good condition.</p> <p><b>Deck or Space bottom</b>  No obvious defects found, structure was in good condition.</p> <p><b>Internal structure</b>  No obvious defects found, structure was in good condition.</p> <p><b>Other structure</b>  None noted</p> <p><b>Coating details</b>  Both sides area covered with insulation material - not inspected  Space bottom coating partly broken down  Floor coating poor within height 50mm to bottom</p>

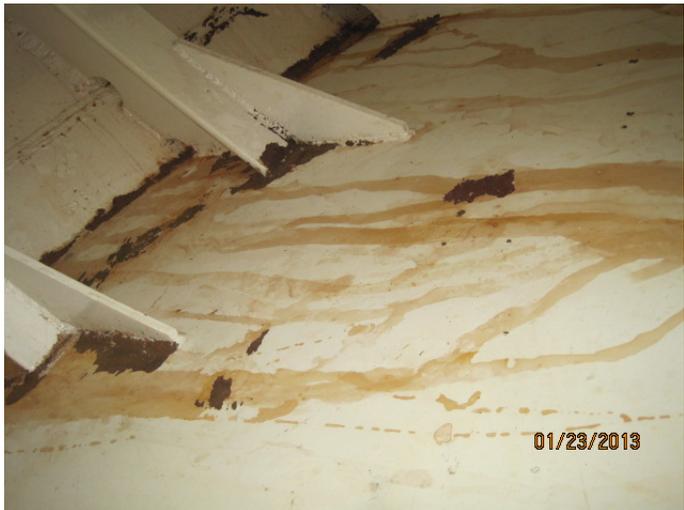
4.97: Coferdam F18-30 Port - Ship Side & Bottom

General condition of structure		GOOD	
General condition of cathodic protection		N/A	
General condition of coatings		good	
Type of coatings:	Epoxy	Extent	FULL
<p><b>Limit of Inspection</b>  Frame 18-30  Inboard aft end two frame spaces not seen as pipe occupied access way  Cleanliness was satisfactory</p> <p><b>Deckhead</b>  No obvious defects found, structure was in good condition.</p> <p><b>Transverse Bulkheads</b>  No obvious defects found, structure was in good condition.</p> <p><b>Deck or Space bottom</b>  No obvious defects found, structure was in good condition.</p> <p><b>Internal structure</b>  No obvious defects found, structure was in good condition.</p> <p><b>Other structure</b>  None noted</p> <p><b>Coating details</b>  Tank top coating 20% gone at F27-30 and 15% gone at F19-20  Typically coating along welds found 20% broken</p>

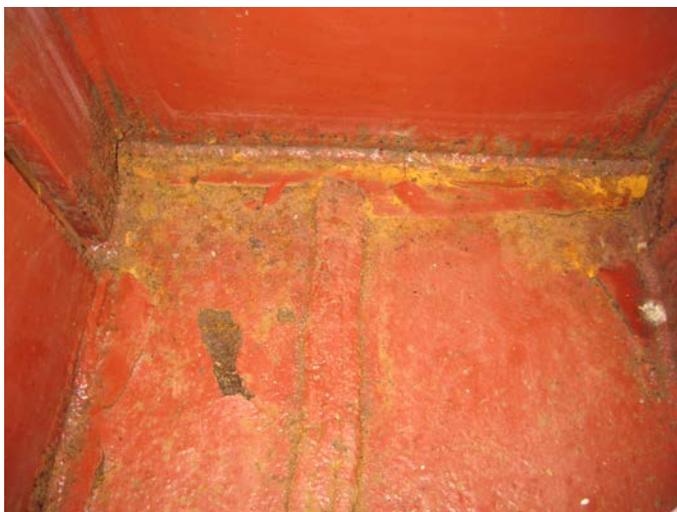
4.104: Fwd DP Thruster Cofferdam - Bottom Mild Corrosion
