**Geotechnical and Structural  
Assessment - Hopedale  
Mission Provisions House,  
Hopedale Mission National  
Historic Site, Hopedale, NL**

**Report No: 121619875**

**Final Report (Rev. 1)**

February 9, 2017

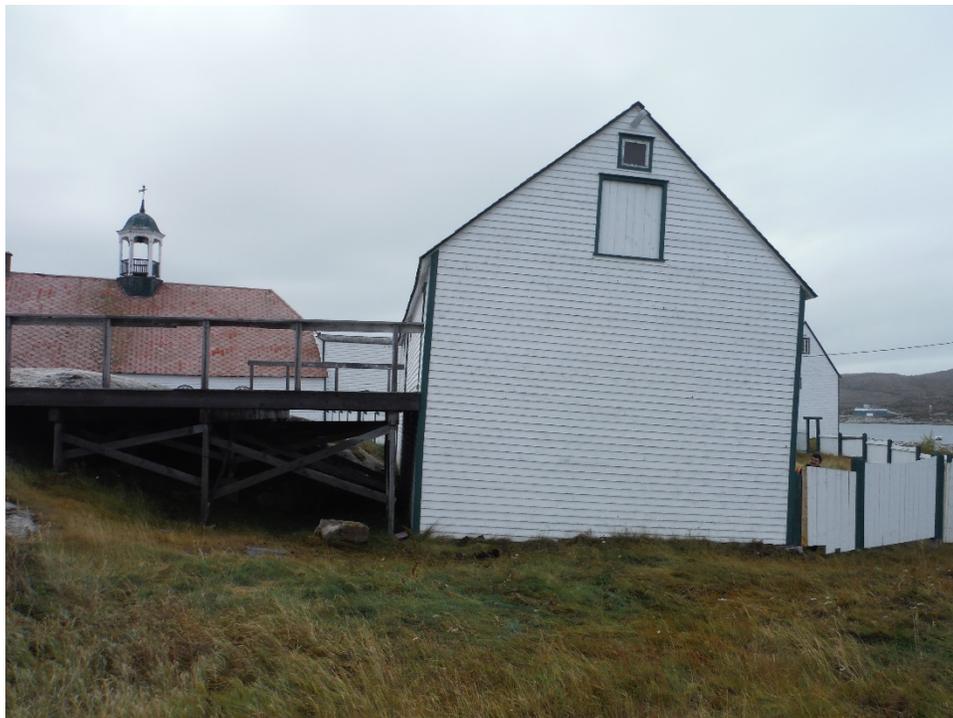
As developed and discussed in the 2010 Moravian Mission Structural Investigation report, the settled foundation and building lean does not appear to be a recent or new occurrence. No additional distress of a structural significance was noted when compared to the 2010 structural investigation in the wood frame components during the recent site walk through. When taking both points into consideration and the fact that it has withstood the environmental and usage loading since its original construction in 1817, the building is not considered to be at immediate structural risk.

**Photo 11a – Looking at North Side leaning**
