SITE SAMPLING DIAGRAM: #1 ADMINISTRATION OFFICE Basement

Project Name: Hazardous Materials Assessment

Project Location: Beaverlodge Research Centre

Project No.: 11166

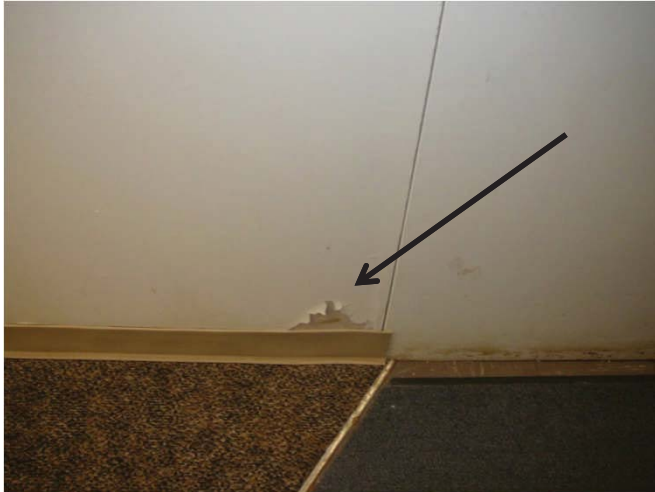
#1: Administration Office

Sample A37: Drywall mud on basement hallway wall

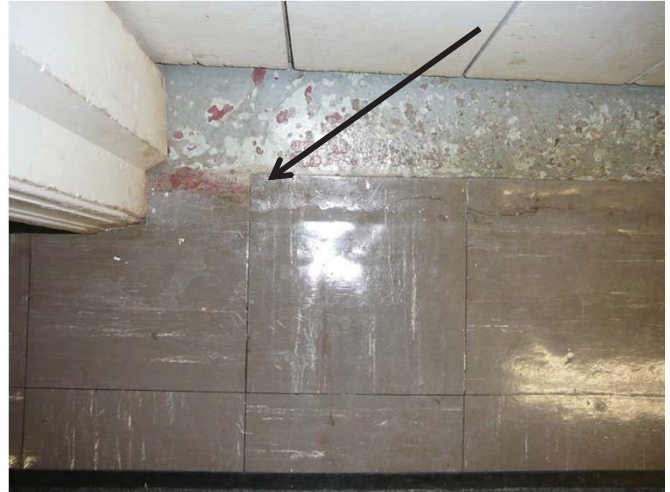
#1: Administration Office

Sample A41 & A75: Brown/white 9x9 floor tile on basement hall floor

Lab No.:	4218856	Description / Location:	Grey Floor Tile; 9x9	
Client No.:	A41		(1) Bsmt Hallway	
<u>% Asbestos</u>	<u>Type</u>	<u>% Non-Asbestos Fibrous Material</u>	<u>Type</u>	<u>% Non-Fibrous Material</u>
PC 1.6	Chrysotile	None Detected	None Detected	PC 98.4

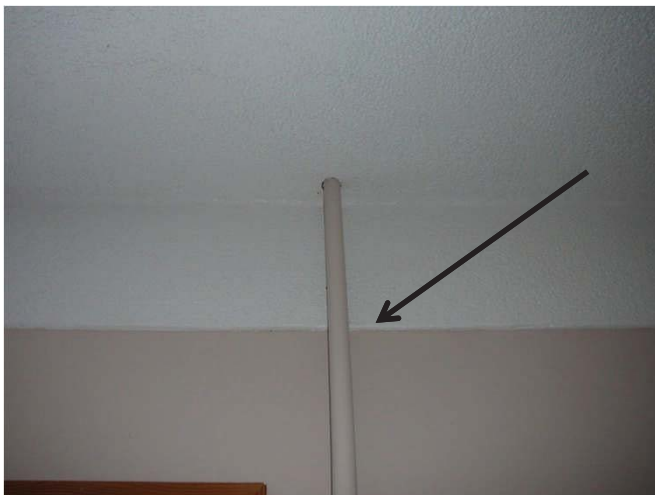
#1: Administration Office

Sample A62: Ceiling texture on SW wall of Office 3

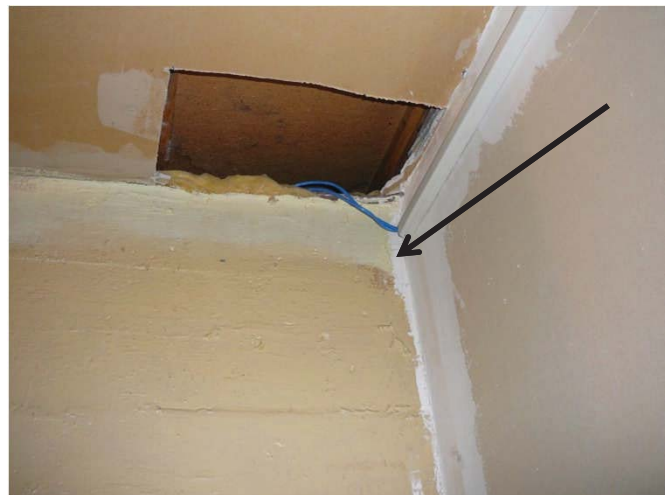
#1: Administration Office

Sample A42: Drywall mud on Furnace Room wall

Lab No.:	4218856	Description / Location:	Lt. Tan Joint Compound	
Client No.:	A42		(1) Bsmt Furance Room	
<u>% Asbestos</u>	<u>Type</u>	<u>% Non-Asbestos Fibrous Material</u>	<u>Type</u>	<u>% Non-Fibrous Material</u>
PC 1.8	Chrysotile	None Detected	None Detected	PC 98.2
