Hazardous Materials Assessment

Type of Document
Final Report

Project Name
Hawthorne Cottage
Civic No. 1 South Street
Brigus, Newfoundland and Labrador

Project Number
SJN-00239615-A0

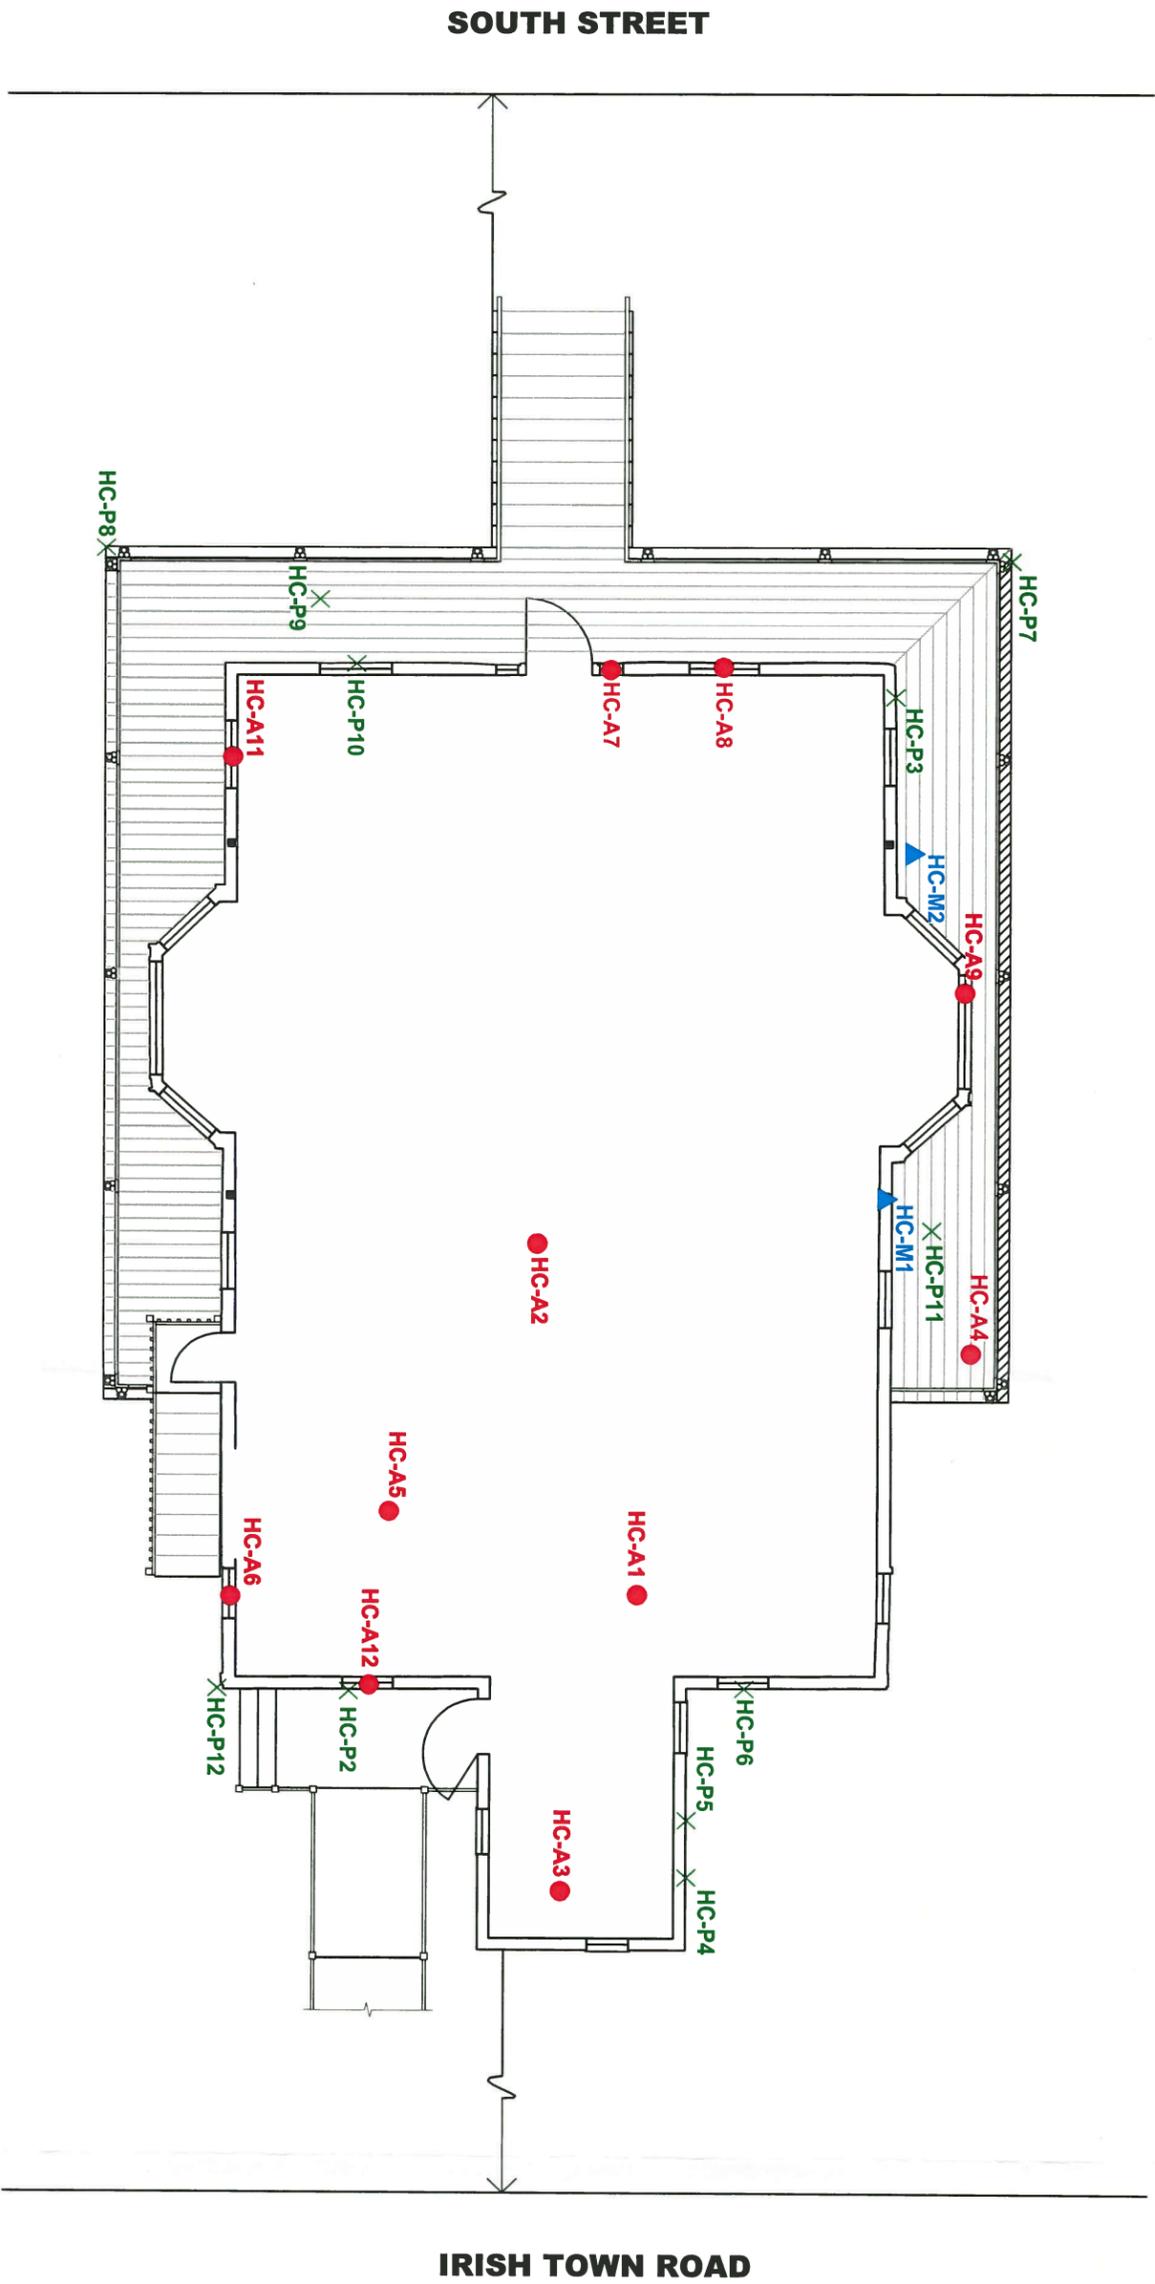
FIGURE 2

NOTE: SAMPLE HC-A10 & HC-P1 WERE COLLECTED FROM A STORM WINDOW THAT WAS IN STORAGE IN BASEMENT.

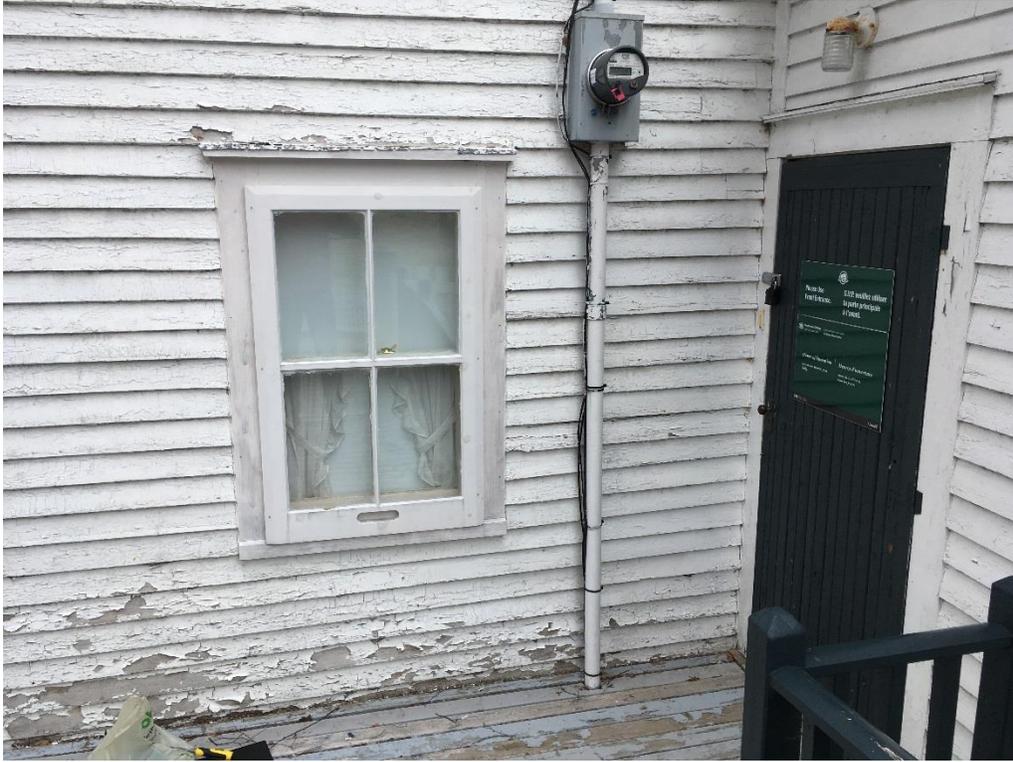
Photo 5 – South side of the building with peeling paint (Sample HC-P2 from under window)

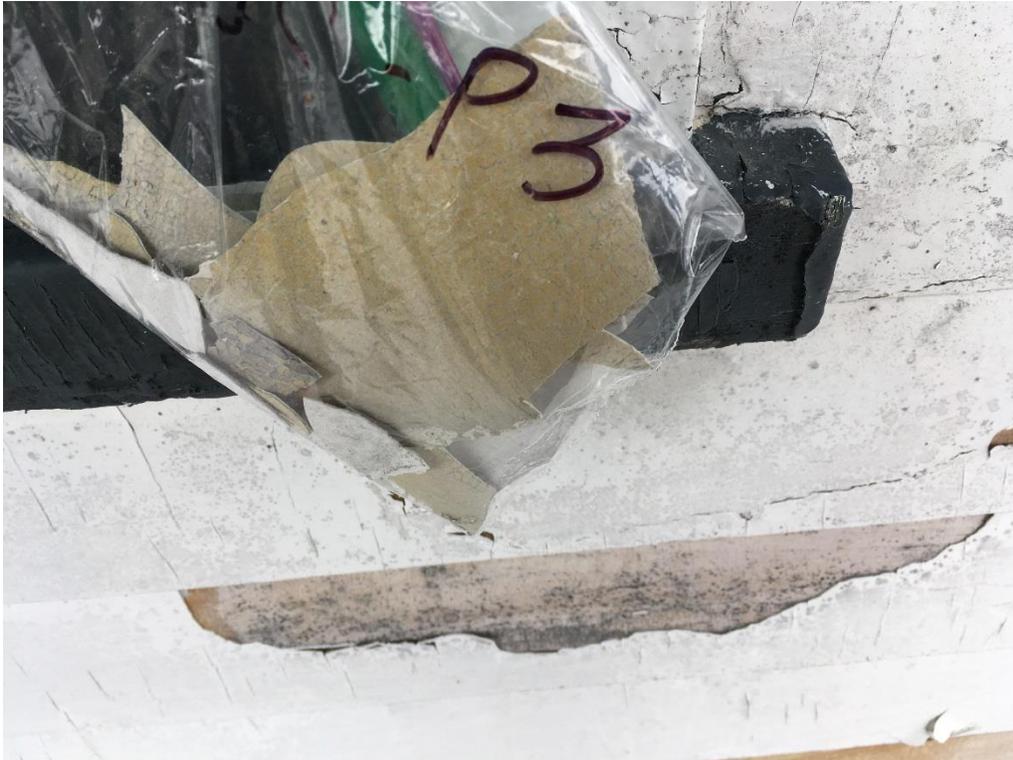
Based on the laboratory testing, each of the samples had fungal growth indicated (*Cladosporium*). *Cladosporium* is a very common mould often found outdoors year round.

Photo 6 – Suspect mould on paint (Sample HC-P3) and on underlying clapboard

Safe work practices developed for removal/handling of the lead paint will adequately protect workers from any mould. Once the paint is removed, areas of the bare wood clapboard exhibiting traces of mould should be treated via chemical cleaning or

physical stripping via sanding. If the mould/moisture damage is found to be penetrating into the wood greater than 5 mm, then the material should be replaced to prevent reoccurrence. When re-painting, consideration should be given to using a paint with a mould inhibiting additive.

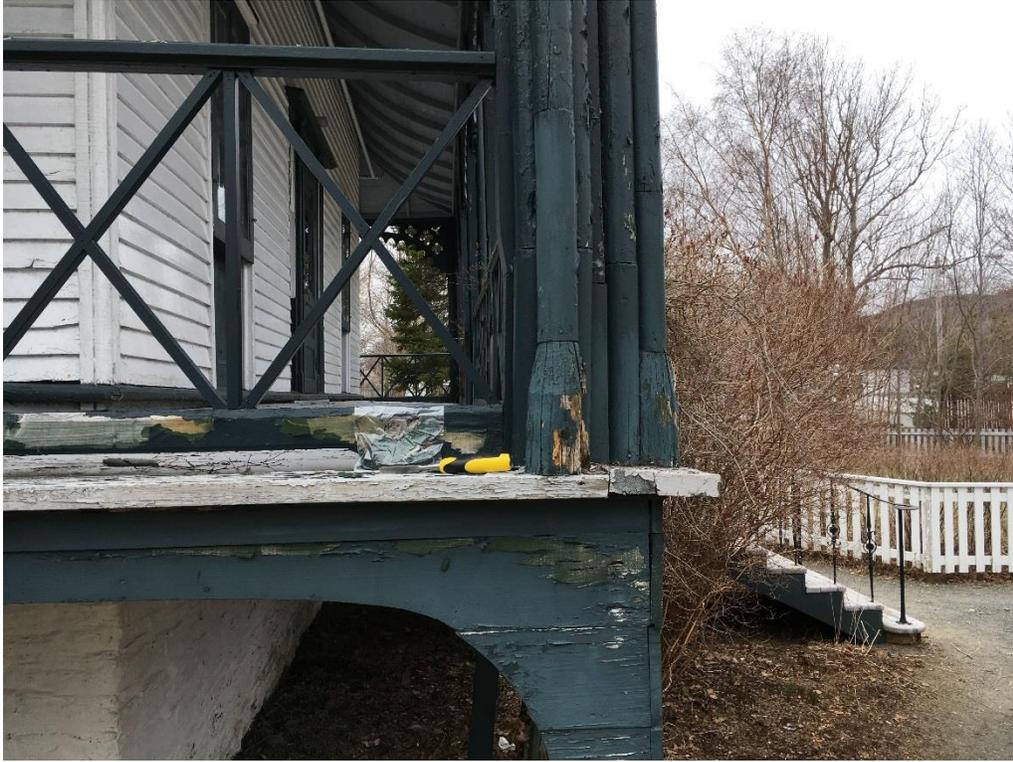
Photo 7 – Veranda section at northeast corner of building (note rot/deterioration and peeling paint) – Sample HC-P7

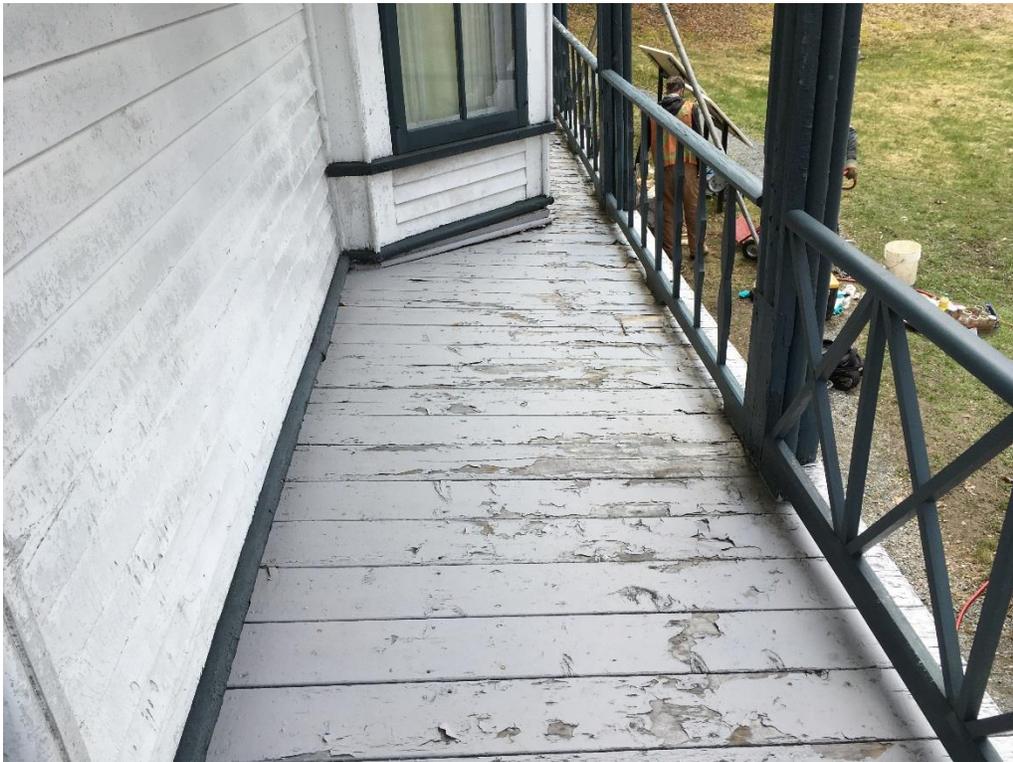
Photo 8 – Veranda deck at west side of building (note peeling/flaking paint)

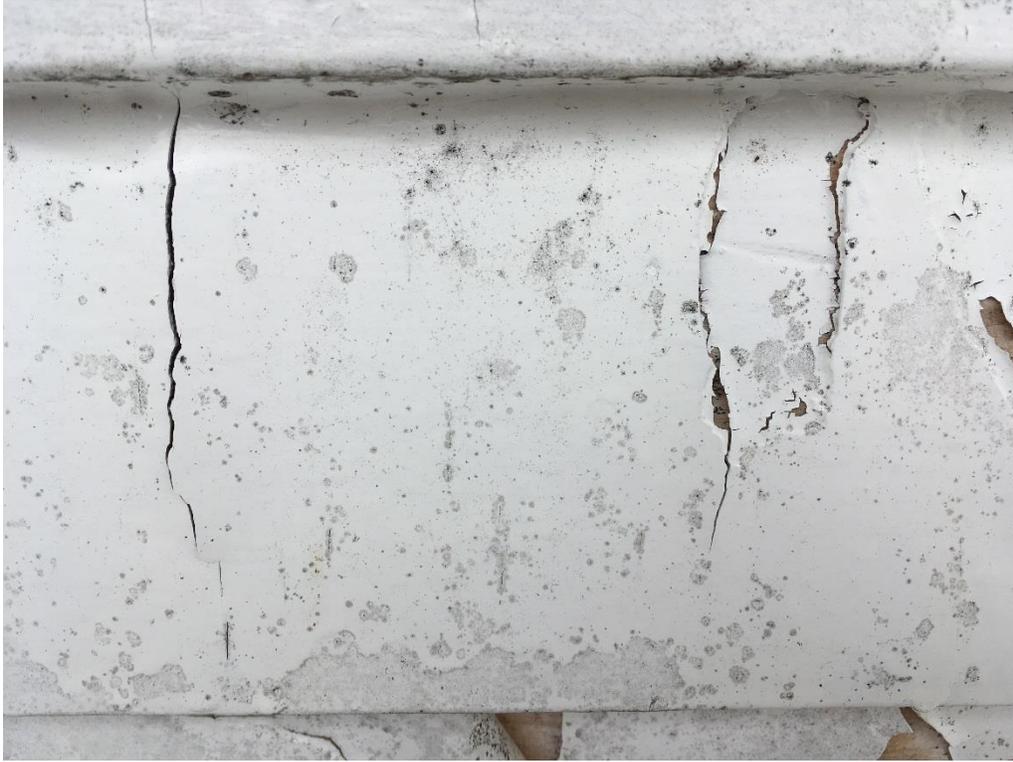
Suspect visible mould was noted on the exterior clapboard on the east side of the building. Two samples (labelled HC-M1 and HC-M2) of mould-impacted, flaking paint collected from the exterior cladding were submitted for laboratory analysis for bulk mould, as indicated in *Table 4.5 Summary of Laboratory Results (Bulk Mould)*.

Active mould growth was confirmed on the painted clapboard at the east side of the building. It is expected that most of this mould will be removed incidentally during the scraping, removal, and disposal of paint from the exterior. Safe work practices/procedures employed to prevent building occupants/site workers from receiving accidental lead exposure, should also protect workers from accidental mould exposure. Once the paint is removed, areas of the bare wood clapboard exhibiting traces of mould should be treated via chemical cleaning or physical stripping via sanding. If the mould/moisture damage is found to be penetrating into the wood greater than 5 mm, then the material should be replaced. When re-painting, consideration should be given to using a paint with a mould-inhibiting additive.

Photo 9 – Mould growth on painted clapboard – east side of building

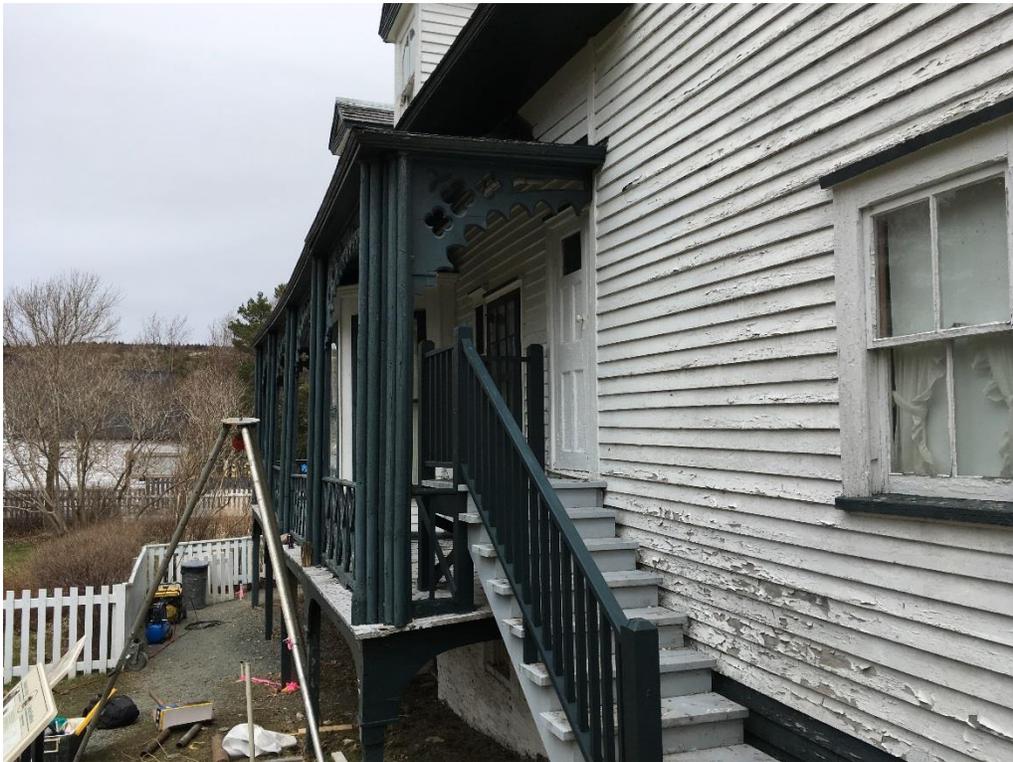
Photo 10 – Peeling paint on west side of building.
