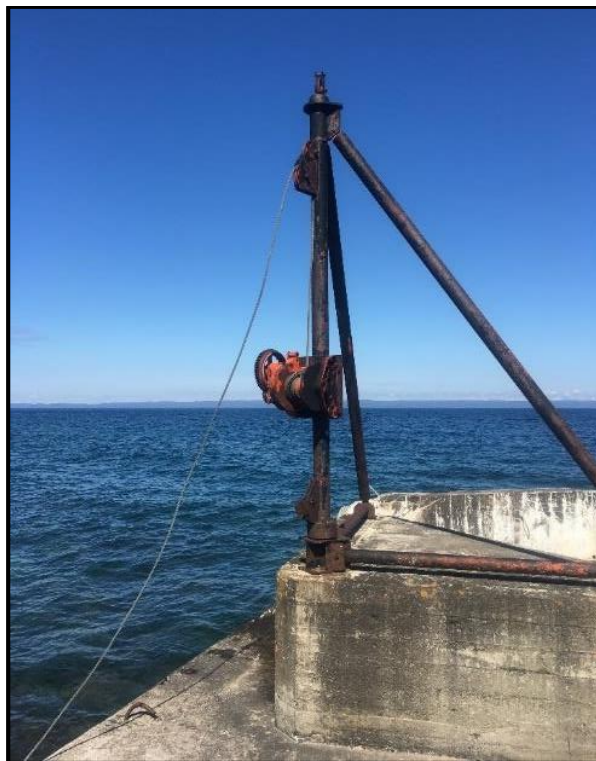
Photograph 8: North dock – concrete dock with dock hoist located north of the generator shed, both dock and hoist painted with lead-based paint.

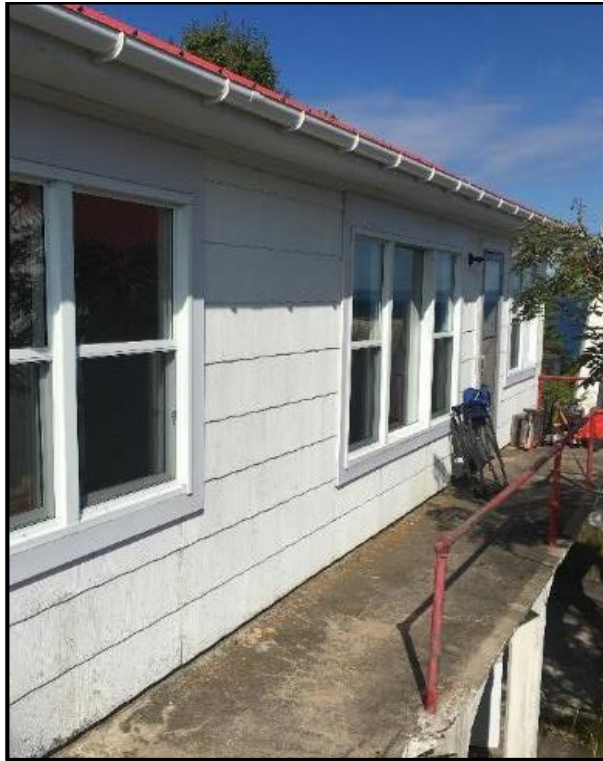
Photograph 9: Exterior of living quarters building looking northeast. Lead-containing white paint on asbestos containing transite siding.

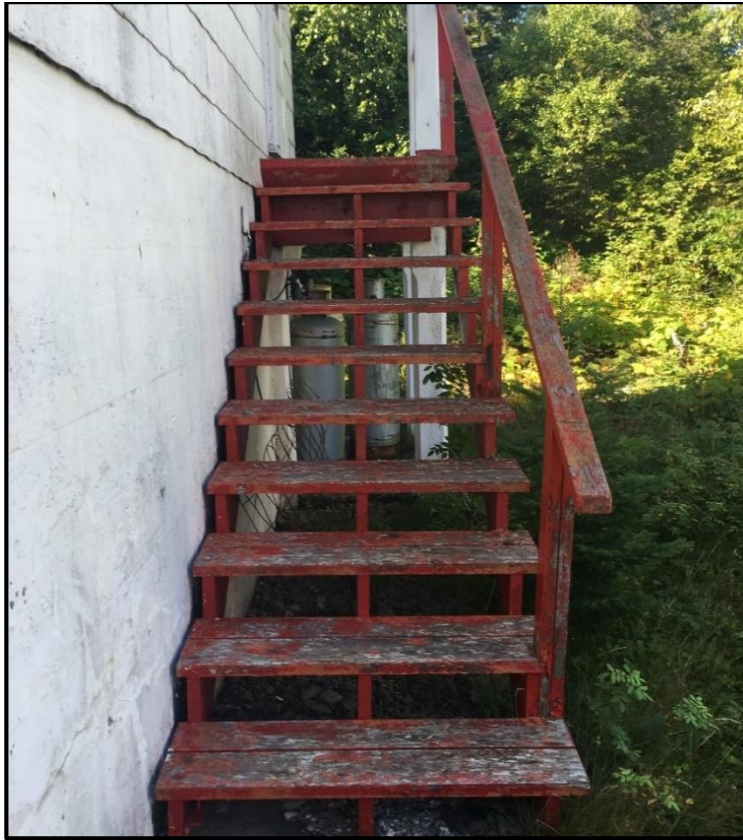
Photograph 11: Wooden staircase located on the north wall of the living quarters building with red lead-based paint.

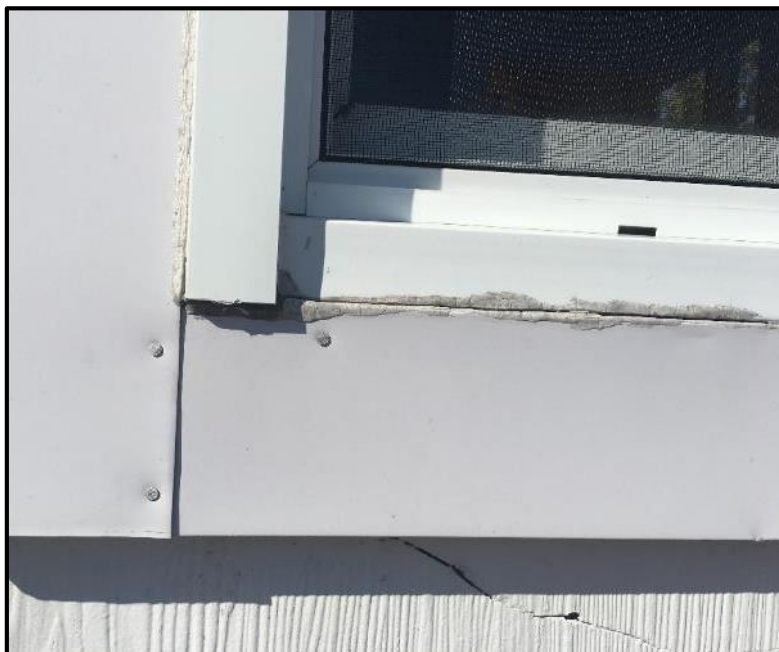
Photograph 12: Asbestos containing white caulking and transite siding on the exterior of the living quarters.

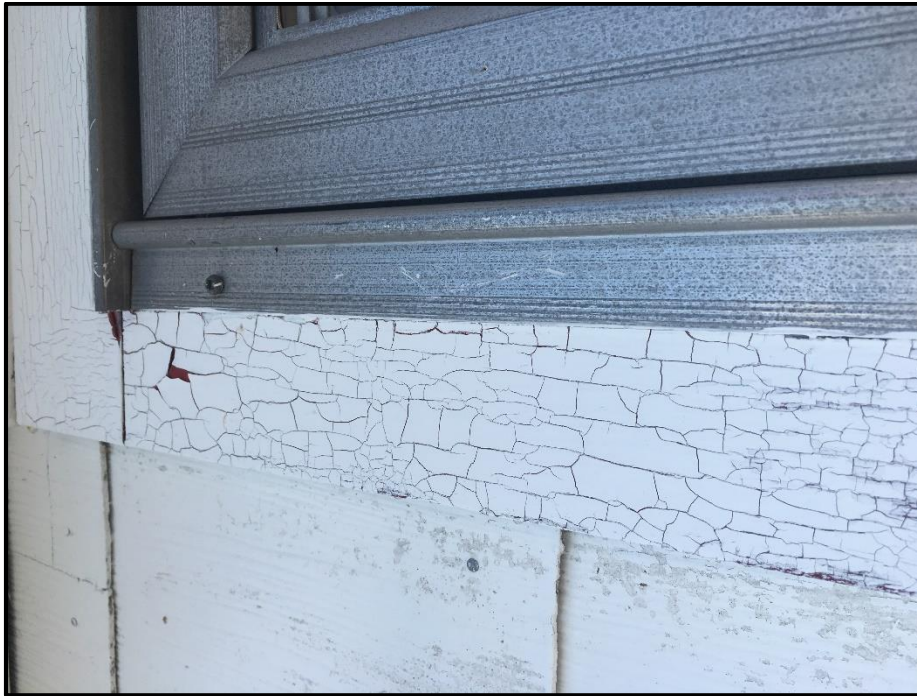
Photograph 13: View of white on red lead-based paint observed on window and door trim of the living quarters building.

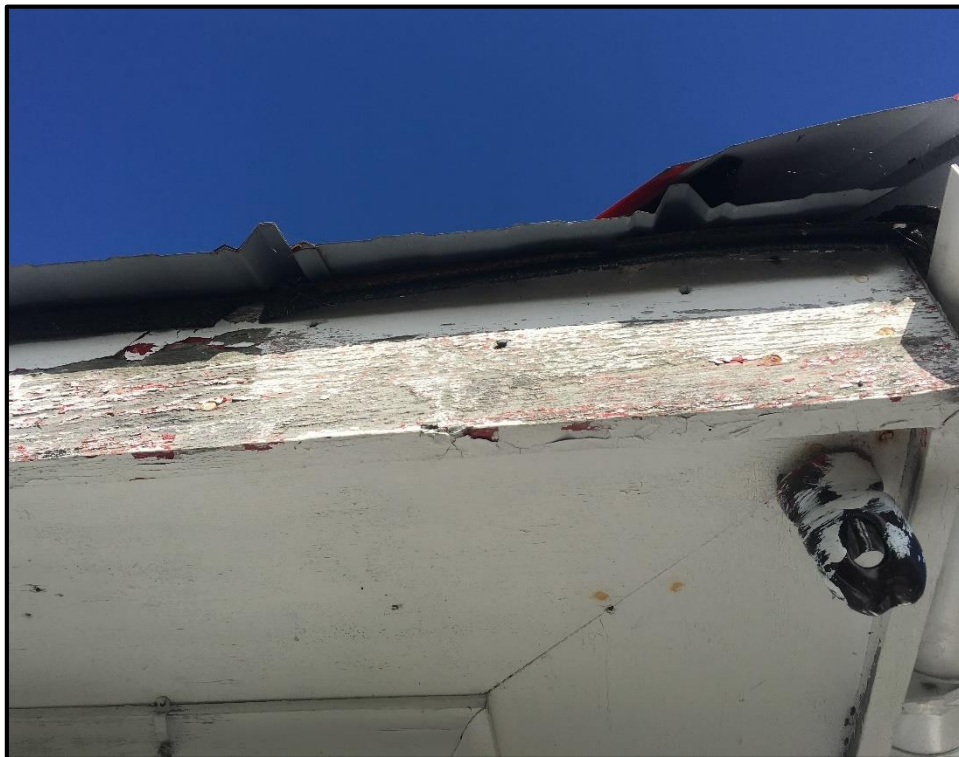
Photograph 14 – View of white lead- based painted soffit and fascia on the exterior of the living quarters building.

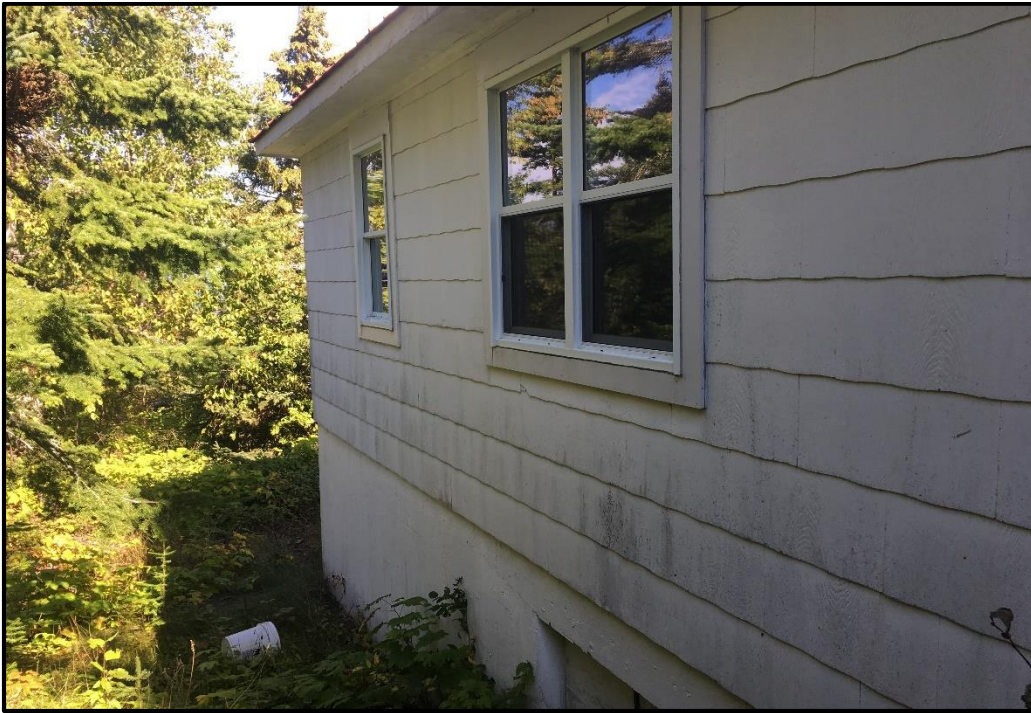
Photograph 15: Asbestos containing transite siding painted with white lead-based paint on the exterior of the living quarters building.

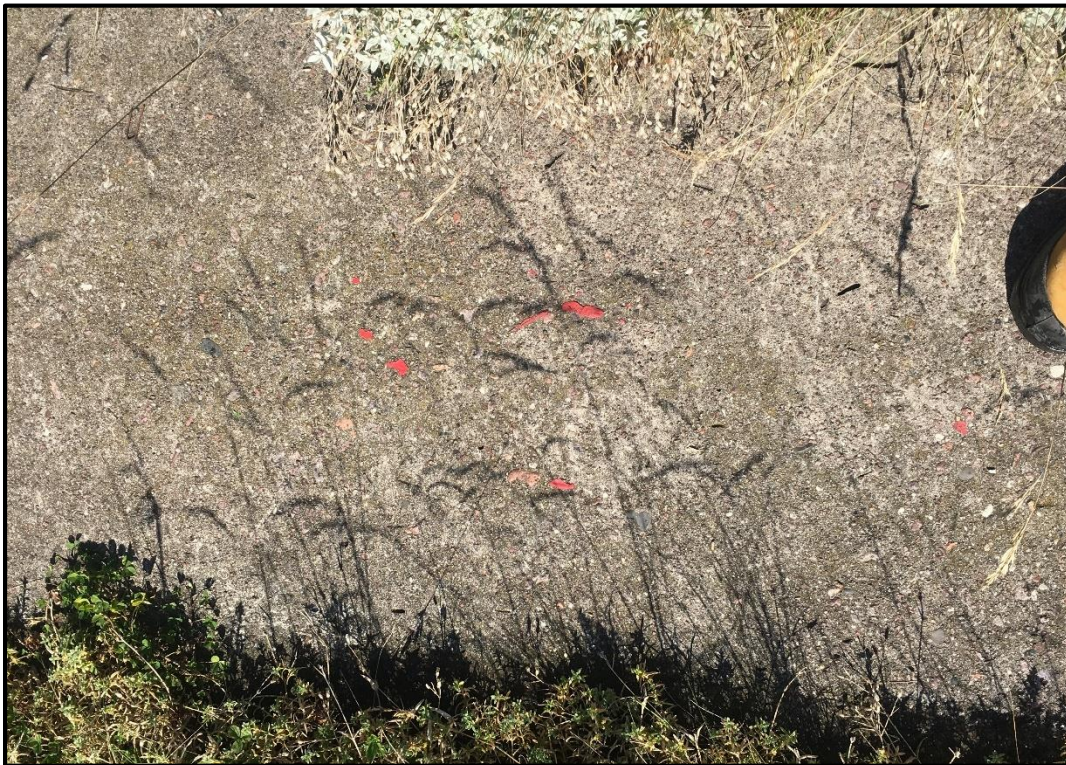
Photograph 16 – Red lead-based paint observed on the sidewalk near the living quarters building.

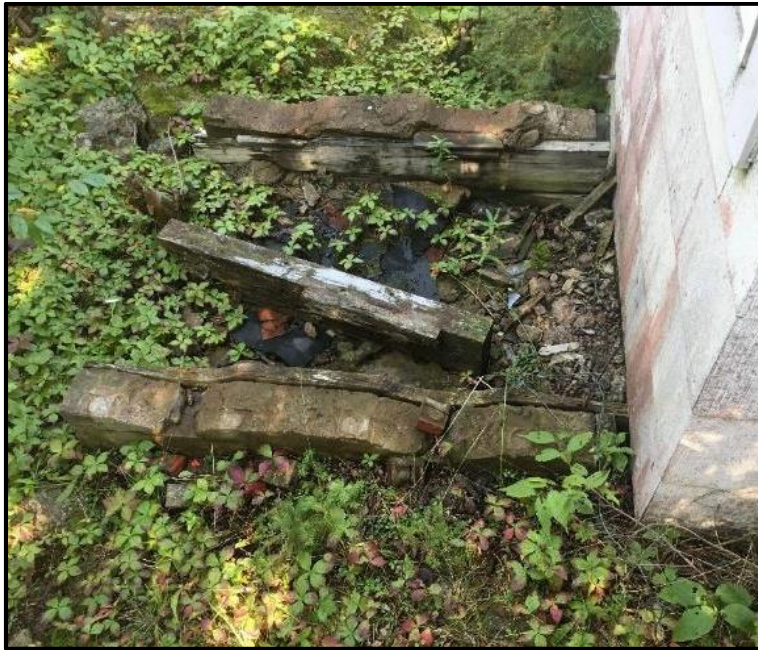
Photograph 17: Asbestos containing shingle debris located behind the living quarters building.

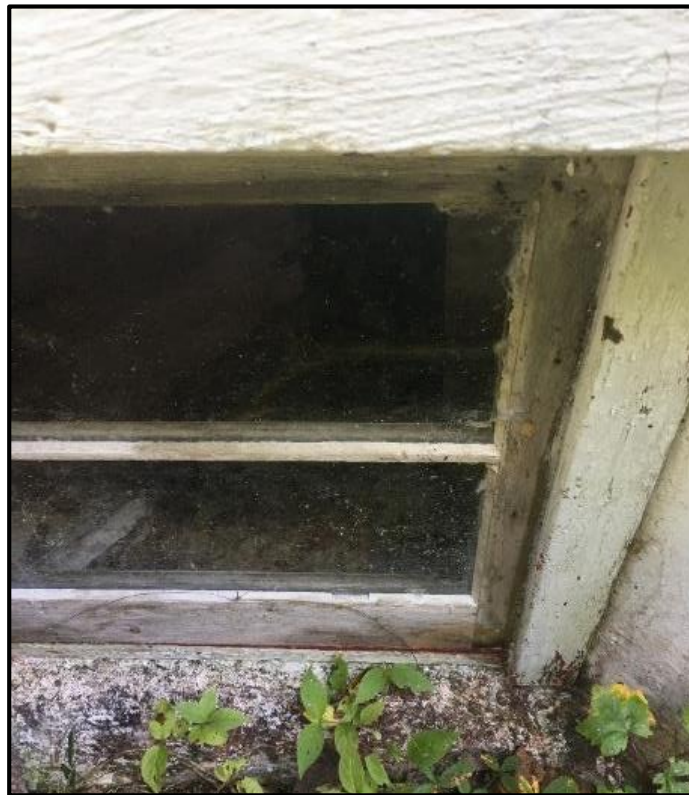
Photograph 18: View of exterior basement window of the living quarters building. Asbestos containing grey caulking is present.

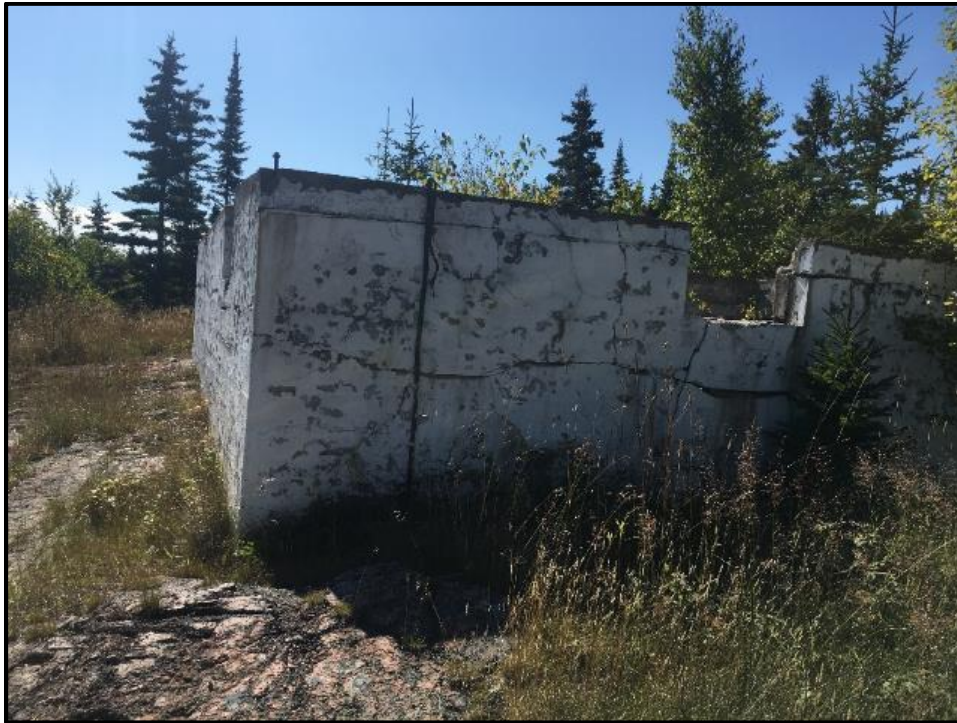
Photograph 19: View of the radio beacon building foundation. Concrete foundation has lead-based white paint. Debris inside foundation includes painted concrete pieces.

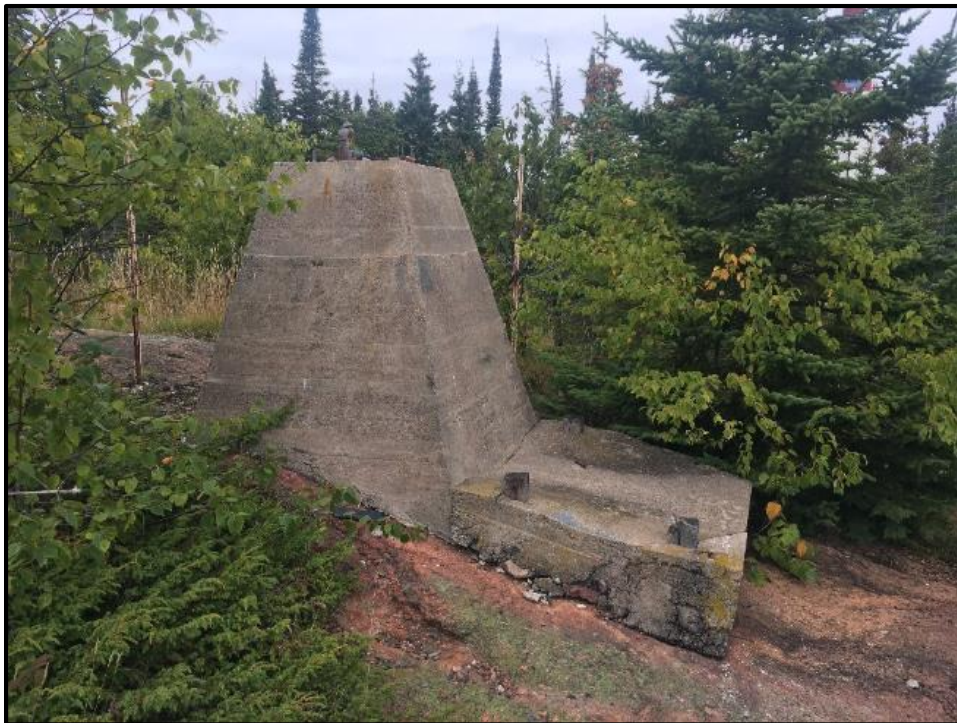
Photograph 20: Radio tower base, located west of the radio beacon building foundation. Lead-based grey and white paint are present.

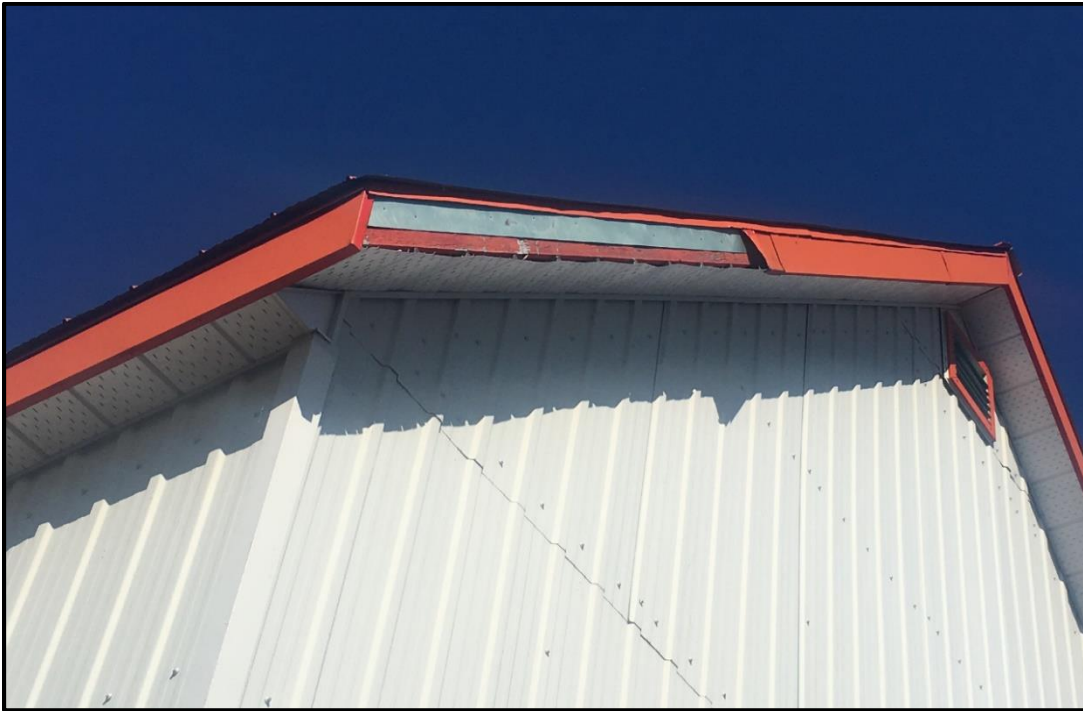
Photograph 21: Exposed red lead-based painted wood trim underlying red metal flashing along roof line of garage/former living quarters building.

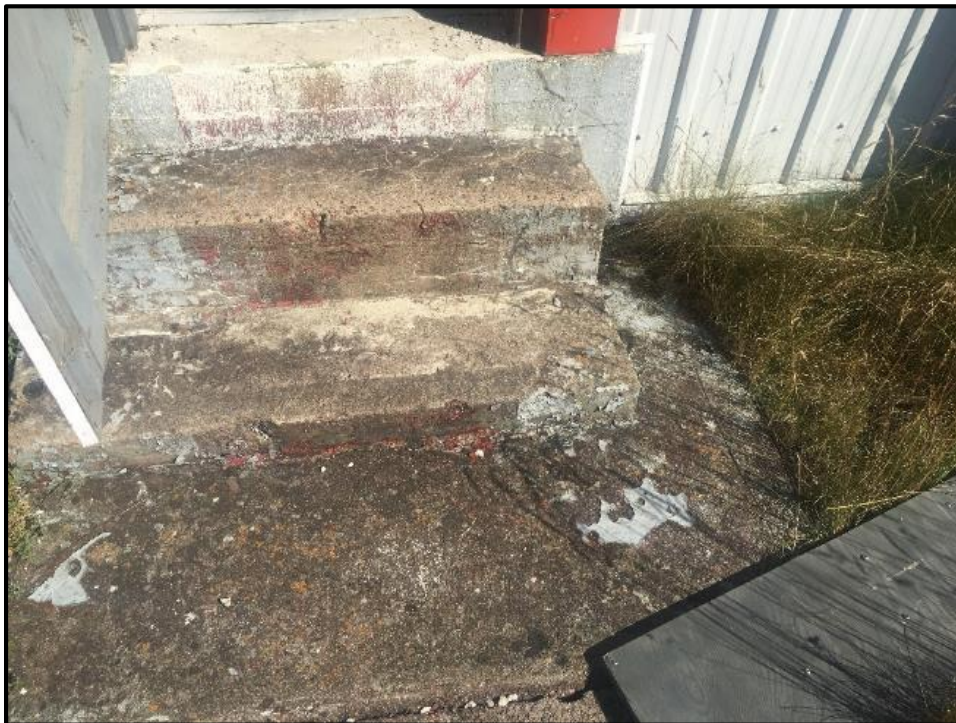
Photograph 22: Lead-based red and grey paint on the concrete steps at the south side of the garage/former living quarters building.

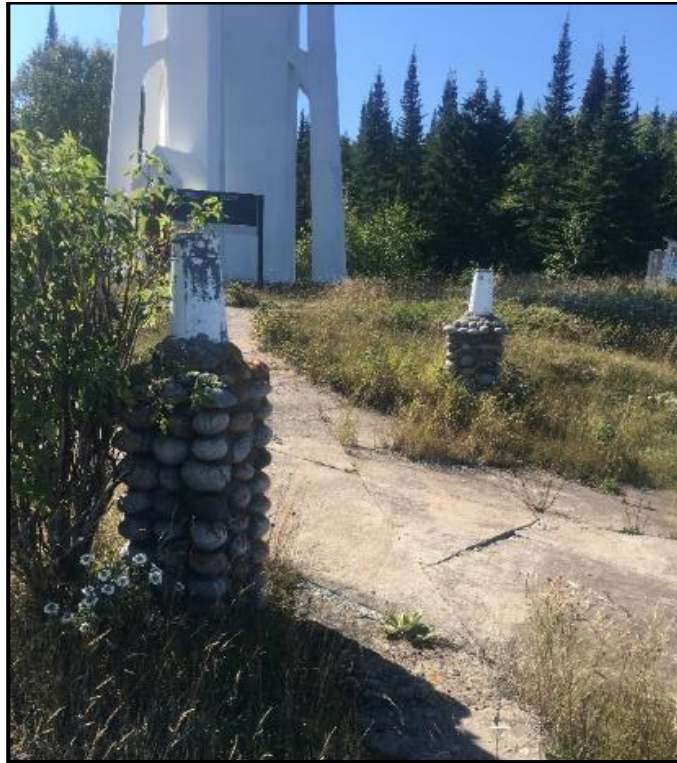
Photograph 23: Two rock pillars with lead-based painted posts located north of the lighthouse.

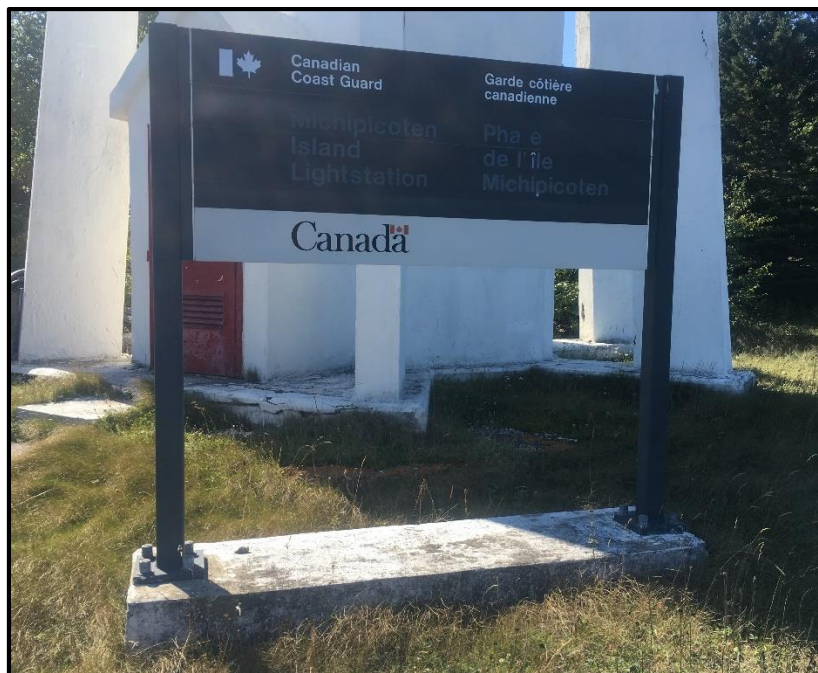
Photograph 24: Lighthouse sign with lead-based painted concrete base located north of the lighthouse.

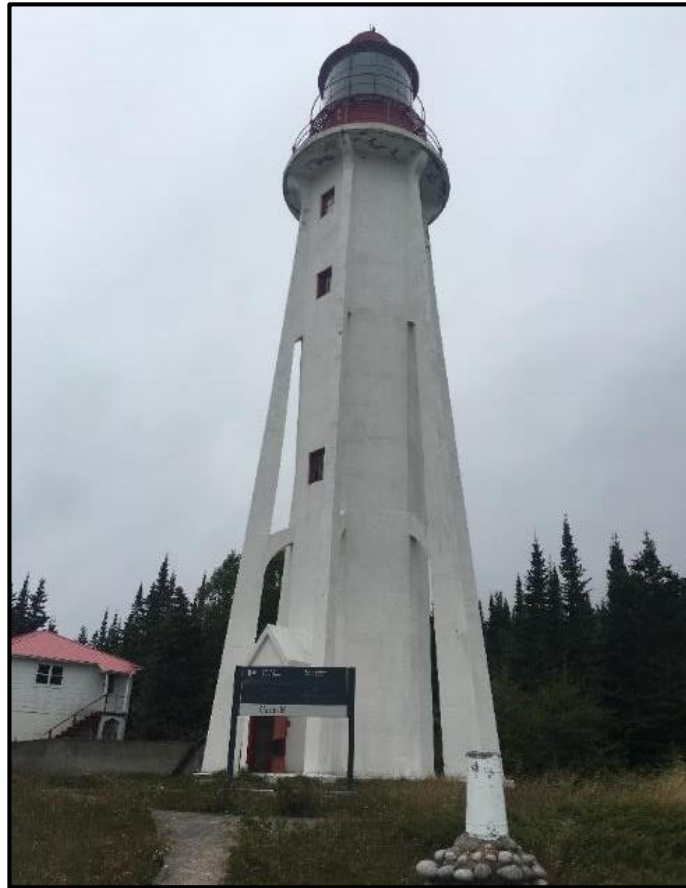
Photograph 25: View of the lighthouse exterior painted with lead-based paint, facing south.

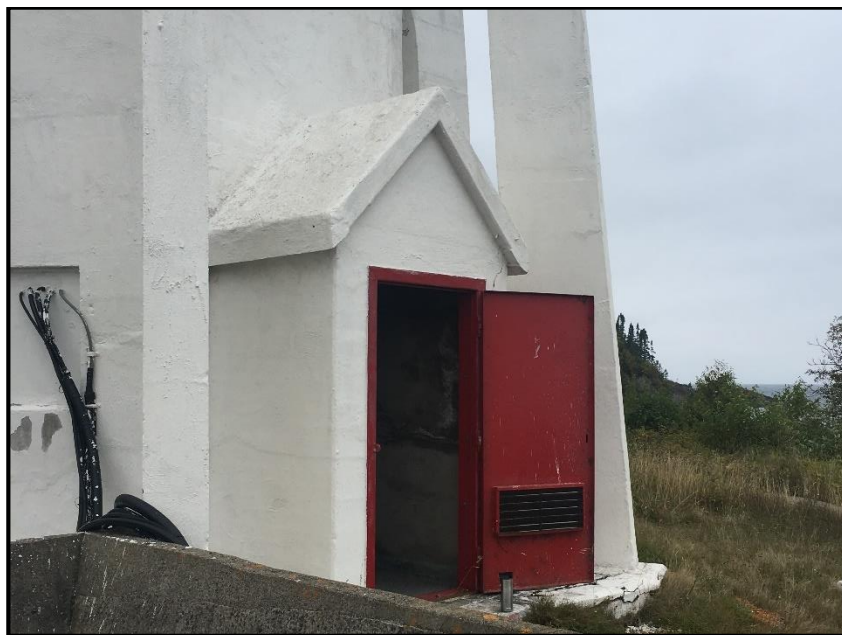
Photograph 26: Exterior of the lighthouse entry, with red lead-based paint on door and trim.

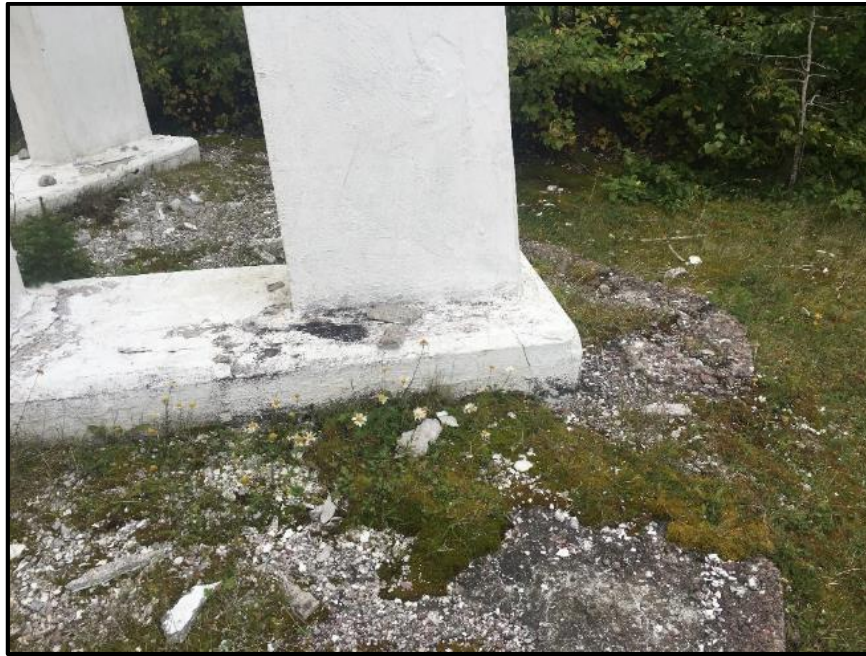
Photograph 27: Debris including lead-based paint chips and painted parging located at the base of the lighthouse.

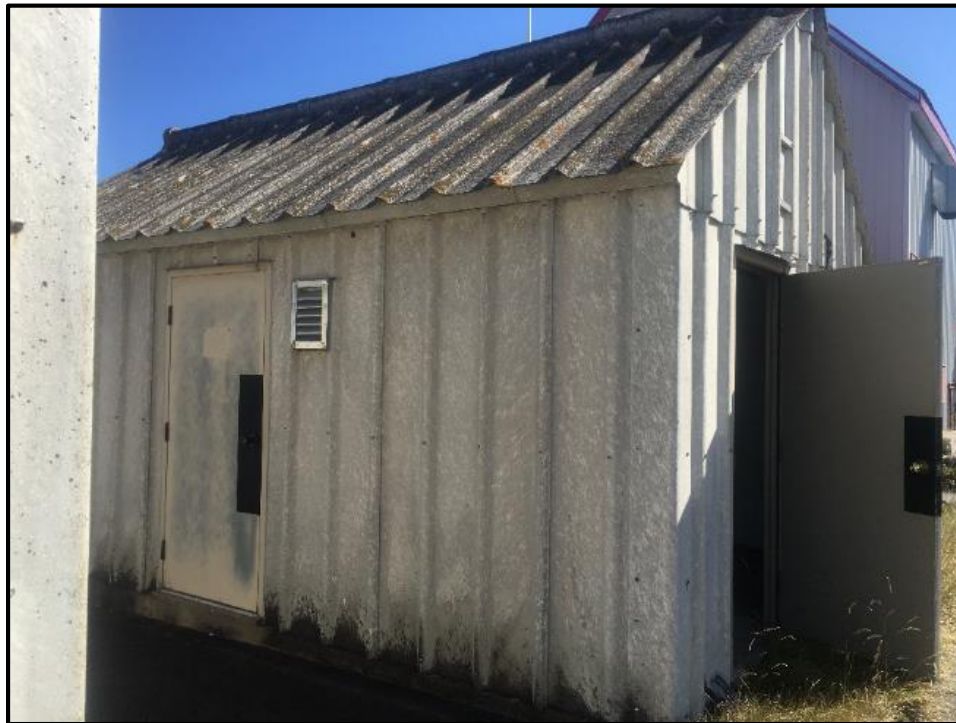
Photograph 28: View of the equipment shed. Interior floor contains grey lead-based paint and asbestos shingles observed inside.

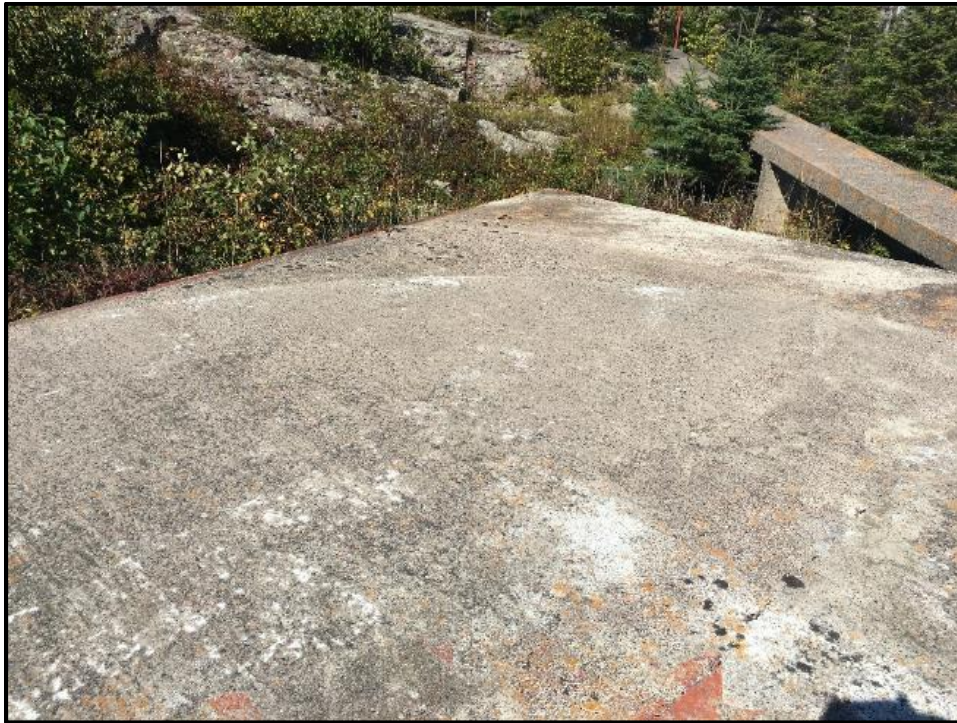
Photograph 29: Helipad with residual lead-based red and white paint.

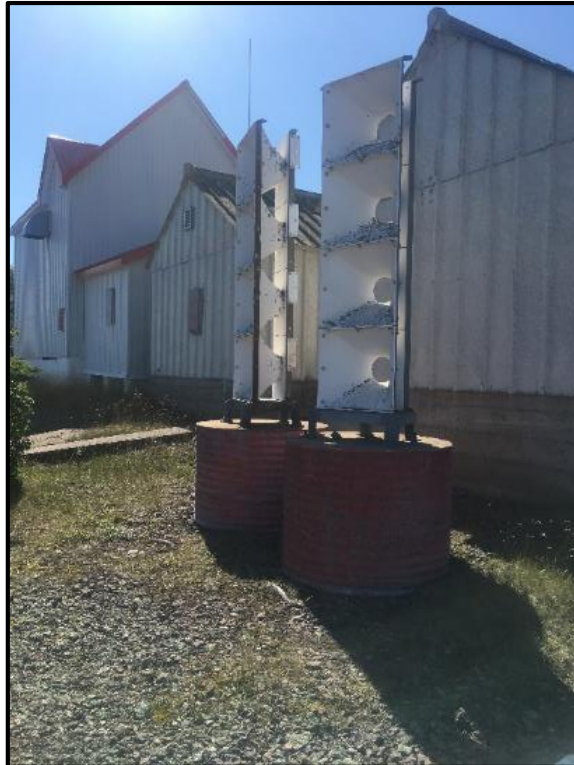
Photograph 30: Two navigation aids located east of the generator shed. Lead-based white and red paint on surfaces.

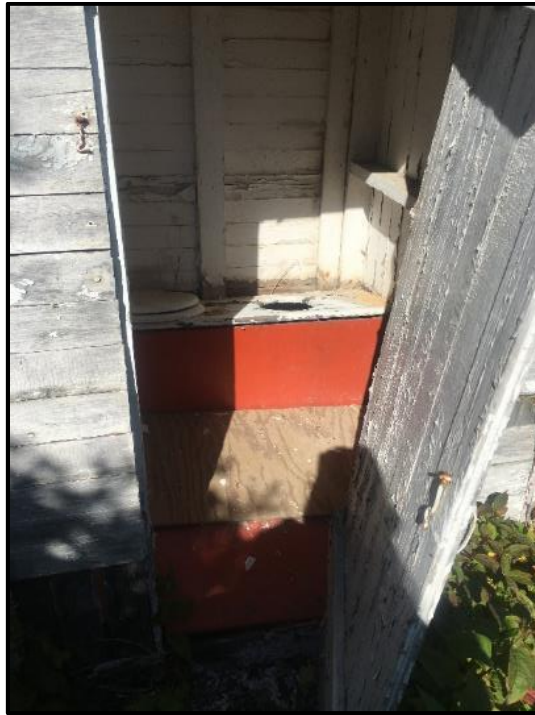
Photograph 31: North outhouse with lead-based wood on the exterior and interior. Lead paint debris was also observed on the ground surrounding the outhouse. Asbestos-containing shingles observed on the roof and as debris surrounding the structure.

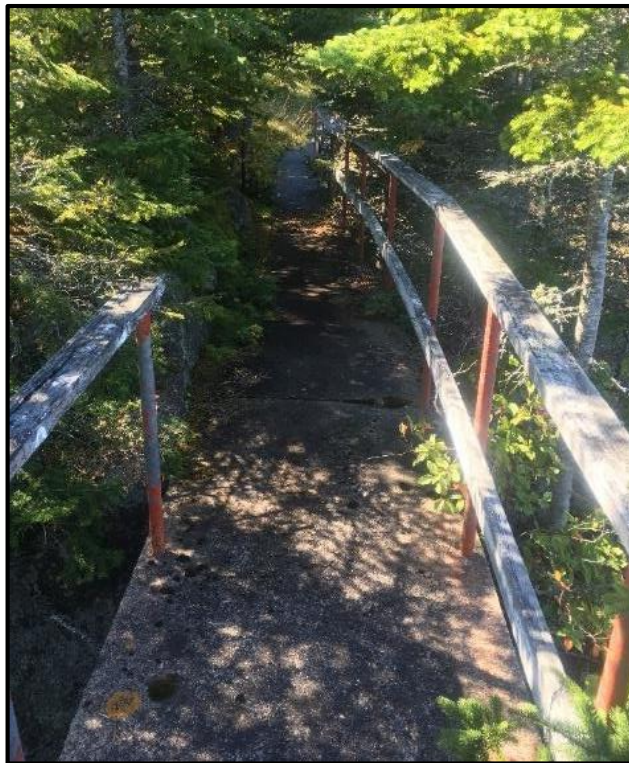
Photograph 32: View of the walkway leading north towards the duplex dwelling foundation. Lead-based paints on metal and wood rails.

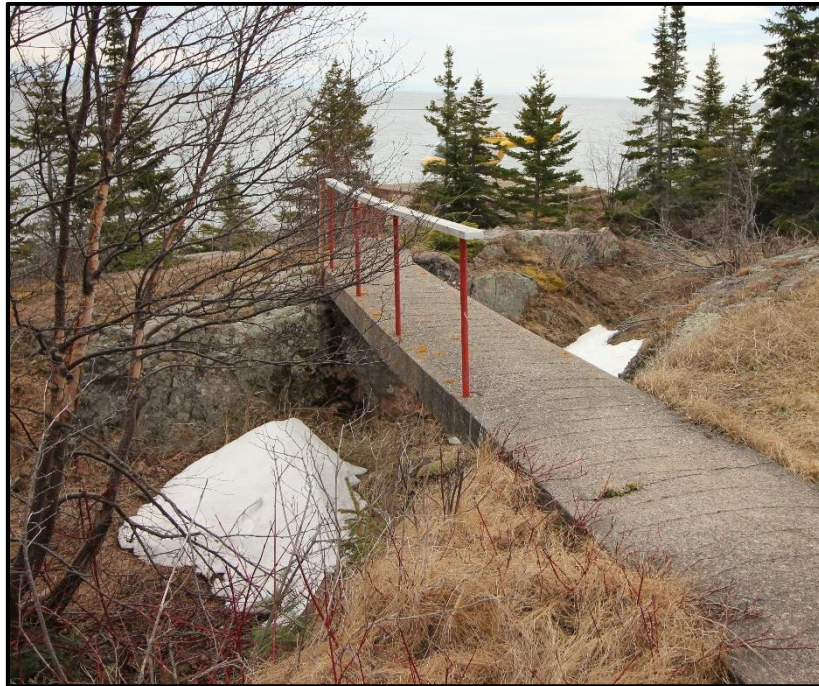
Photograph 33: View of walkway leading south towards the helipad. Lead-based paints on metal and wood rails.

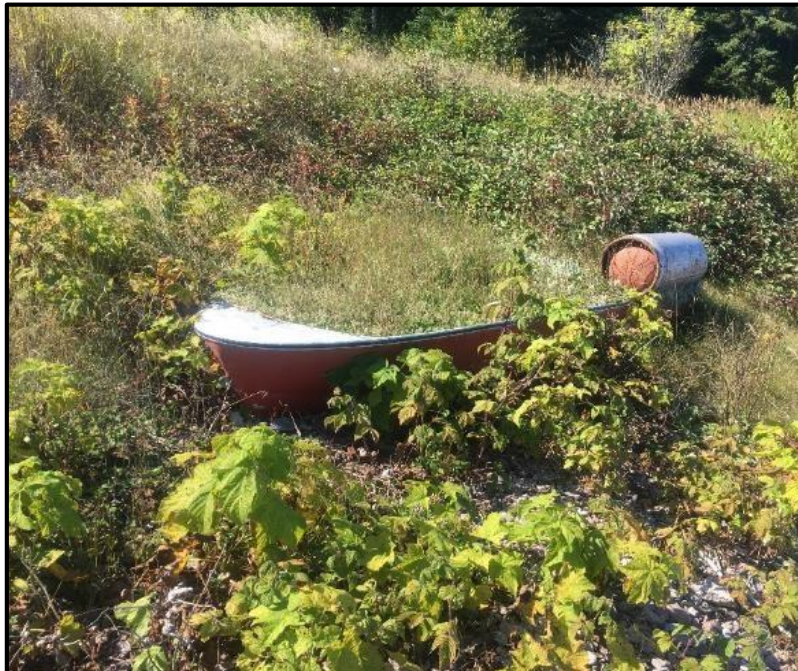
Photograph 34: Boat located east of the duplex dwelling foundation, with nearby metal debris. Lead-based white and red/orange paint are present on the boat, which is filled with soil.

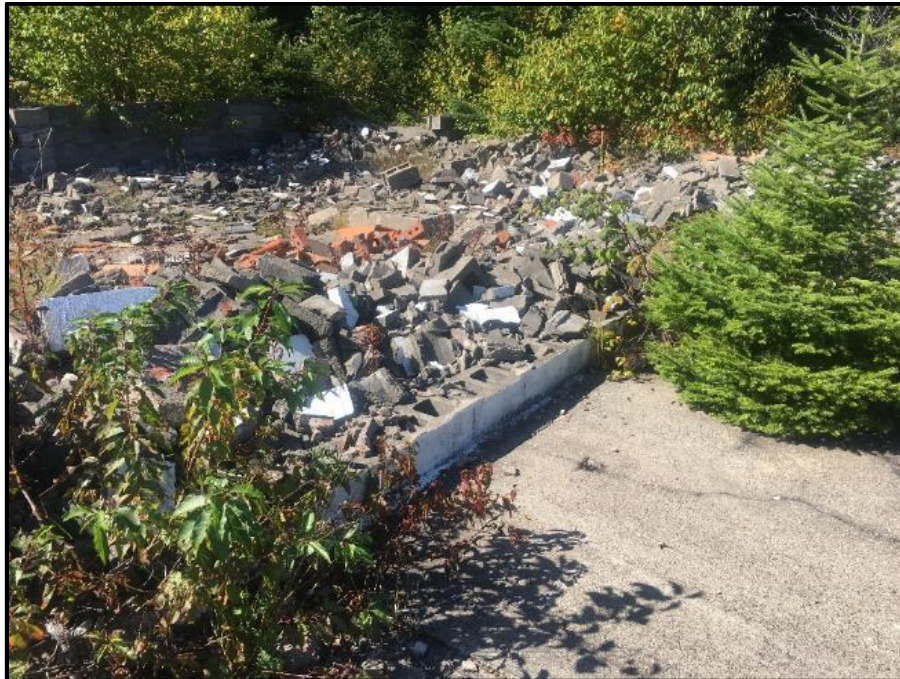
Photograph 35: Duplex dwelling foundation with white lead-based paint on concrete blocks.

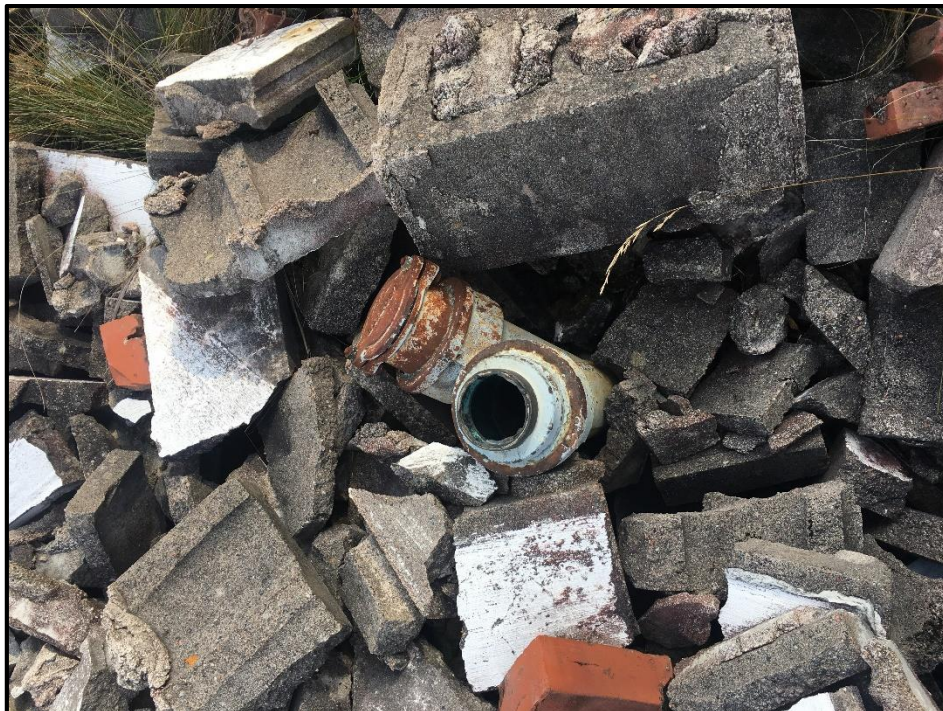
Photograph 36: Lead-based painted concrete debris observed in the foundation of the duplex dwelling.

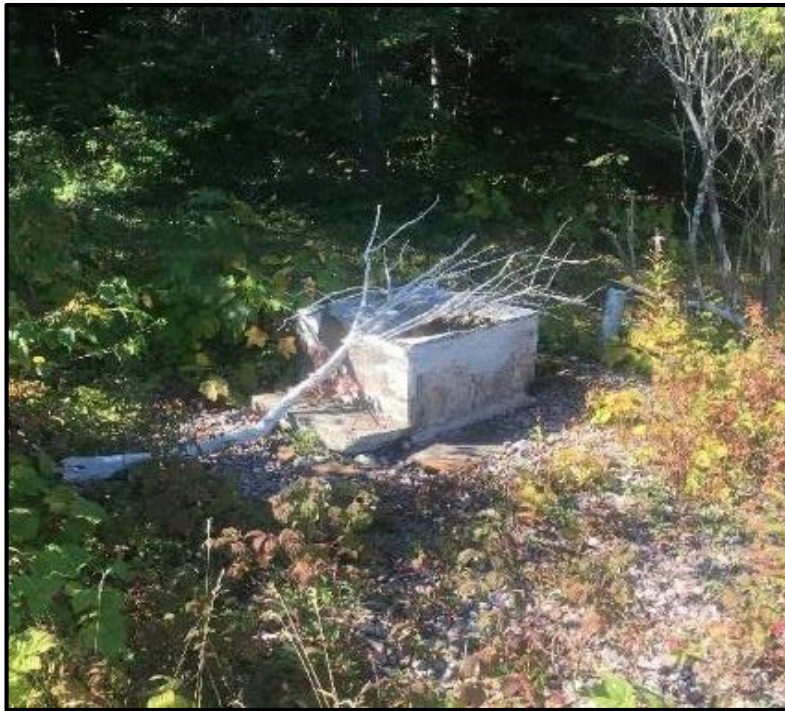
Photograph 37: View of outhouse foundation located north of the duplex dwelling foundation. White lead-based paint on concrete surfaces.

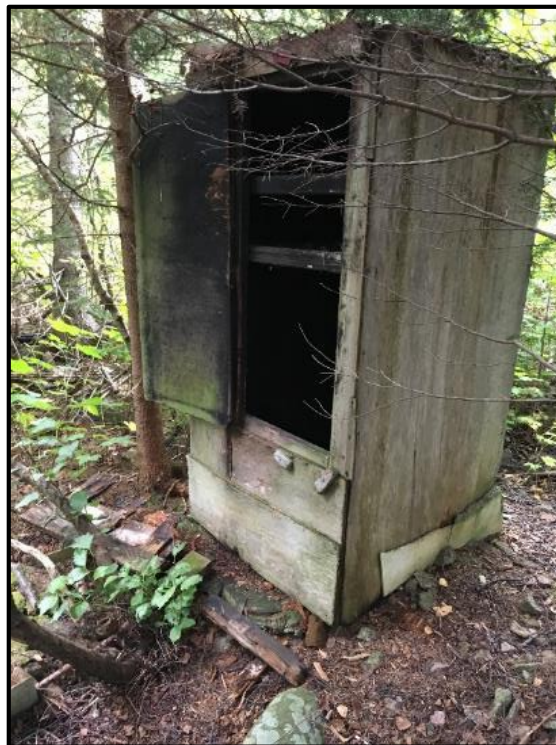
Photograph 38: South outhouse located in wooded area west of living quarters building. Asbestos-containing transite panels with tar paper form the roof and walls, and lead-based paint debris and other debris is present within the outhouse and surrounding ground.

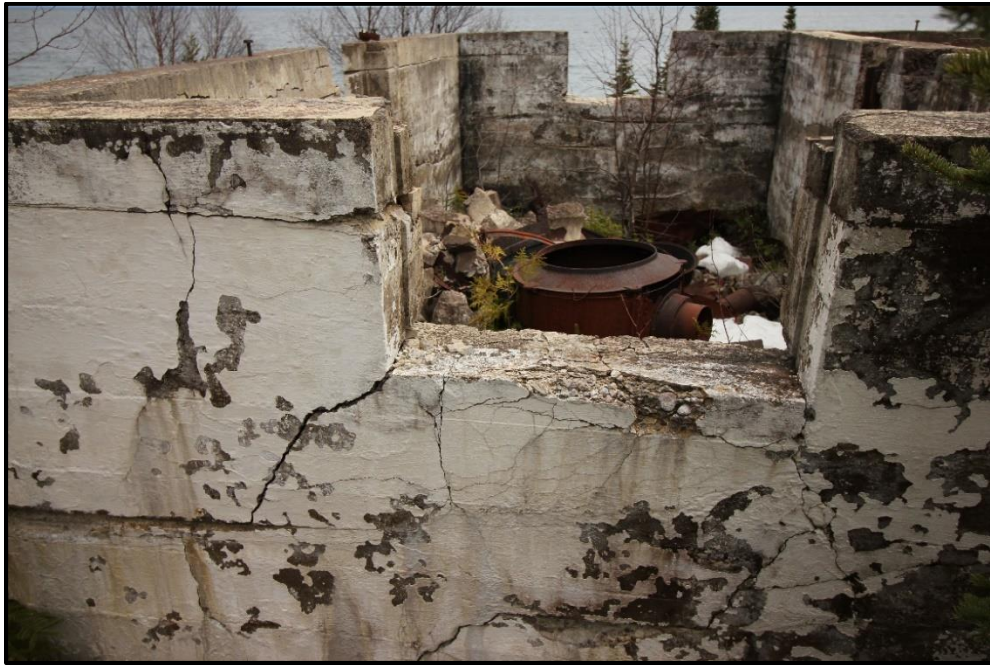
Photograph 39: Concentrated debris observed inside of the radio beacon building foundation. The concrete foundation has lead-based painted surfaces.

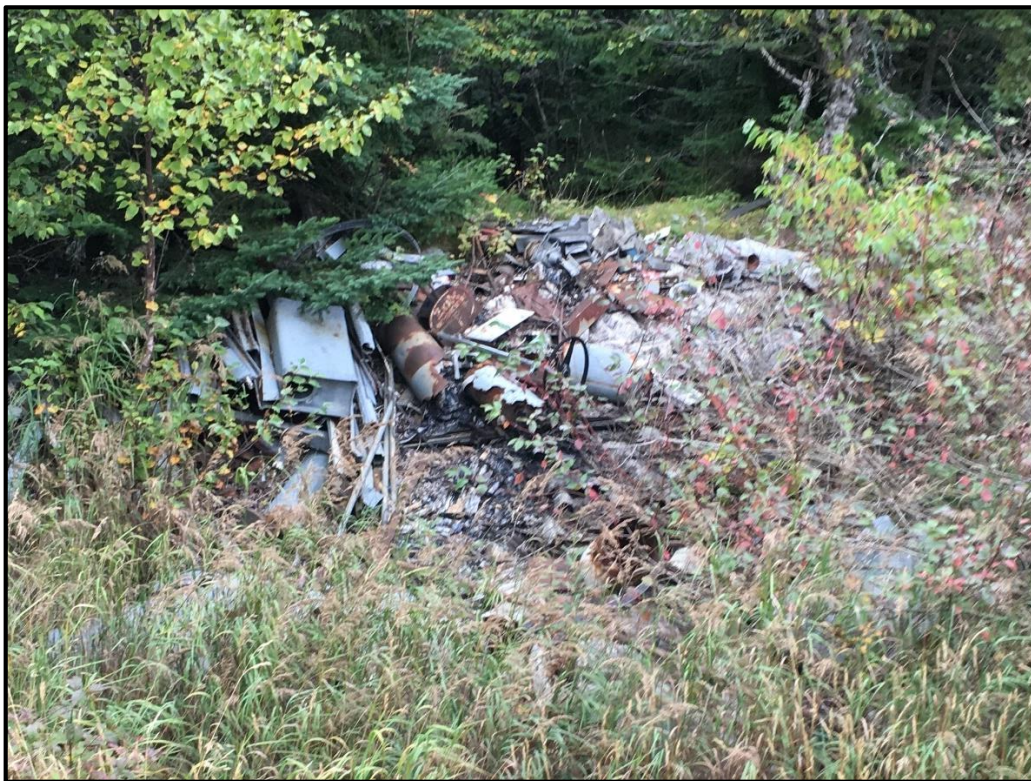
Photograph 40: Concentrated debris within debris pile 1 located in a wooded area west of the living quarters building.

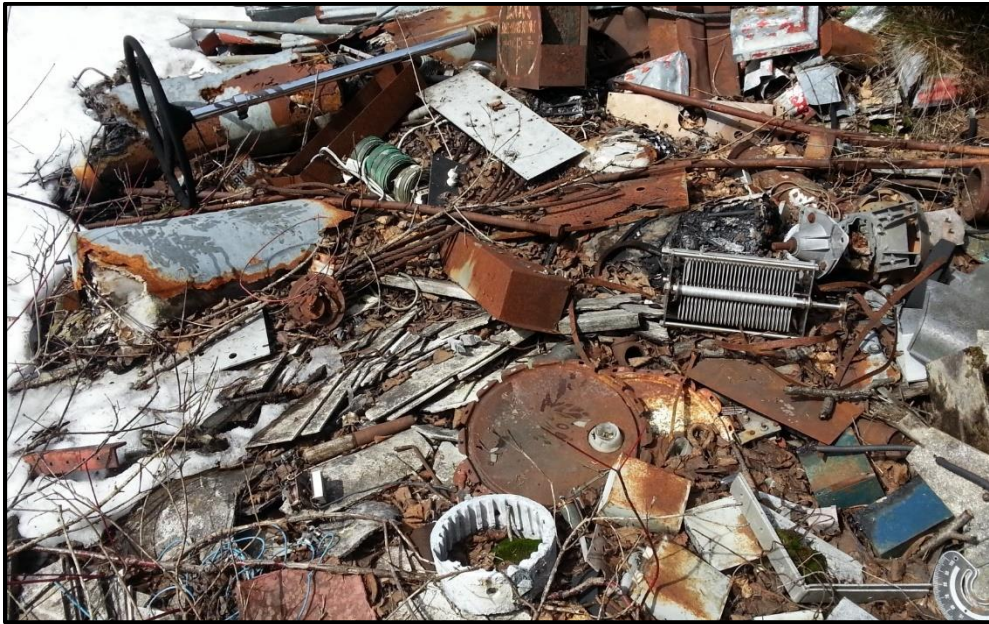
Photograph 41: Waste observed in Debris Pile 1. Wood with lead-based paint and asbestos containing materials, such as transite and shingles were observed.

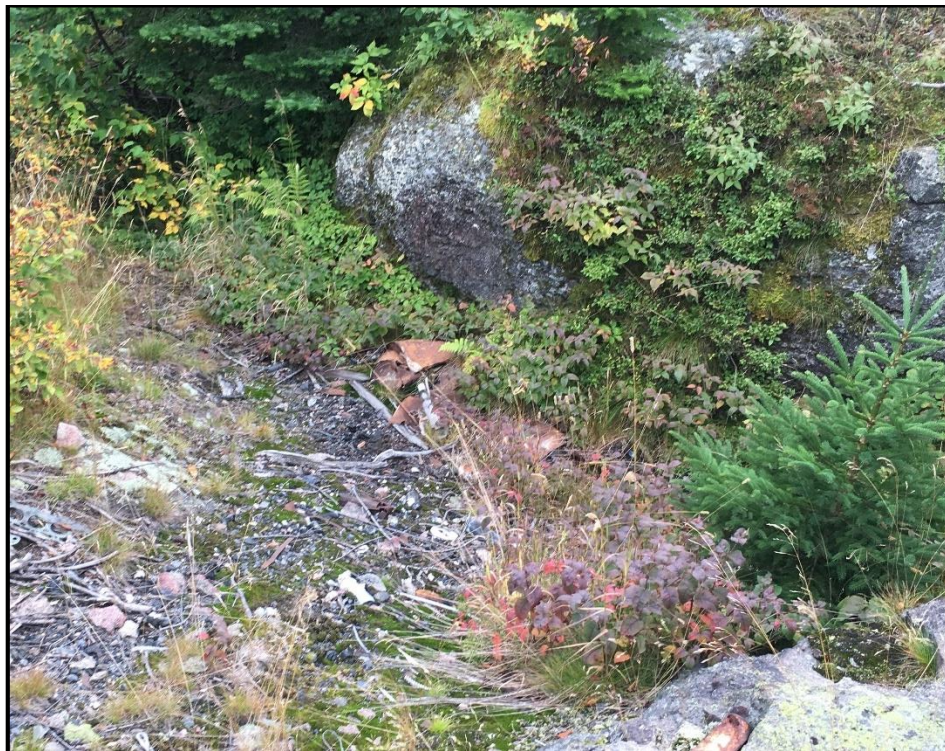
Photograph 42: Debris Pile 2 located in a rock crevice south of the radio beacon building foundation.

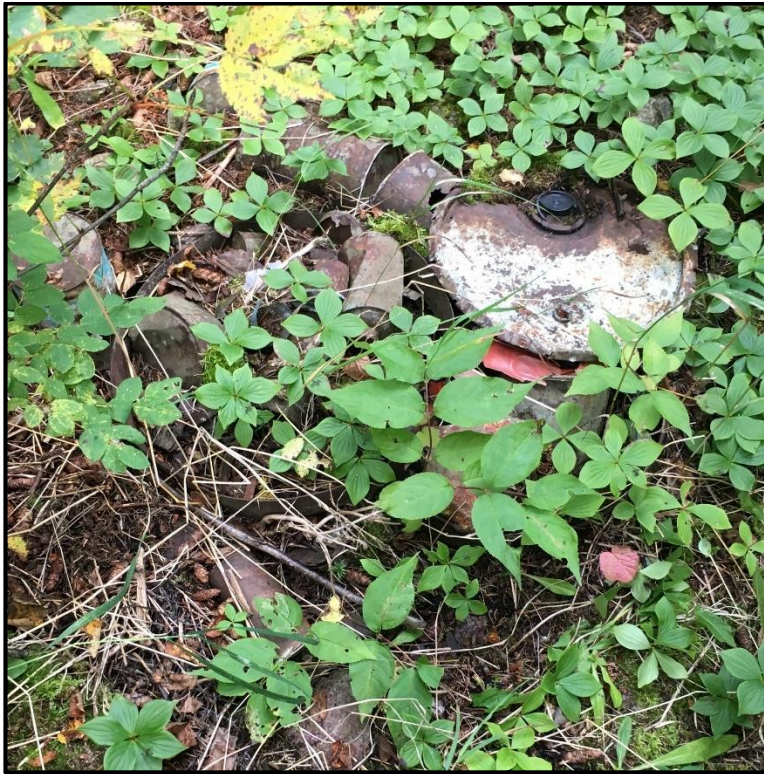
Photograph 43: Scattered debris observed in wooded area behind the duplex dwelling foundation.

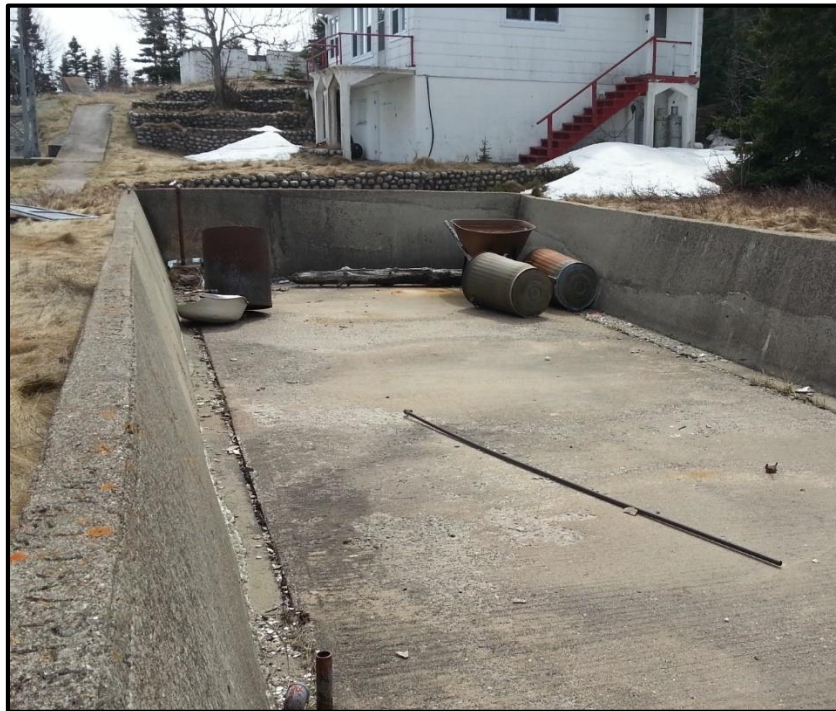
Photograph 44: Scattered metal debris observed in the concrete dyke.
