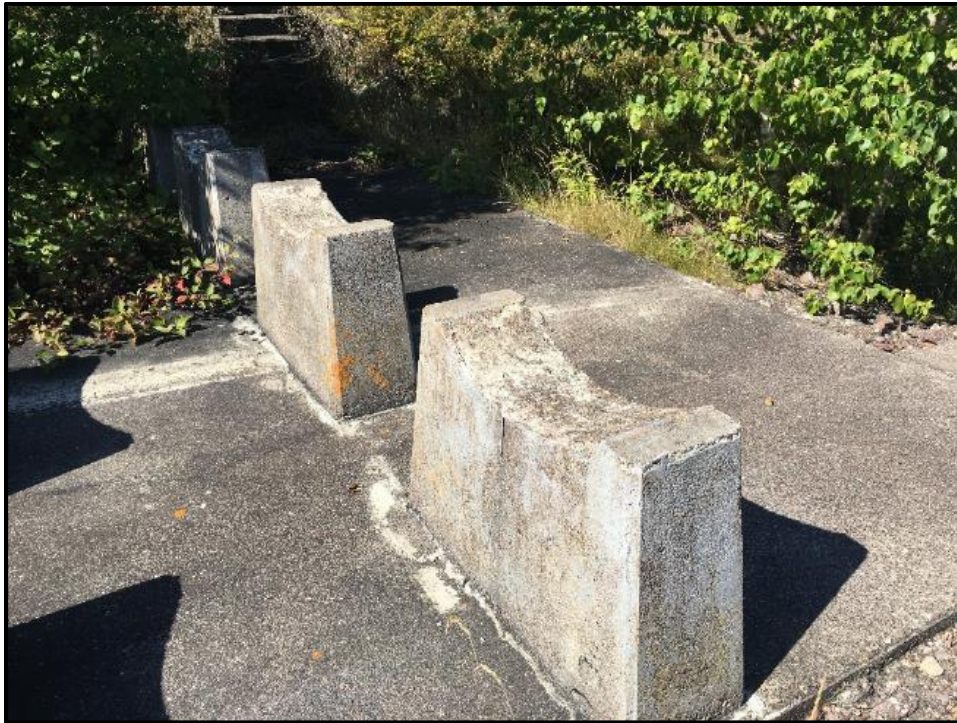
Photograph 45: Tank cradles located south of the garage/former living quarters. Residual lead-based white paint observed.
