January 12, 2017

SHOREPLAN

**RE: Marine Assessment, Michipicoten Island Lightstation, Lake Superior
Our file 16-2455**

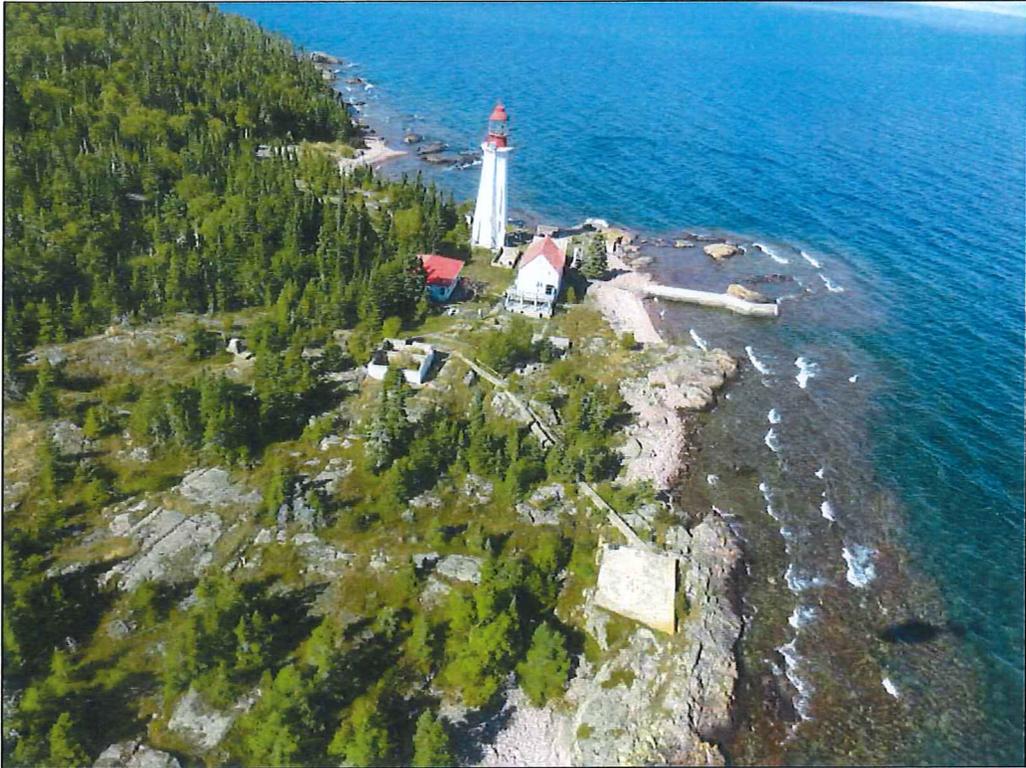
Photo 1 **Northerly Looking View of Lightstation**

Figure 2 is a site plan of the lightstation property. The shoreline is generally jagged rock that is not well suited for marine access. Photo 1 is a northerly looking view of the site. There is a concrete helicopter landing pad in the foreground and a concrete breakwall extending a short distance offshore in an easterly direction. Photo 2 shows a westerly looking view of the breakwall and a narrow channel adjacent to it that was dredged through the nearshore rock substrate. The shoreline on the south side of the breakwall is a cobble beach (Photo 3). There is also a short dock north of the lighthouse which does not extend offshore of the rock outcrop that abuts its eastern side (Photo 4).

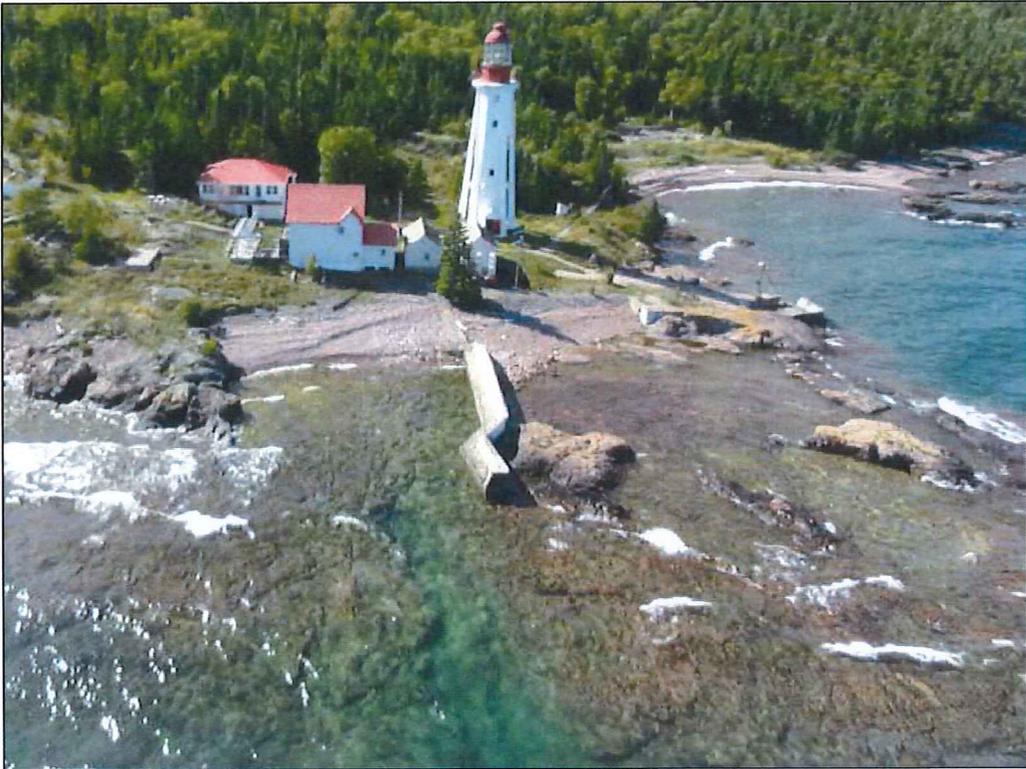
Photo 2 **Westerly Looking View of Breakwall and Channel**

The breakwall east of the lighthouse is approximately 21.5m long in total, but there is a bend in it that effectively limits the area available for berthing to the innermost 13m. Depths over that 13m length range from approximately 0.25m at the shore to 0.75m at its mid-point and 1.1m at its outer end. The dredged access channel (Photo 2) was visually estimated to be approximately 3m wide and in the order of 1m deep.

allow access to the island via the cobble beach on the south side of the breakwall (Photos 2 and 3).

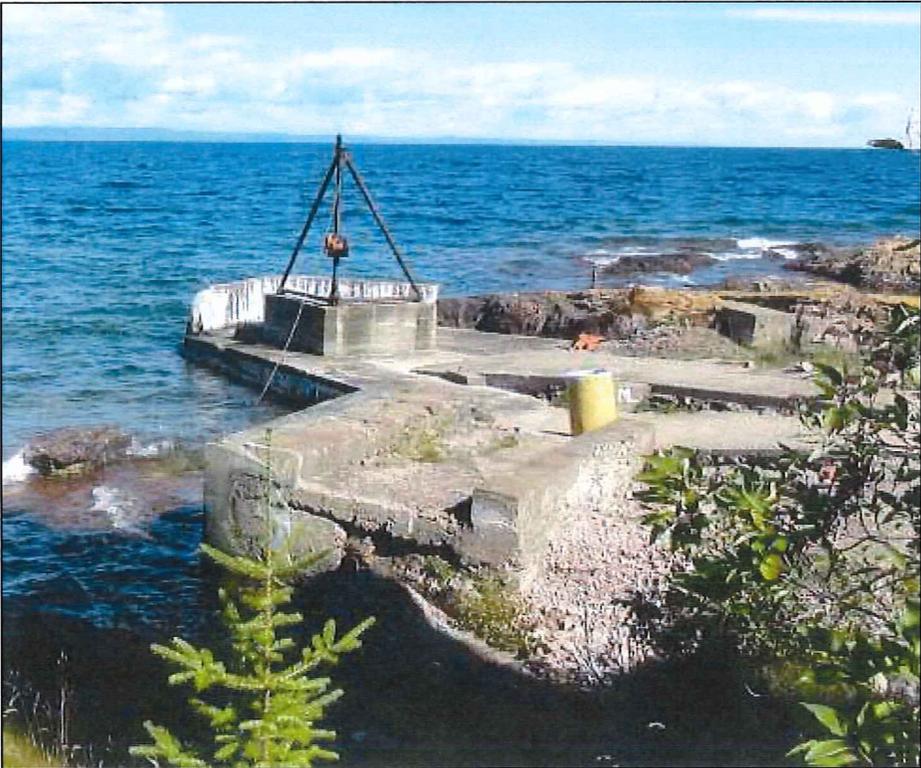
Photo 4 Dock North of Lighthouse

The dock north of the lighthouse is approximately 10m long with water depths varying irregularly from 1.2 to 2.0m over that length. A shallow draft vessel could be berthed here during calm conditions, but there is a 2m long concrete base for a hoist (Photo 4) that limits access to the berth.
