Structural Review

Michipicoten Island  
East End  
Light Station

Novatech 116136

**Reference: Michipicoten Island - East End Light Station - Lighthouse and Other Buildings  
Structural Condition Evaluation**

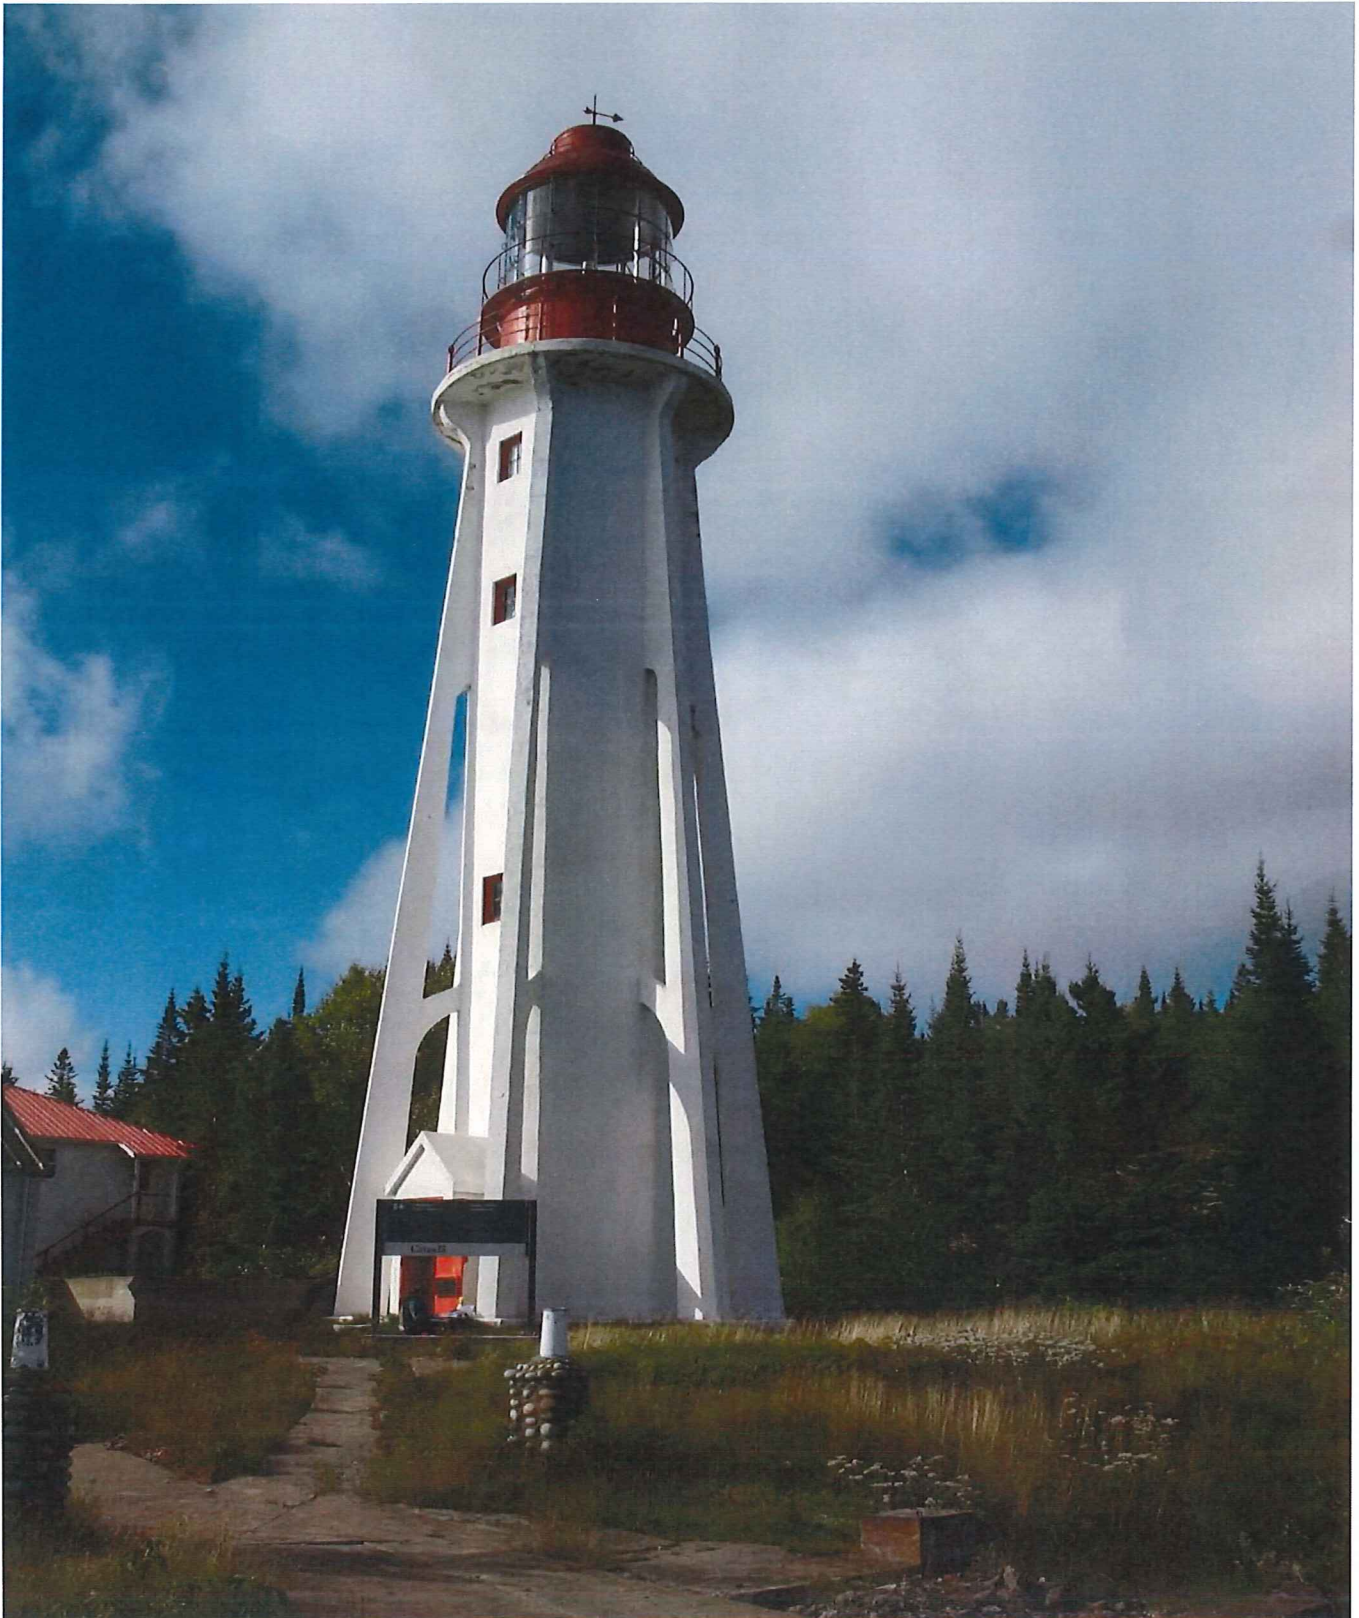
P2

Overall view of Lighthouse. Six flying buttresses. Top floor extends as exterior concrete platform.

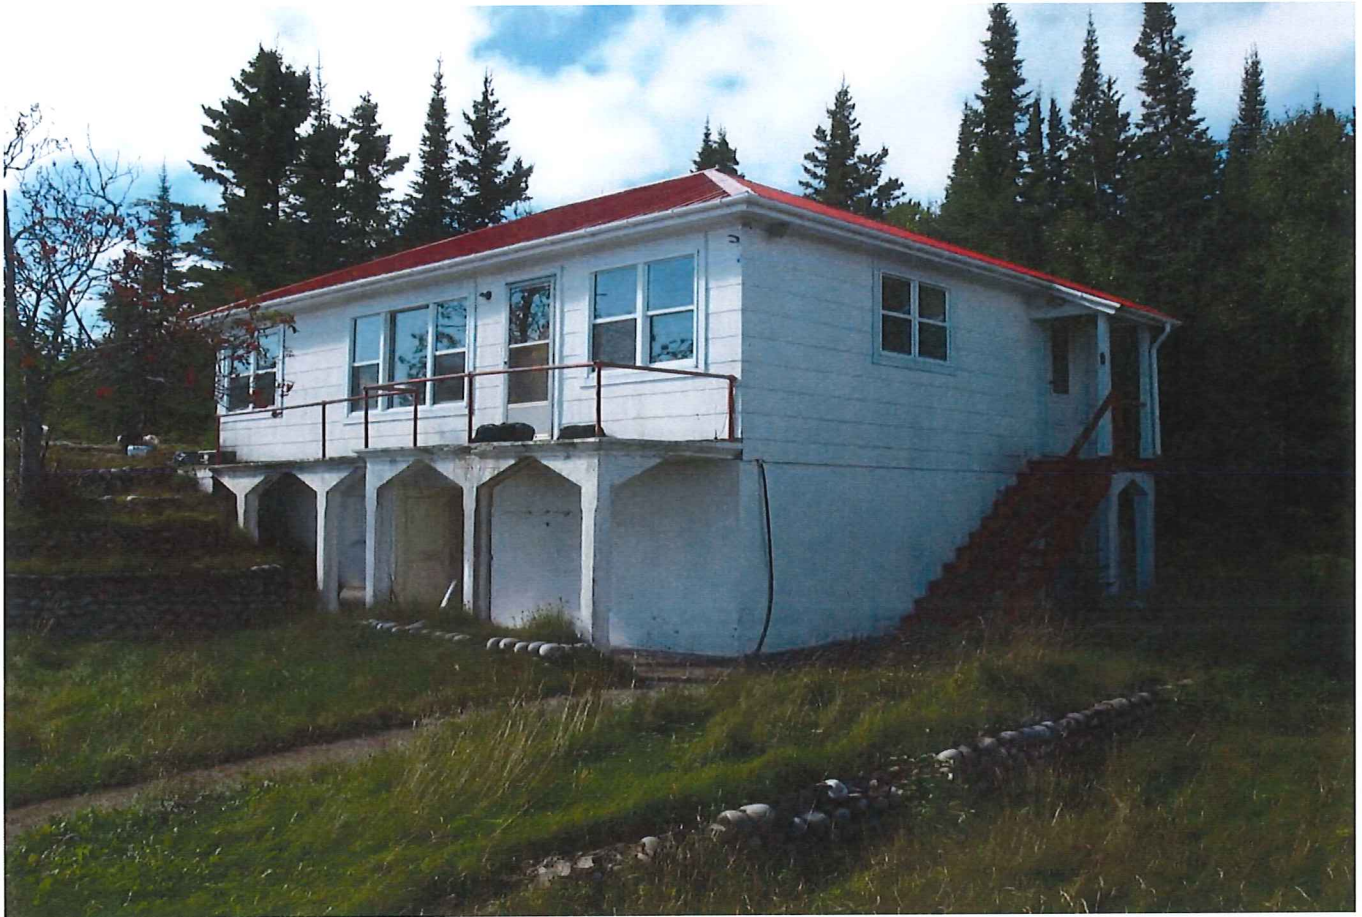
Overall view of house. Concrete balcony, concrete landing at side door.  
Roof, siding & windows in good condition.

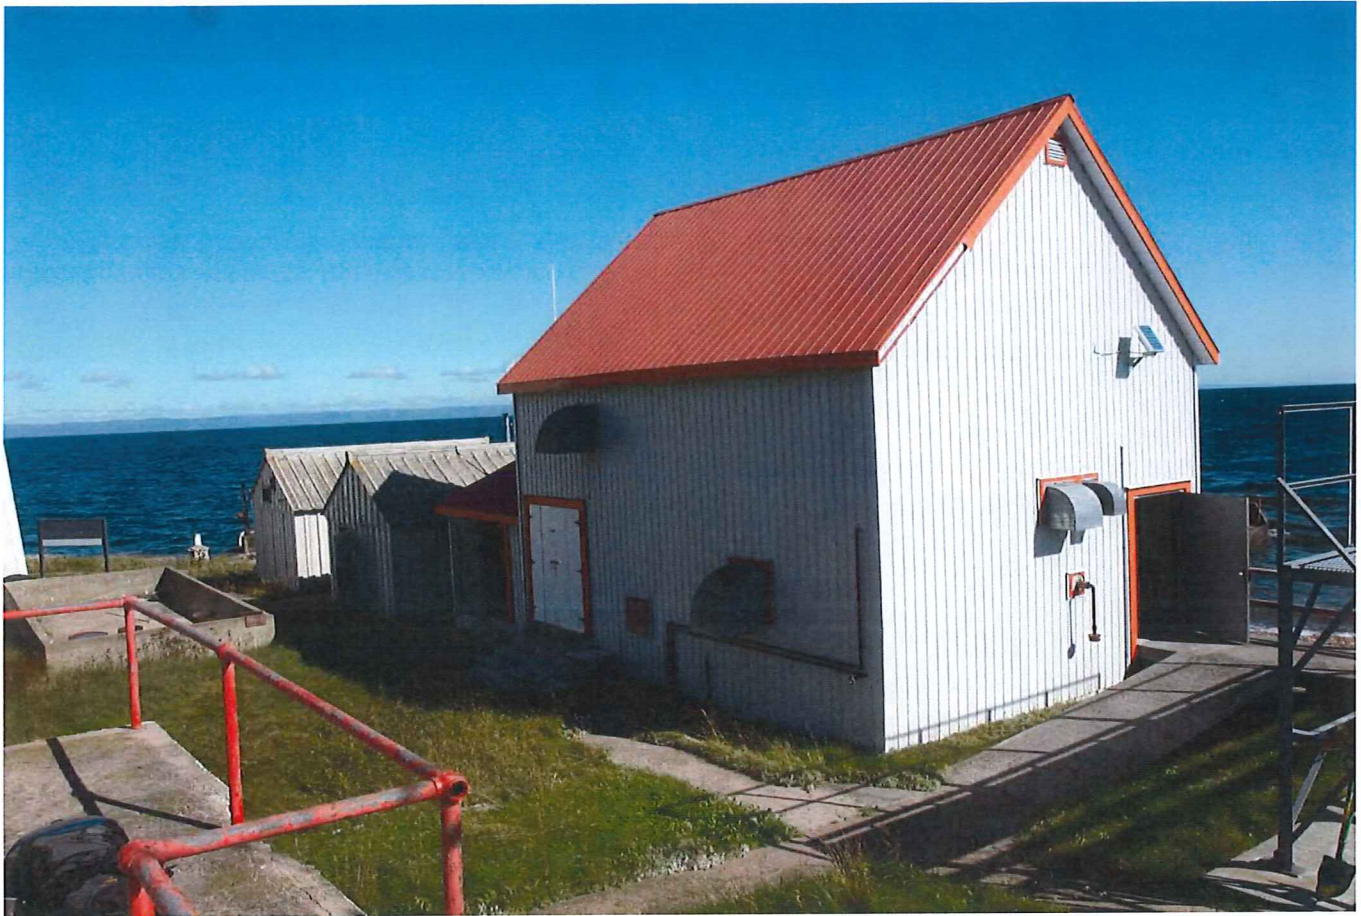
Overall view of generator building, annex in shadow, and two small storage buildings beyond. Metal cladding in good condition, one fascia piece missing.

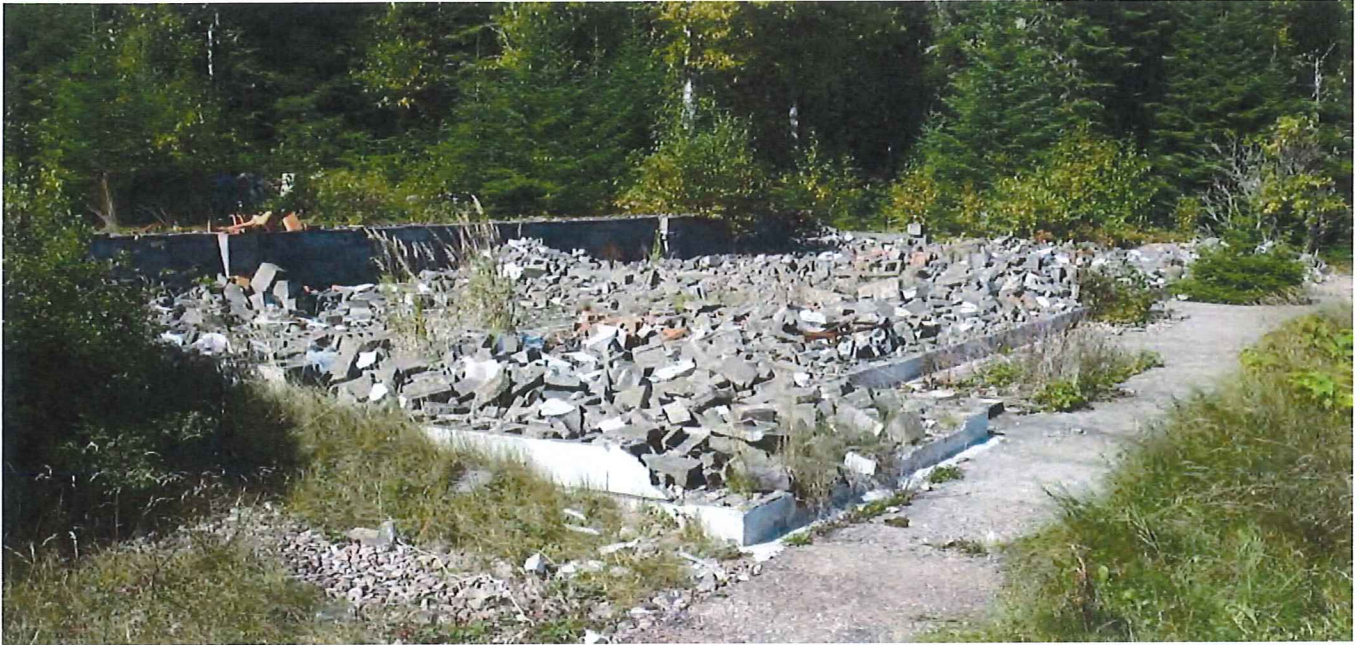
Part-demolished concrete block foundations.

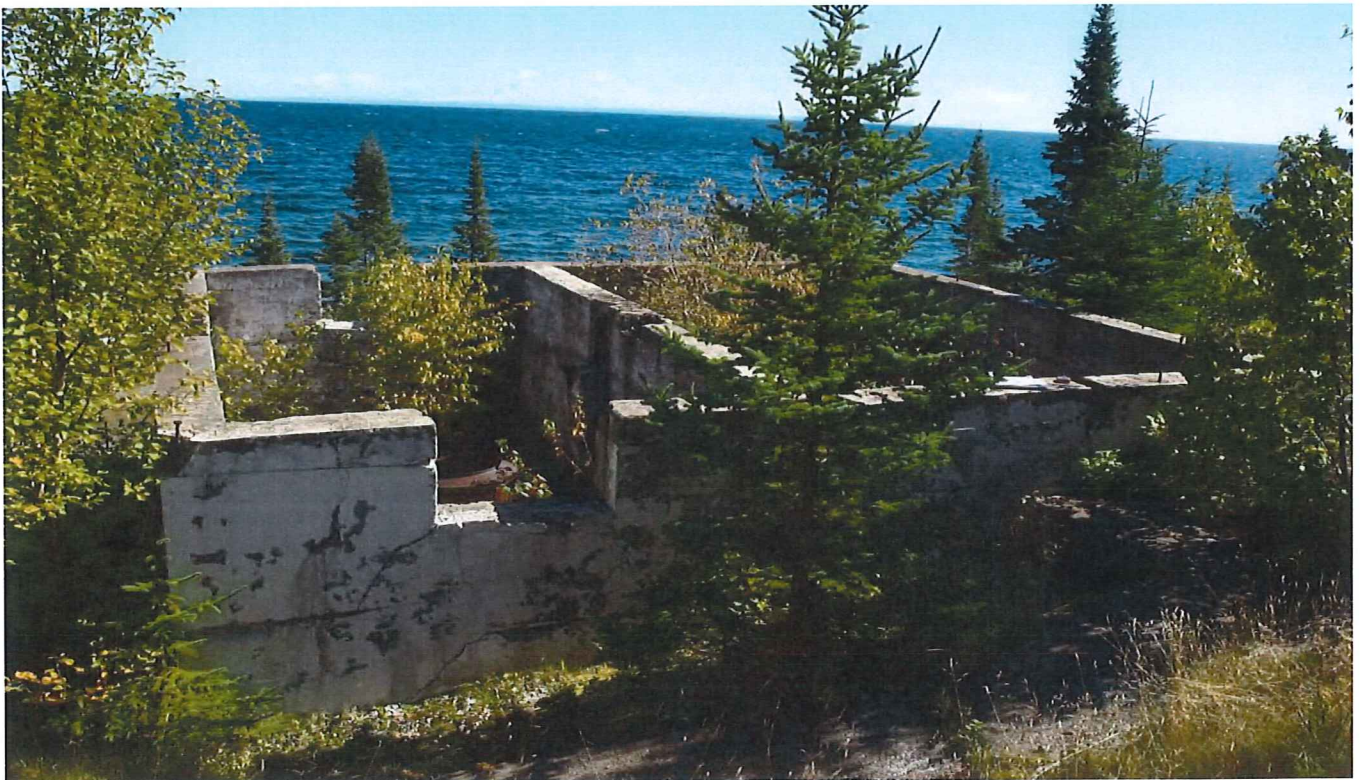
Abandoned concrete foundations.

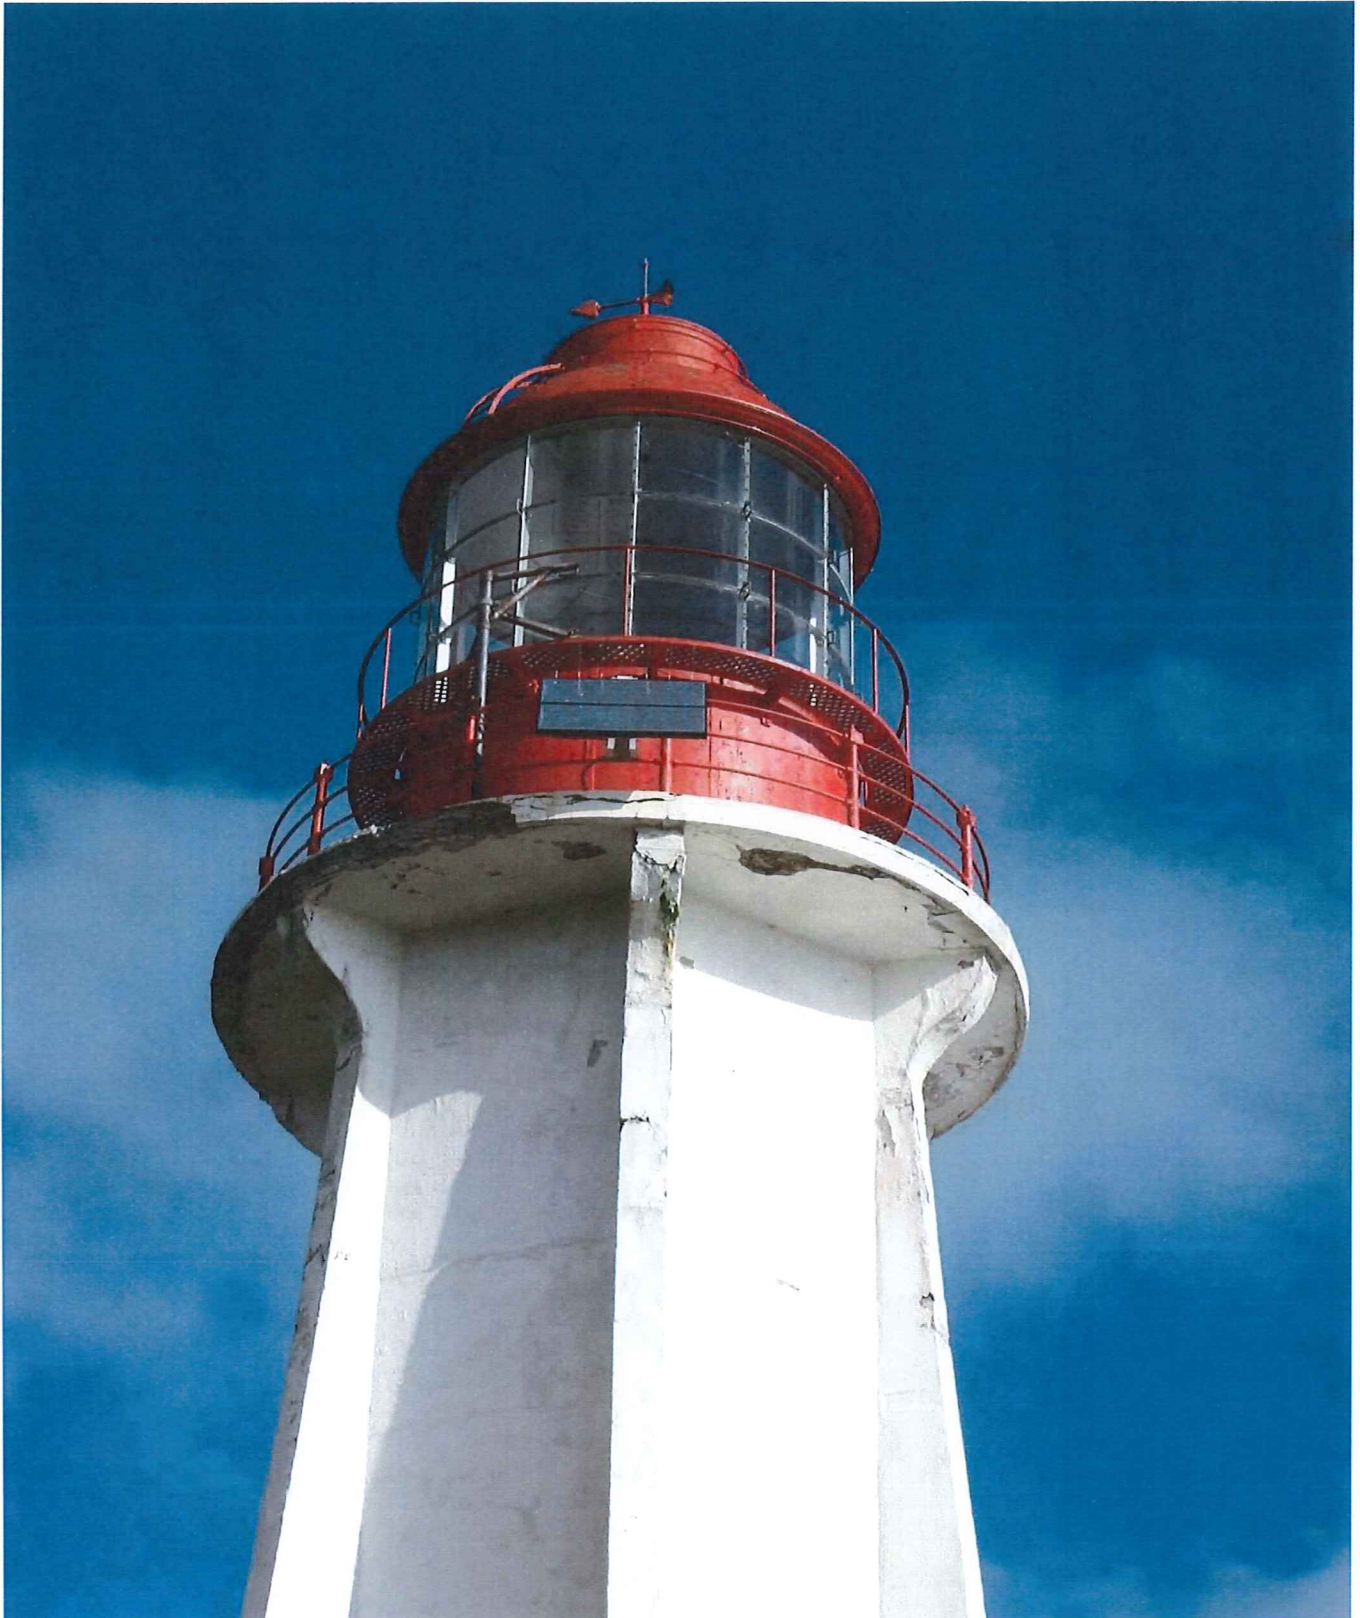
P6

- 4.8 There is significant concrete deterioration at the outer edge and the underside of the exterior platform. There is a horizontal crack at about mid-depth of the edge of the platform that extends around at least 25% of the perimeter of the platform. There are several spalled areas, and some pieces of concrete have fallen. It can be expected that the top surface of the exterior platform will also have experienced some deterioration. At the ladder opening through the top floor there is significant horizontal cracking that is probably the inward extension of the horizontal crack observed at the edge of the exterior platform.

- 9.2 The probable existence of horizontal cracking in the top floor / exterior platform slab, extending from the exterior edge of the slab to the ladder opening inside the tower, is potentially a significant problem. The spalling and the cracking are indicative of “top-of-slab concrete delaminations”, which occur when expansive forces created by corrosion of the top layer of rebars cause the concrete to fail in tension (crack) in the plane of the rebars, resulting in the concrete above the corroded rebars becoming separated from the concrete below the rebars. When this occurs, the top rebars become debonded, and thus ineffective, resulting in the slab losing its capacity to resist cantilever action. Additionally, the now-separated upper and lower layers of concrete are at greater risk of cracking, and pieces of concrete may fall to the ground.

- 9.3 Rebar corrosion and concrete spalling at the exterior platform can be expected to continue, probably at a gradually increasing rate due to both the increasing exposure of fractured concrete to freeze-thaw action and the increasing exposure of the rebars to wet conditions. Accordingly, it can be expected that the amount of spalling and top-of-slab delamination will increase, and it can be expected that pieces of concrete will continue to fall. Additionally, the extension of the cracking into the interior section of the top floor slab, as already seen, provides a path for water to penetrate further into the slab, and thus to enter the tower itself, increasing the potential for corrosion and further deterioration.

Concrete spalling at exterior concrete platform. Note horizontal crack at edge of slab. See P8.

- .1 Re-support the lantern room structure directly down to the inside faces of the tower walls, anchored to sound concrete below the floor slab.
- .2 Remove the full area of the exterior section of the slab (will likely require scaffolding).
- .3 Remove the interior section of the slab (could be undertaken from inside the tower).
- .4 Replace the interior section either with a concrete slab, or with steel framing.
- .5 Provide weather-tight detail at the lantern tower / infill / concrete tower connection.

- .1 Remove the lantern room, either in one piece by helicopter, or by dismantling.
- .2 Demolish the entire slab.
- .3 Replace slab with a precast concrete slab, or with a lightweight structure - eg steel and fibreglass - with the same appearance as the present slab.
- .4 Reinstall the lantern room.

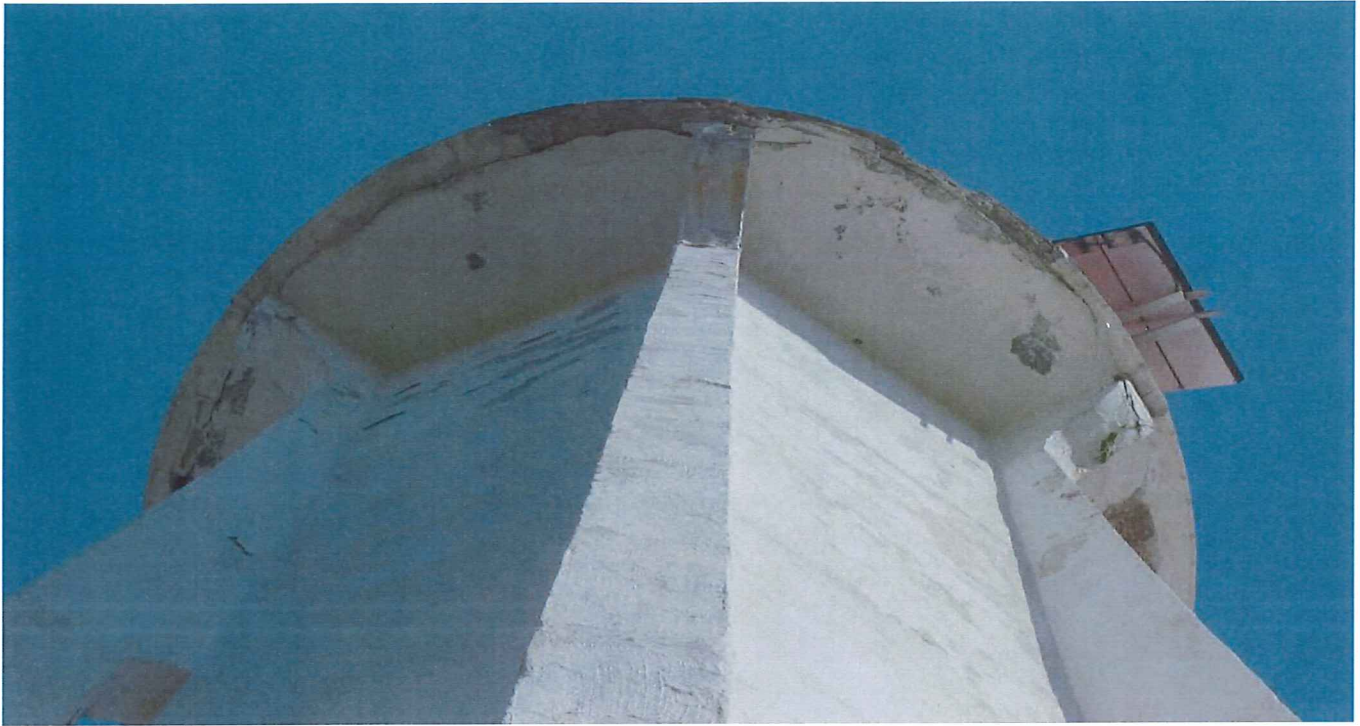
- 4.9 There is local spalling of the top-most sections of some of the buttresses, and at the top-most section of one face of the tower. There is also local cracking and spalling at the bases of some of the buttresses.

Concrete spalling on wall face and at buttress flares.

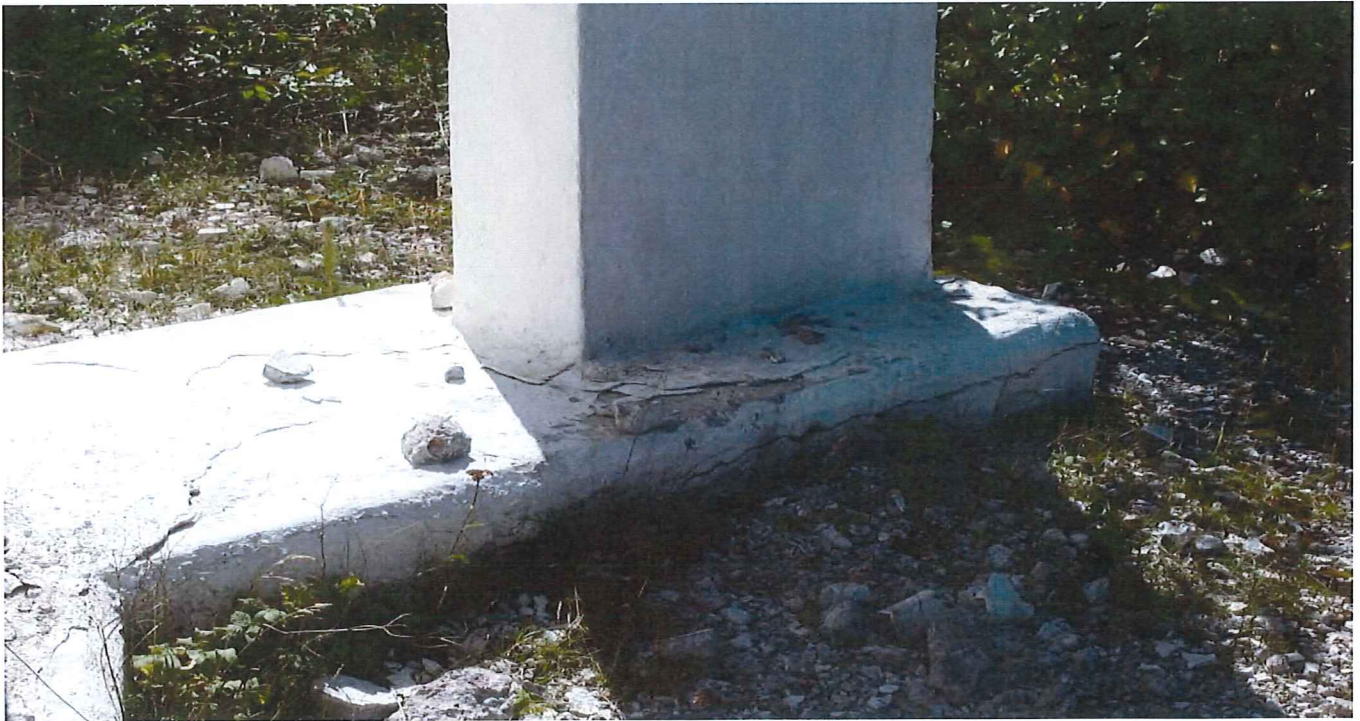
- 9.6 With respect to the primary structure of the lighthouse, the tower and the flying buttresses are generally in satisfactory condition. The condition of the base, which does have some local cracking and spalling, and which is mostly hidden, should be further investigated.

Concrete cracking and spalling at base of buttress.

- .1 Investigate the condition of the footings. Undertake concrete repairs to restore the integrity of the footings, as required. Consider protecting the footings and the lower-most sections of the flying buttresses to minimize the risk of future deterioration.
- .2 At the interior, repair deteriorated concrete and metal components. Remove efflorescence, surface scaling, corrosion, etc, and repaint.
- .3 Repaint the metal components of the lantern room and upper platform. If the paint is removed to bare metal, caulk all joints before the metal is primed and repainted.
- .4 Check all components such as windows, doors and hatches, particularly at the lantern level, for weather-tightness, and repair or upgrade as required.

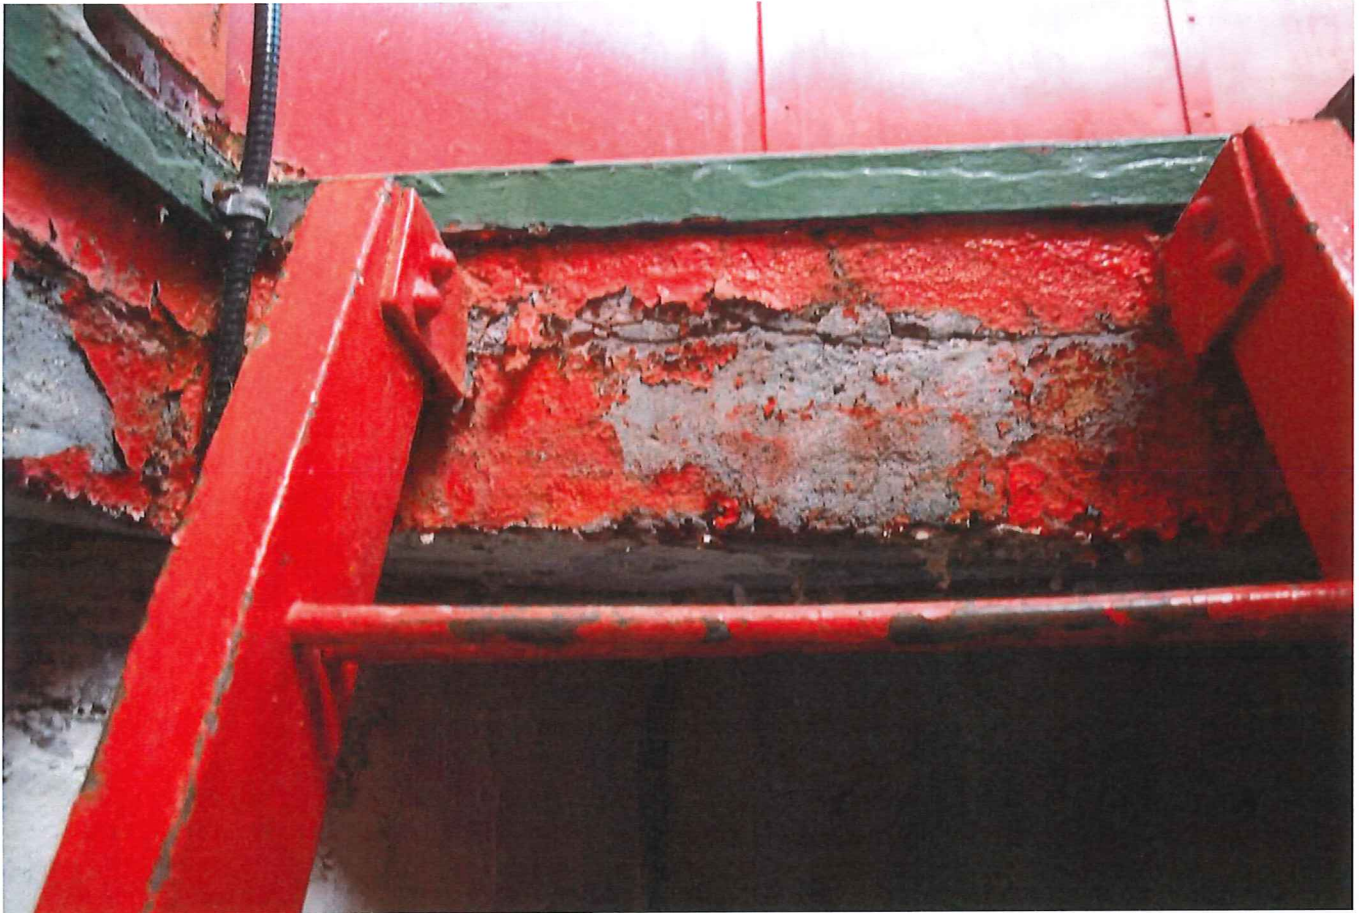
Ladder opening through top floor. Horizontal crack in slab is probably same crack visible at outside edge of exterior concrete platform. See P6.

10.8 If no work is planned in the near future, as a minimum precaution against potential damage to the lantern room structure caused by deterioration of the top floor slab, the lantern room structure should be securely anchored to the tower walls. This work could be undertaken from the inside of the tower.

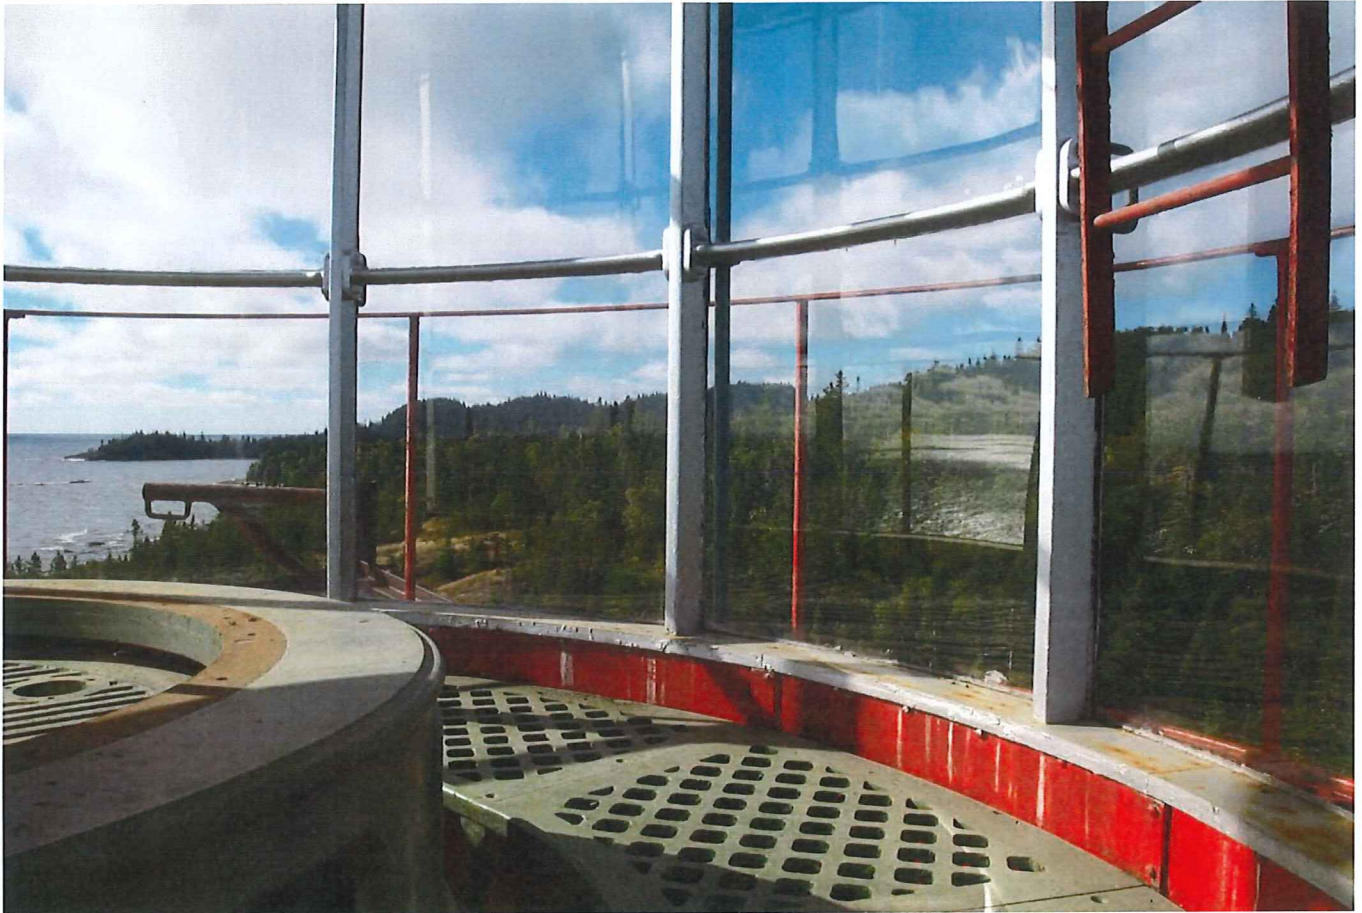
Lantern room: Metal-plate wall, open-grate cast iron upper floor. Condition generally satisfactory.

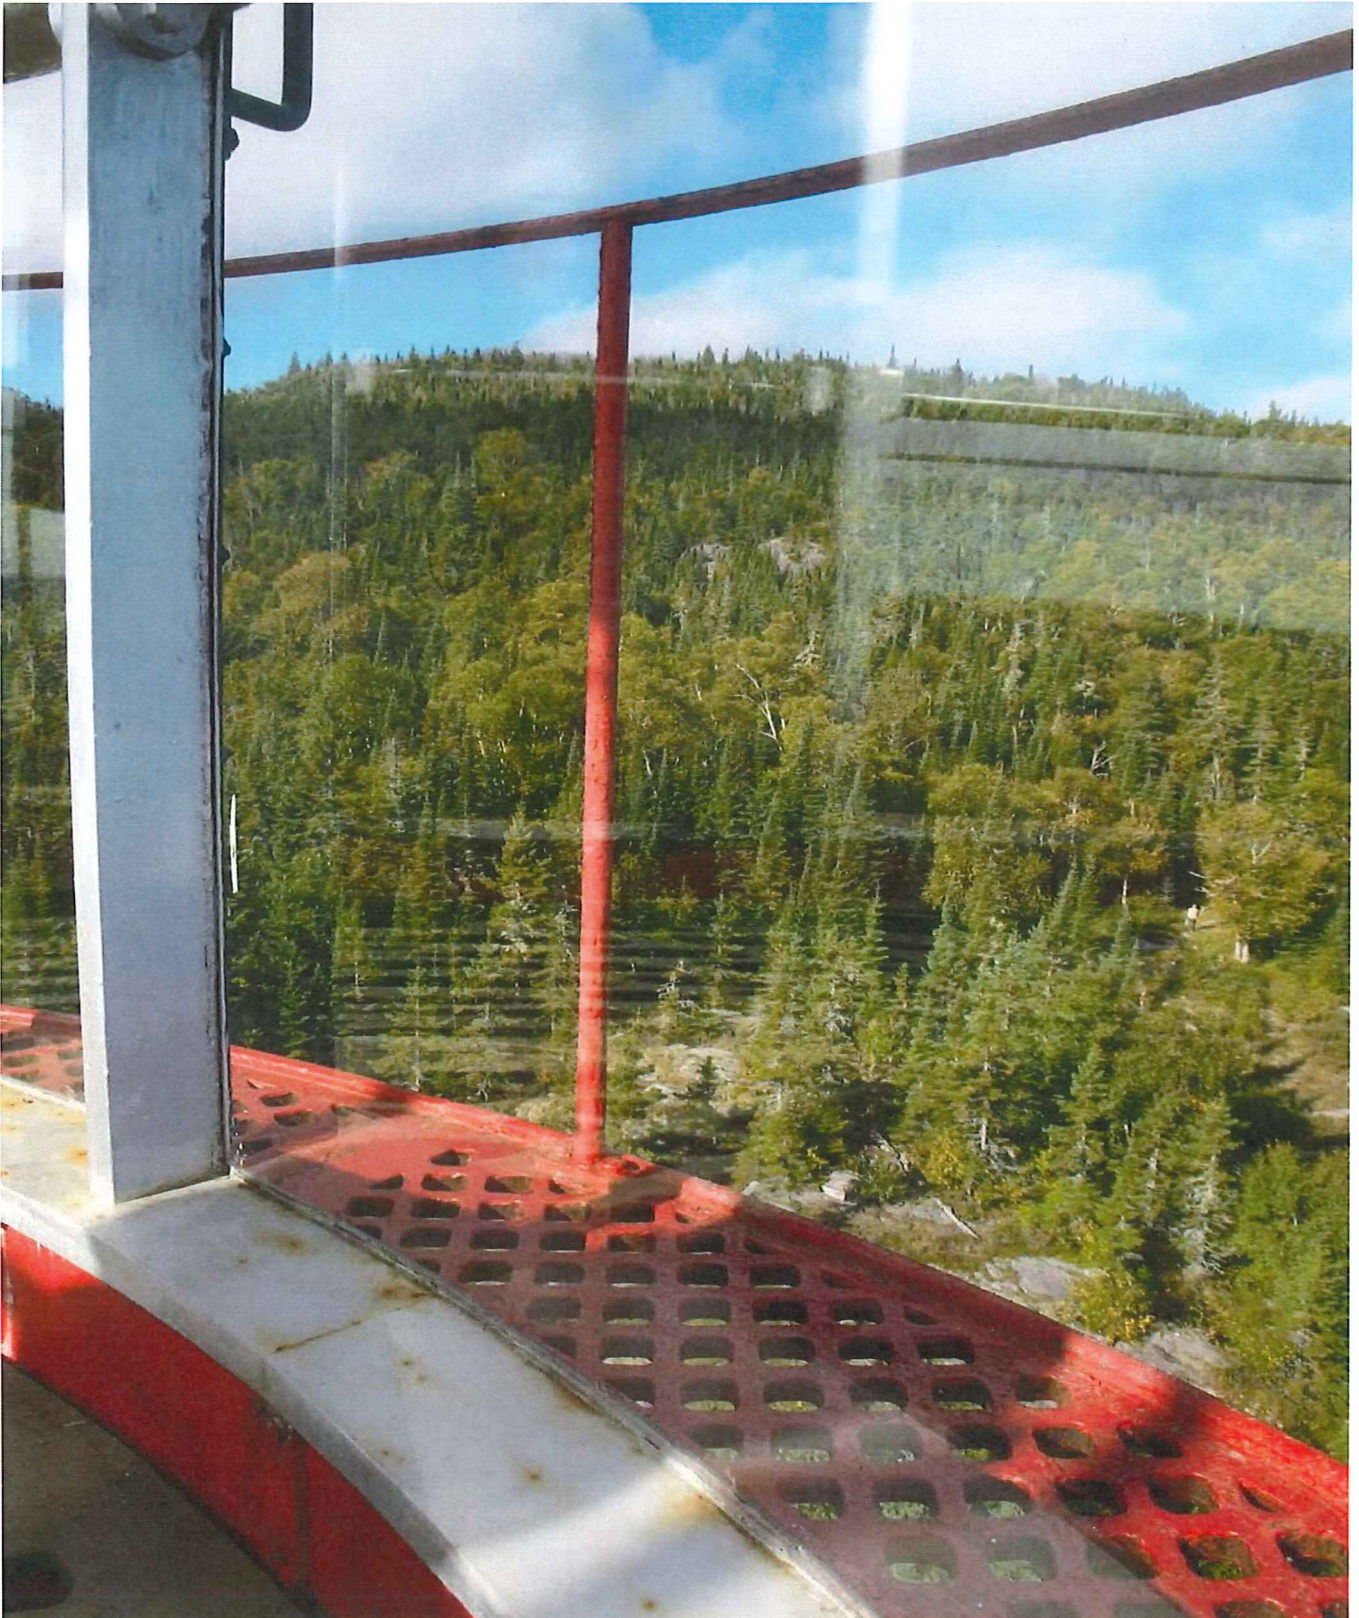
P10

Exterior platform: Open-grate cast-iron with steel pipe railing. Local corrosion.

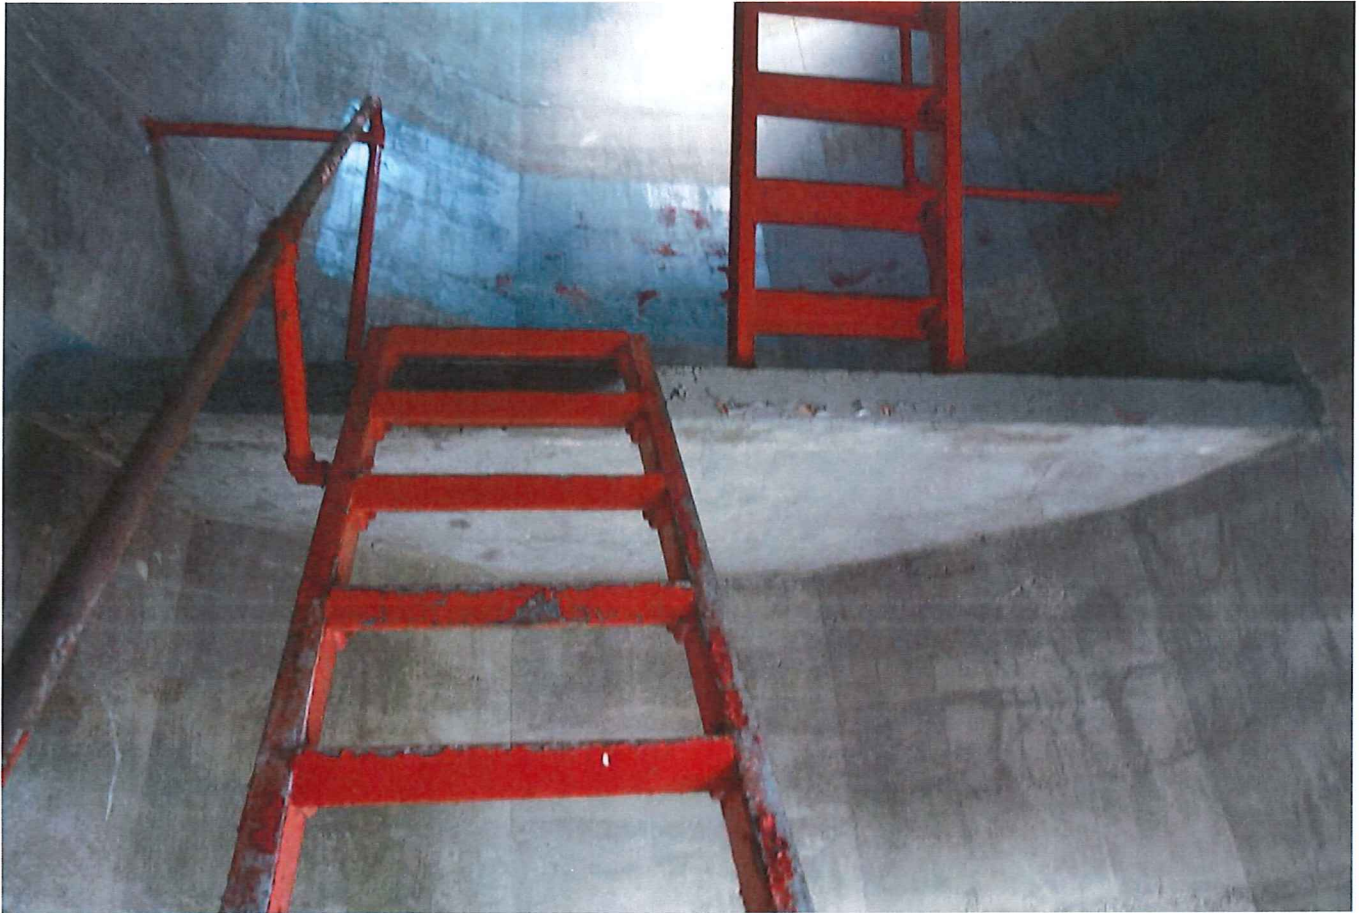
Typical ladders, pipe railings, concrete landing. Note walls generally in good condition.

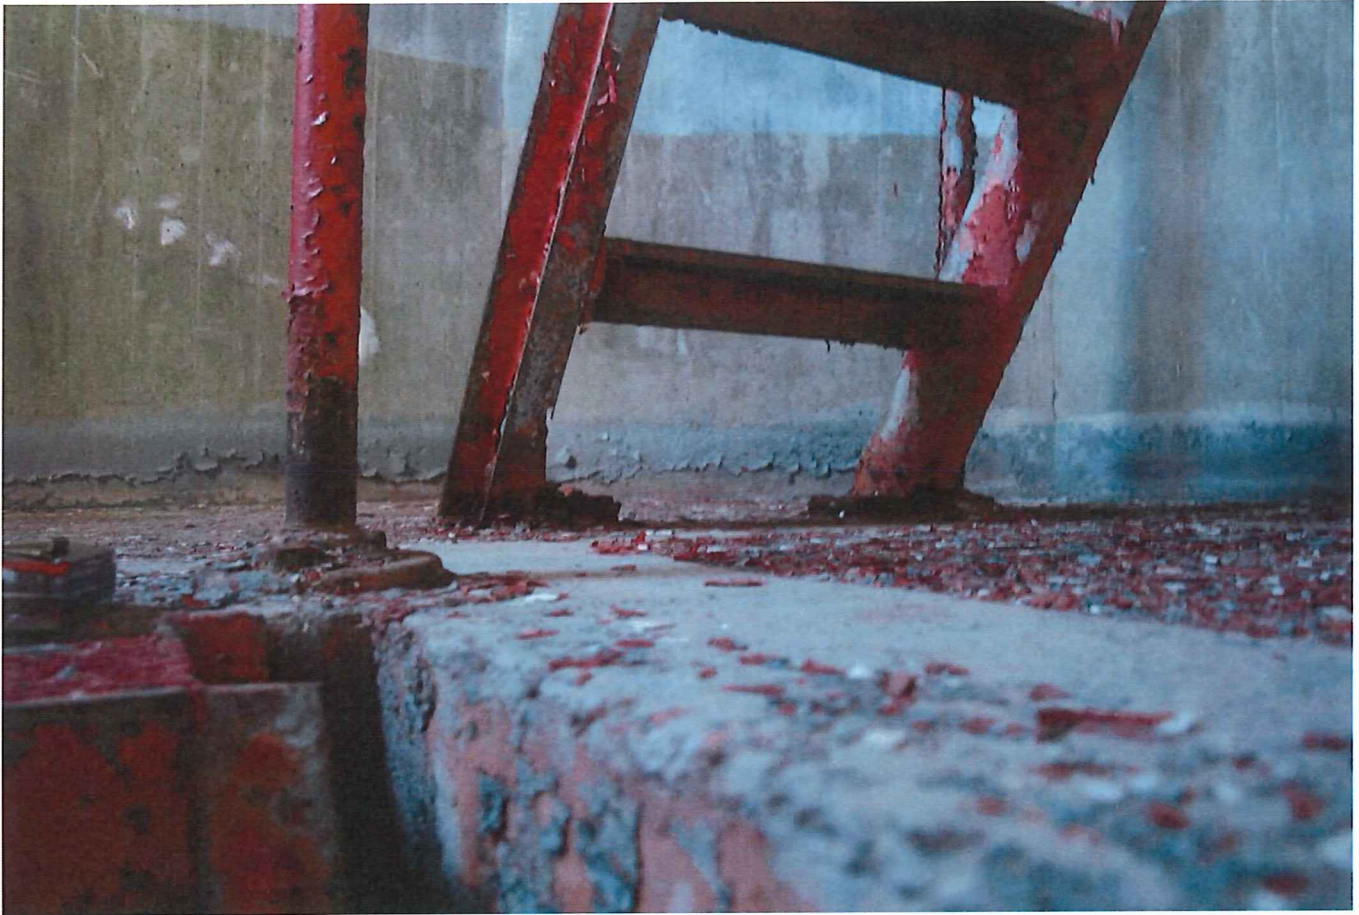
- 4.11 All the metal components are painted. The paint on the ladders is in poor condition. The paint at the lantern room is generally in satisfactory condition.

- 4.12 There is localized corrosion of some metal components, mostly at the lower supports of the ladders, and at the railing supports.

Typical condition of ladders and railings at supports. Peeling paint, local corrosion.

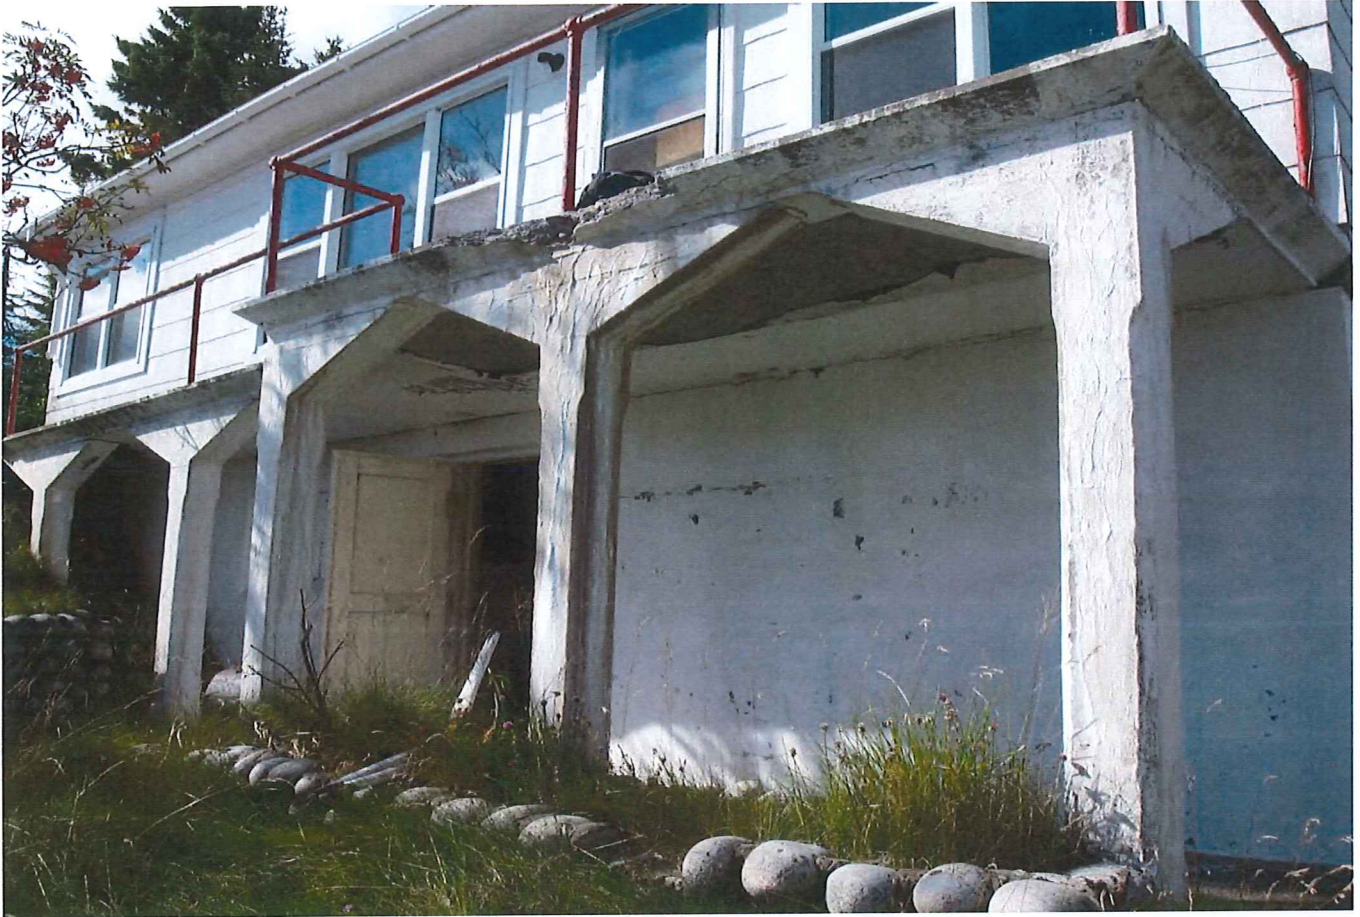
Significant spalling of slab edge. Loss of integrity at base of railing post. Peeling paint on slab soffit.

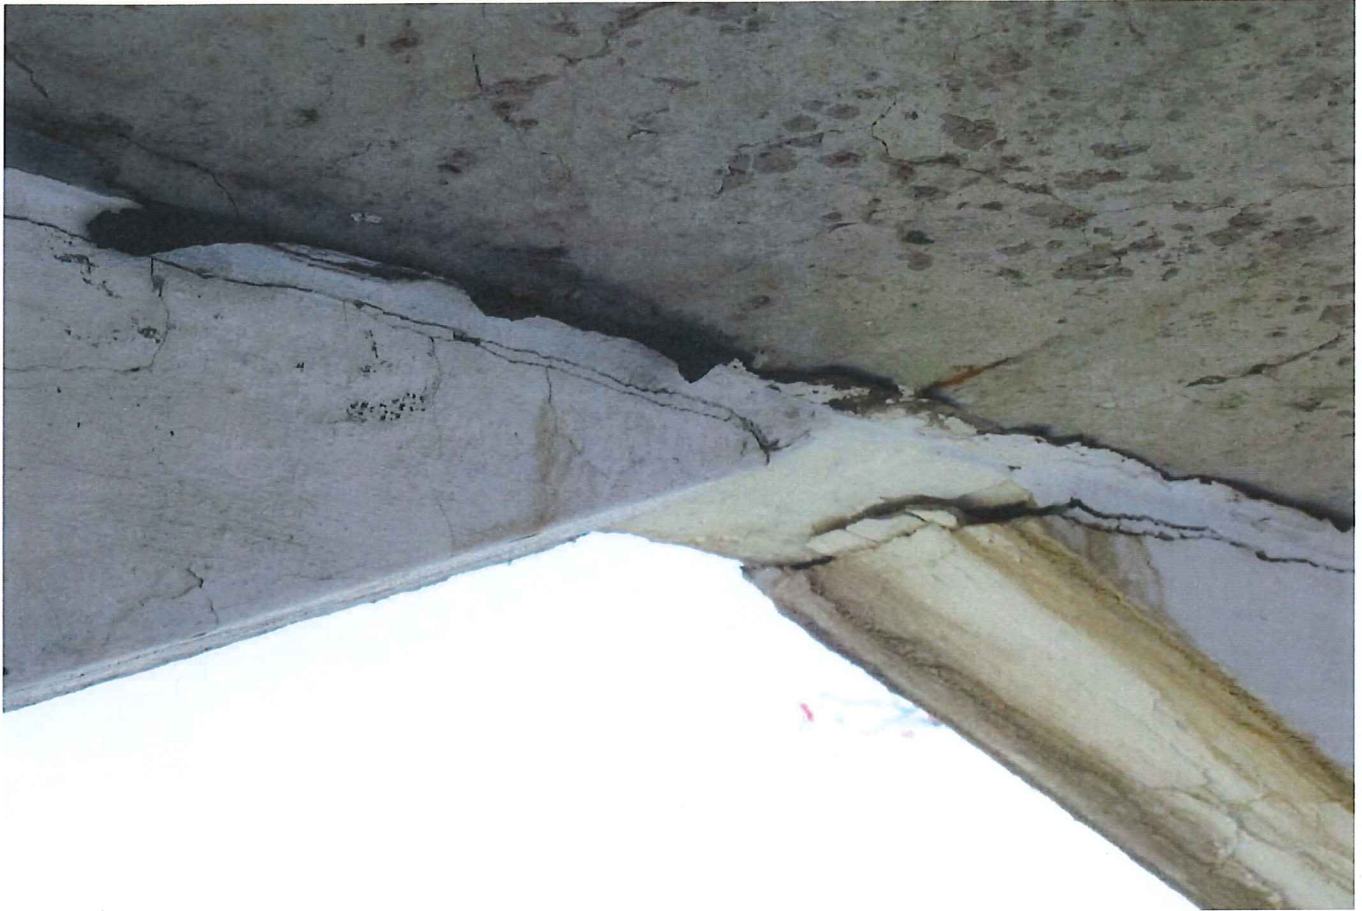
- 5.4 All the exterior concrete components are painted. The foundation walls are in satisfactory condition. The balcony slab, the column haunches and the columns are in poor condition, including peeling paint, efflorescence, cracking, scaling and heavy local spalling.

Balcony slab. Cracking at column haunches. Paint fully peeled-off slab underside.
