Structural Review

Michipicoten Island  
East End  
Light Station

Novatech 116136

**Reference: Michipicoten Island - East End Light Station - Lighthouse and Other Buildings  
Structural Condition Evaluation**

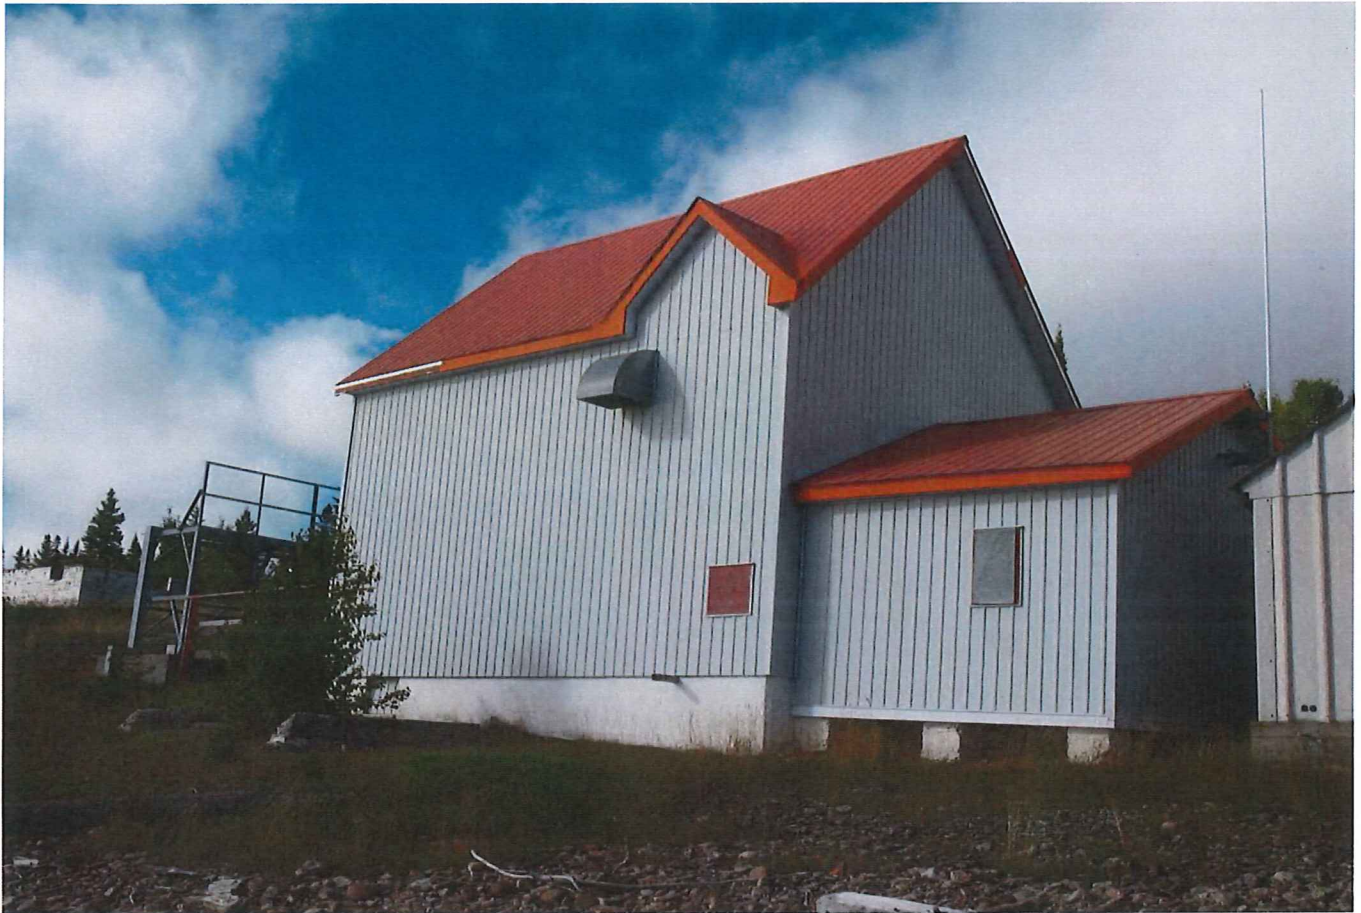
Generator Building & Annex. Metal cladding in good condition, several fascia pieces missing.

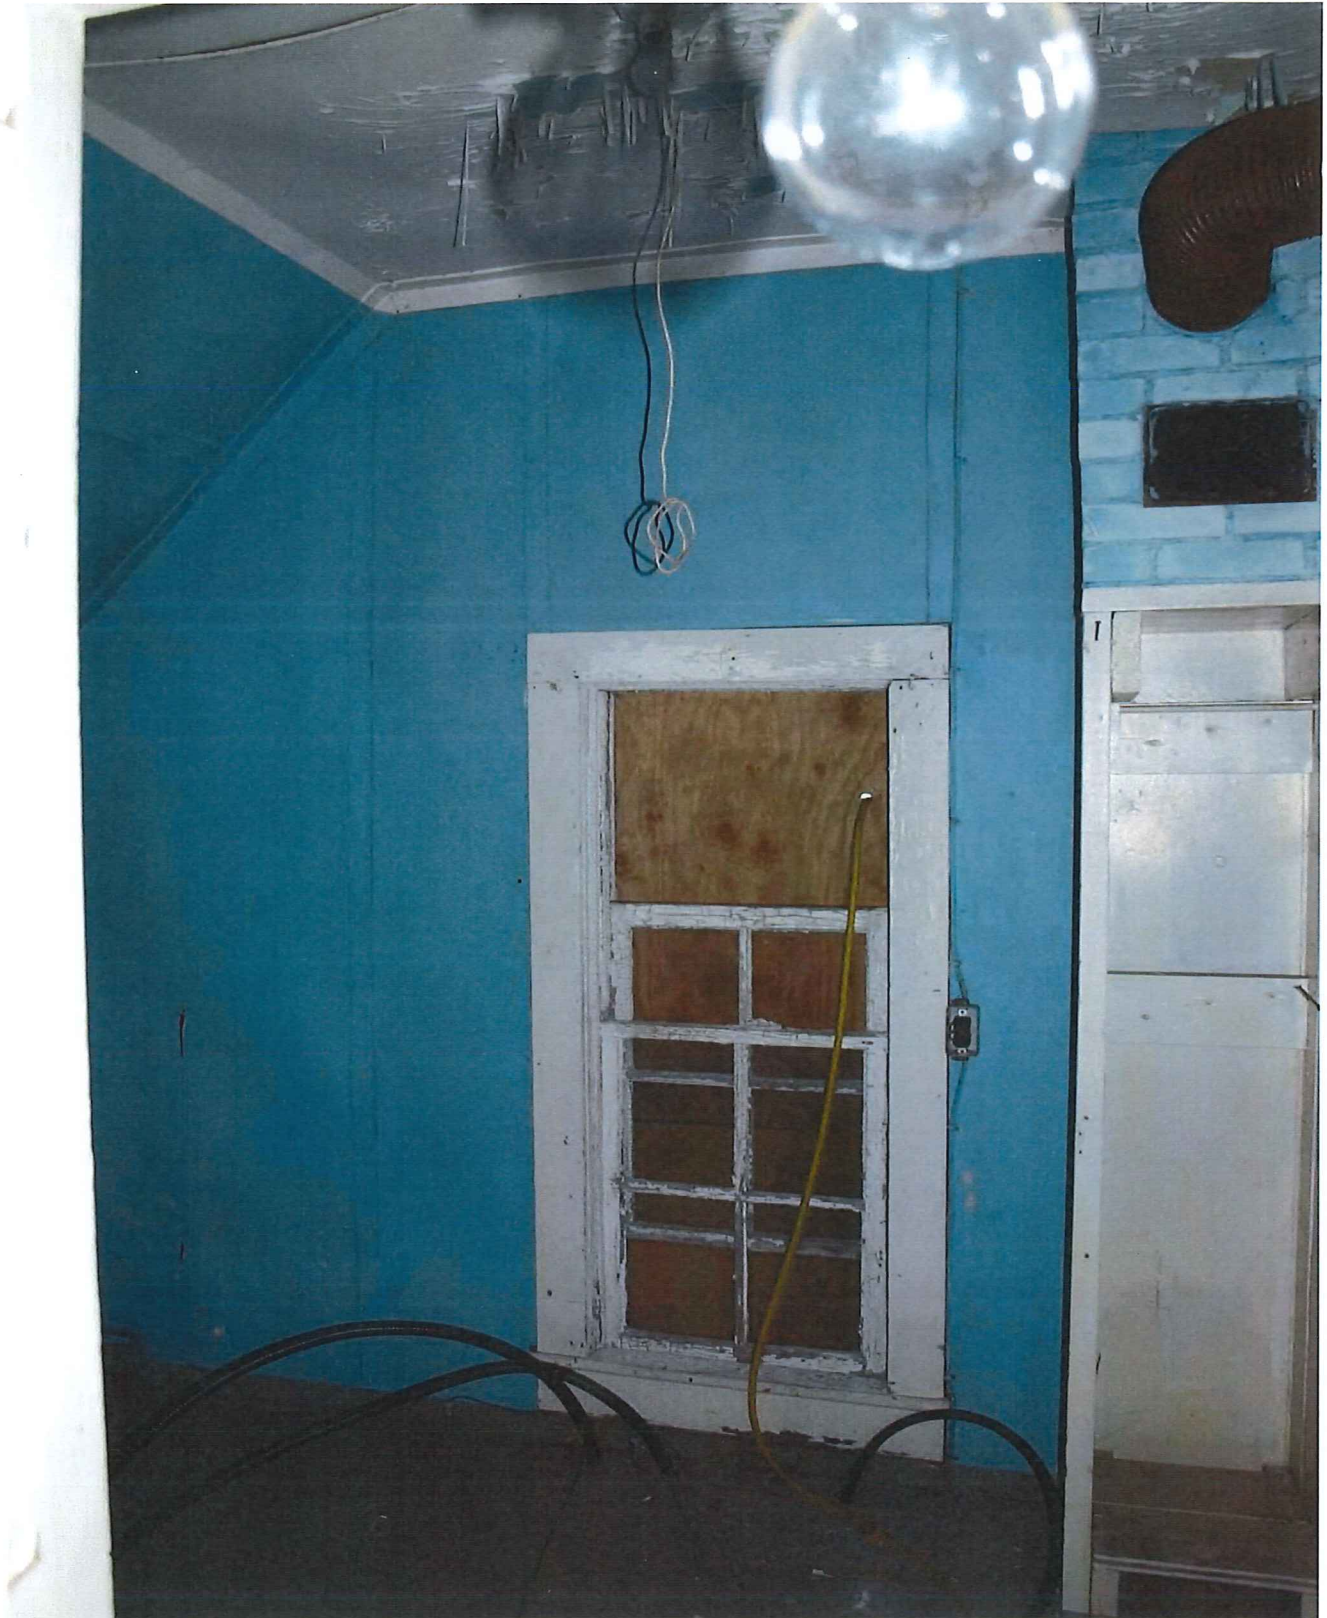
P18

Generator Building: Second floor - boarded-over window, original finishes.

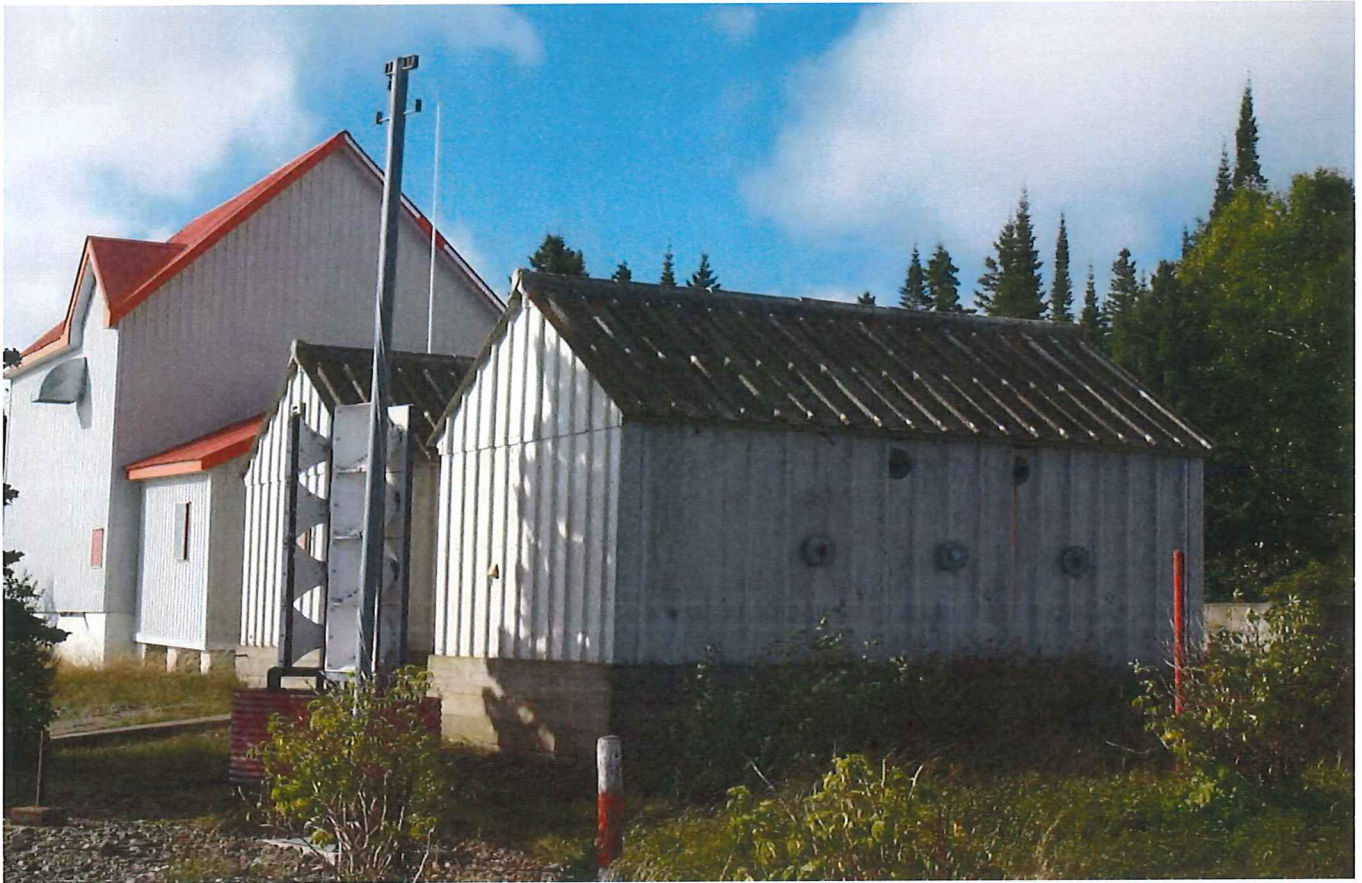
Two small storage buildings. Generally good condition.
