**NAME:** Peyto Lake Viewing Platform

**LOCATION:** Hwy 93N approx. 25 km from Trans Canada Highway

**PARK:** Banff National Park

**Current Inspection Date:** September 23, 2010      **Date of Previous Inspection:** N/A

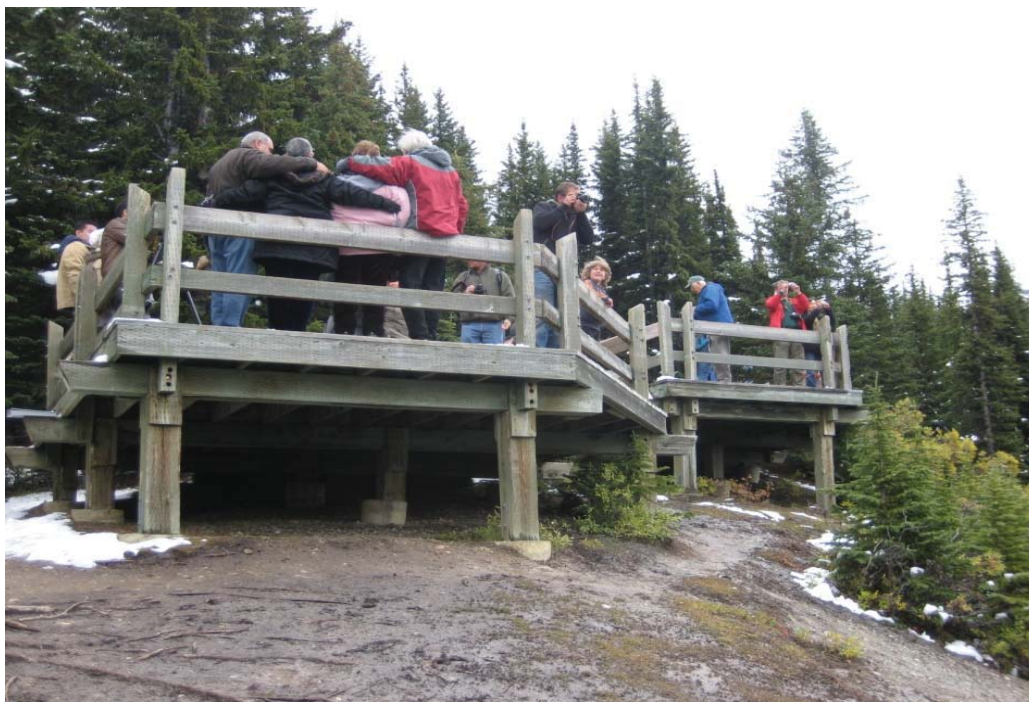
**ELEVATION LOOKING NORTH (TOWARDS PARKING LOT)**

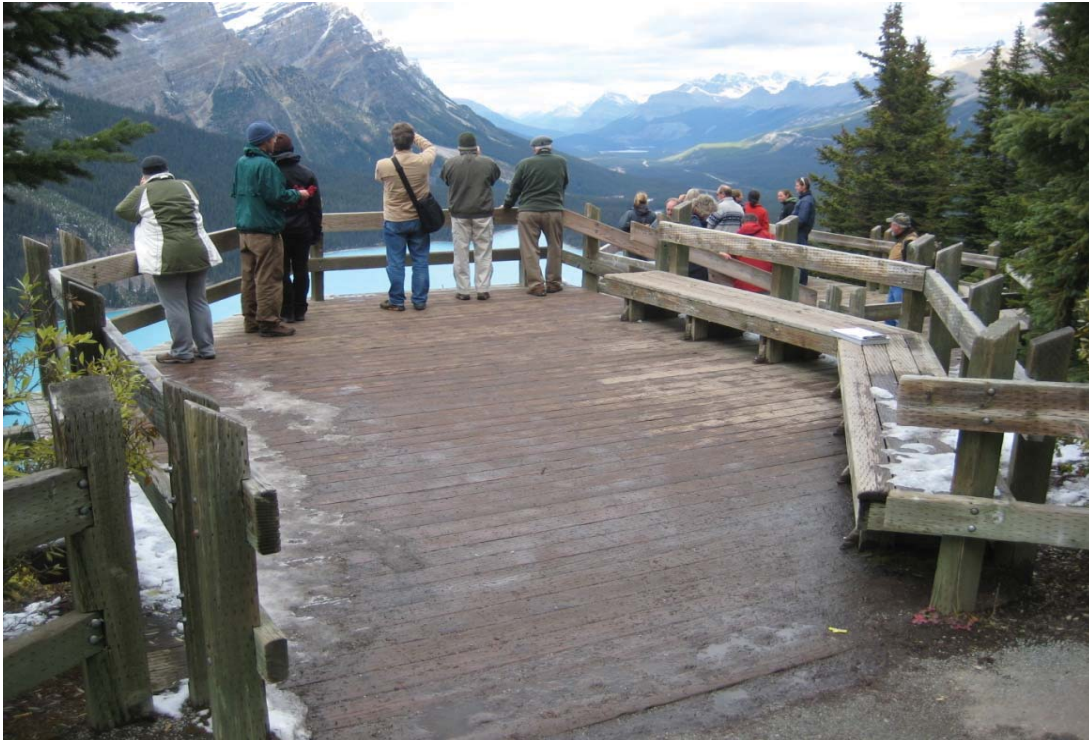
**P01: VIEW OF UPPER PLATFORM LOOKING SOUTH AT PEYTO LAKE**

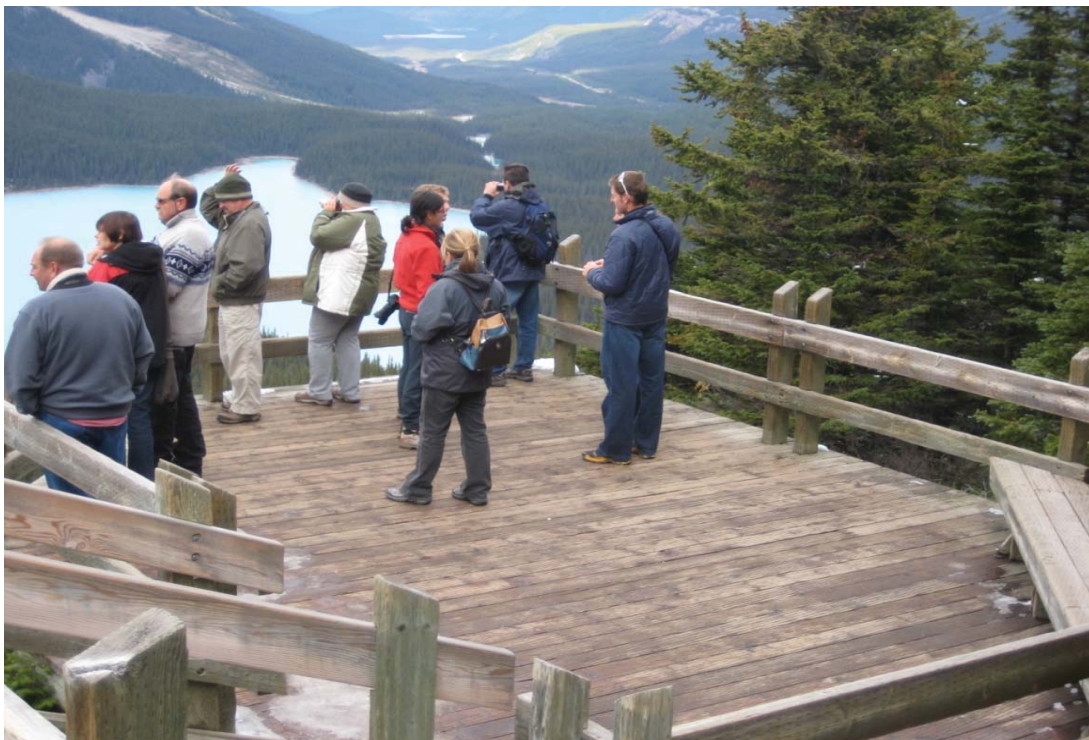
**P02: VIEW OF LOWER PLATFORM LOOKING SOUTH AT PEYTO LAKE**

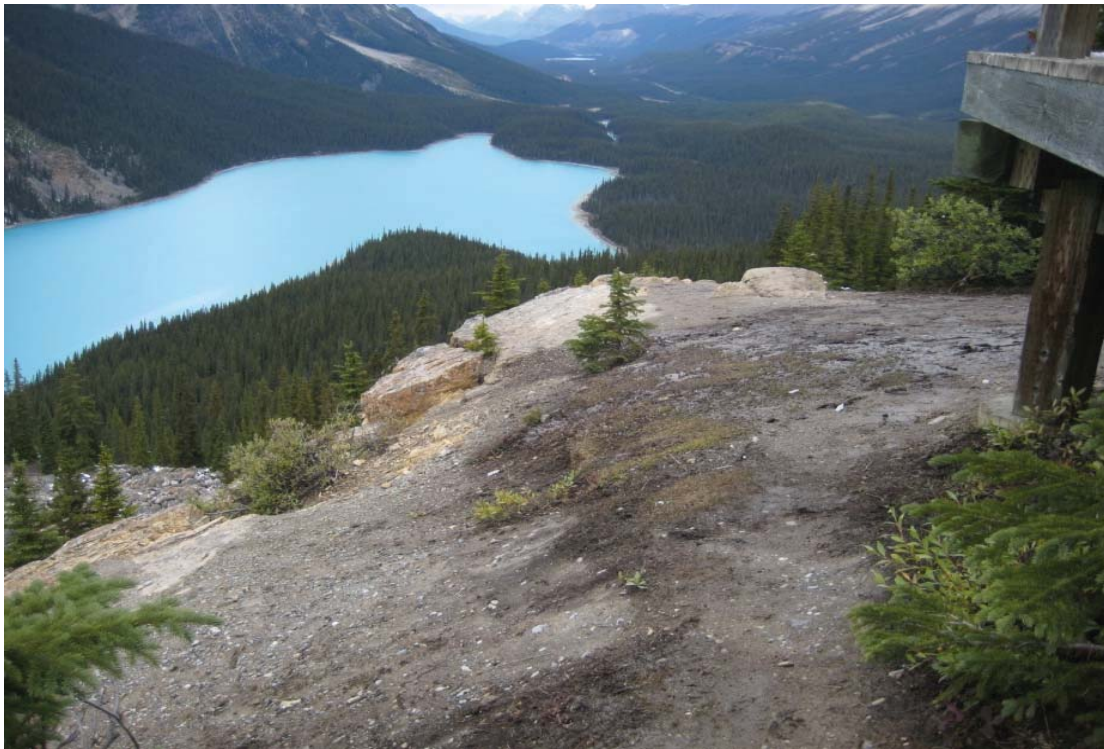
ELEMENT	OBSERVATIONS	PREVIOUS CONDITION RATING	CURRENT CONDITION RATING	PRIORITY CODE
<b>Embankments: (S)</b>	Steep embankments mixed with gravel and vegetation to the east of the platform; no issues noted. (P03, P04)	-	4	D
<b>Foundations: (P)</b>	Circular concrete foundation projecting above ground 0 mm to 400 mm. No issues noted.	-	6	D
<b>Approaches: (A)</b>	Two separate chipseal approaches from parking lot to platform. Steepest grade is approx. 10% or more. Poor drainage and uneven surface causing icy surface and creating hazardous conditions. (P05) Approach hand railings do not meet NBCC (too low). (P06)	-	2	U, S
<b>Columns: (P)</b>	Treated columns resting on concrete foundations ranging in height from 100 mm to 1000 mm. Eight columns each supporting upper level and lower level. (P07) Bark remaining on edges of columns typical and needs to be removed to prevent decay or acceleration of decay. (P08) Significant splits common but functional. Approx. 20% of columns not fully bearing on concrete foundation; remove existing deteriorated wood shims and install/replace shims to obtain proper contact. (P09) Remove soil accumulation around base of columns to minimize onset or acceleration of wood decay. (P10)	-	4	B, M

**P03: LOOKING SOUTH AT EMBANKMENTS**

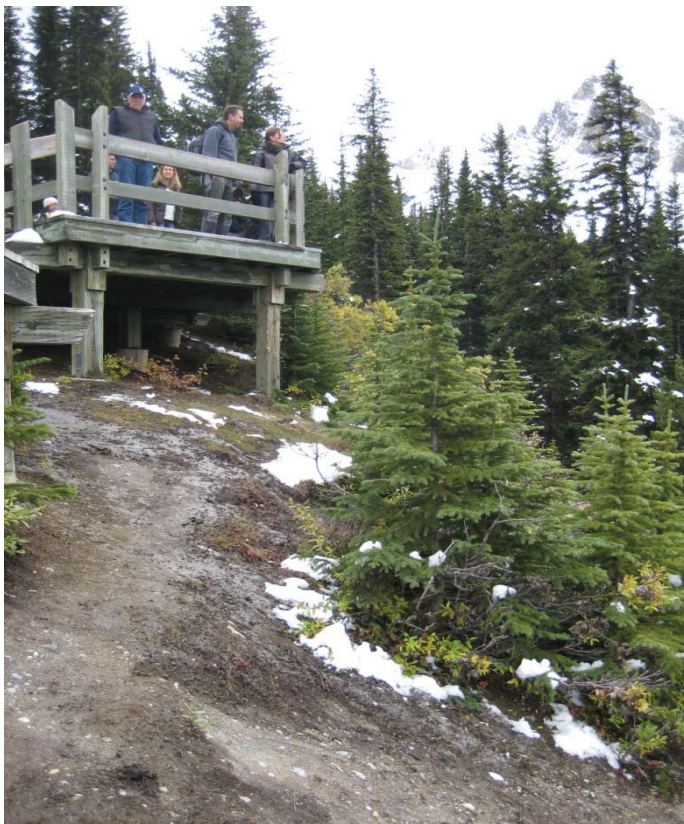
**P04: UPPER LEVEL AND EAST EMBANKMENT LOOKING NORTH**

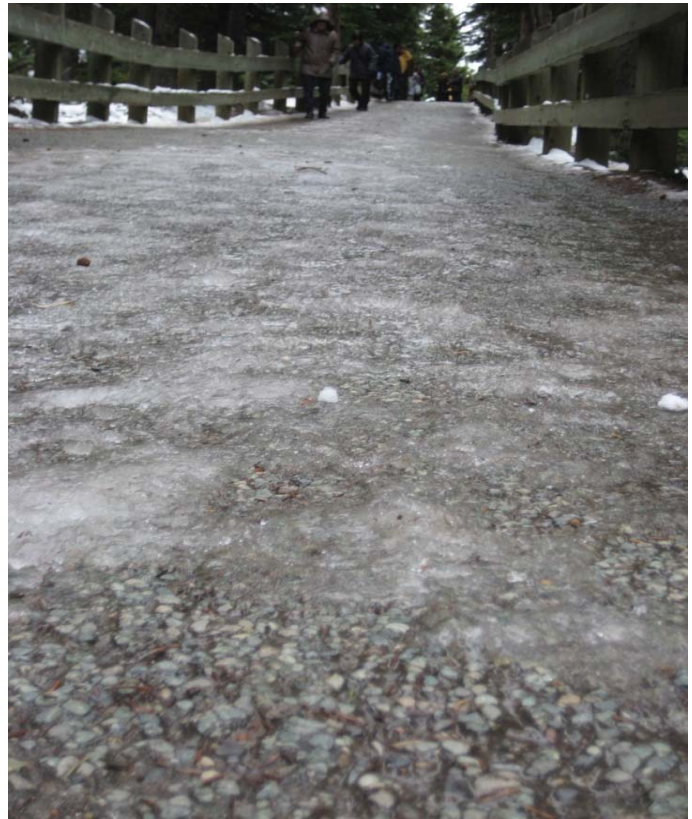
**P05: EAST APPROACH LOOKING NORTH AT  
ICEY WALKING SURFACE**

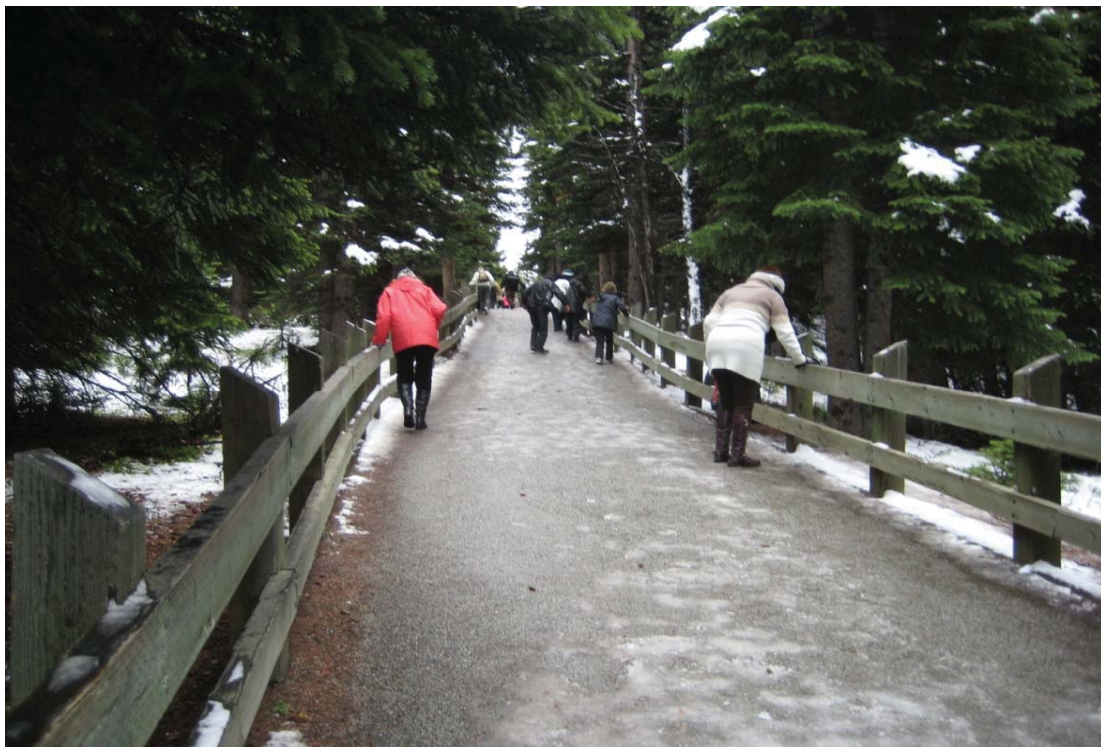
**P06: EAST APPROACH LOOKING NORTH. NOTE LOW HEIGHT OF HANDRAILING**

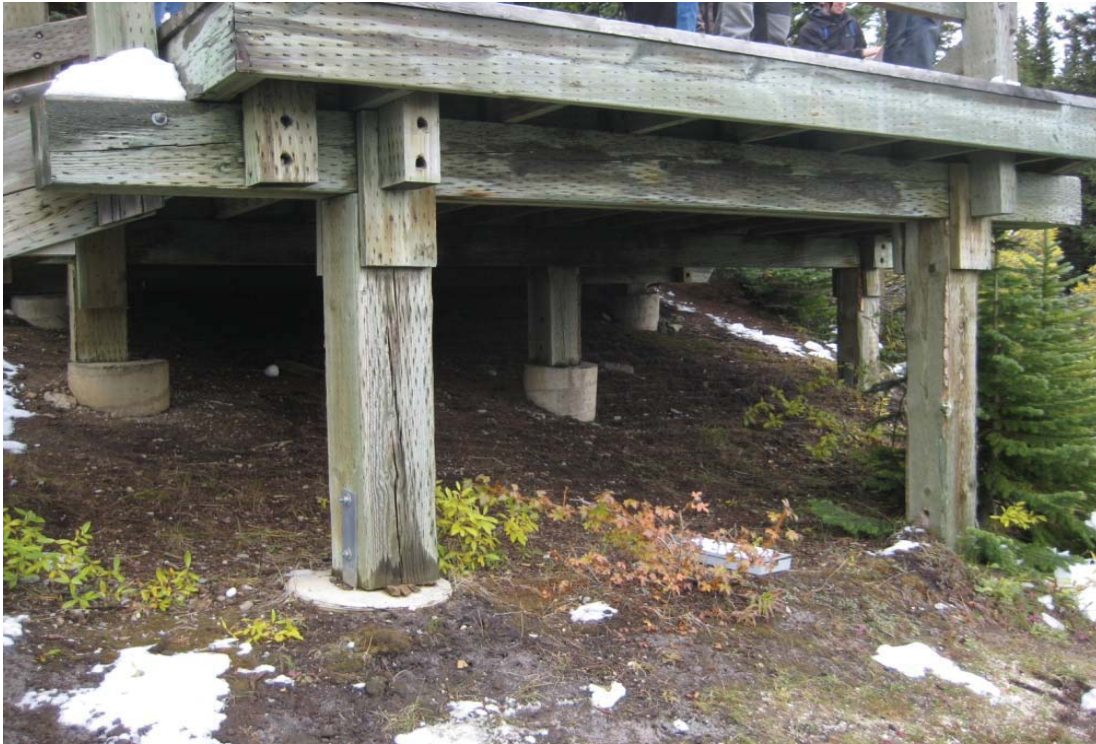
**P07: TYPICAL COLUMNS LOOKING NORTH AT LOWER LEVEL**

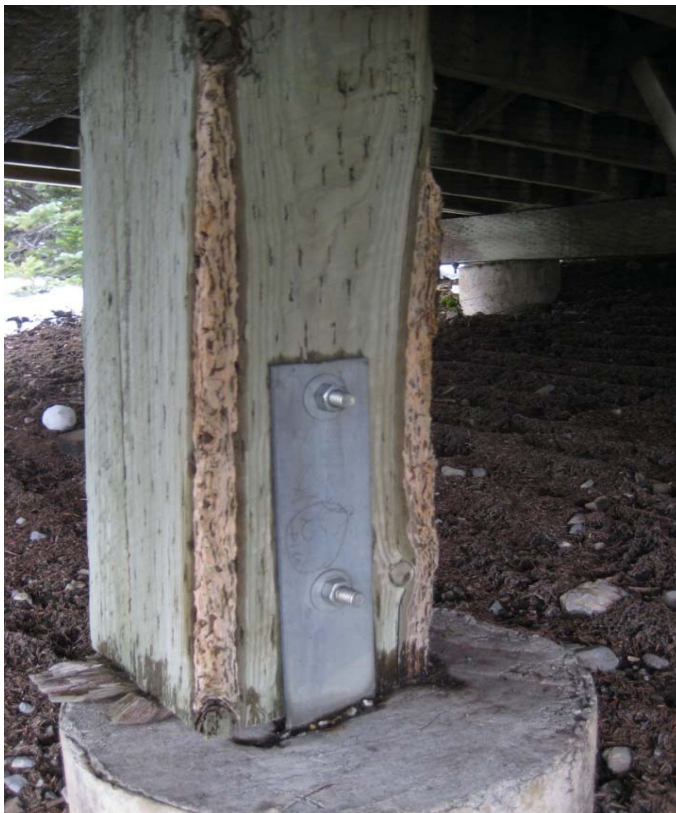
**P08: BARK ON EDGES OF COLUMNS**

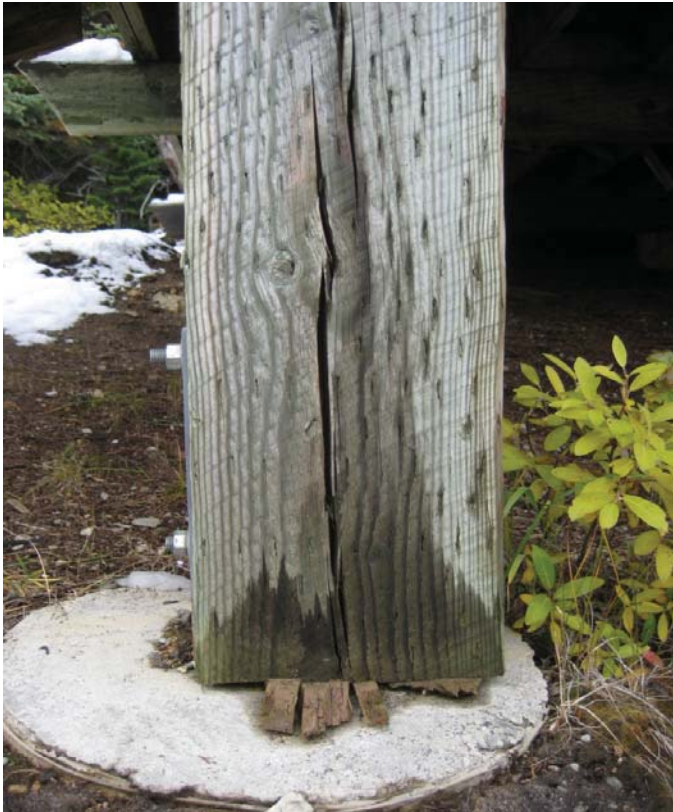
**P09: SPLITS IN COLUMN AND POOR BEARING CONTACT WITH FOUNDATION**

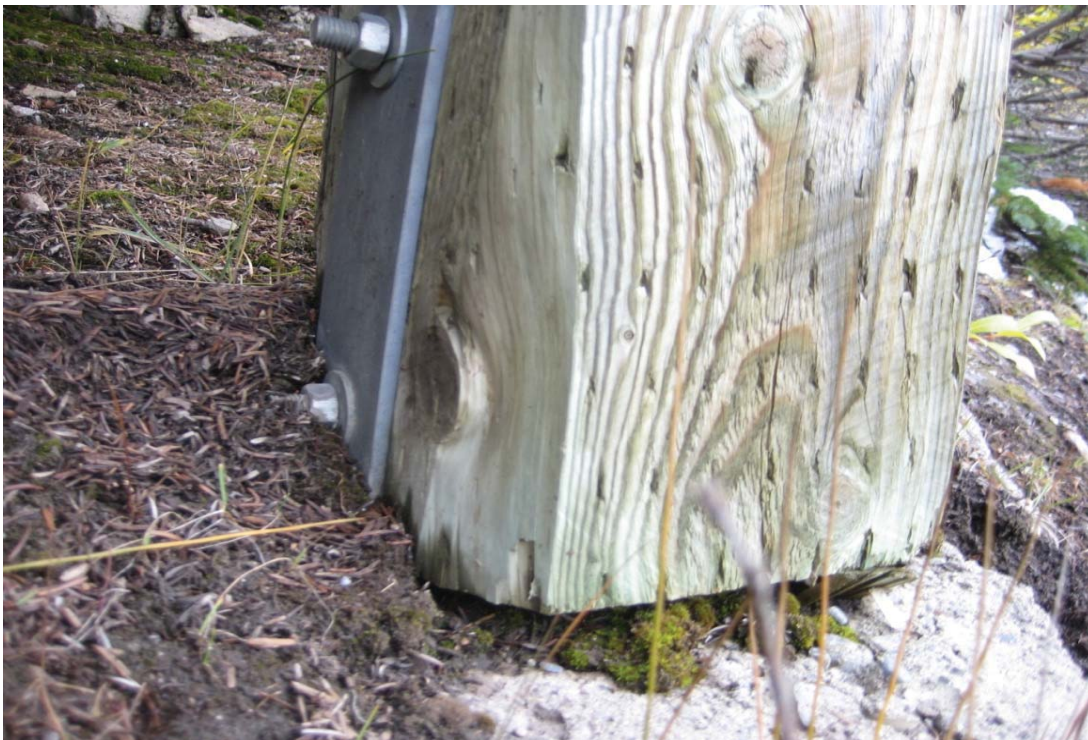
**P10: DEBRIS ACCUMULATION AROUND COLUMN BASE**

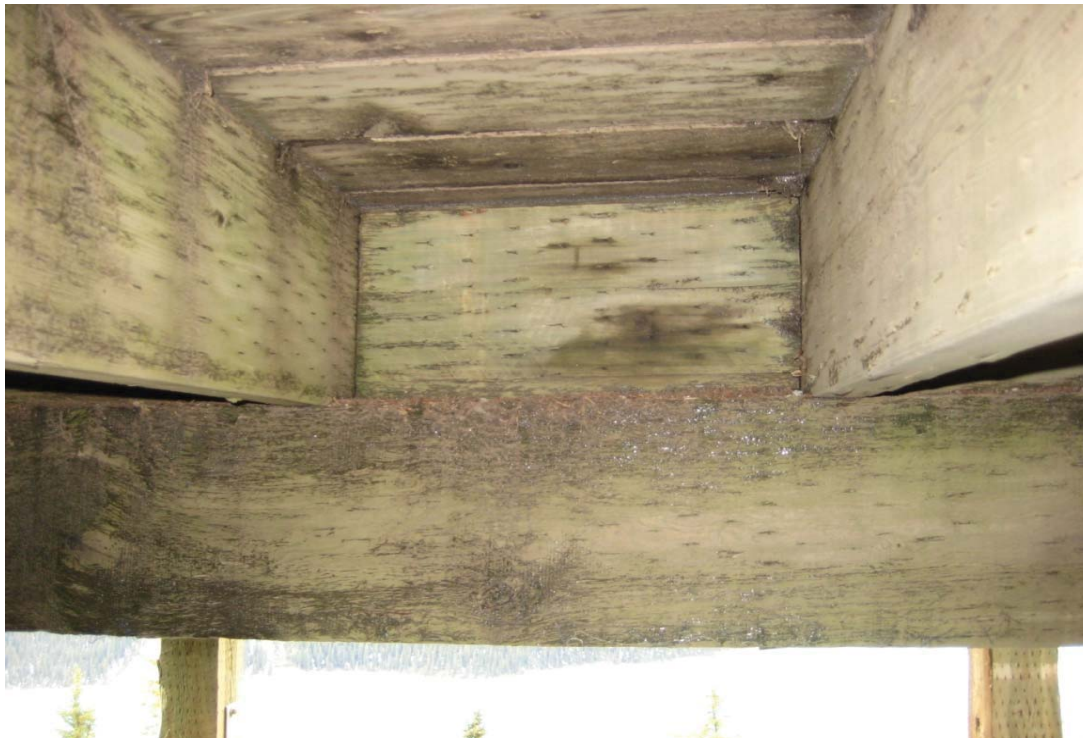
<b>Stringers: (P)</b>	Treated stringers 200mm x 200mm in dimension and generally in good condition. Remove debris accumulation on top of stringers as part of regular maintenance program. (P11)	-	5	D, M
<b>Joists/Edging: (S)</b>	Treated joists, 38mm x 184mm (2"x8") in dimension spaced at 400mm; moderate splits/checks at less than 10%.	-	4	D
<b>Connections: (P)</b>	<u>Concrete Foundation/Columns</u> Galvanized plate connecting foundations to columns. Galvanizing in tact and in good condition. Approx. 10% of connections bent or not installed to accommodate low column height but functional. (P12) <u>Railings/Posts</u> Galvanized carriage bolts connecting railings and posts; no issues noted.	-	4	D
<b>Deck/Treads: (P)</b>	Treated deck and stair treads, 38mm x 140mm (2"x6") dimensions. Treatment remaining only at 10% of top surface. Wear and abrasion typical but overall deck is still functional; nails are protruding slightly due to wear and abrasion. (P13,14)	-	4	D

**P11: DEBRIS ACCUMULATION ON STRINGERS**

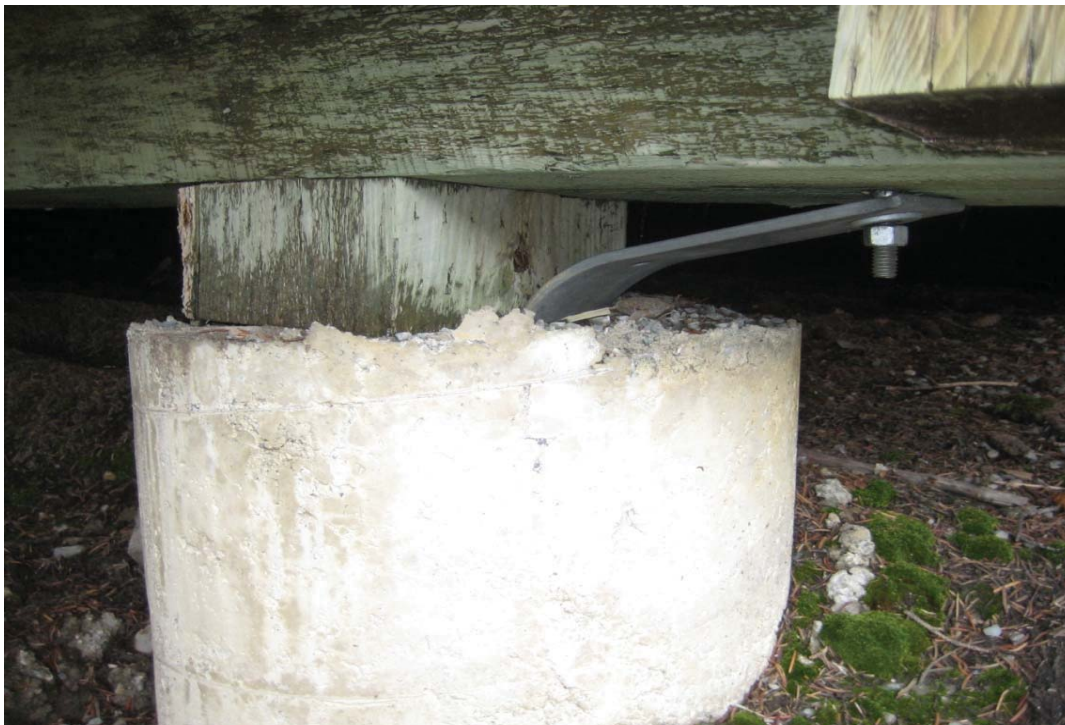
**P12: BENT SPLICE PLATE**

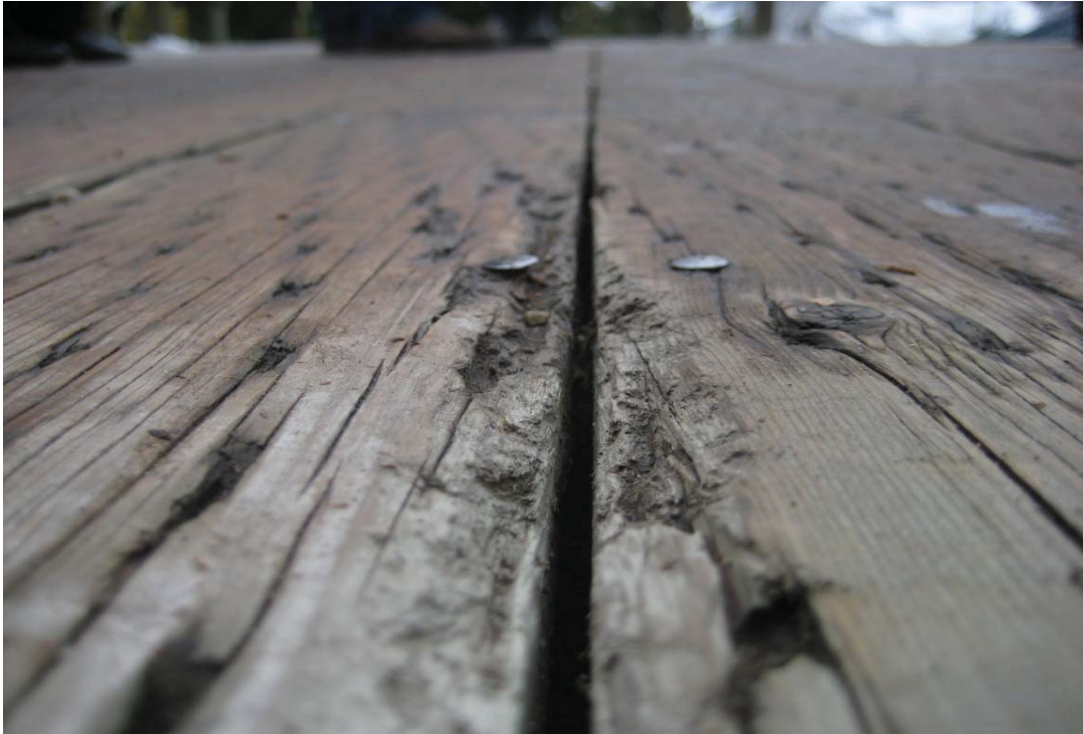
**P13: WEAR AND ABRASION ON DECK BOARDS**

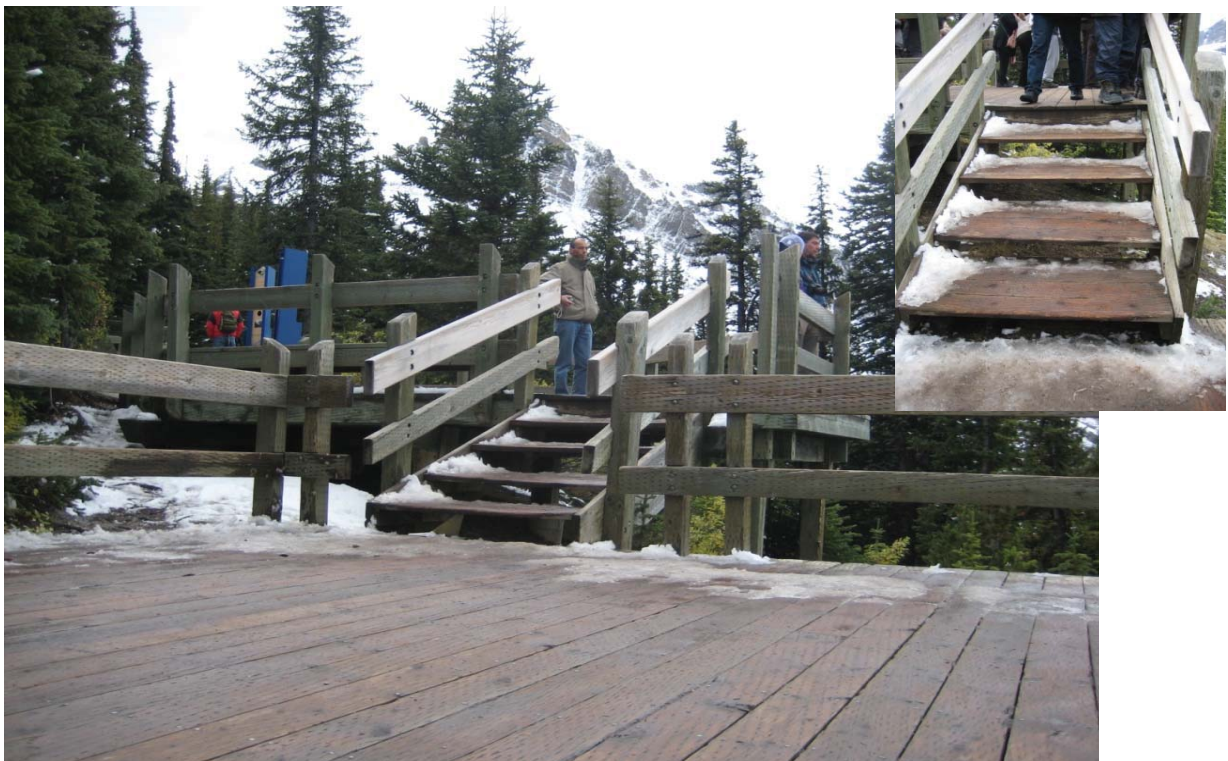
**P14: STAIRS AND STAIR TREADS**

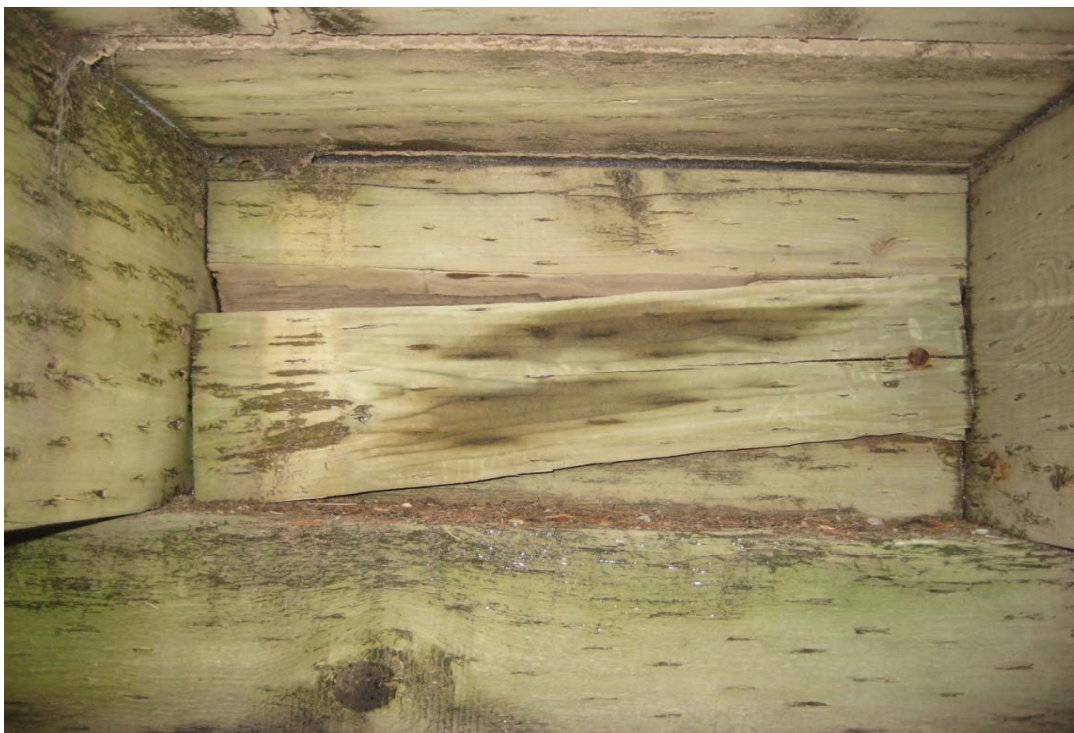
<b>Diaphragms: (S)</b>	Untreated 1"x1" cross bracing used between joists at halfway point of stringers and treated 2"x8" diaphragms used above stringers. One cross bracing disengaged from joist and requires reconnection. One diaphragm split, end to end, and requires replacement. (P15)	-	4	B
<b>Railings/Guards: (S)</b>	Treated wood posts, top and mid railings. Railing dimensions are 38mm x 140mm (2"x6"). Post dimensions are 89mm x 140mm (4"x6"). Post exhibit moderate splits/checks at less than 20% of locations. (P16) Current height from top of deck to top of railing is 850mm. Top handrail is treated and needs to be replaced with untreated wood as per PCA Directive. Bench seats should also be replaced with untreated wood. (P17) Top handrails of stairs from upper to lower level replaced with untreated wood (date unknown) ; no issues noted.	-	3	B

**P15: SPLIT DIAPHRAGM ABOVE STRINGER (LOWER LEVEL)**

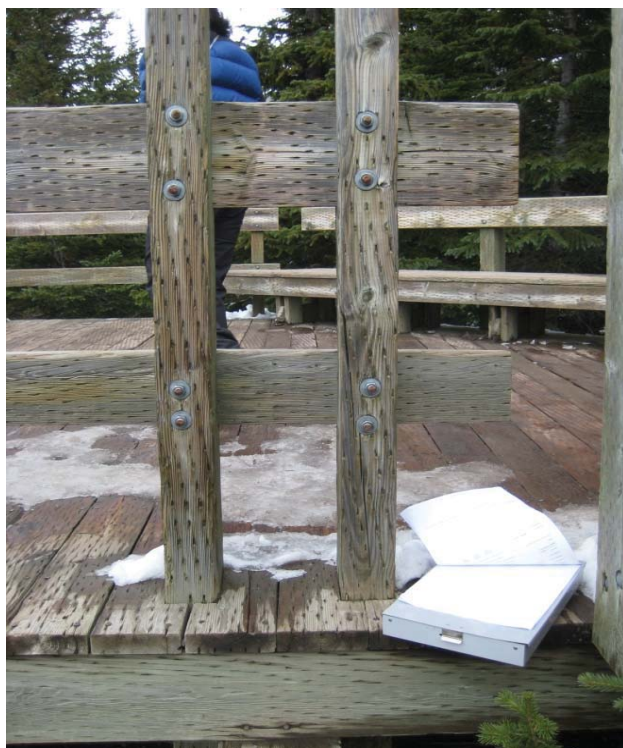
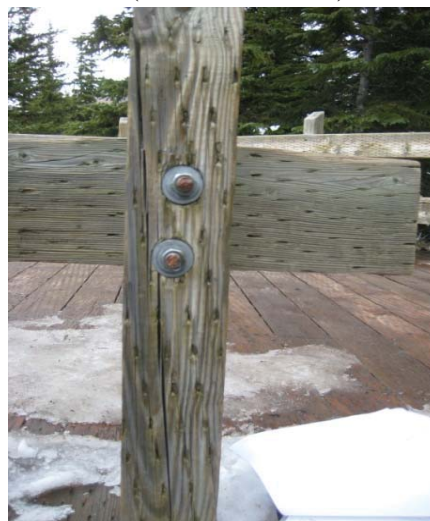
**P16: TYPICAL MID-RAILING AND POSTS. NOTE SPLIT ON POST (REFER TO PHOTO ABOVE).**

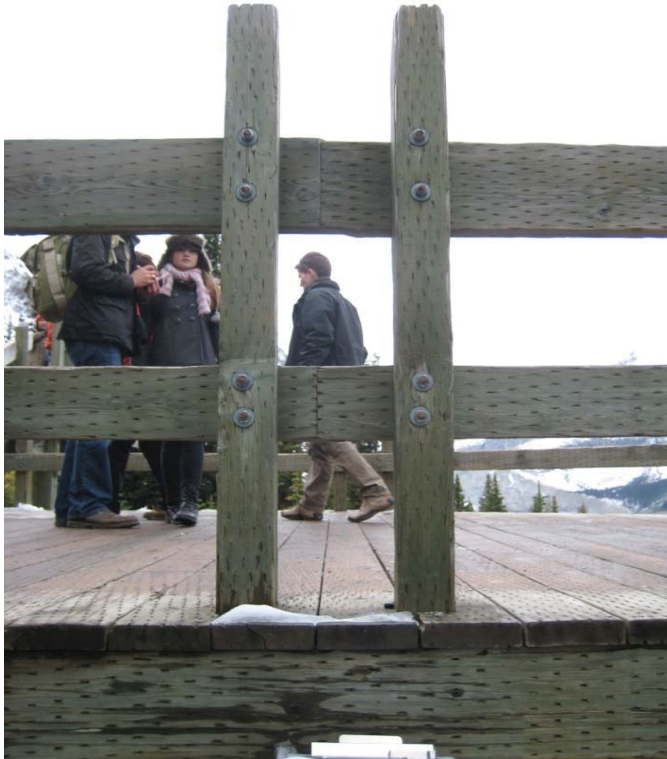
**P17: NOTE TREATMENT IN TOP  
HANDRAILING AND OVERALL LOW  
BARRIER HEIGHT.**
