HAZARDOUS BUILDING MATERIALS ASSESSMENTS

Parks Canada Buildings
Kluane National Park
Haines Junction, YT

Project No.: 144901924

November 19, 2014

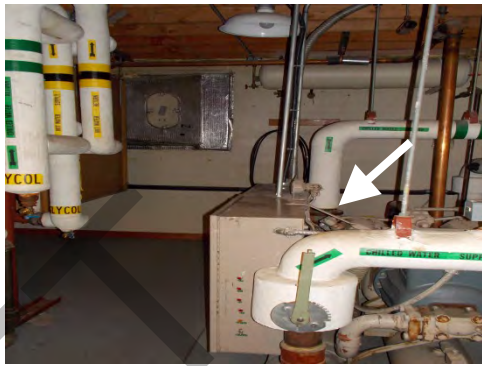
Identified ACM Description and Condition Information		Photo
White mechanical gaskets in flanges of chilled water supply lines in the penthouse

Friability	Friable	
Condition	Good	
Content	25% Chrysotile	
Black window pane caulking between window frames and glass panes throughout, including inner vestibule windows at the front entrance		No photo.
Friability	Non-friable	
Condition	Good	
Content	< 0.25 – 1.4% Chrysotile	
White 2'x4' ceiling tile – Standard fissure and pinhole (light red backing) throughout

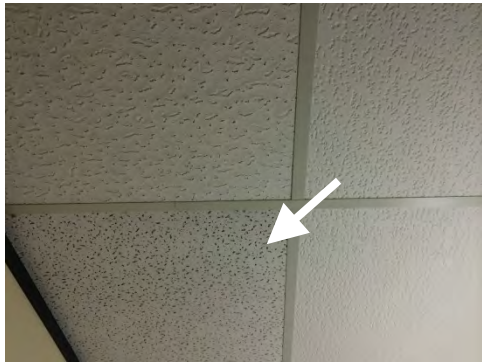
Friability	Friable	
Condition	Good	
Content	< 1% Chrysotile

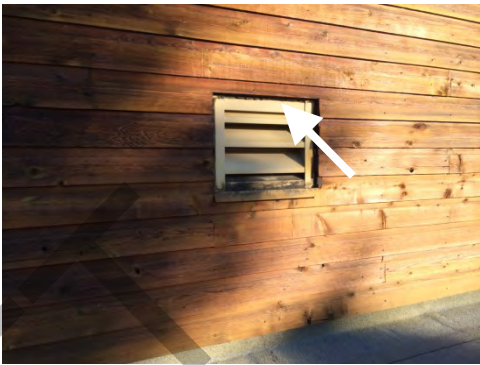
Identified ACM Description and Condition Information		Photo
Black HVAC vent caulking around the seams of a vent from the penthouse to the roof

Friability	Non-friable	
Condition	Good	
Content	< 0.25 – 1.2% Chrysotile	
12"x12" vinyl floor tile – Brown with white streaks in locations as indicated on attached drawings

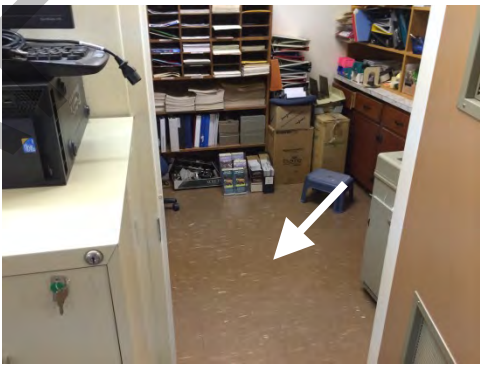
Friability	Non-friable	
Condition	Good	
Content	< 0.25% Chrysotile	
Cement panel around the base of exterior walls

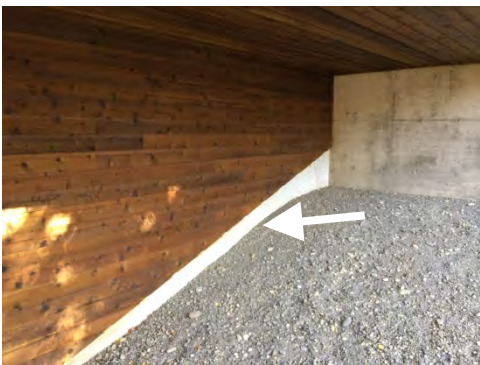
Friability	Non-friable	
Condition	Good	
Content	8% Chrysotile

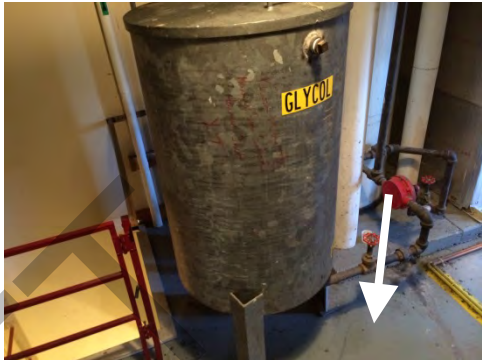
Identified LCP Description	Photo
Grey paint on the floor of the penthouse. This paint was observed to be in good condition (not bubbling, flaking or peeling).

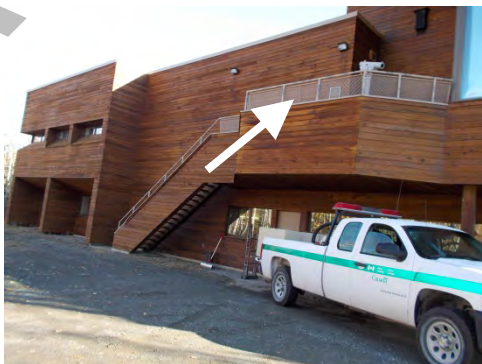
Red paint on structural steel components throughout. This paint was observed to be in good condition (not bubbling, flaking or peeling).	No photo.
Beige paint on exterior railings. This paint was observed to be in good condition (not bubbling, flaking or peeling).

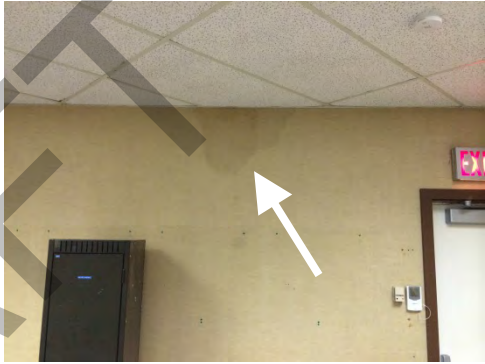
Identified Mould and/or Moisture Impacted Materials Description	Photo
Moisture stained drywall was observed at the top of the South wall in the theater.

- Remove and replace moisture-stained materials (drywall) with new materials.
 - This work can be conducted by renovation workers that are notified of the potential presence of mould contamination and provided with appropriate training and personal protective equipment (e.g. N95 respirators, disposable protective clothing).
 - If significant concealed mould contamination is identified during the work, additional assessment and/or completion of work by an experienced mould abatement contractor may be required.
 - An assessment to determine the likely source(s) of the observed moisture staining should be undertaken once building materials are removed, and the source(s) should be corrected as part of the renovation project.

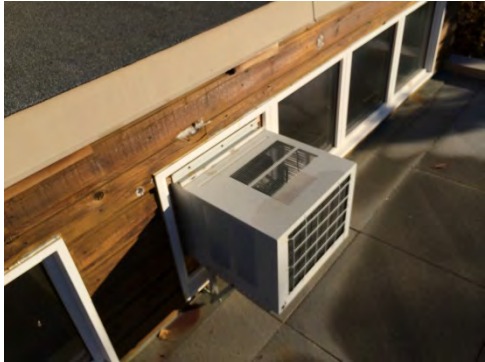
Suspected ODS-Containing Equipment	Photo
The small air conditioning unit located on the roof is suspected to contain ODSs.

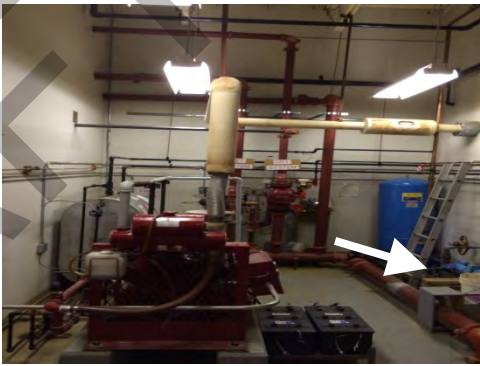
Identified ACM Description and Condition Information		Photo
Black window pane caulking between window frames and glass panes throughout		No photo.
Friability	Non-friable	
Condition	Good	
Content	1.3% Chrysotile	
Cream pipe sealant inside fittings of 2" decommissioned black pipes next to water tank in the pump room

Friability	Non-friable	
Condition	Good	
Content	0.32 – 0.42% Chrysotile	
White window frame caulking between window frames and siding throughout the exterior

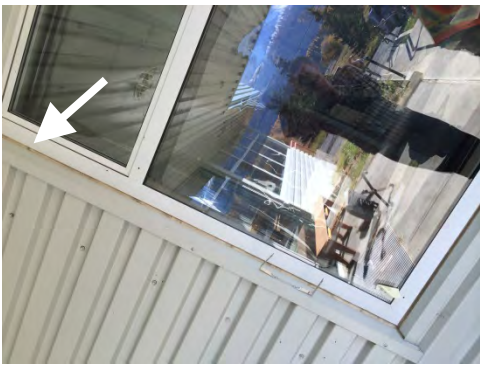
Friability	Non-friable	
Condition	Good	
Content	<0.25 – 0.97% Chrysotile

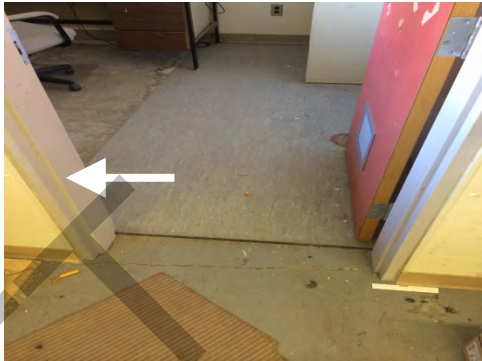
Identified LCP Description	Photo
<p>Grey paint on interior trim.</p> <p>This paint was observed to be in good condition (not bubbling, flaking or peeling).</p>

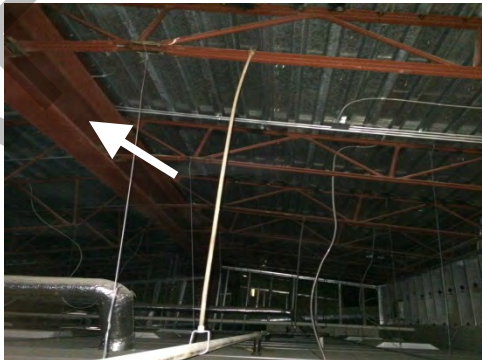
<p>Red paint on structural steel.</p> <p>This paint was observed to be in good condition (not bubbling, flaking or peeling).</p>

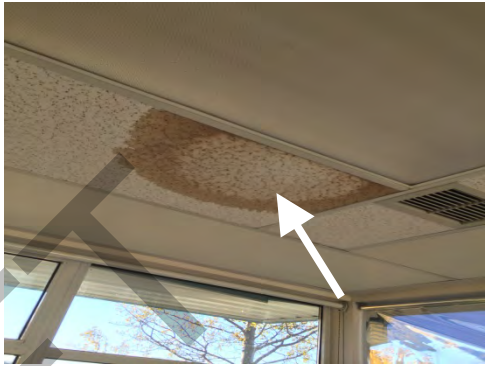
Identified Mould and/or Moisture Impacted Materials Description	Photo
Moisture stained ceiling tiles were observed in various locations throughout.

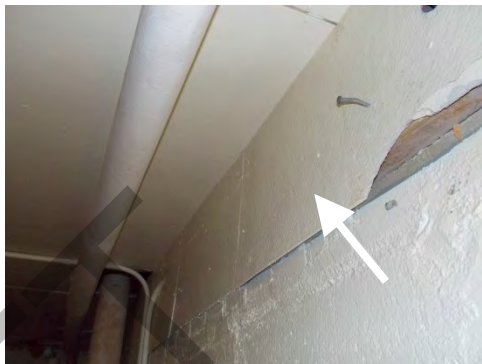
Identified ACM Description and Condition Information		Photo
Cement panel around the top of the walls in the boiler room.

Friability	Non-friable	
Condition	Good	
Content	8% Chrysotile	
Pipe fitting insulation throughout (cementitious insulation applied to elbows, t's, and valves)

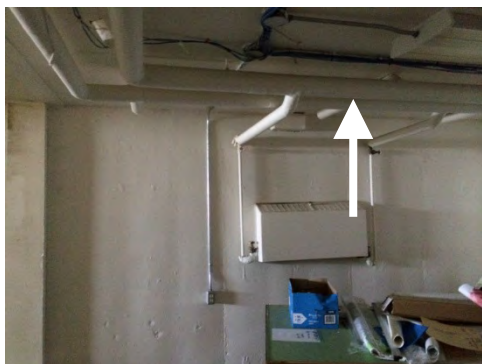
Friability	Friable	
Condition	Good	
Content	45% Chrysotile	
Pipe straight insulation throughout ("Air-O-Cel" corrugated paper insulation on straight sections of pipe)

Friability	Friable	
Condition	Good	
Content	20% Chrysotile

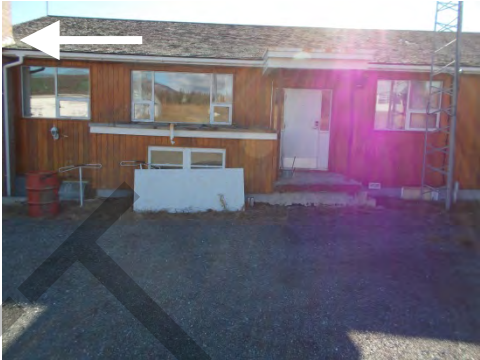
Identified ACM Description and Condition Information		Photo
Black (painted brown) flashing sealant between the chimney and the roof

Friability	Non-friable	
Condition	Good	
Content	2.8% Chrysotile	
Black window pane caulking (between window frame and glass pane) on windows throughout

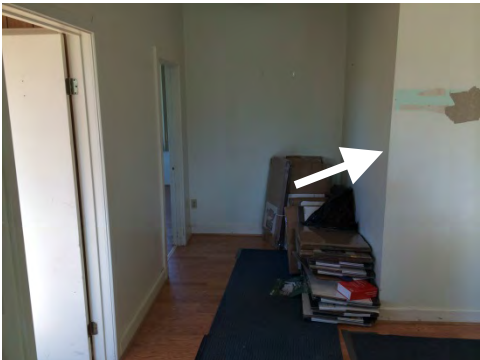
Friability	Non-friable	
Condition	Good	
Content	1.5% Chrysotile	
Drywall joint compound applied to walls throughout

Friability	Non-friable in-situ but may become friable when it is disturbed	
Condition	Good	
Content	3% Chrysotile

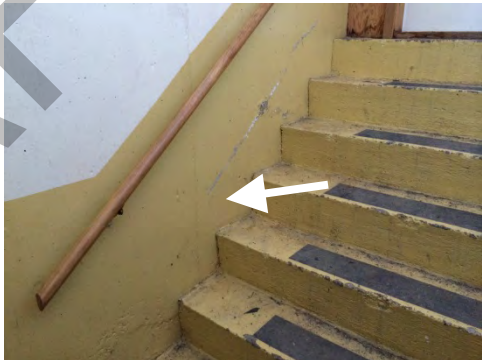
Identified LCP Description	Photo
Red/grey paint on the basement corridor floor. This paint was observed to be in fair condition (minimal bubbling, flaking or peeling).	 
Yellow paint on the basement stairwell. This paint was observed to be in good condition (not bubbling, flaking or peeling).

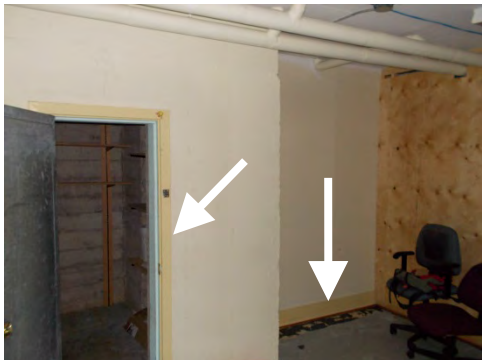
Yellow paint on trim throughout the basement. This paint was observed to be in good condition (not bubbling, flaking or peeling).

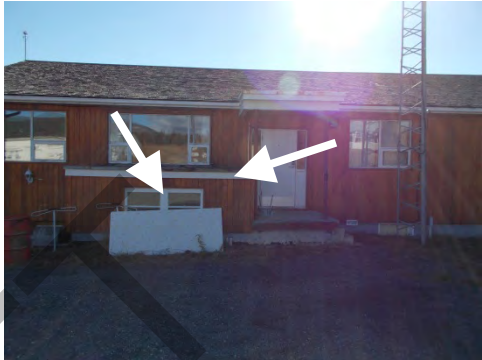
Identified LCP Description	Photo
<p>White paint on exterior trim.</p> <p>This paint was observed to be in good condition (not bubbling, flaking or peeling).</p>

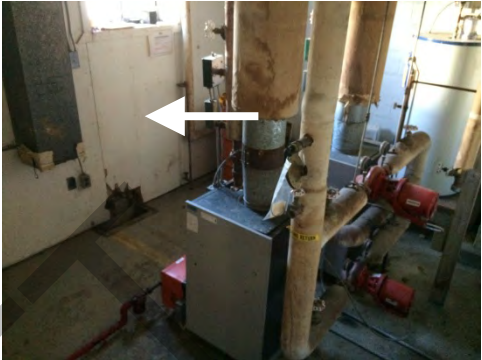
Identified ACM Description and Condition Information		Photo
Cement panel on interior walls and ceiling throughout.

Friability	Non-friable	
Condition	Good	
Content	10% Chrysotile	
Pipe sealant cream/black inside cast iron pipe fittings throughout

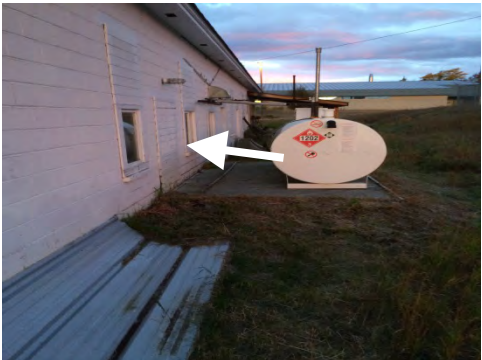
Friability	Non-friable	
Condition	Good	
Content	0.39% Chrysotile	
Yellow window frame caulking (painted black) on the exterior of windows at the rear of the building (between window frame and the building)

Friability	Non-friable	
Condition	Good	
Content	1.1% Chrysotile

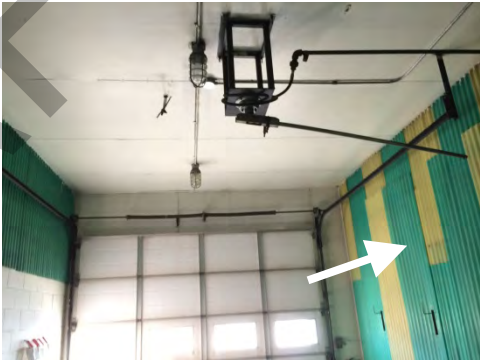
Friability	Non-friable	
Condition	Good	
Content	0.29 - 0.47% Chrysotile	
Beige mastic on the backside of corrugated wall panels throughout

Friability	Non-friable	
Condition	Good	
Content	0.48 – 1.3% Chrysotile

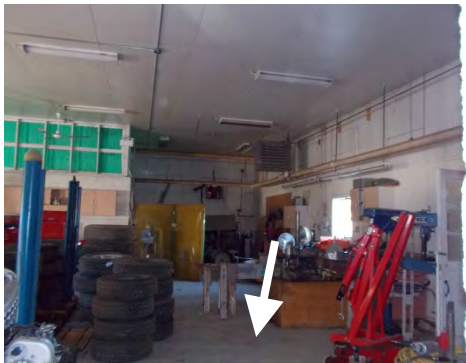
Identified LCP Description	Photo
<p>Grey paint on floors.</p> <p>This paint was observed to be in good condition (not bubbling, flaking or peeling).</p>

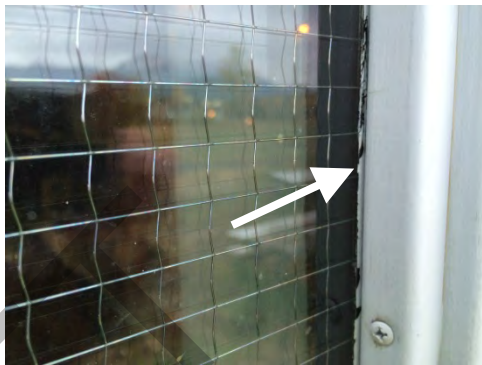
Identified ACM Description and Condition Information		Photo
Black/grey window pane caulking between window frame and glass pane on exterior of windows beside doors

Friability	Non-friable	
Condition	Good	
Content	1.7% Chrysotile	
Grey/white door caulking around the exterior door frames

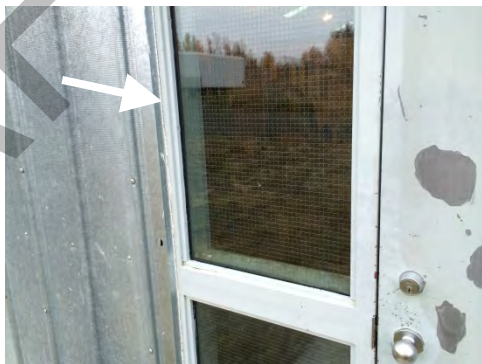
Friability	Non-friable	
Condition	Good	
Content	<0.25% Chrysotile

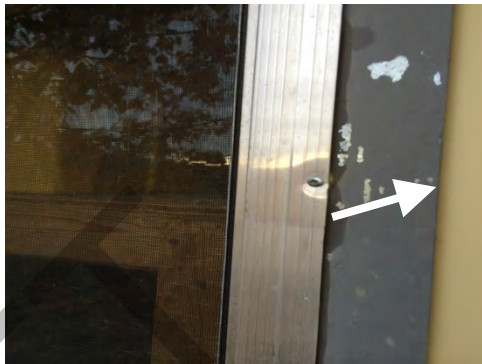
Identified ACM Description and Condition Information		Photo
Grey window frame caulking between window frame and building on the exterior

Friability	Non-friable	
Condition	Good	
Content	3.1% Chrysotile

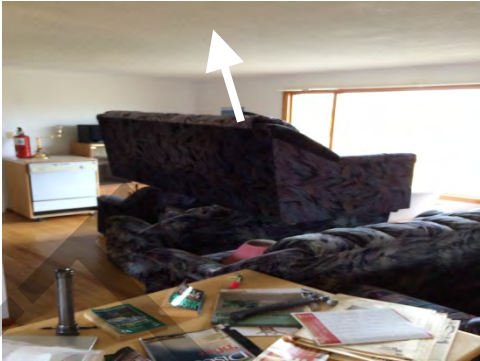
Identified ACM Description and Condition Information		Photo
White ceiling texture coat throughout the main house

Friability	Non-friable in situ can be made friable during removal	
Condition	Good	
Content	1 - 3% Chrysotile	
Drywall joint compound throughout

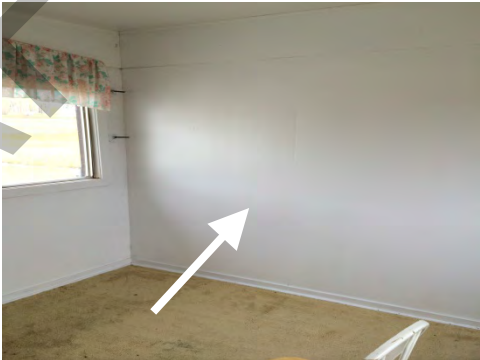
Friability	Non-friable in situ can be made friable during removal	
Condition	Good	
Content	<1 - 2% Chrysotile

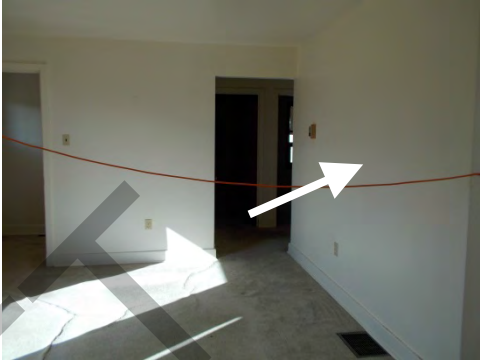
Identified ACM Description and Condition Information		Photo
Drywall joint compound throughout

Friability	Non-friable in situ can be made friable during removal	
Condition	Good	
Content	<1 - 3% Chrysotile	
Grey pipe sealant inside cast iron bell fittings in the basement		No photo
Friability	Non-friable	
Condition	Good	
Content	1.1% Chrysotile	
Grey window pane caulking between window frame and glass panes throughout

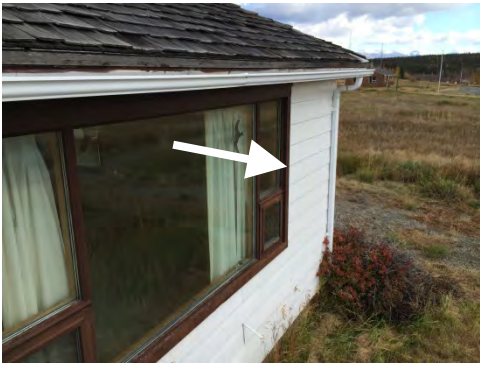
Friability	Non-friable	
Condition	Good	
Content	1.0 – 2.3% Chrysotile

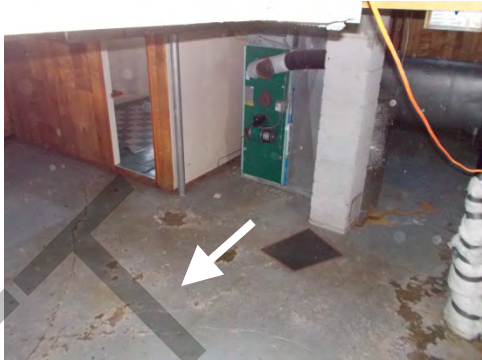
Identified LCP Description	Photo
Grey paint on the basement floor. This paint was observed to be in fair condition (minimal bubbling, flaking or peeling).

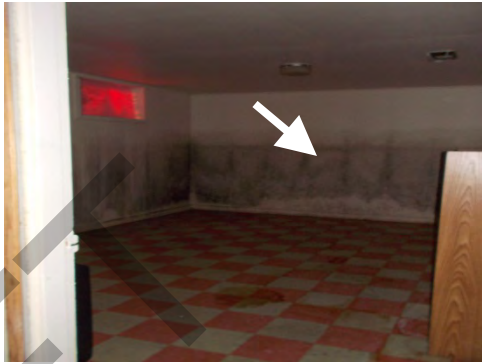
Identified Mould and/or Moisture Impacted Materials Description	Photo
Suspect mould growth was observed on the walls of basement room 3.

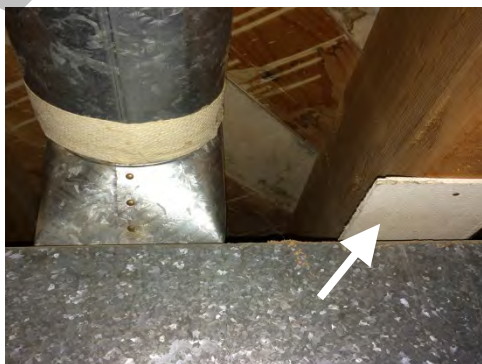
Identified ACM Description and Condition Information		Photo
White woven duct tape on seams of furnace ducting in the basement		 
Friability	Friable	
Condition	Good	
Content	55% Chrysotile	
White duct shields on wooden joists in the basement above furnace ducting

Friability	Friable	
Condition	Good	
Content	45% Chrysotile	
Brown square pattern sheet flooring in the kitchen

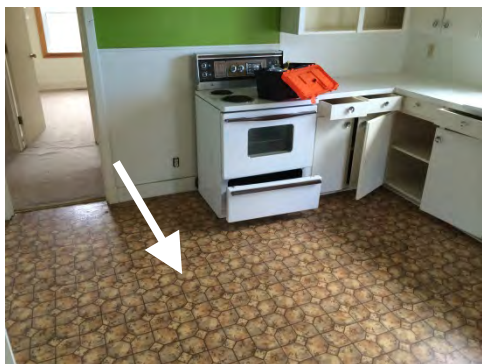
Friability	Friable during removal	
Condition	Good	
Content	22.4% Chrysotile

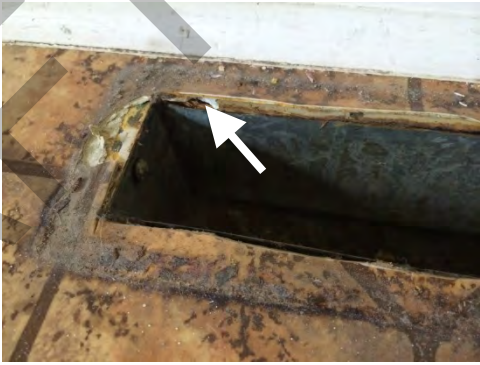
Identified ACM Description and Condition Information		Photo
Tan spots pattern sheet flooring in the mudroom		No photo
Friability	Friable during removal	
Condition	Good	
Content	5.2% Chrysotile	
Cream vinyl floor tile concealed under carpet and other flooring throughout the majority of the main level

Friability	Non-friable	
Condition	Good	
Content	1.4 – 1.7% Chrysotile	
Brown exterior window frame caulking between window frames and the building on the exterior of windows

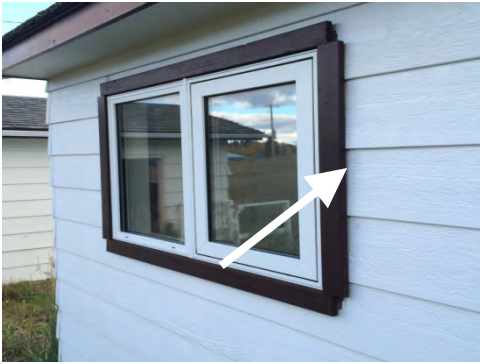
Friability	Non-friable	
Condition	Good	
Content	0.66% Chrysotile

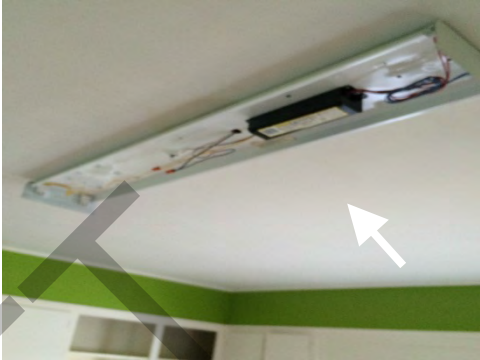
Identified ACM Description and Condition Information		Photo
Drywall joint compound throughout

Friability	Non-friable in situ; can be made friable during removal	
Condition	Good	
Content	2% Chrysotile
