PUBLIC SERVICES AND PROCUREMENT CANADA

# KINGSTON MILLS LOCKS 46 TO 49 REHABILITATION DRAFT GEOTECHNICAL REPORT

JUNE 27, 2018

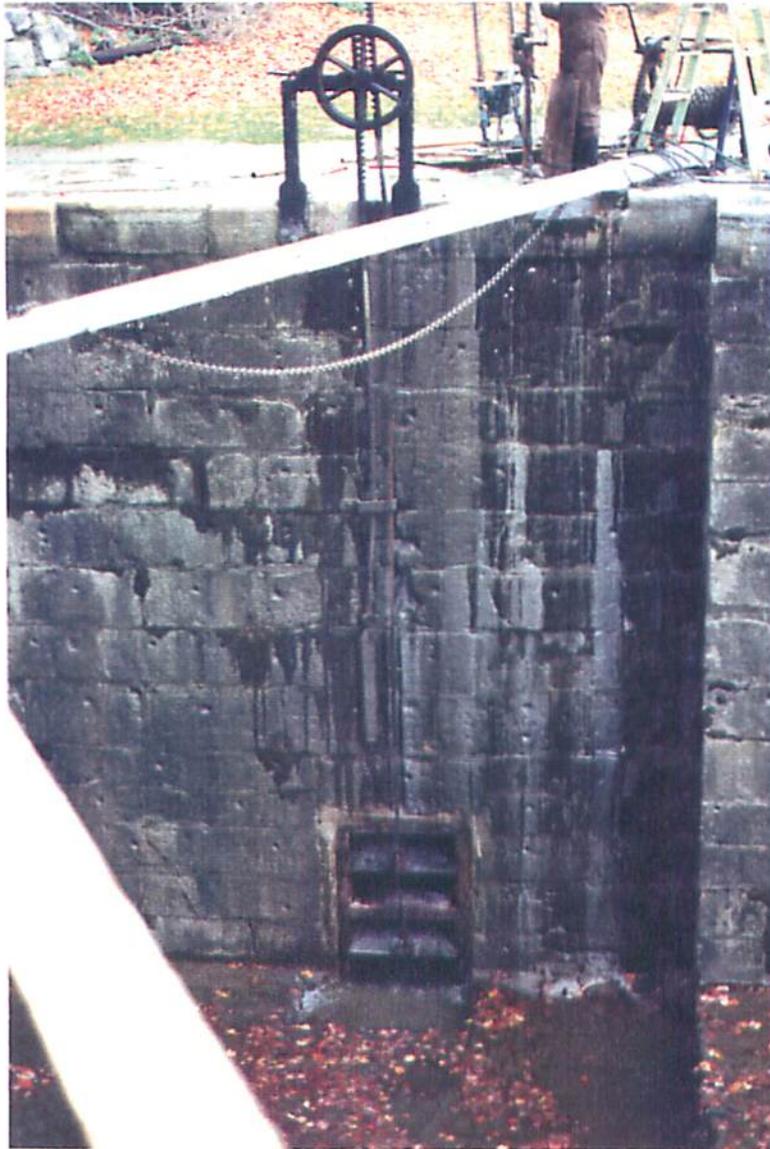
Photograph No. 2      Seepage noted in Run No. 2 - Hole V2

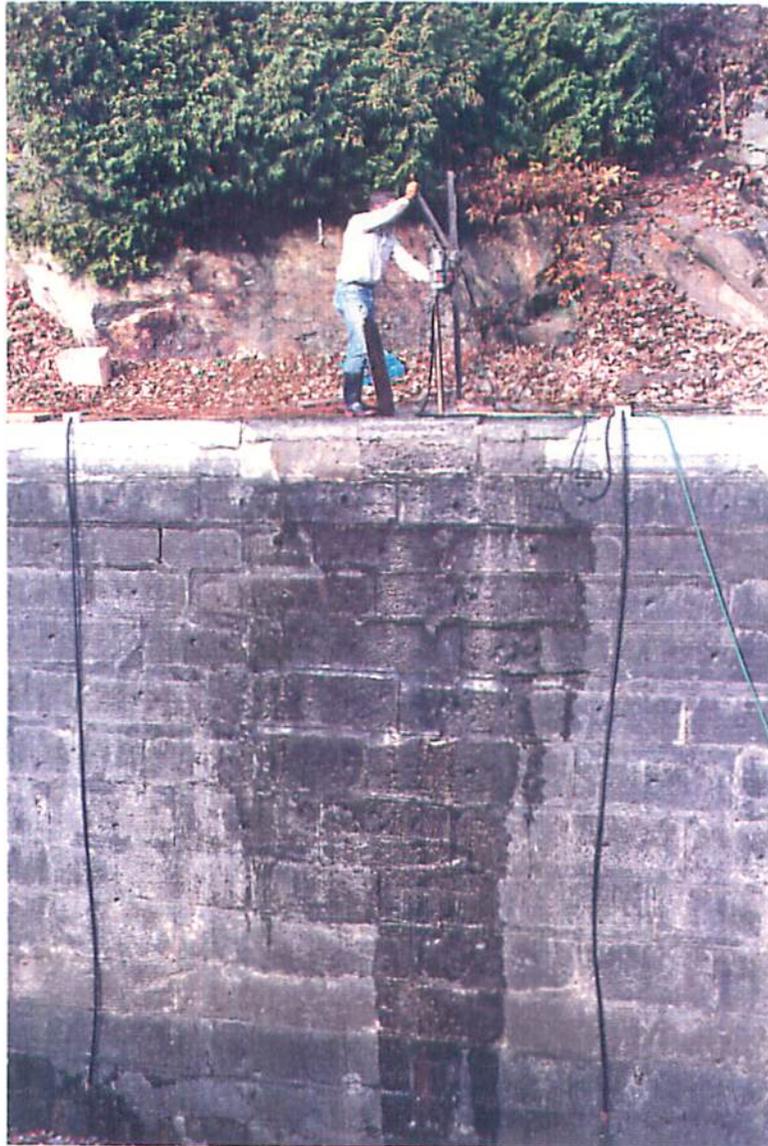
Photograph No. 3      Seepage noted in Run No. 17 - Hole V2

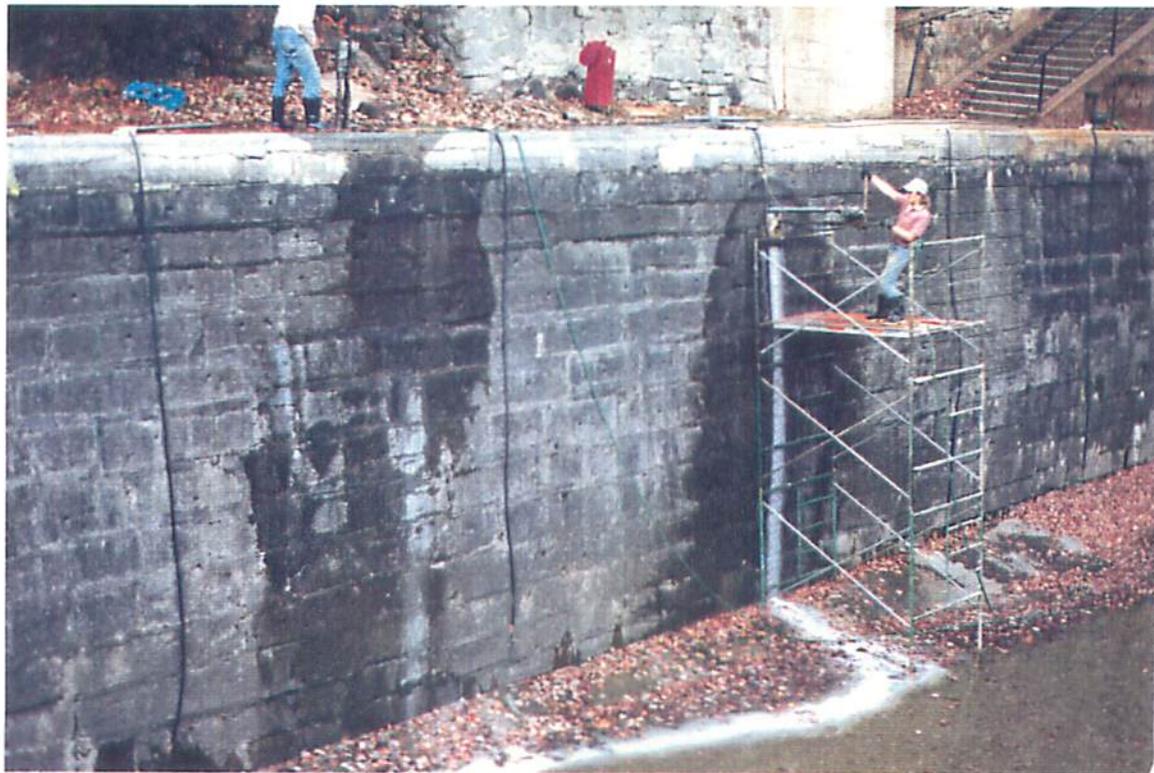
Photograph No. 4 Seepage noted in Run No. 2 - Hole V3

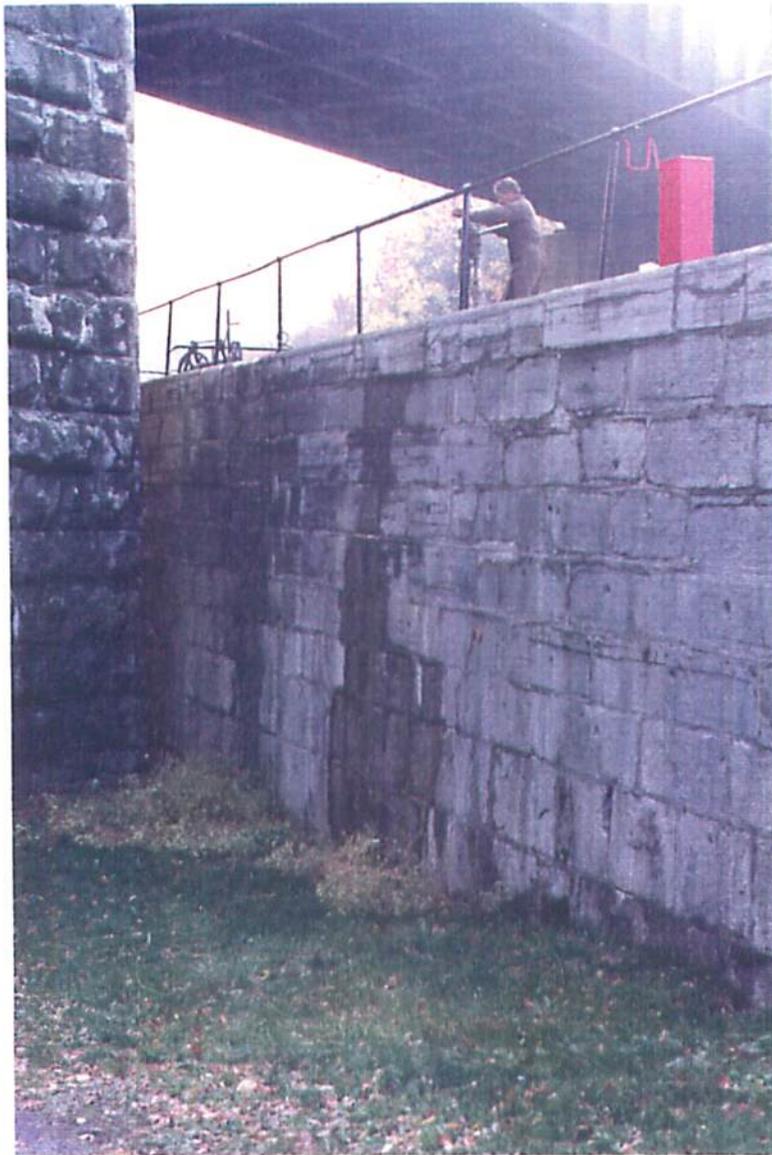
Photograph No. 5      Seepage noted in Run No. 2 - Hole V3

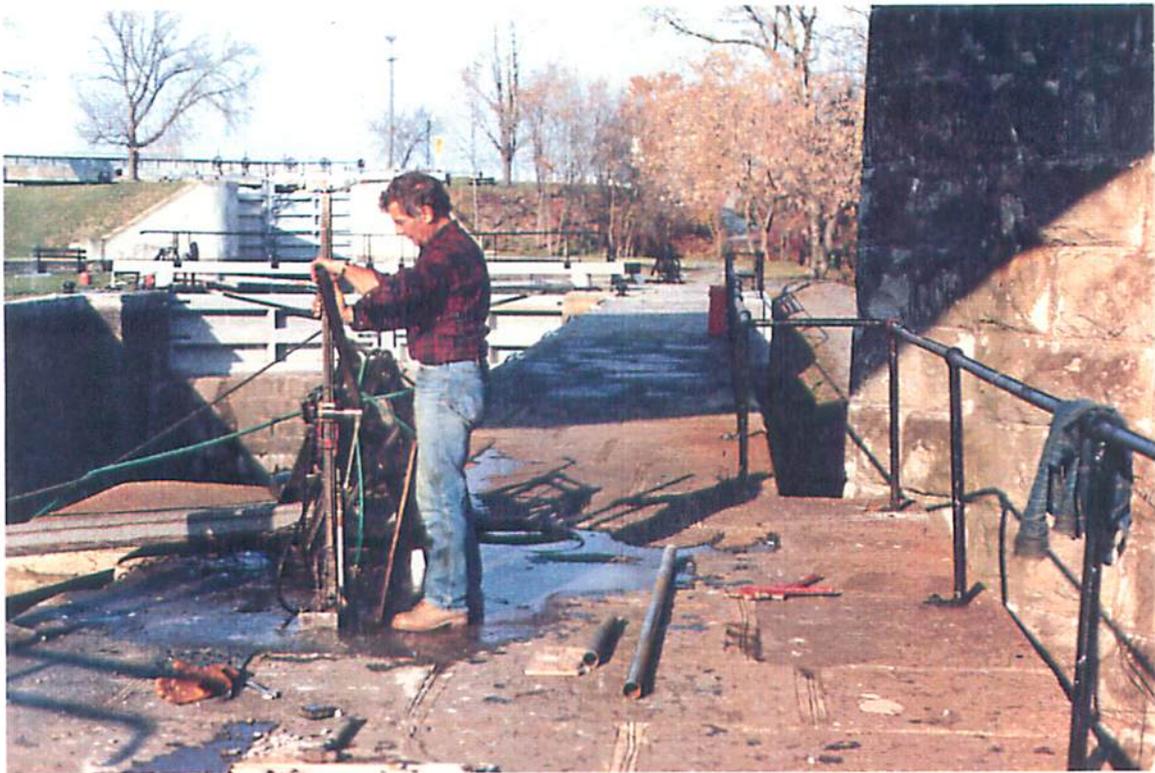
Photograph No. 6      Seepage noted in Run No. 2 - Hole V4

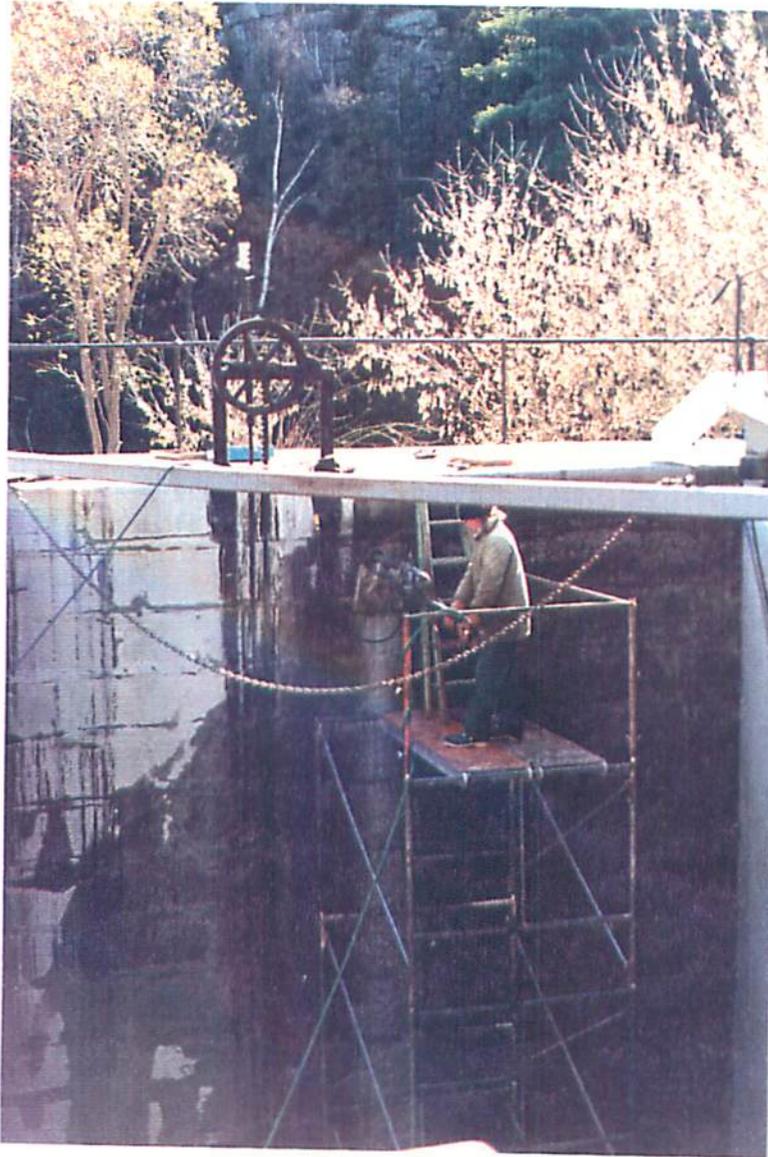
Photograph No. 8      Seepage noted in Run No. 13 - Hole V5

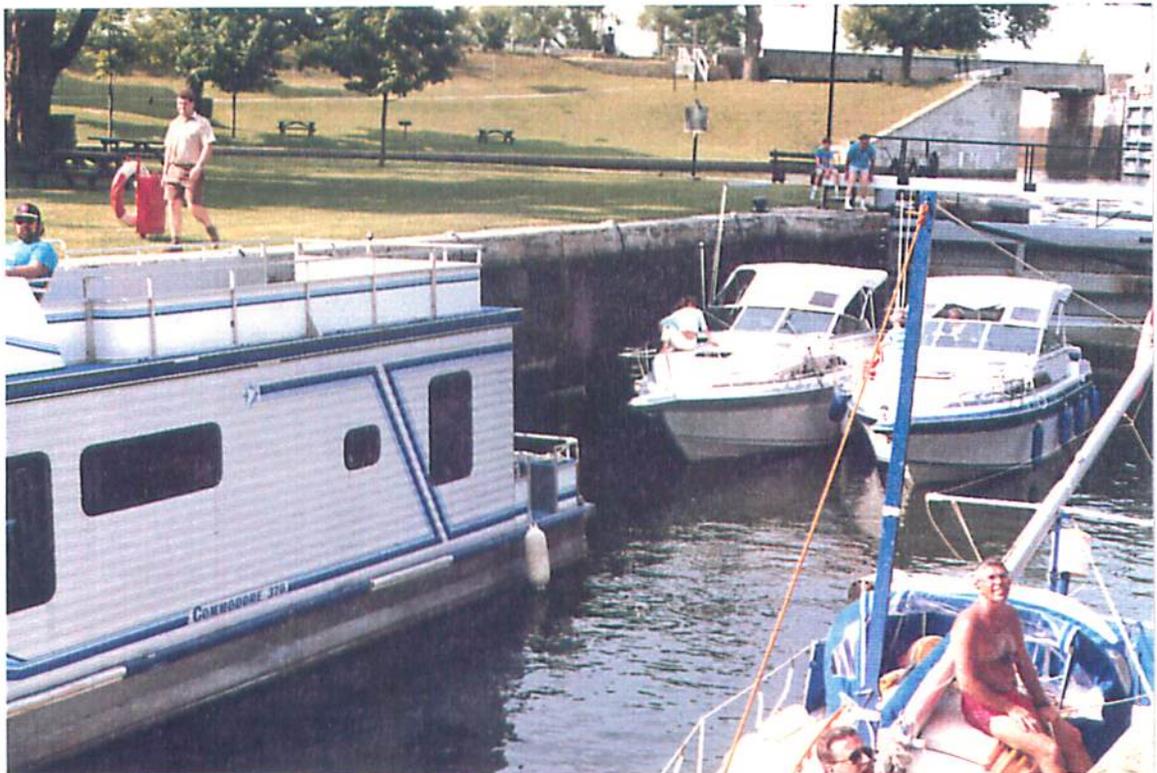
Lock 47 West Wall - Close Up View  
Note Running Leak Between Boats On West Wall

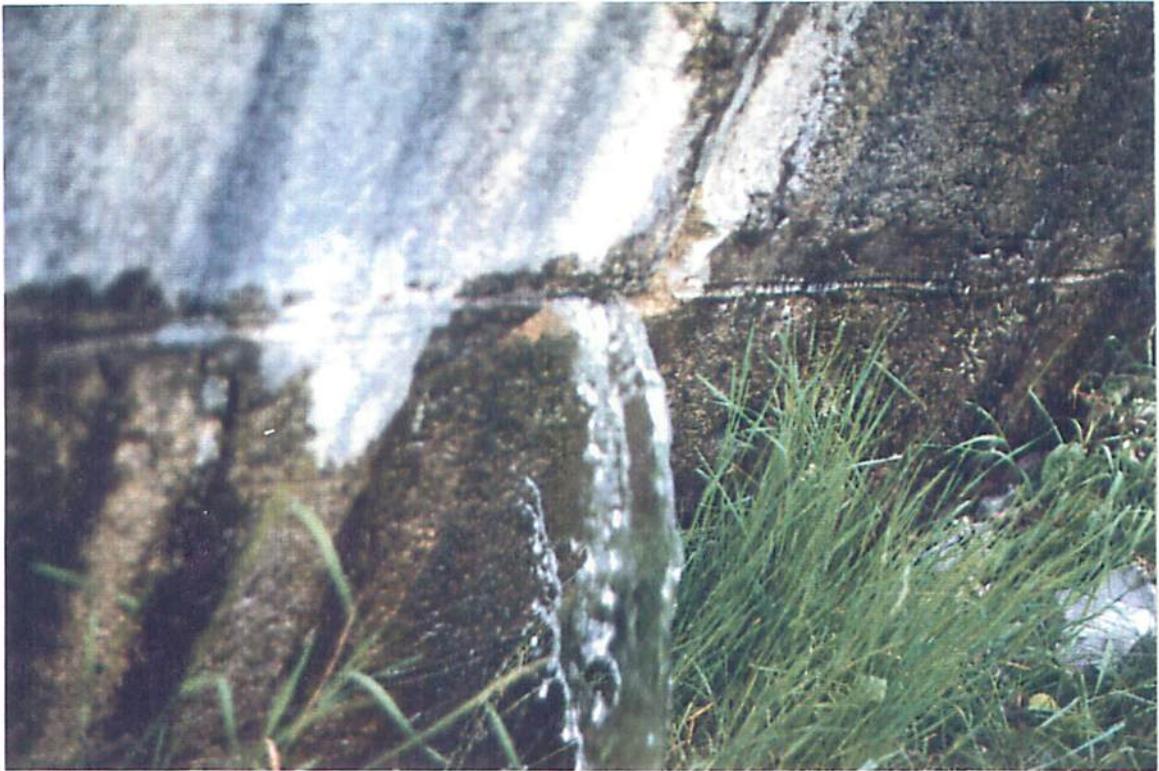
Lock 47 East Wall - External Seepage  
Note Gushing Leak

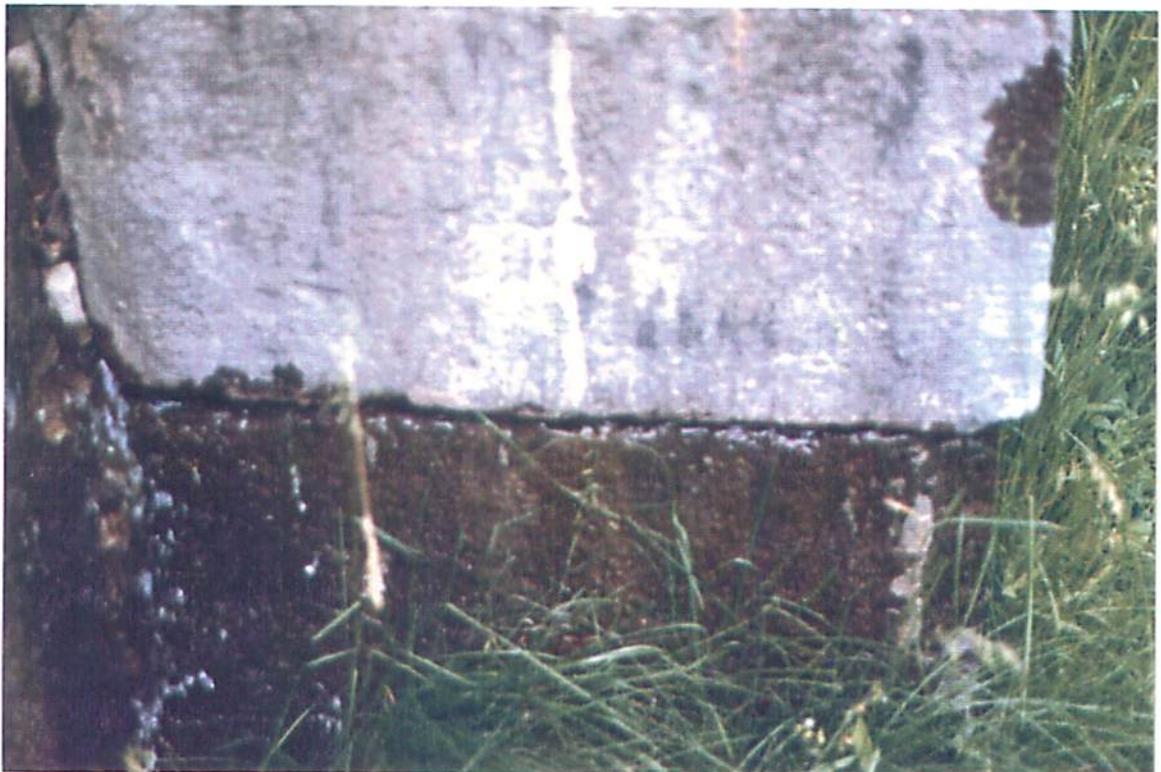
Lock 47 East Wall - External Seepage  
Note Flowing Water

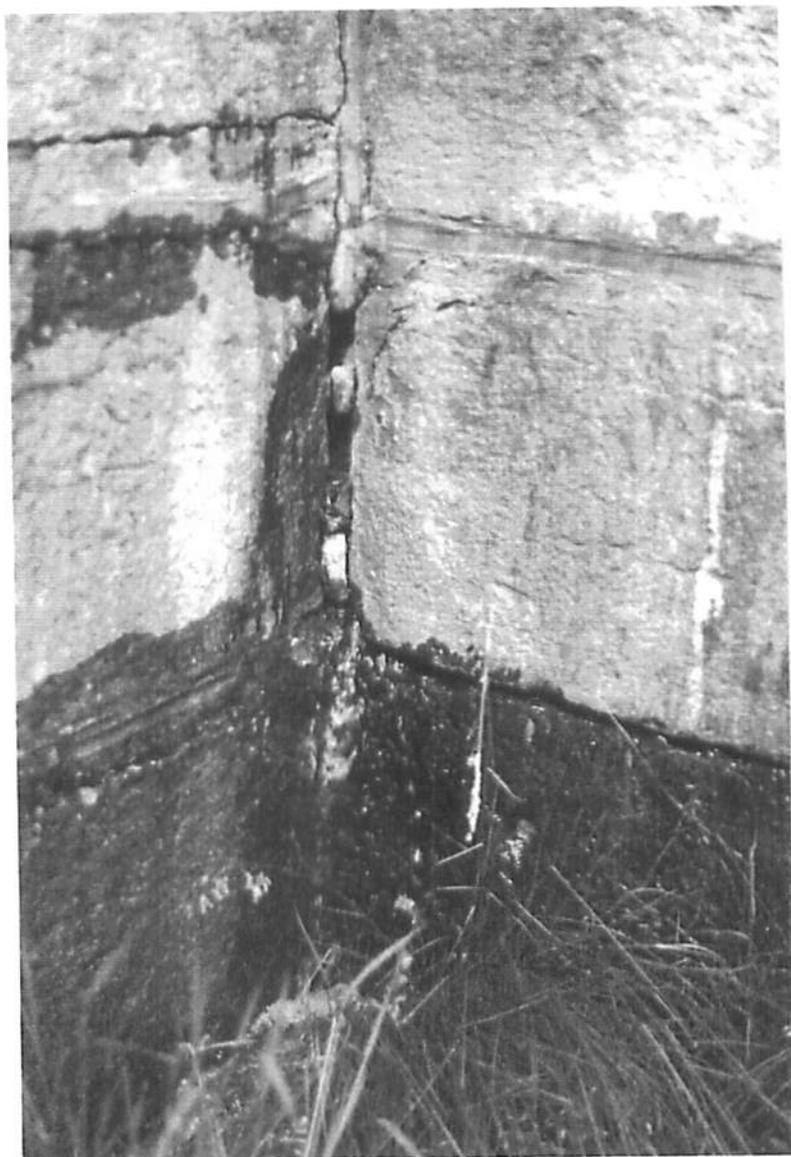
Lock 47 East Wall - External Seepage  
Close Up Of Flowing Water Leak

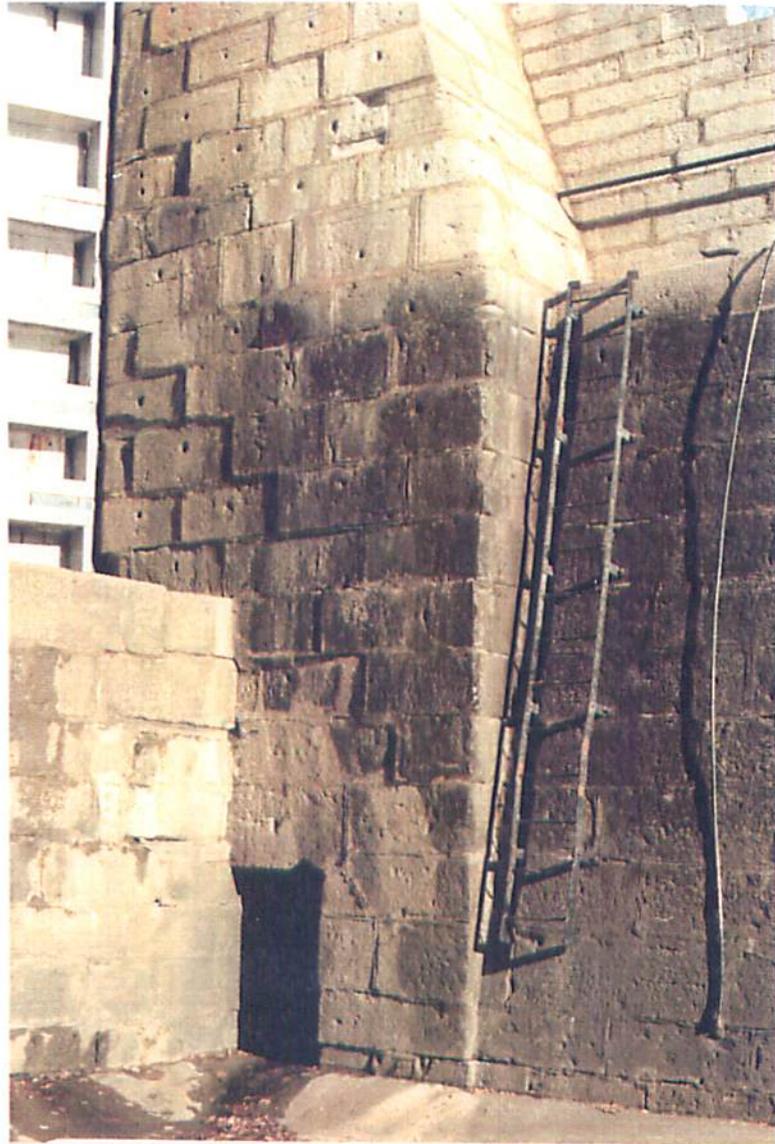
Lock 48 - East Wall Upstream Abutment  
Note Movement Of Masonry Blocks Due To Freeze/Thaw Action

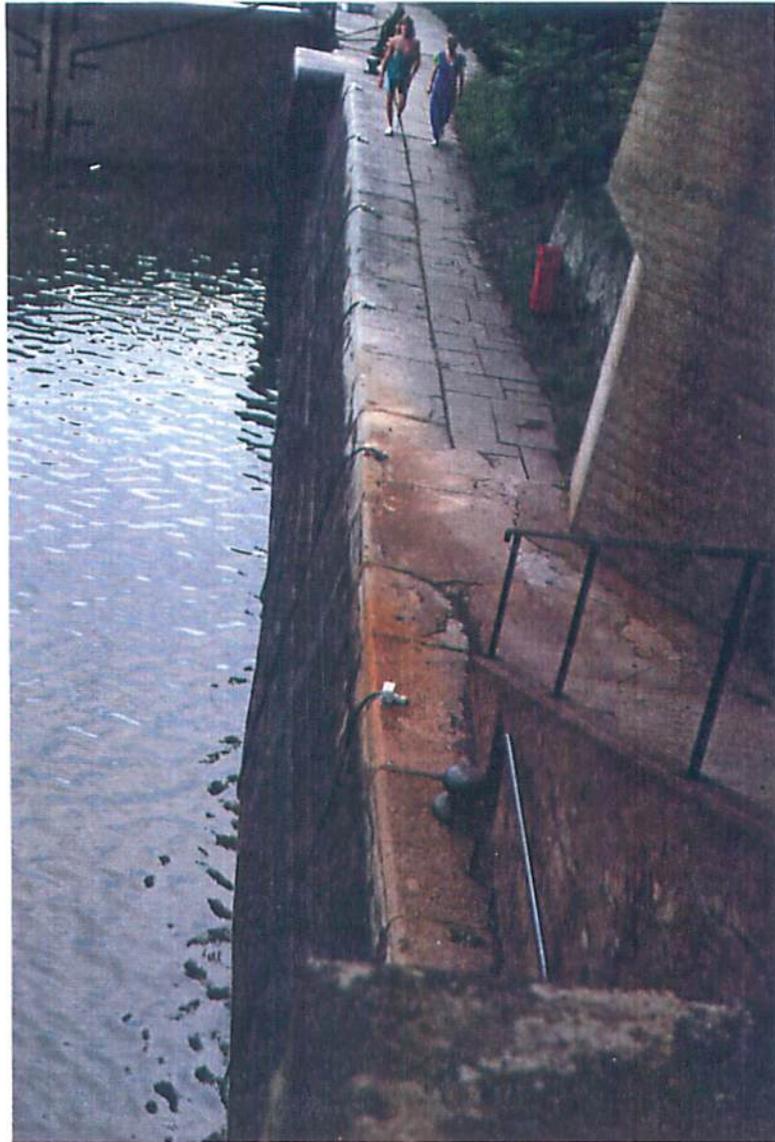
Lock 48 - West Wall  
Showing Bulge Due To Freeze/Thaw Action

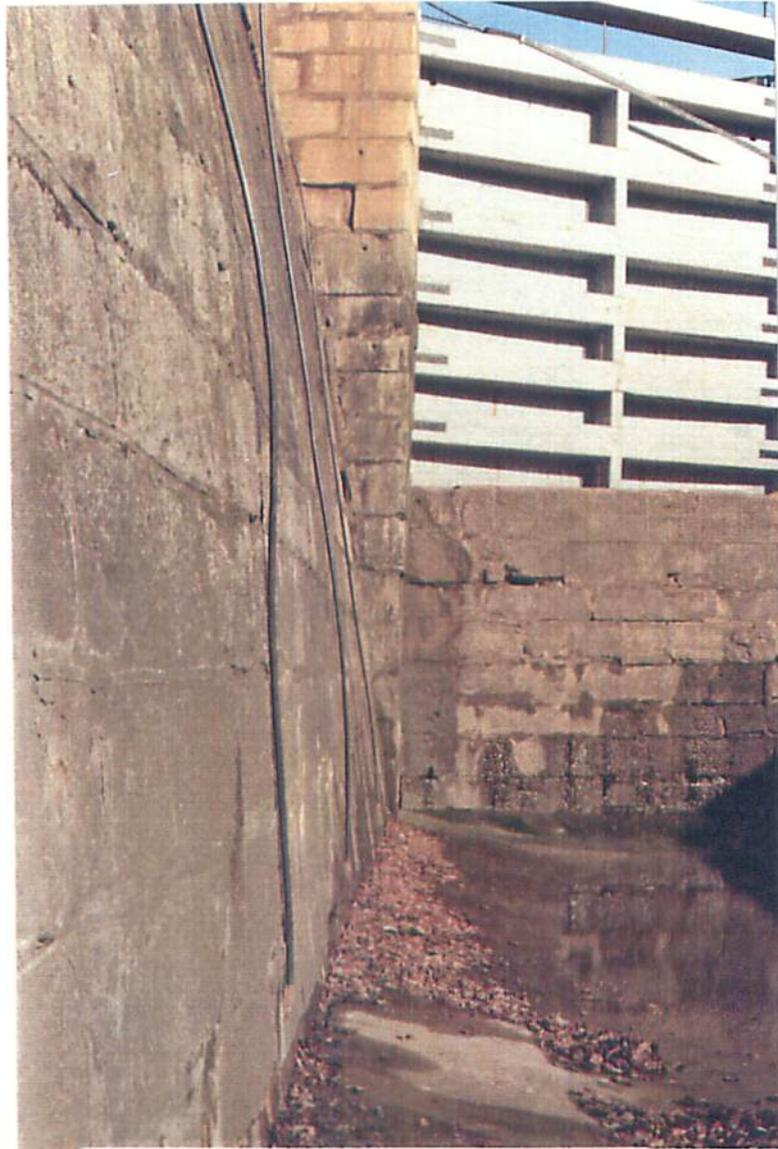
Lock 48 - West Wall  
Showing Bulge Due To Freeze/Thaw Action  
Also Note Movement Of Masonry Blocks  
And Poor Condition Of Sill With Open Joints & Seepage

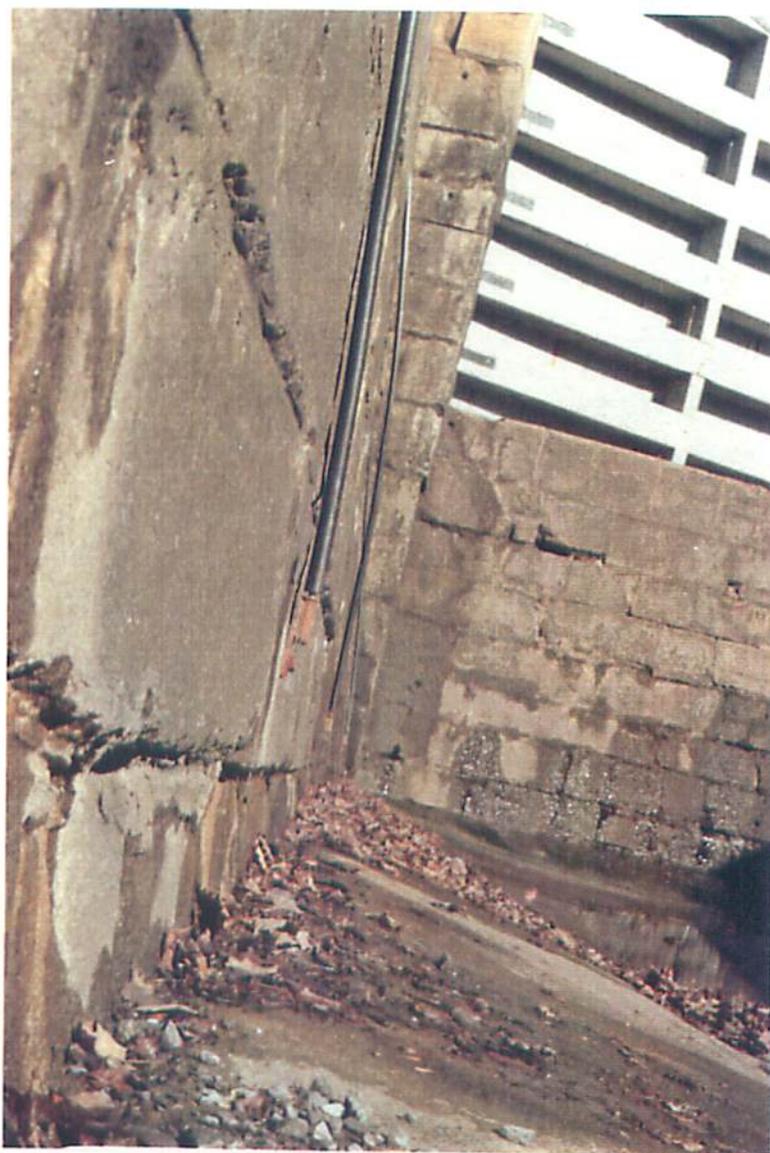
Lock 48 - West Wall  
Close Up Showing Bulge Due To Freeze/Thaw Action  
Also Note Movement Of Masonry Blocks  
And Poor Condition Of Sill With Open Joints & Seepage

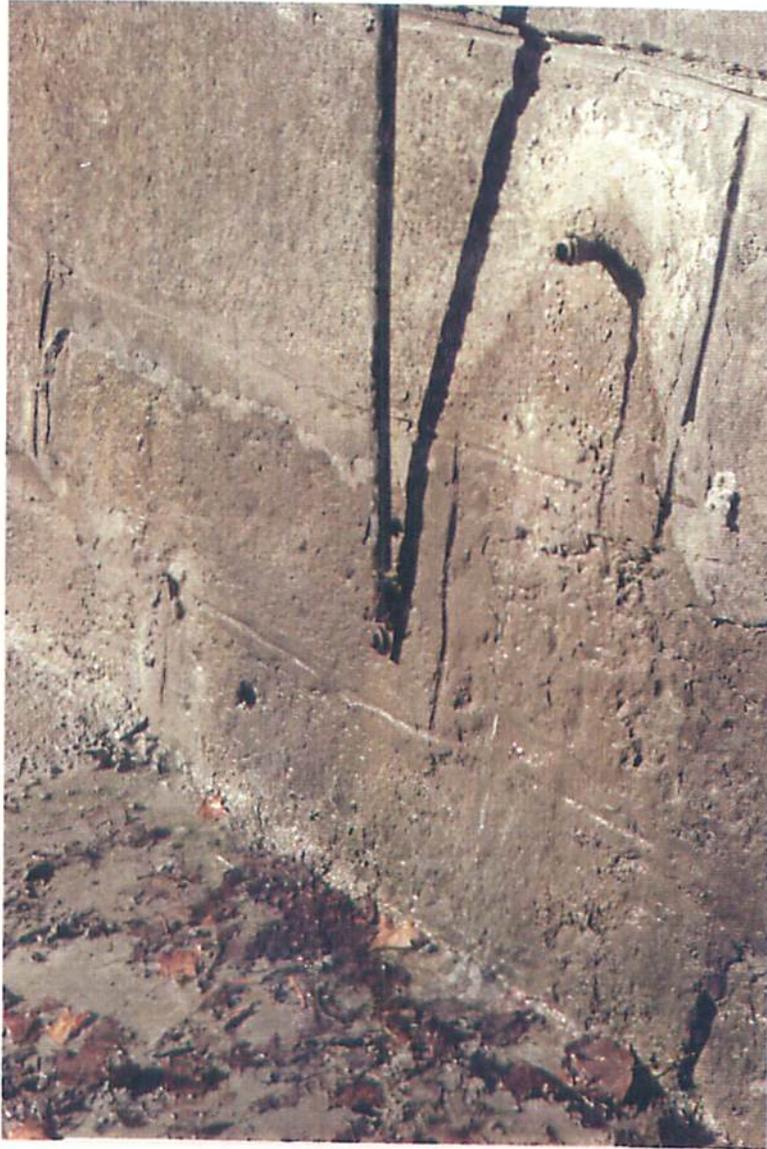
Lock 48 - West Wall  
Test Hole H - 7 Showing Free Flow Of Water  
Note Seepage Beneath Pointing & Missing Jointing

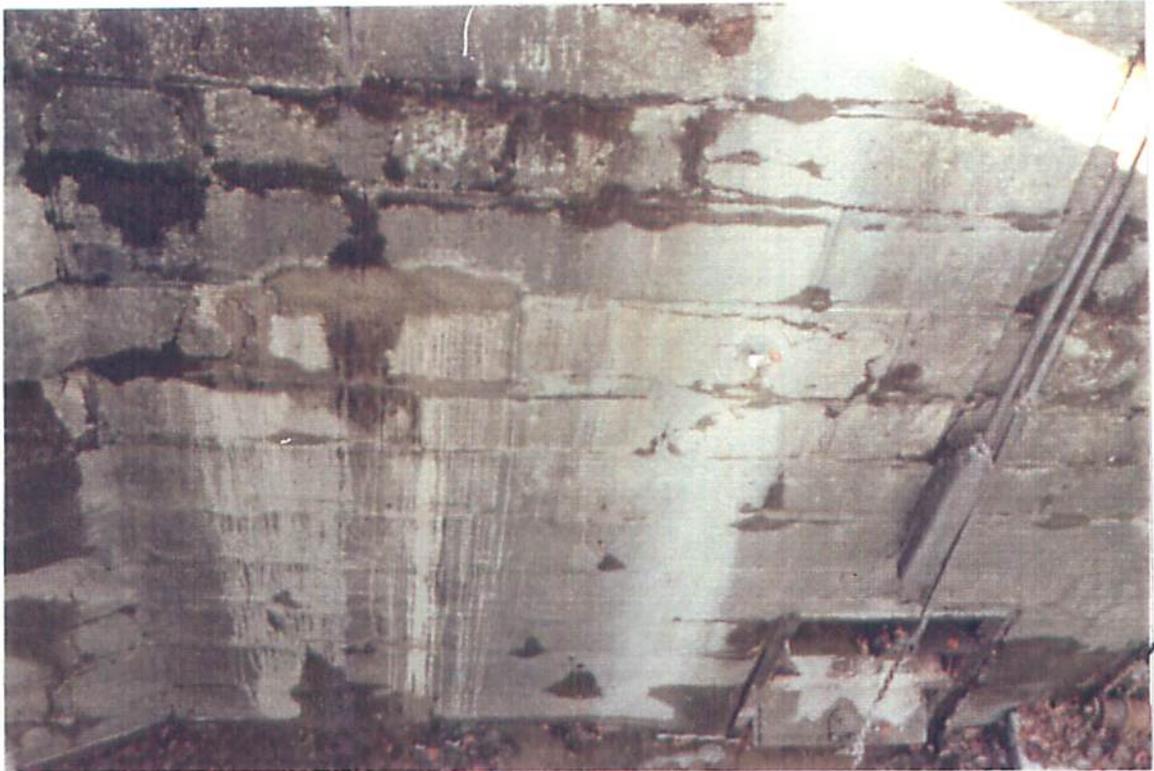
Lock 48 - West Wall Downstream Abutment  
Showing Grout Leak Through Joint 2 m From Test Hole H - 9

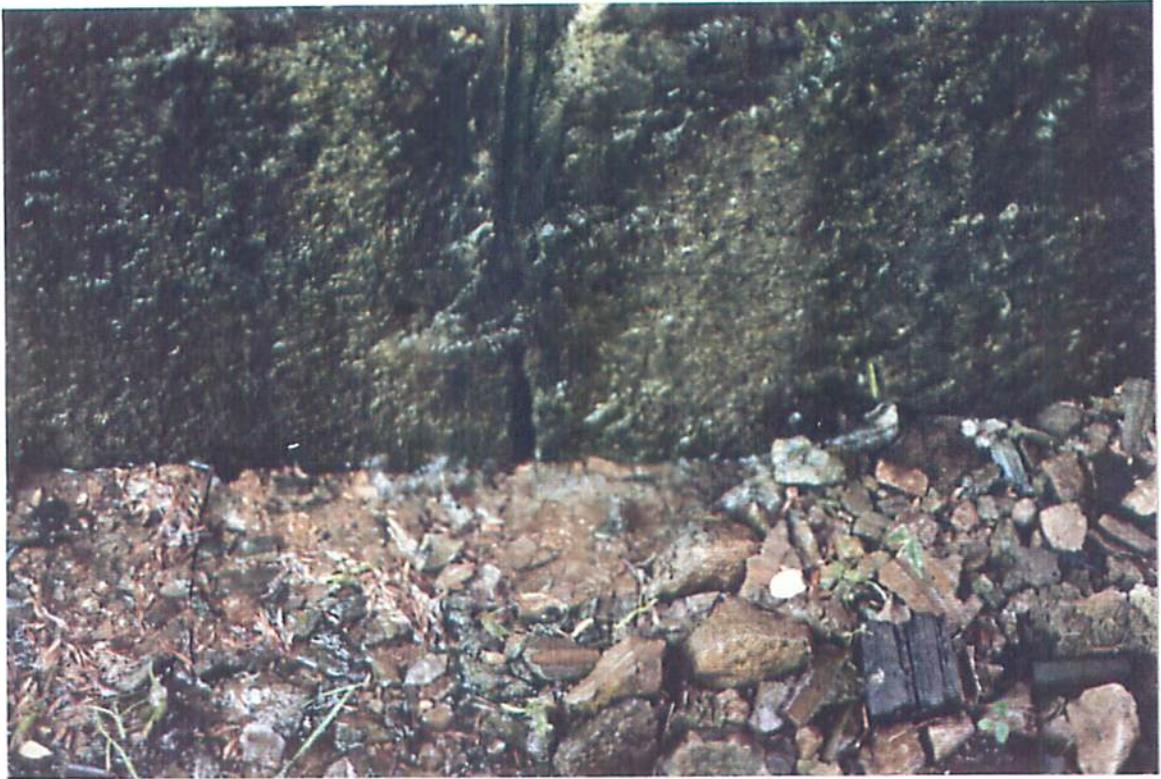
Lock 48 - Exterior East Wall Upstream Abutment  
Showing Water Leak Through Masonry Prior To Grouting

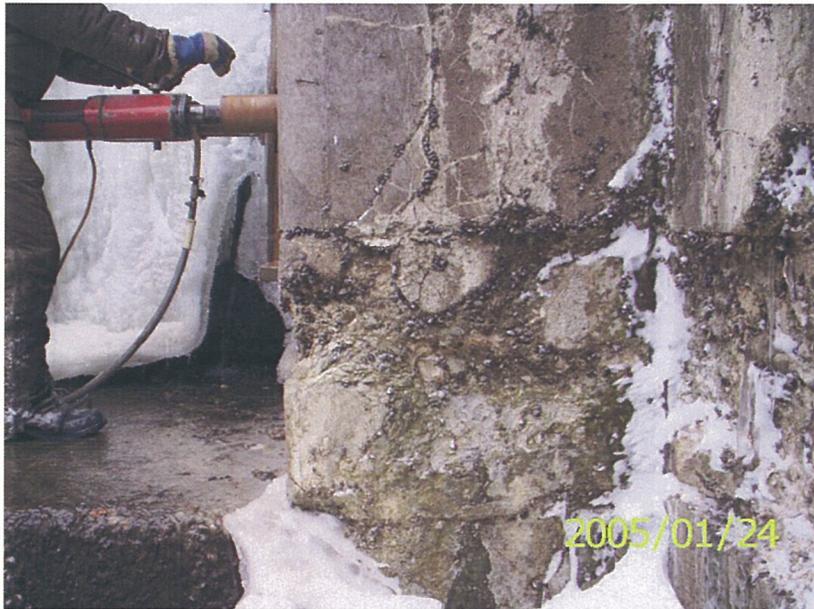
**Photo 5** – BH 05-3, Block being cored through  
Note severe spalling at the corner

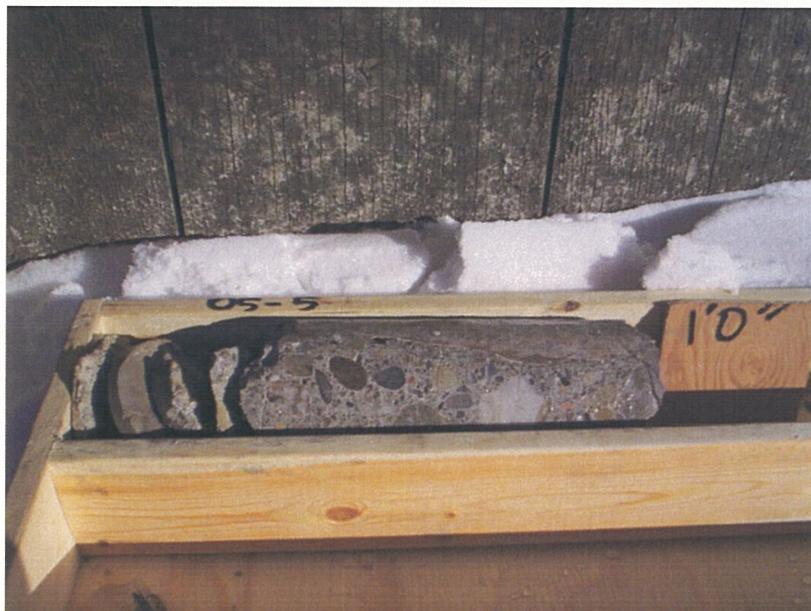
**Photo 2 – BH 05-5, RC1 – 0'0" to 1'0"**  
concrete, severe cracking at the first 4"

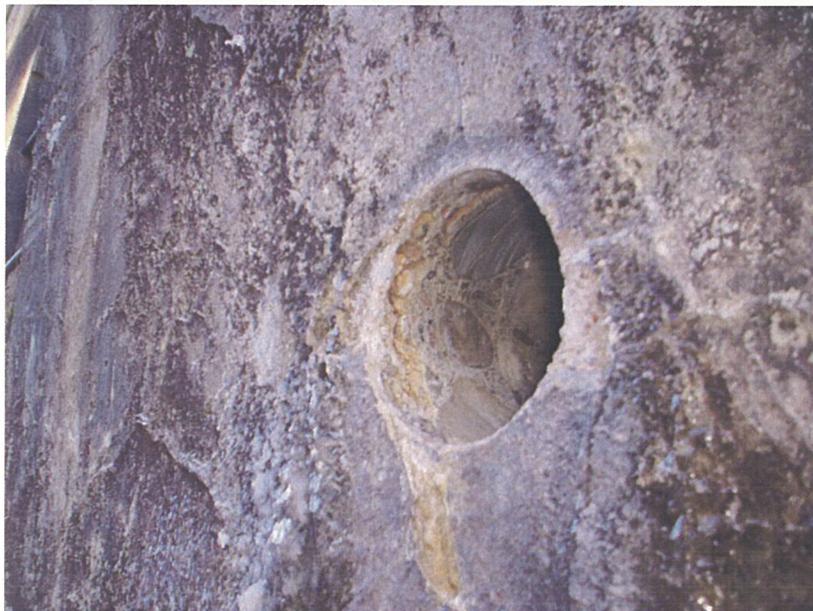
**Photo 4** – BH 05-5, north side of core hole  
Cracking at 2" parallel to surface

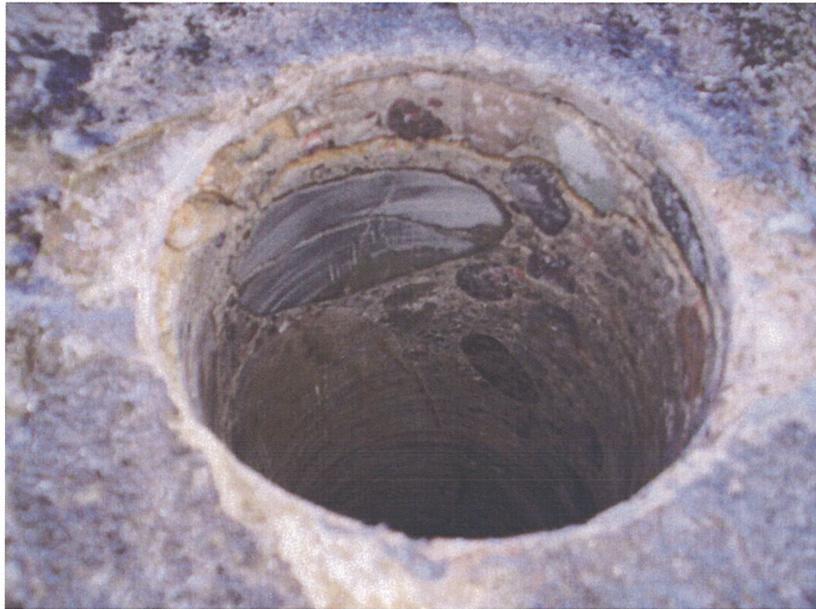
**Photo 5** – BH 05-5, upper side of core hole  
Cracking at 2" depth parallel to surface

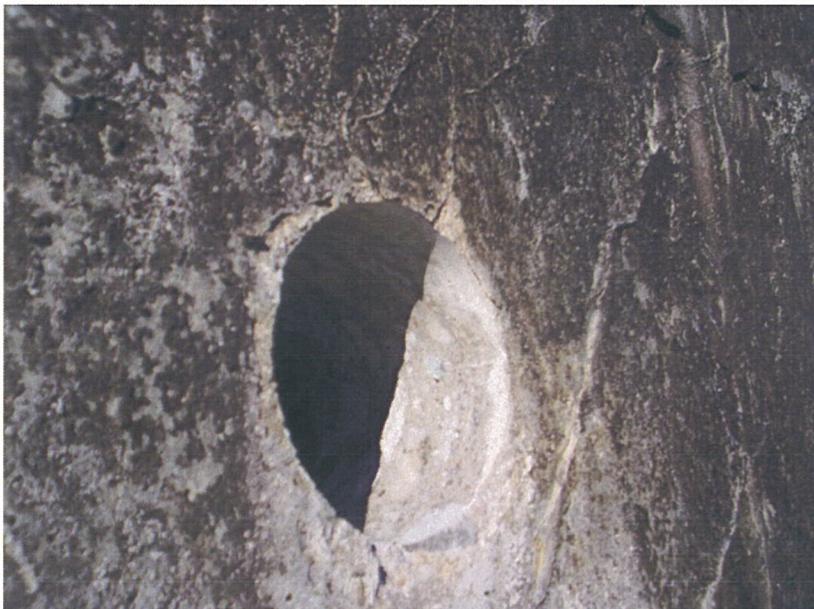
**Photo 4** – BH 05-6, north face of core hole  
Surface cracking

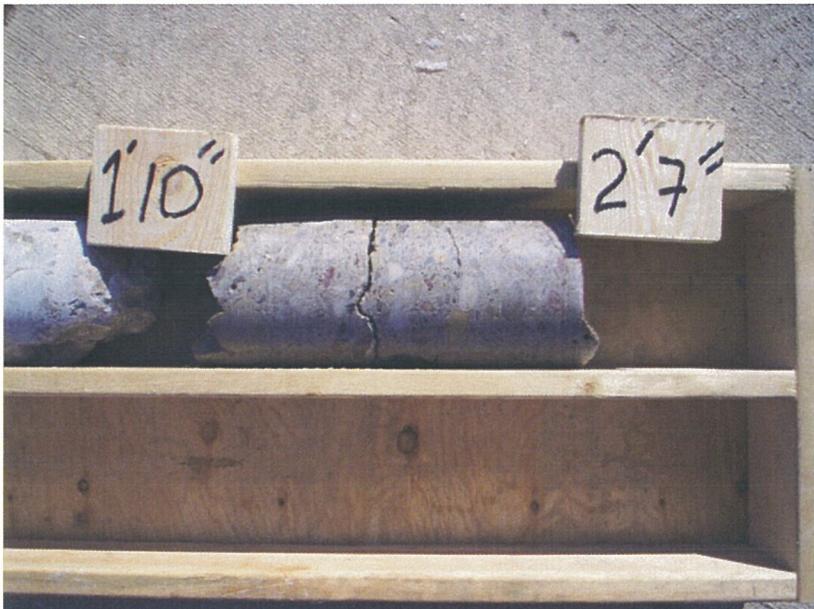
**Photo 4** – BH 05-9, RC 3 – 1'10" to 2'7"  
Cracking at 2'3' in concrete

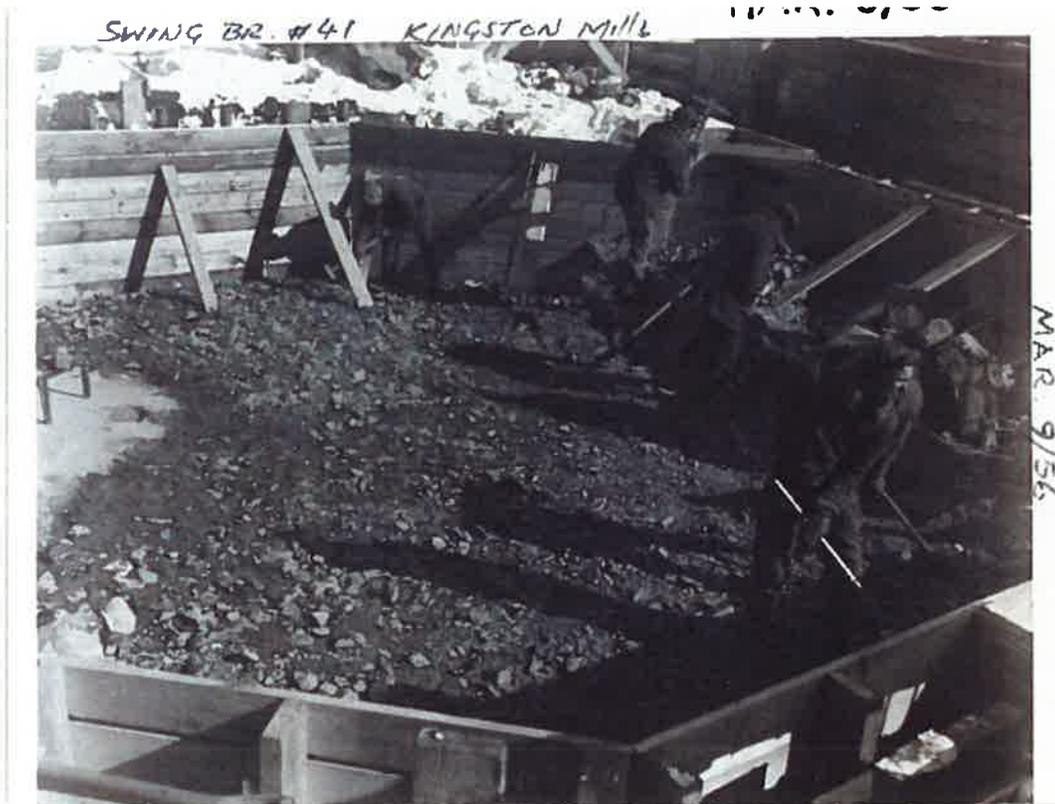
Photograph 1 – Showing the construction of original pier founded on granular fill and the Canal Lock wall on the east side

From the photographs provided, the pivot pier appears to be founded on the bedrock surface on the west side and the canal wall on the east side, with fill between those two relatively rigid supports. The fill appears to be granular fill up to the underside of the footing based on the photographs, but the previous investigations indicate that the fill below the pier consists of predominantly clayey silt with cobbles and boulders. The fill beneath the pier would have limited capacity to support additional loading from the pier.
