**HAZARDOUS MATERIALS INVESTIGATION
LACOMBE, BEAVERLODGE AND FORT VERMILLION
RESEARCH CENTRES**

April 12, 2011 Revised March 2013
File No. 11166

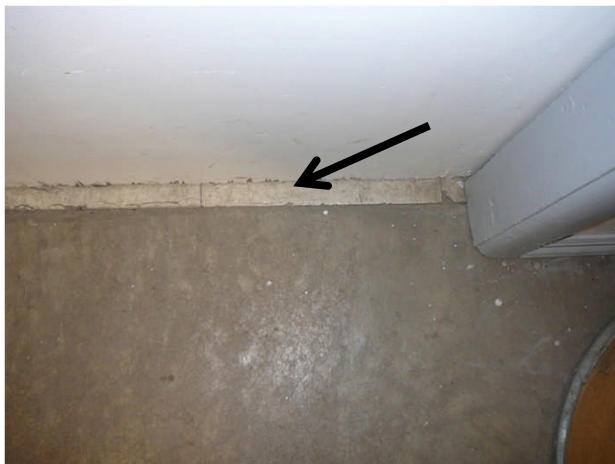
#52 Machine & Vehicle Repair

| ACM (asbestos containing material) | EXTENT | IMPACT* |
|---|--|---|
| Floor Tiles | Main floor office (off- white tiles) Estimated: 8 m ² | The tiles were in average condition. As long as the tiles are in good/average condition, there is low risk. If any tiles become damaged tiles should be removed and replaced. |

Sample A83 : Floor tile containing asbestos in the main office

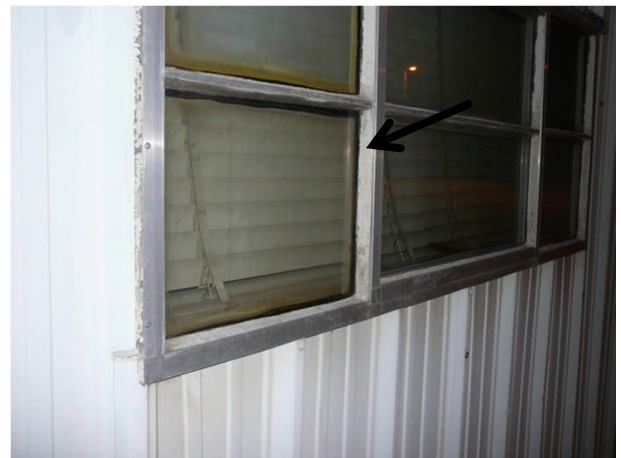
#52 Machine & Vehicle Repair

| ACM (asbestos containing material) | EXTENT | IMPACT* |
|---|--|---|
| Window Glazing | South window 1 window | The exterior glazing is located in a relatively unused area and is in fair condition. As long as there is no disturbance to the ACM there is low risk to occupants. |

Sample A87 : Window glazing containing asbestos on the exterior window

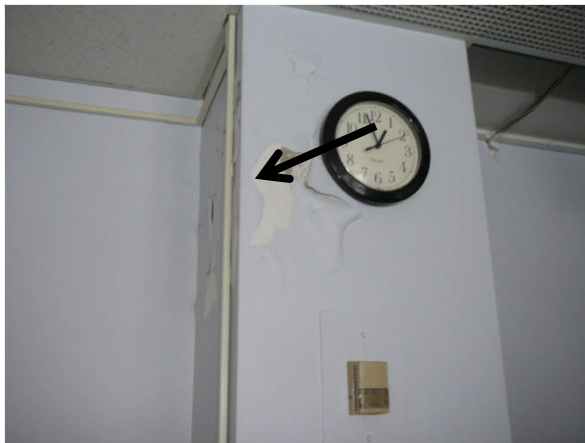
#21 Administration

Area of water damage in room 118

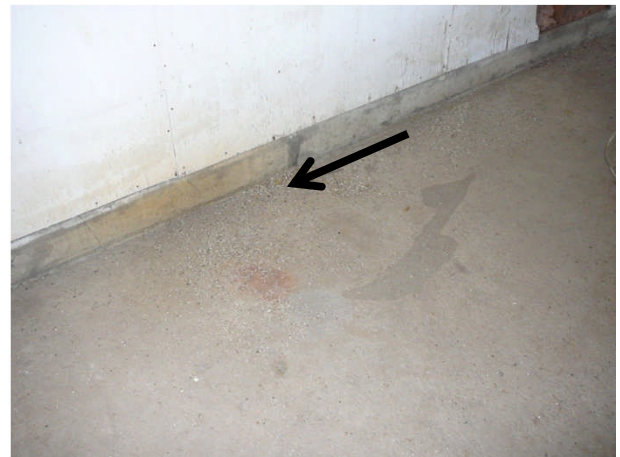
#54 Animal Hospital

| ACM (asbestos containing material) | EXTENT | IMPACT* |
|---|--|--|
| Vermiculite Insulation | Animal hospital (attic: 100 m ²) (walls: 72 m ²) | There is a high risk to occupants if the ACM is exposed and disturbed. ACM is present in the attic and walls. The animal hospital walls and ceiling are compromised and the vermiculite is leaking onto the floor. This area has a high risk of exposure and should be abated as soon as possible. If the area cannot be abated, the vermiculite should be cleaned up (by qualified personnel) and the compromised walls and ceiling repaired before entry of unprotected personnel. |

ACM Vermiculite Insulation on the Floor

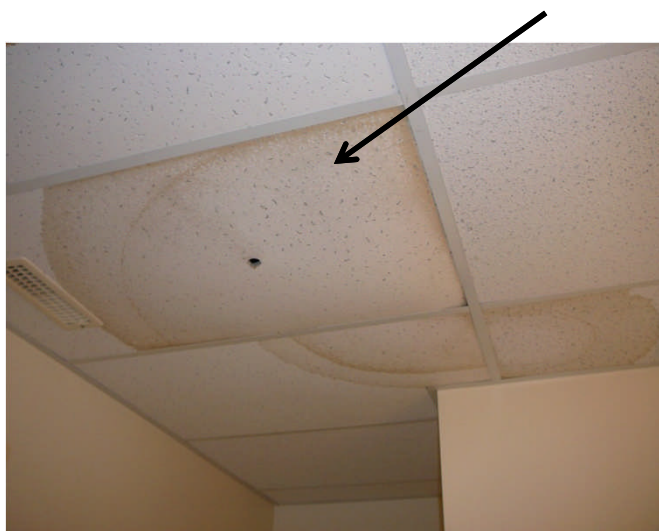
#25: Honey Extraction Building

Water damage on ceiling of bathroom

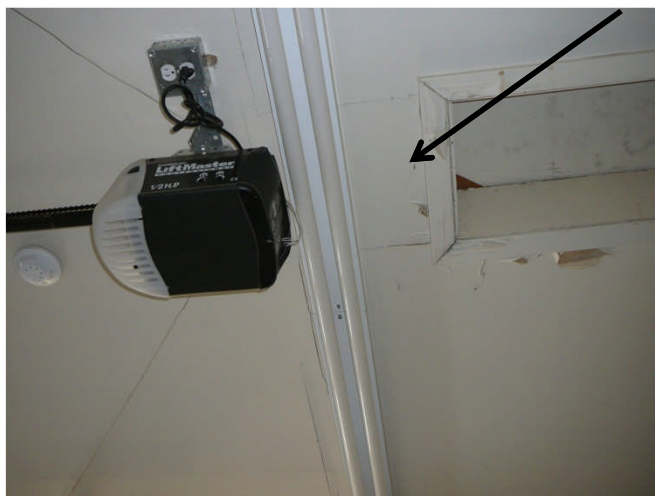
#26: Storage

Water damage on ceiling in the air drying room

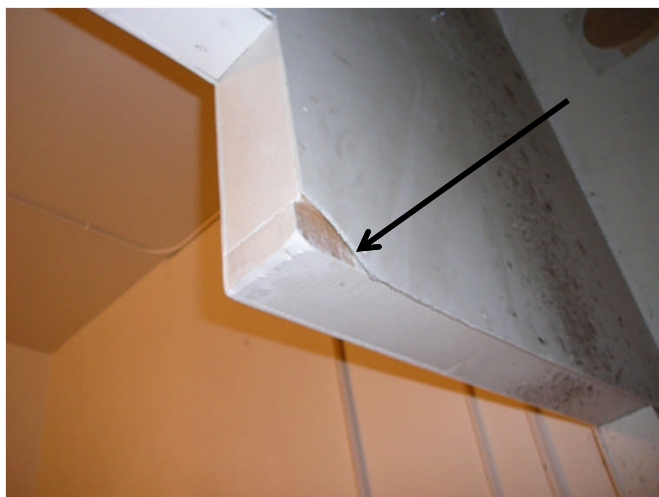
#26: Storage

Sample A200: Gray cement board on northwest enclosure in the threshing room

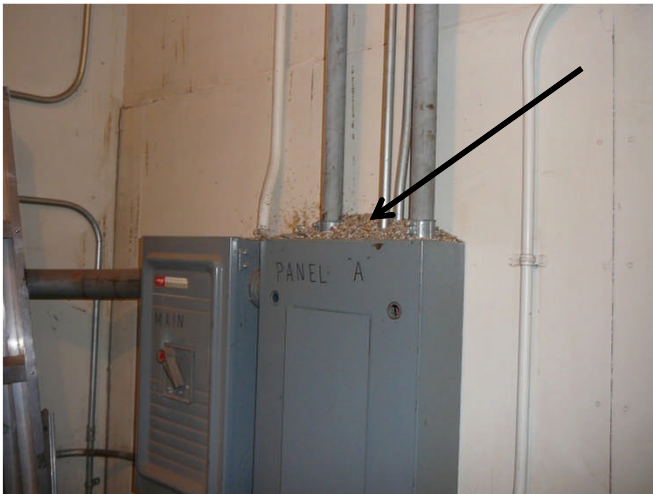
#26: Storage

Vermiculite leakage on panel in furnace room

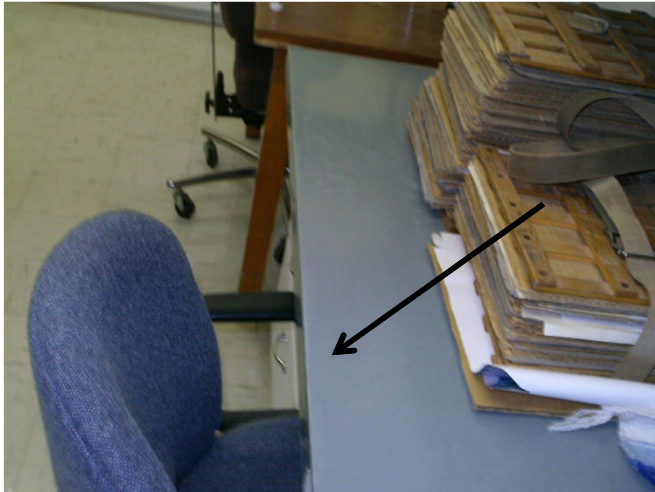
#26: Storage

Sample A212: Gray cement countertop in office 3

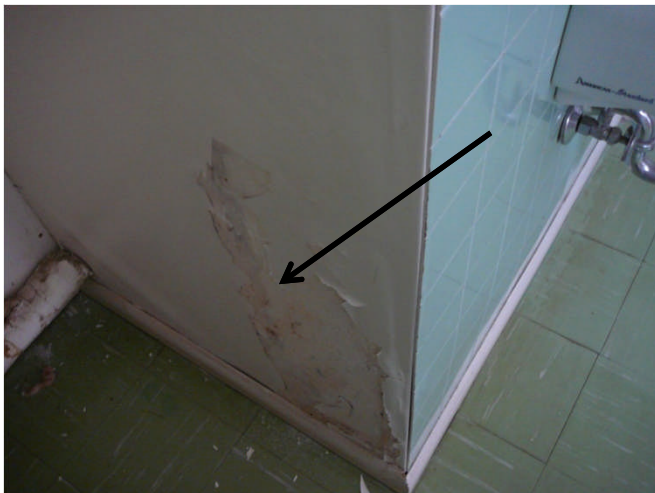
#26: Storage

Water damage and suspect mould growth in Woman's bathroom

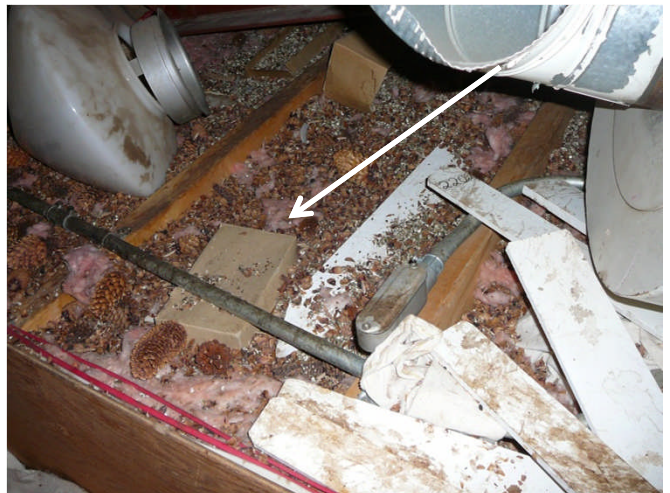
#26: Storage

Evidence of squirrel activity

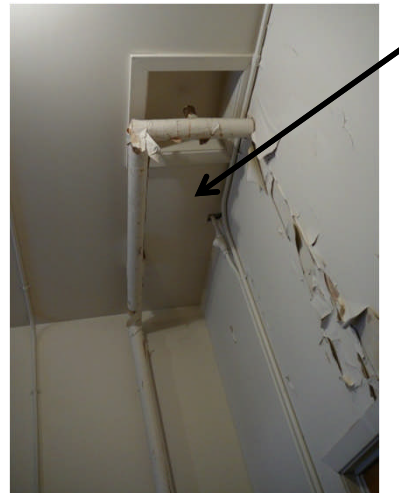
#26: Storage

Water damage on Threshing room wall

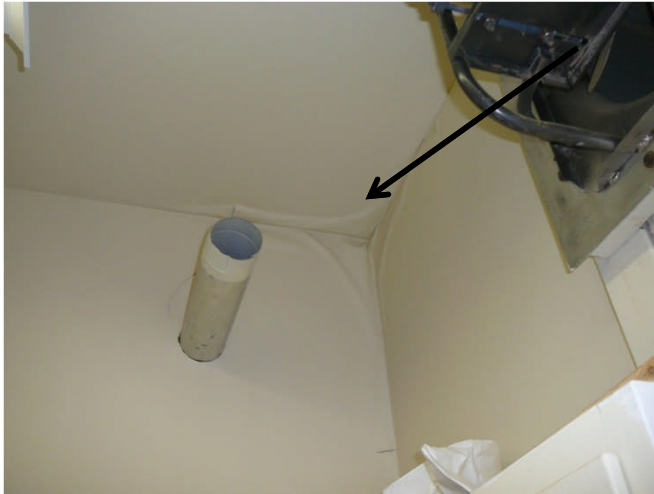
#26: Storage

Water damage on office 1 wall/ceiling corner

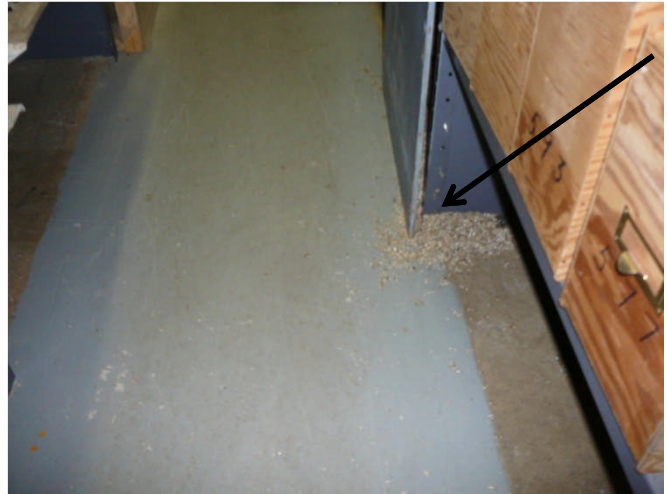
#26: Storage

Vermiculite leakage on floor in seed storage

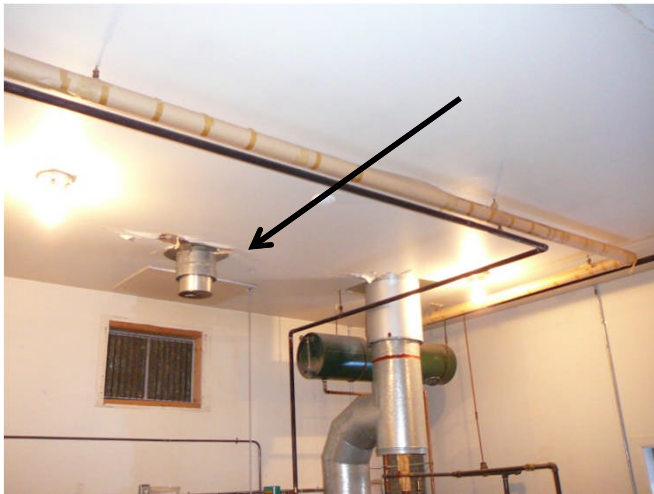
#26: Storage

Water damage on ceiling in furnace room

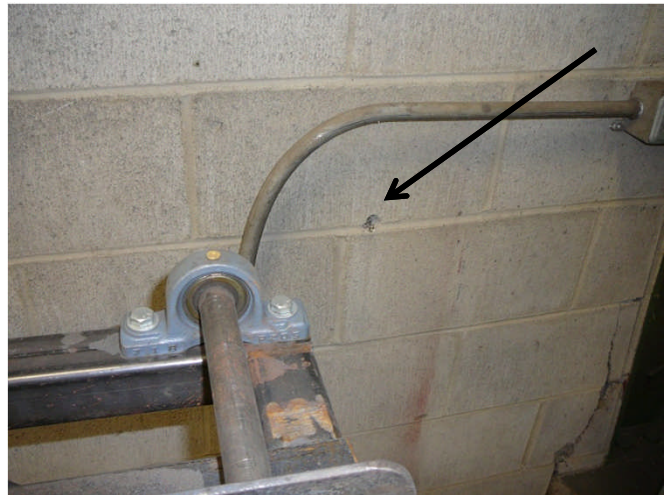
#35 Garage

Sample A198: Vermiculite in cinderblock wall separating garage sections

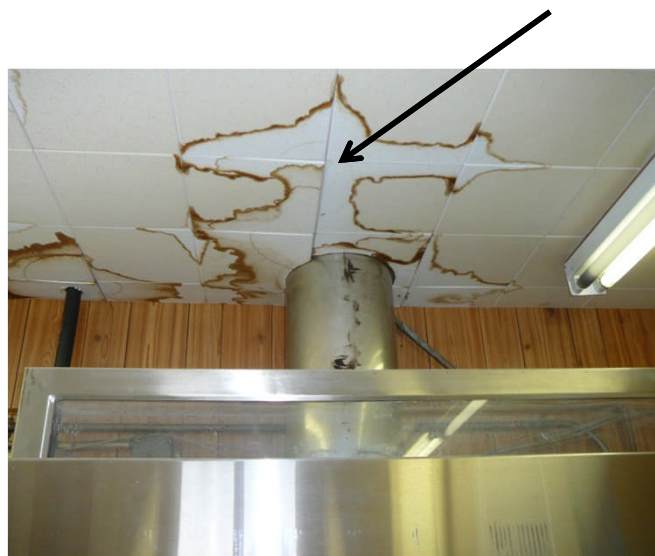
#14: Soils Research Building

Example of water damage at fume hood vent

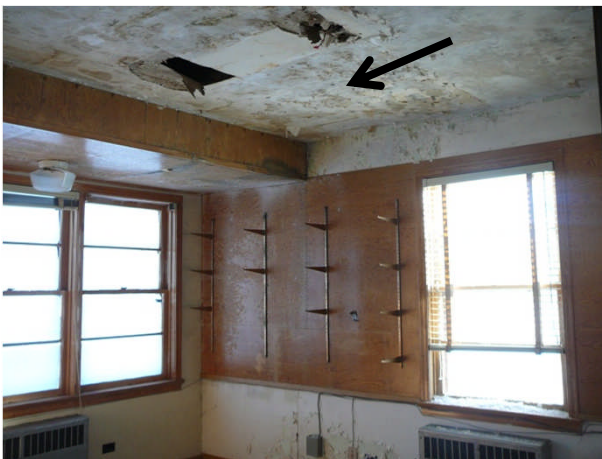
#2 Administration Office – Main Floor
Water damage and failure of the main floor
ceiling

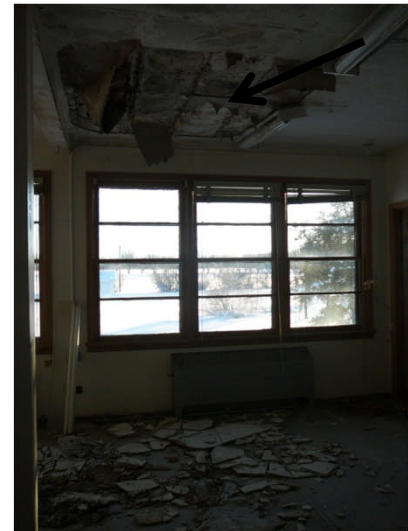
#2 Administration Office – 2nd Floor
Water Damage and debris from failure of the
2nd floor ceiling

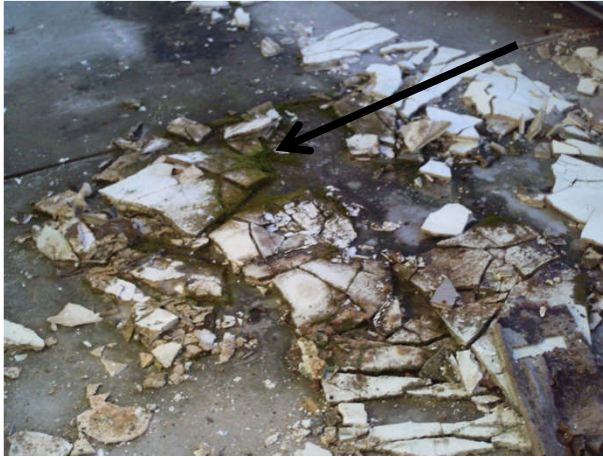
#2 Administration Office – 2nd Floor
Ceiling material on the floor with biological growth

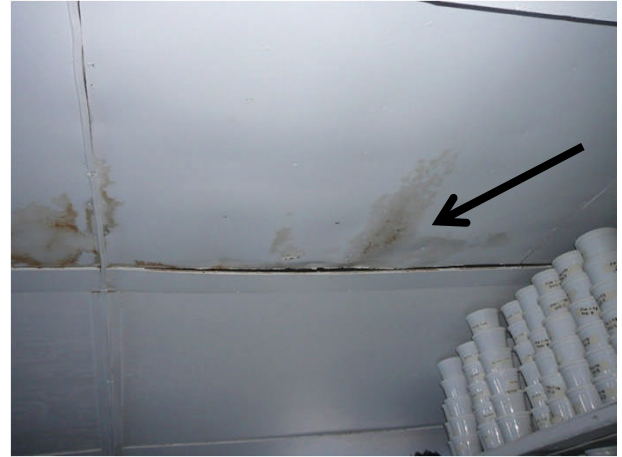
#14 Drying and Threshing Shed
Water damaged ceiling

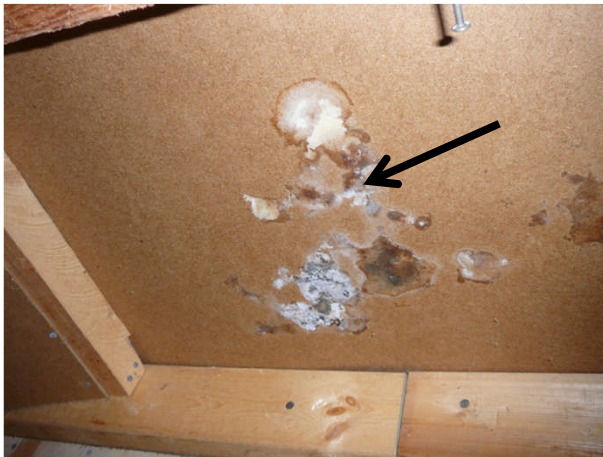
#33 Processing & Carpenter Shop
Attic with some suspect mould growth

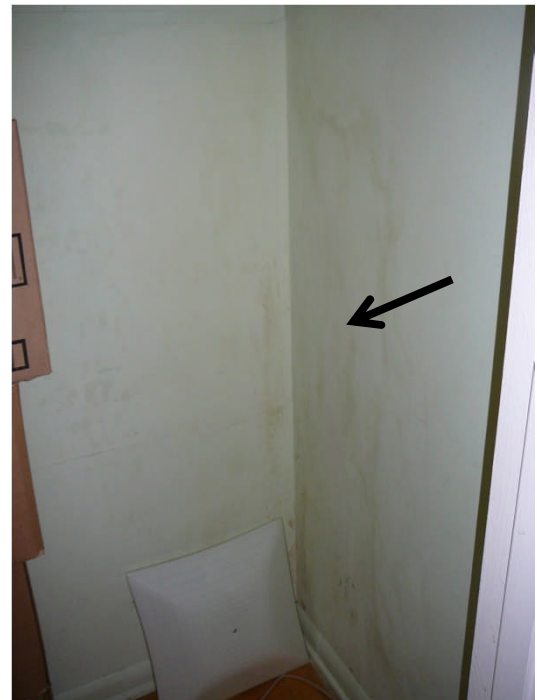
#60 Duplex House – North Unit
Water damage in the conference room closet

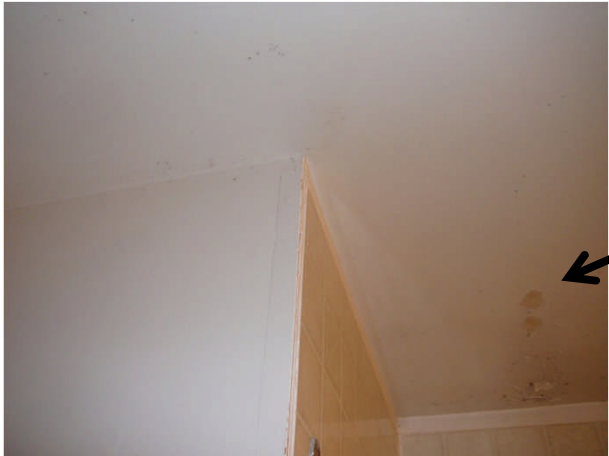
#60 Duplex House – North Unit
Water damage in the washroom

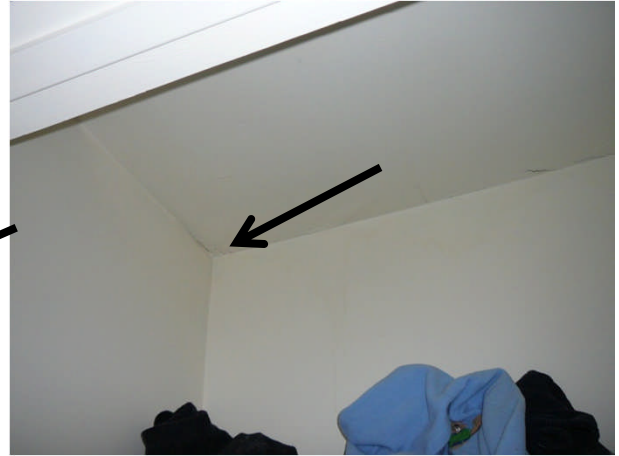
#60 Duplex House – South Unit
Water damage in the northwest bedroom closet
