MacDonald Creek Bridge
Alaska Highway km 628.0

(F – Fixed Bearing, E – Expansion Bearing)

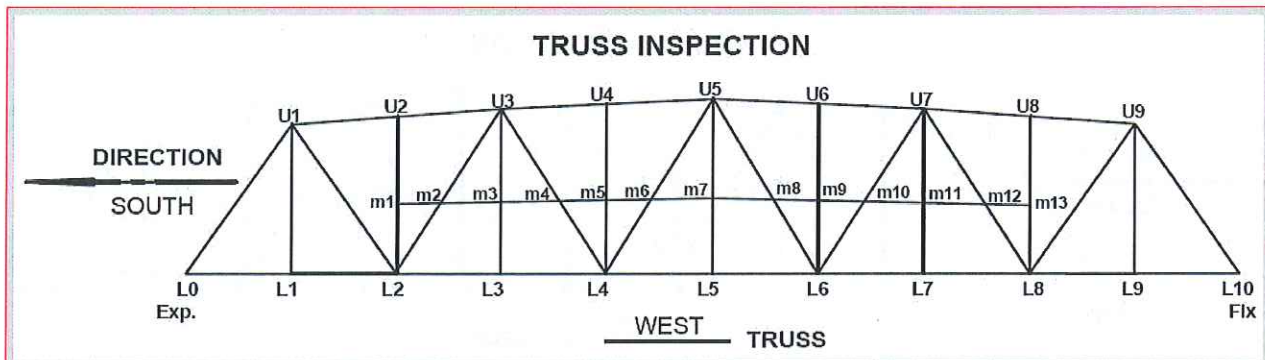
MacDonald Creek Bridge
Alaska Highway km 628.0

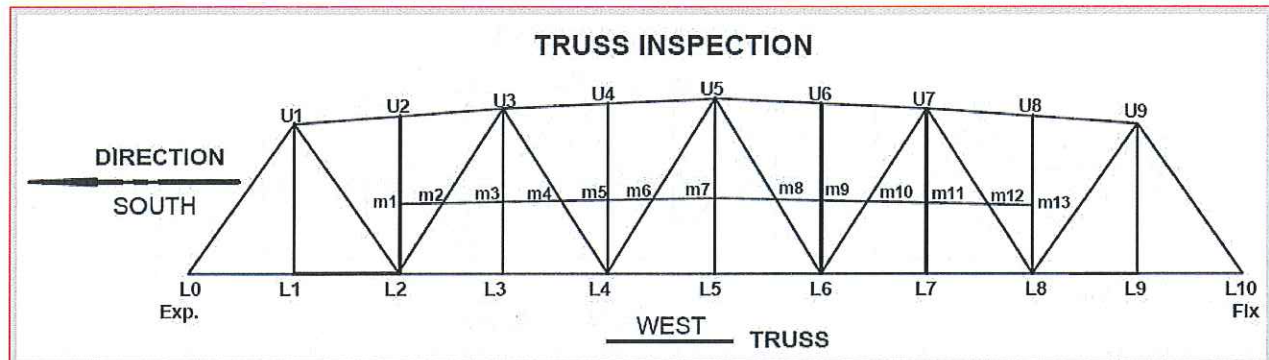
ELEMENT	2015			2017			OBSERVATIONS	PHOTO
	MCR	PCR	PRIORITY	MCR	PCR	PRIORITY		
SPAN 2 – WEST TRUSS								
L1-L2W	5	5	D	5	5	D	No defects noted	
L2-L3W	5	5	D	5	5	D	No defects noted	
L3-L4W	5	5	D	5	5	D	No defects noted	
L4-L5W	5	5	D	5	5	D	No defects noted	
L5-L6W	5	5	D	5	5	D	No defects noted	
L6-L7W	5	5	D	5	5	D	No defects noted	
L7-L8W	5	5	D	5	5	D	No defects noted	
L8-L9W	5	5	D	5	5	D	No defects noted	
L9-L10W	5	5	D	5	5	D	No defects noted

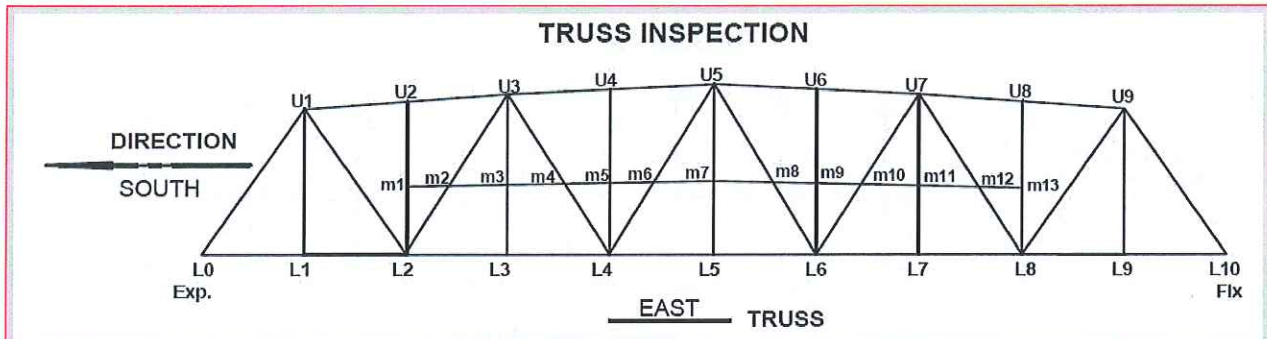
ELEMENT	2015			2017			OBSERVATIONS	PHOTO
	MCR	PCR	PRIORITY	MCR	PCR	PRIORITY

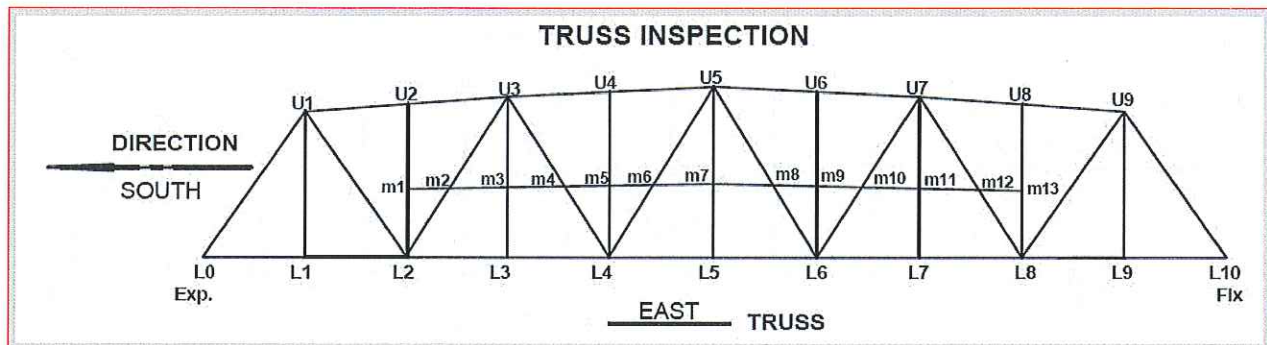
Alaska Highway km 628.0

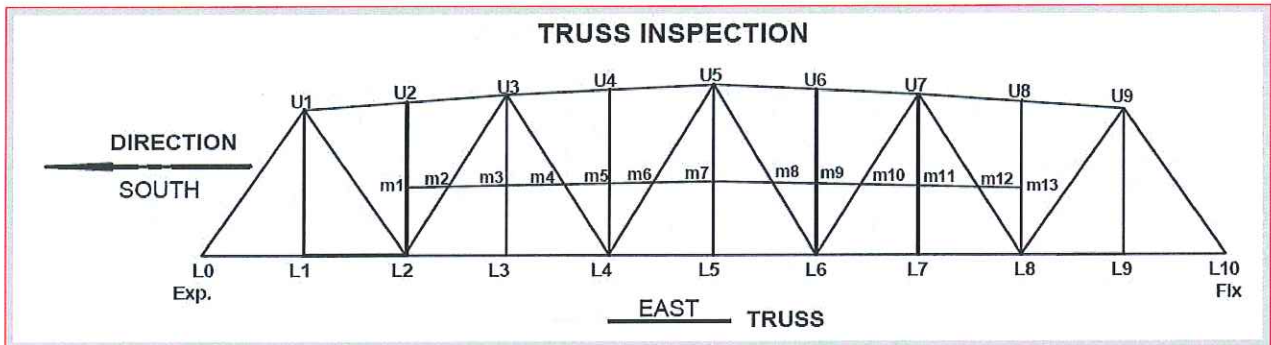
ELEMENT	2015			2017			OBSERVATIONS	PHOTO
	MCR	PCR	PRIORITY	MCR	PCR	PRIORITY		
SPAN 2 – EAST TRUSS								
L3-L4W	5	5	D	5	5	D	No defects noted	
L4-L5W	5	5	D	5	5	D	No defects noted	
L5-L6W	5	5	D	5	5	D	No defects noted	
L6-L7W	5	5	D	5	5	D	No defects noted	
L7-L8W	5	5	D	5	5	D	No defects noted	
L8-L9W	5	5	D	5	5	D	No defects noted	
L9-L10W	5	5	D	5	5	D	No defects noted

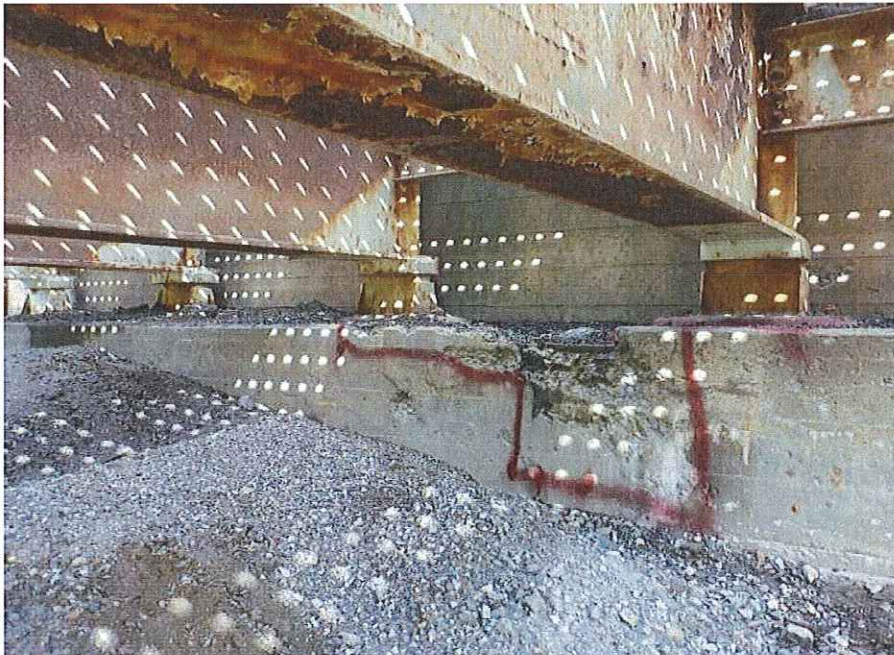
P18 - Spalls on face of N Abutment beneath girder bearing

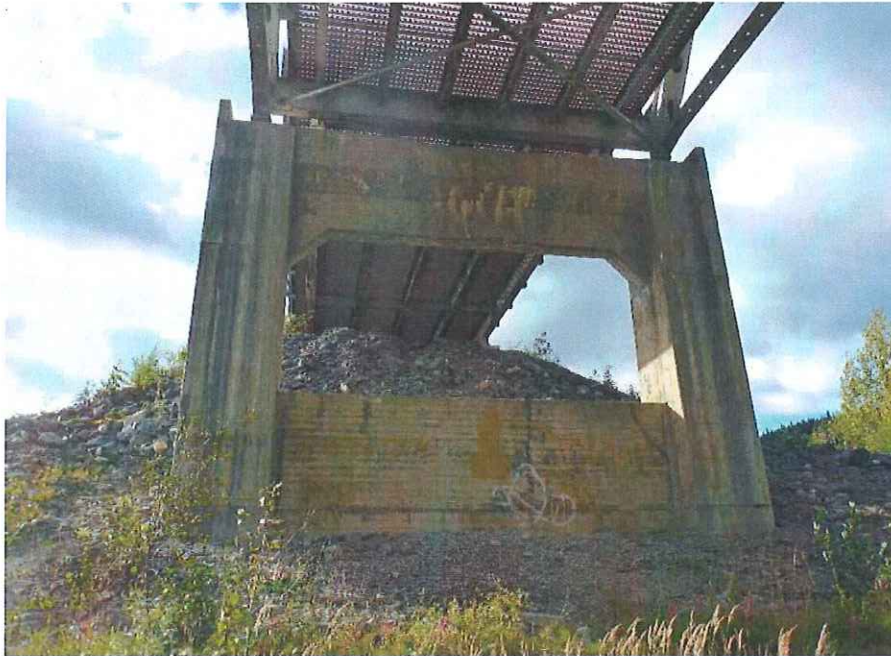
P19 - S Pier facing S from stream bank

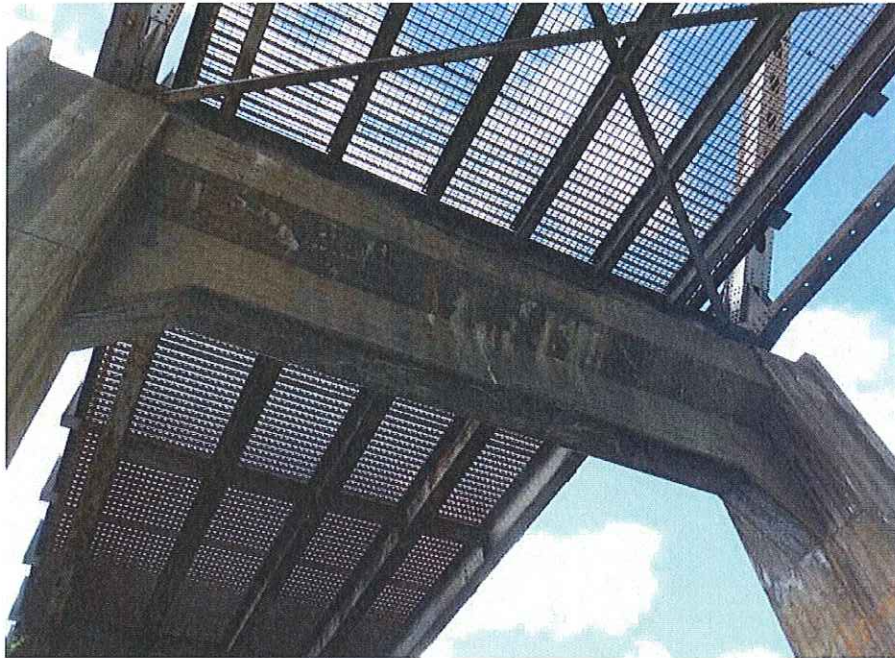
P21 - Leaching cracks and spalls on S Pier cap beam

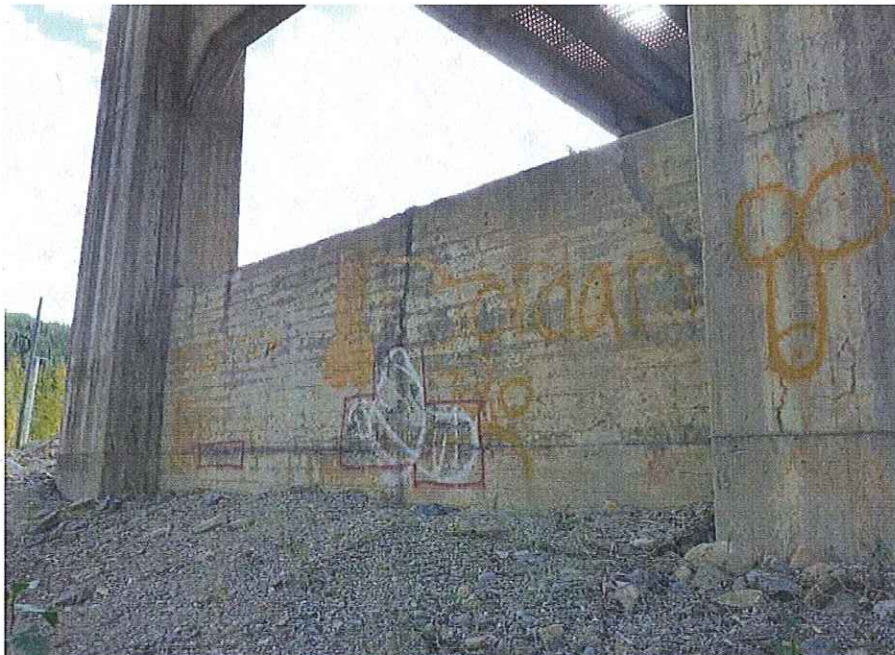
P22 - Delaminations on N face of wall at base of S Pier

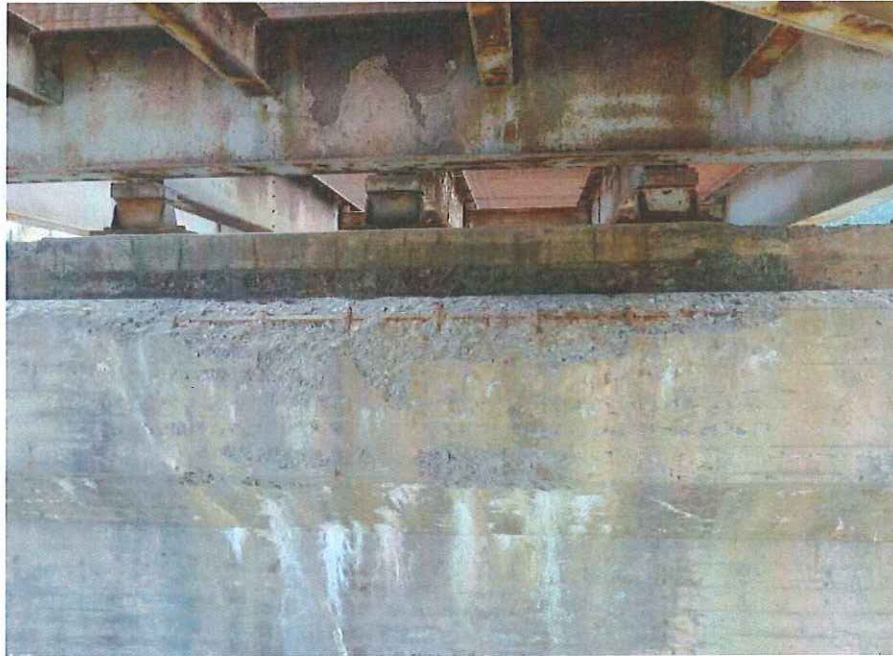
P23 - Spalls and leaching cracks on N face of S Pier

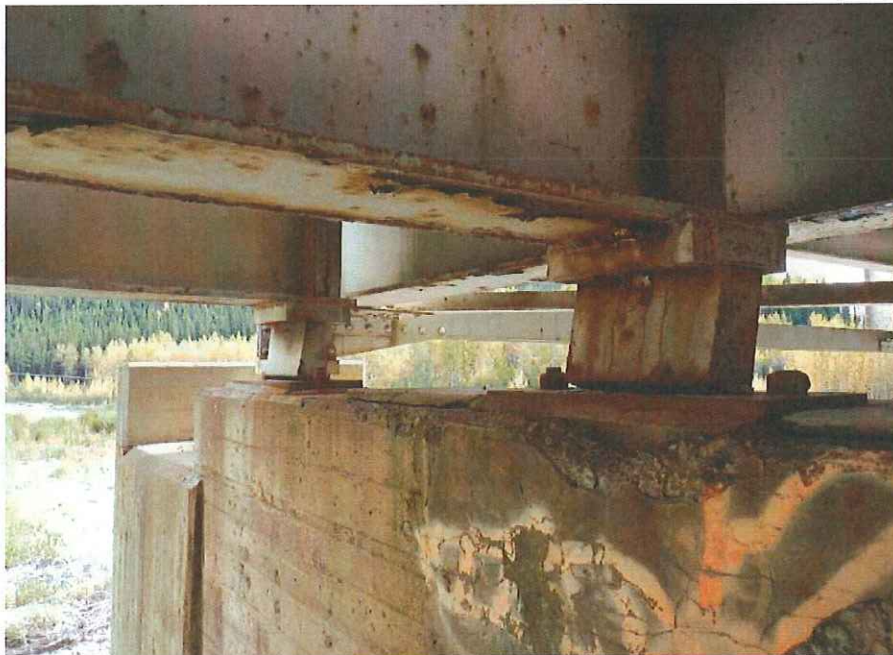
P24 - Span 3 girder bearings at E end of N Pier

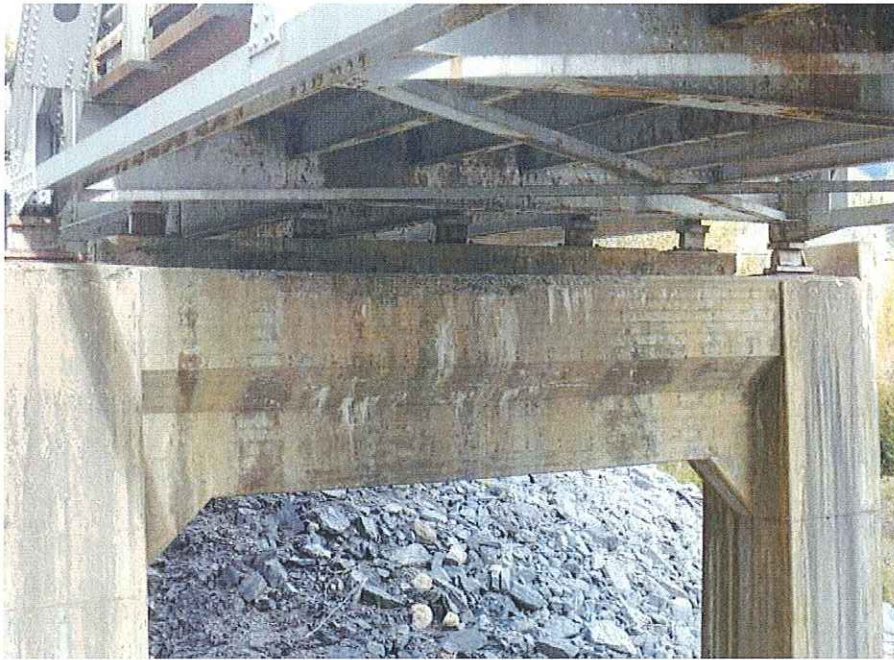
P25 - Spalls and leaching cracks on S face of N Pier

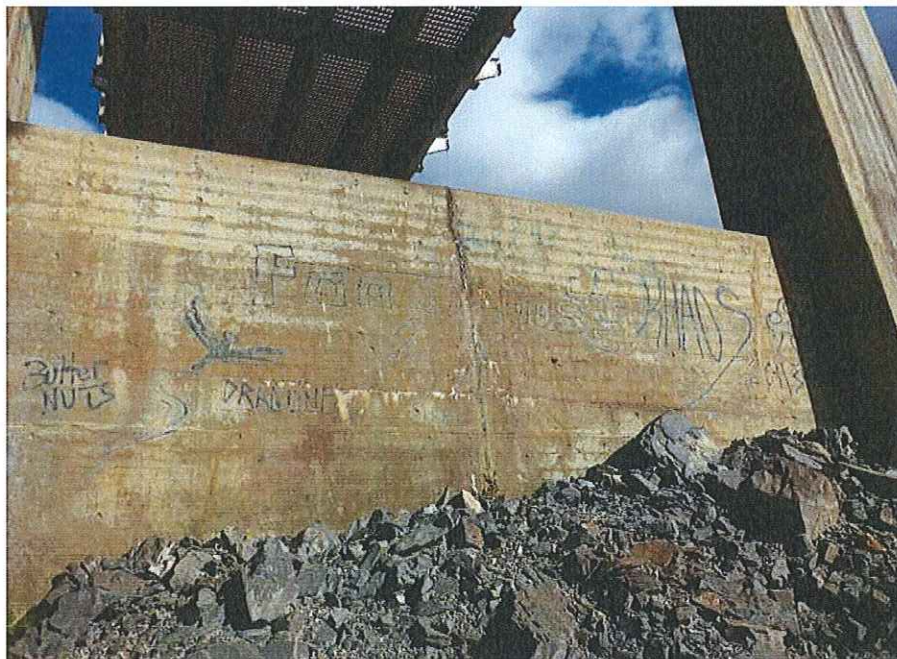
P26 - Wide vertical crack in middle of wall at base of N Pier

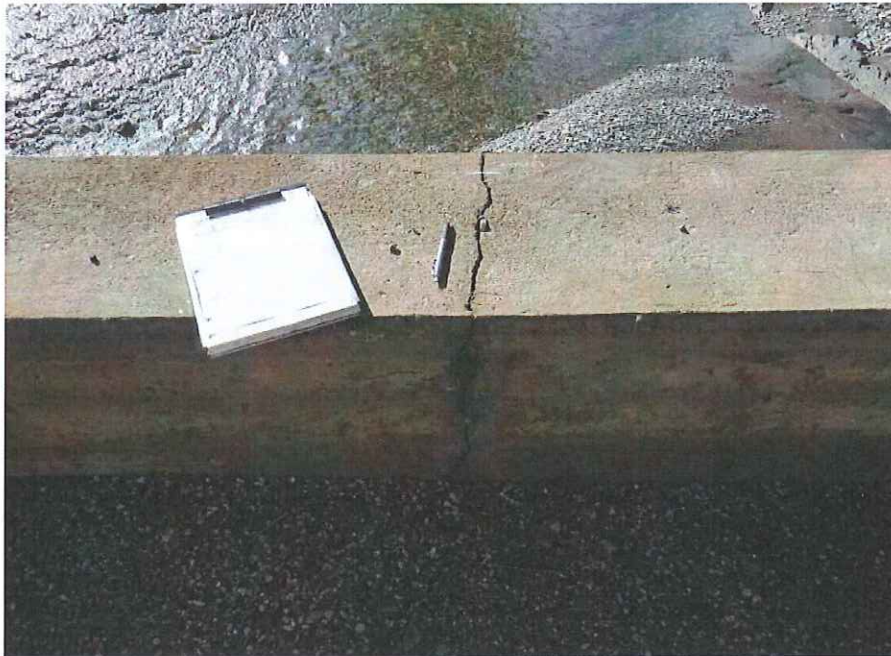
P27 - Wide vertical crack in middle of wall at base of N Pier

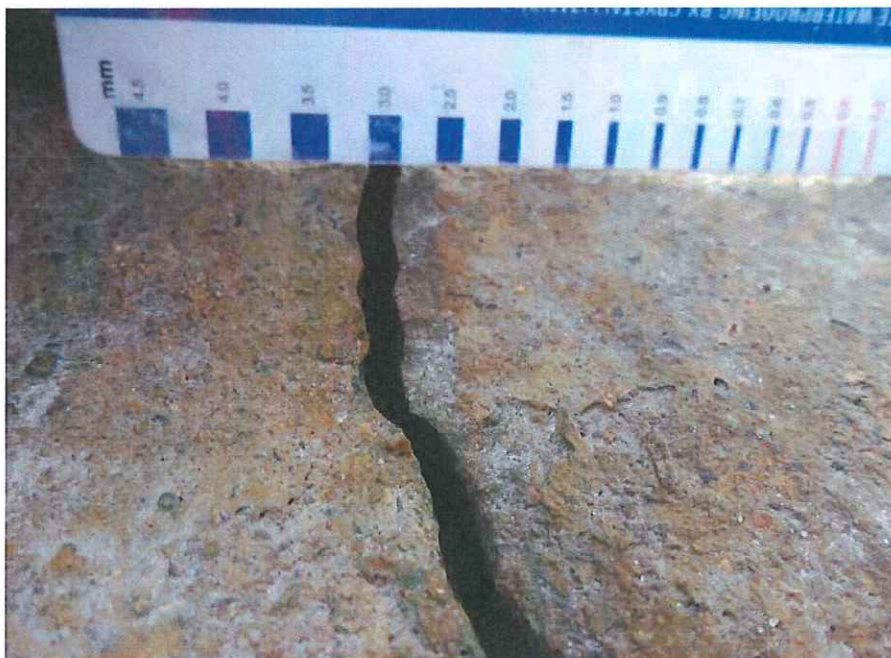
P28 - Wide vertical crack in middle of wall at base of N Pier

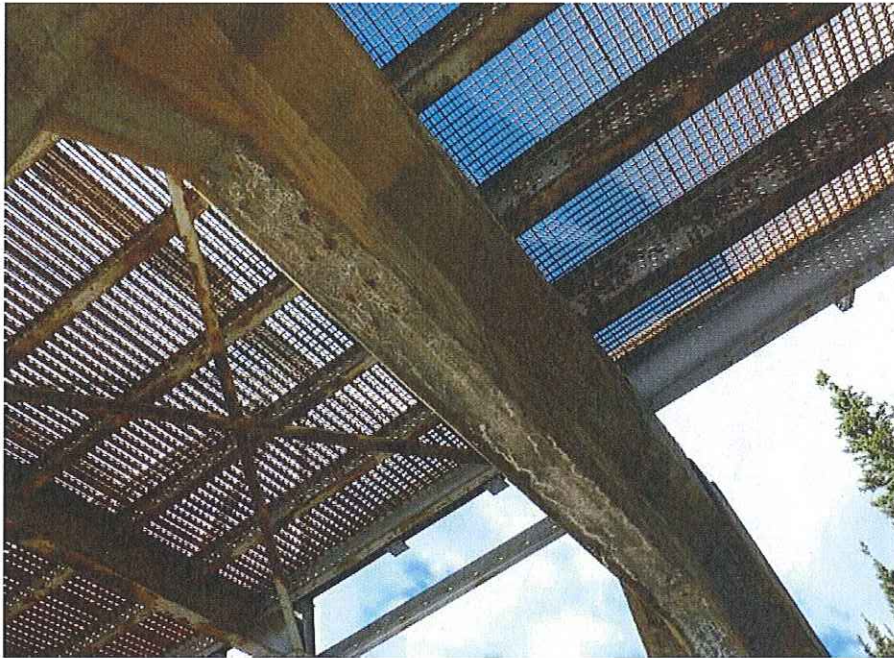
P29 - Efflorescence, cracking and scaling on soffit of N Pier cap beam

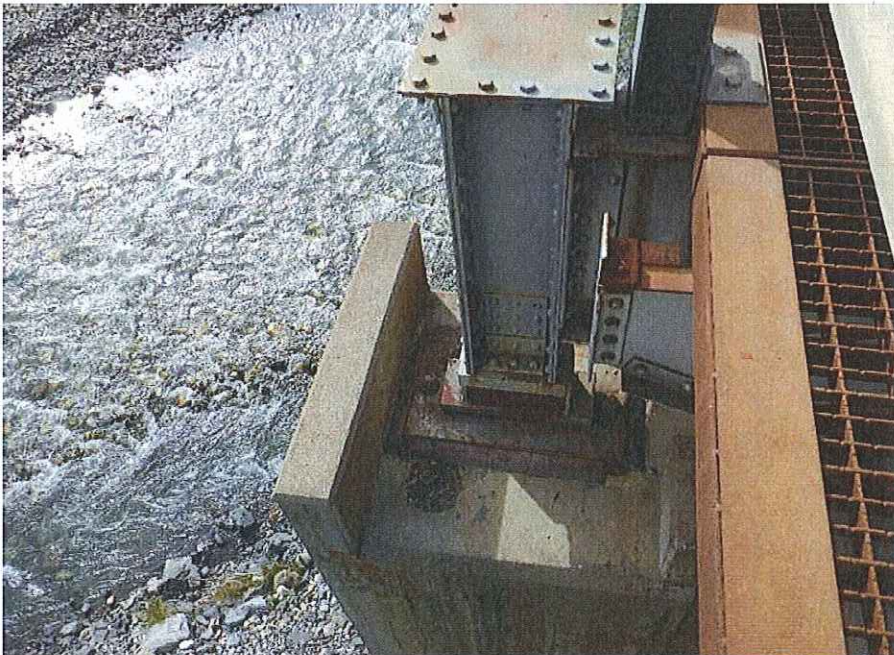
P30 - General view of end post on N end of E truss

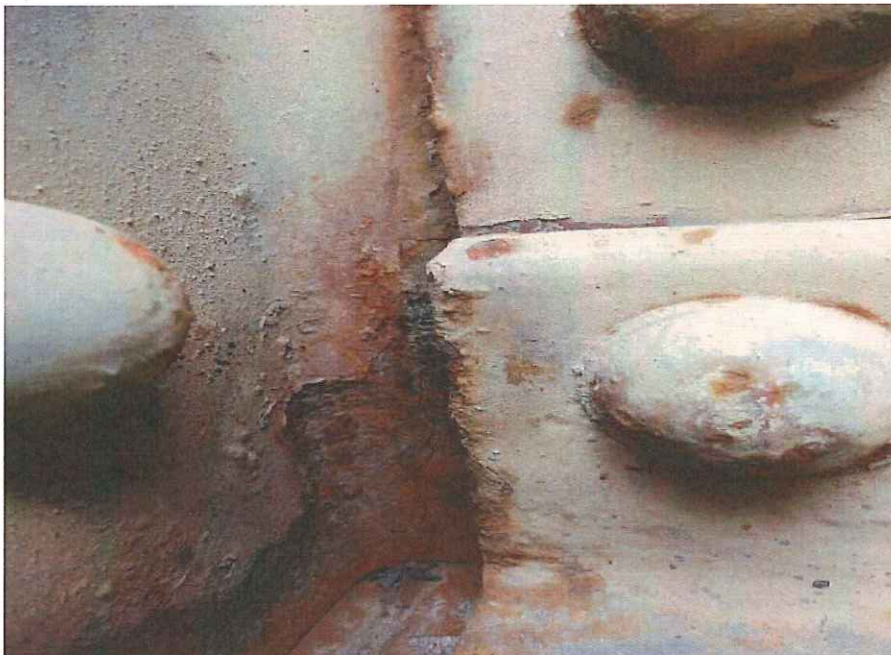
P32 - Cracking in steel at E side of end post at N end of W truss

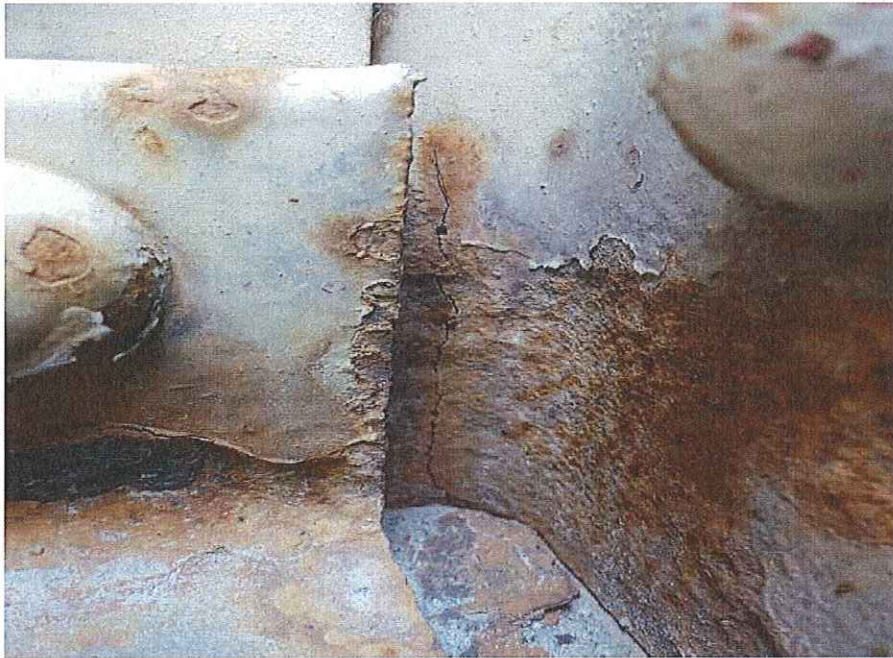
P33 - Cracking in steel at w side of end post at N end of W truss

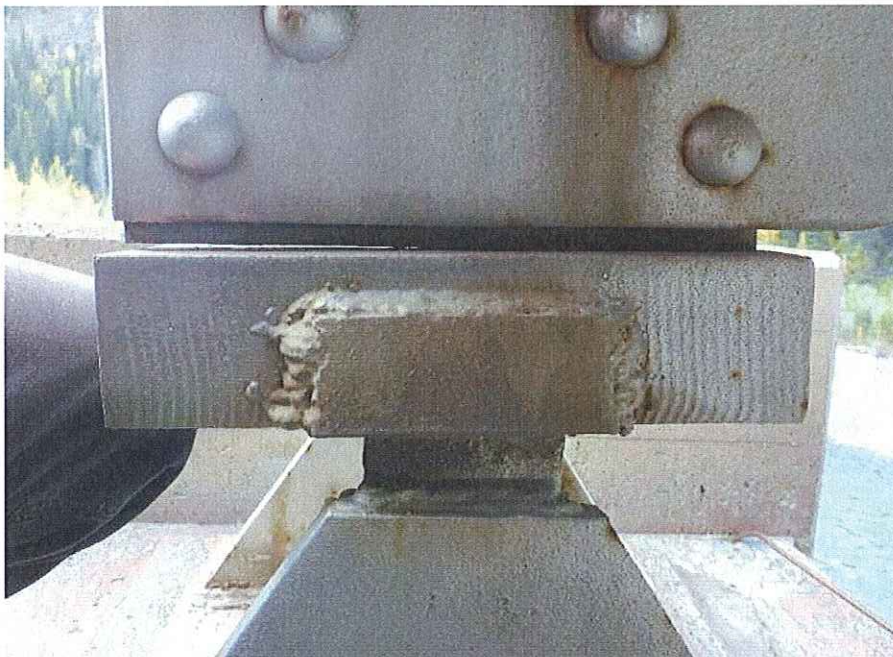
P34 - Gap between E flange on end post and bearing top plate at S end of W truss

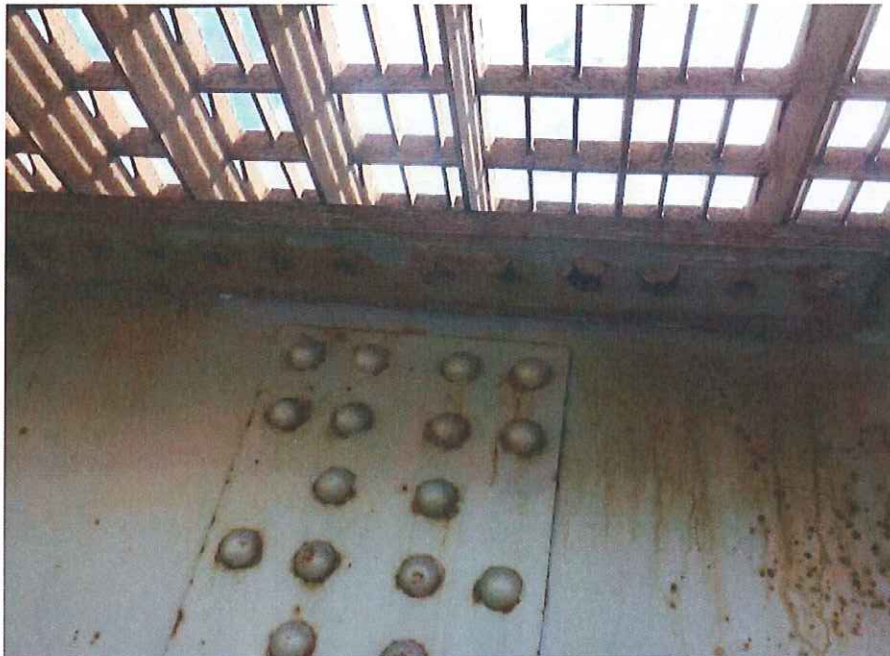
P39 - Missing rivets in top flange splice on W side of Girder G1 in Span 3

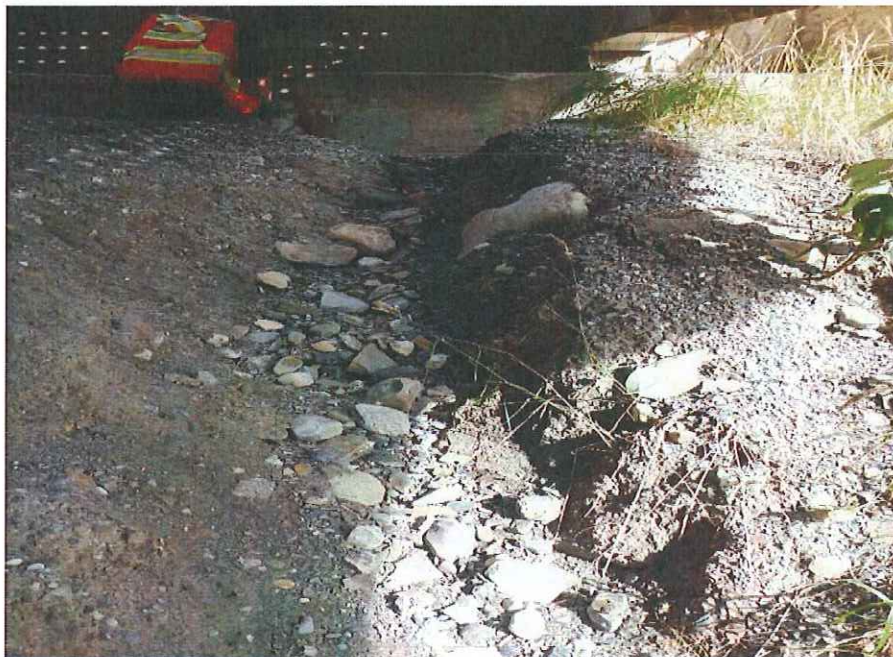
P40 - Erosion of material deposited from roadway onto N embankment beneath Span 3

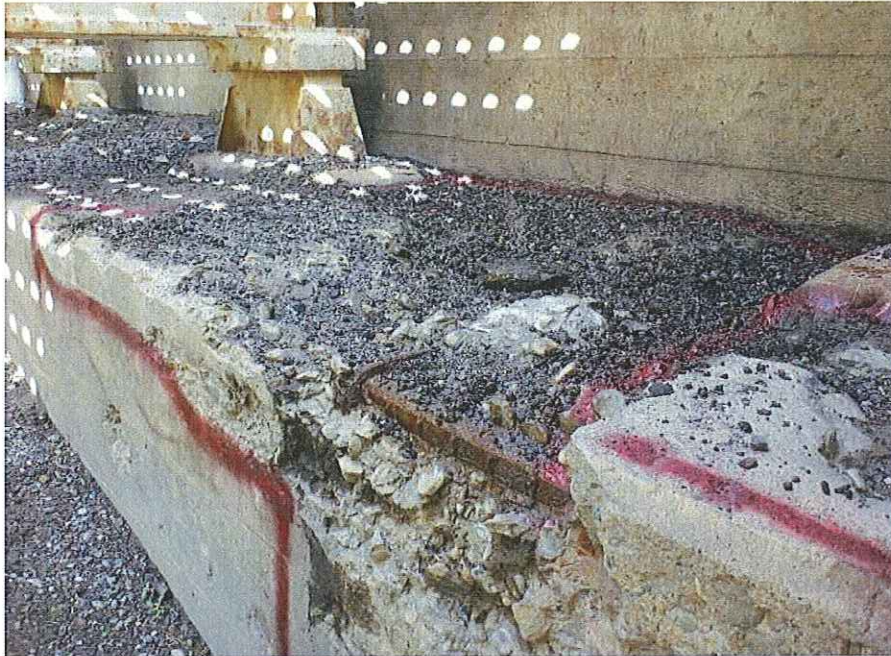
P41 - Spall with exposed rebar on N Abutment bearing seat

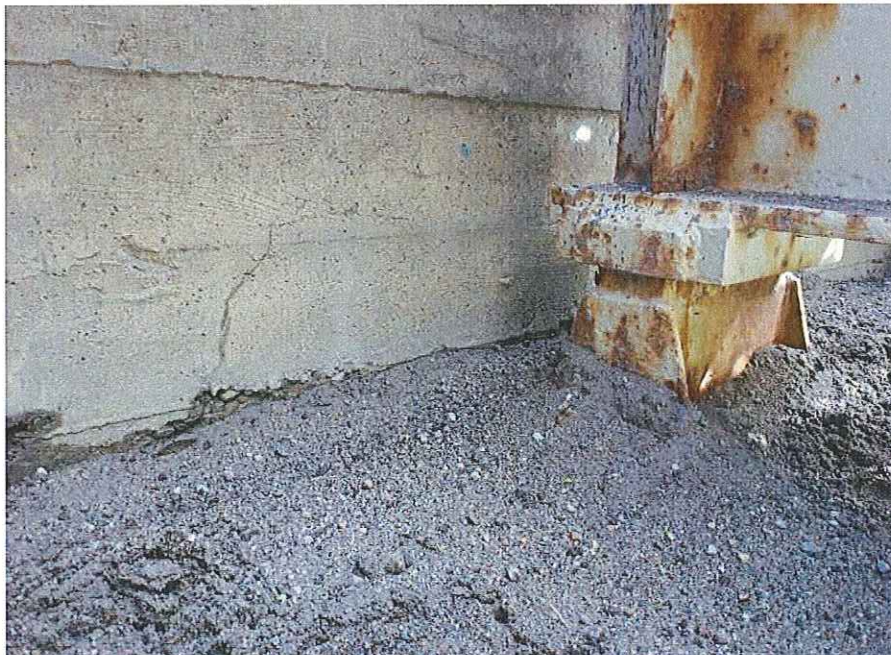
P42 - Typical debris on N Abutment bearing seat

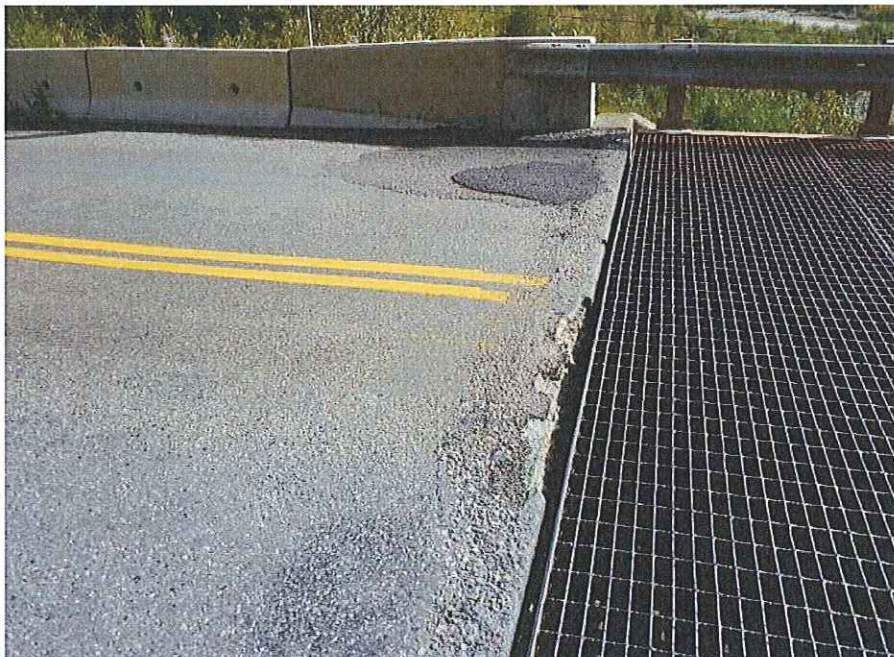
P50 - Damaged BST at N Abutment deck joint

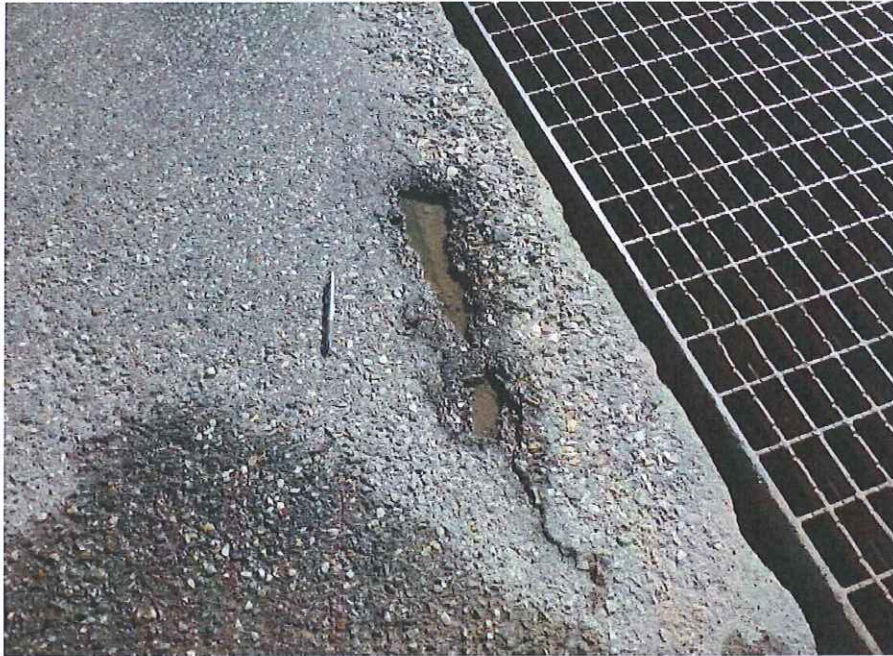
P51 - Damaged BST at N Abutment deck joint

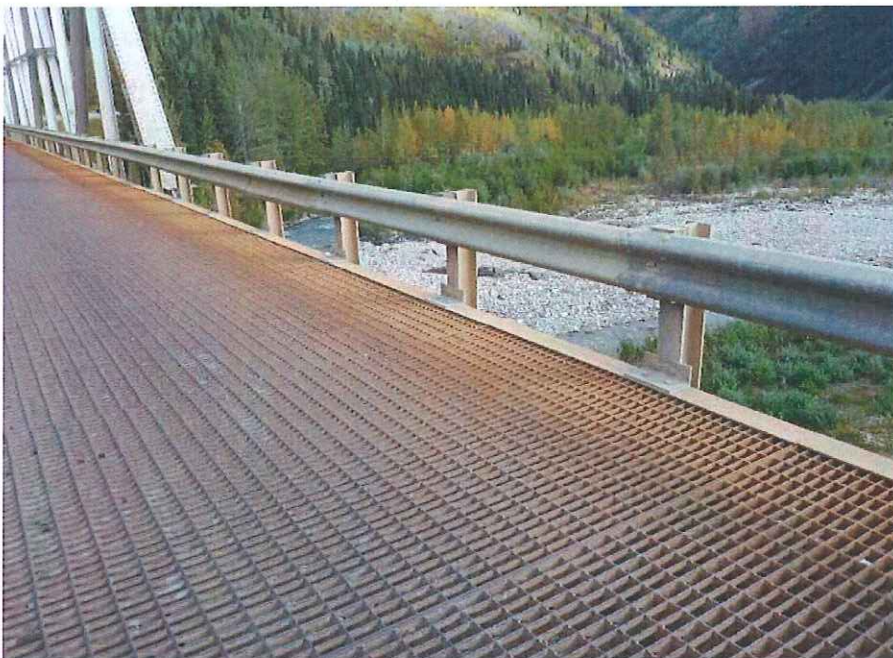
P52 - Typical bridge barrier

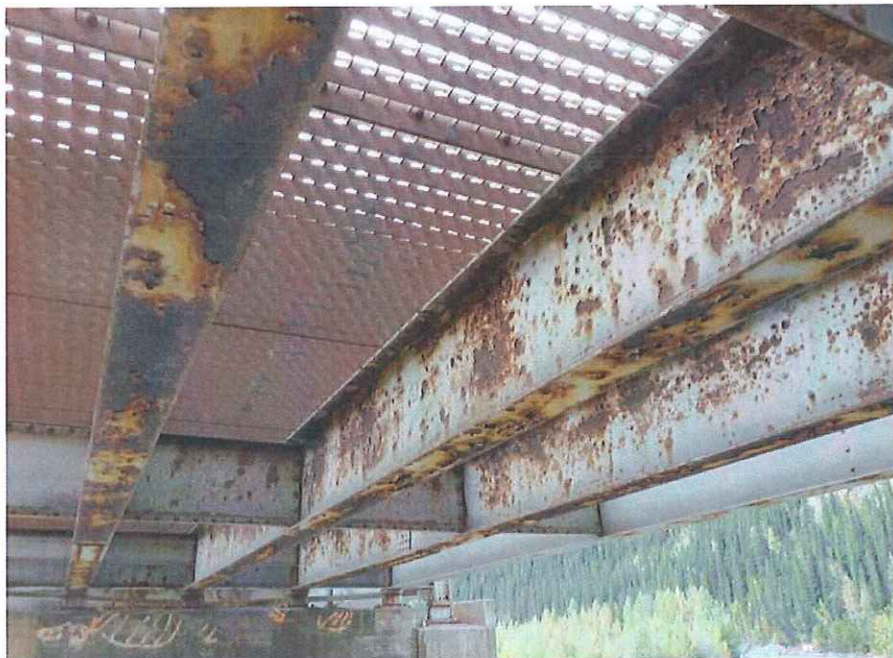
P56 - Typical condition of steel coating on Span 3 girders

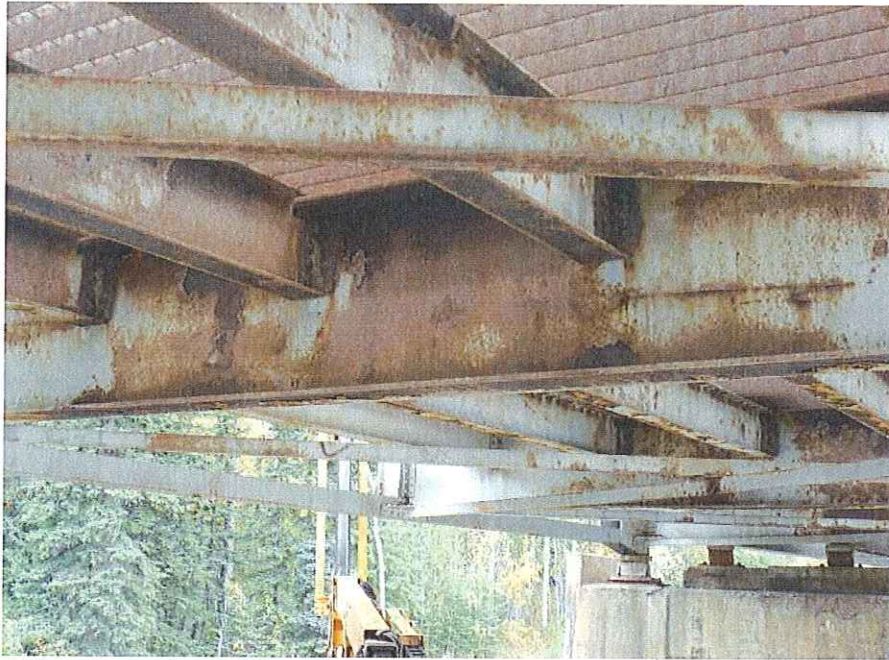
P57 - Typical condition of steel coating on steel floor beams and stringers on Span 2

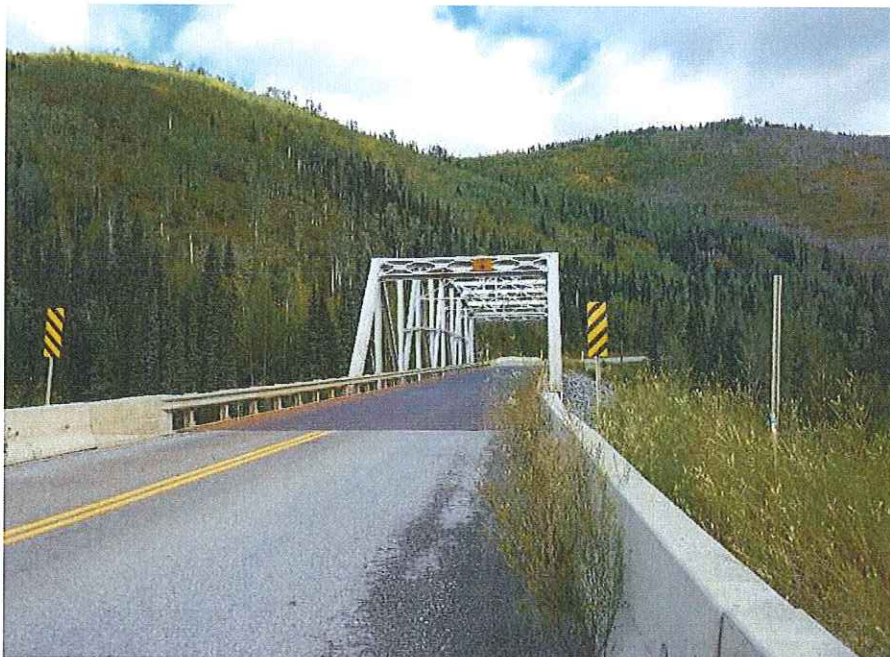
P58 - Missing stream ID sign on S approach
