PUBLIC SERVICES AND PROCUREMENT CANADA

KINGSTON MILLS LOCKS 46 TO 49 REHABILITATION INVESTIGATIVE GEOTECHNICAL REPORT

JUNE 27, 2018

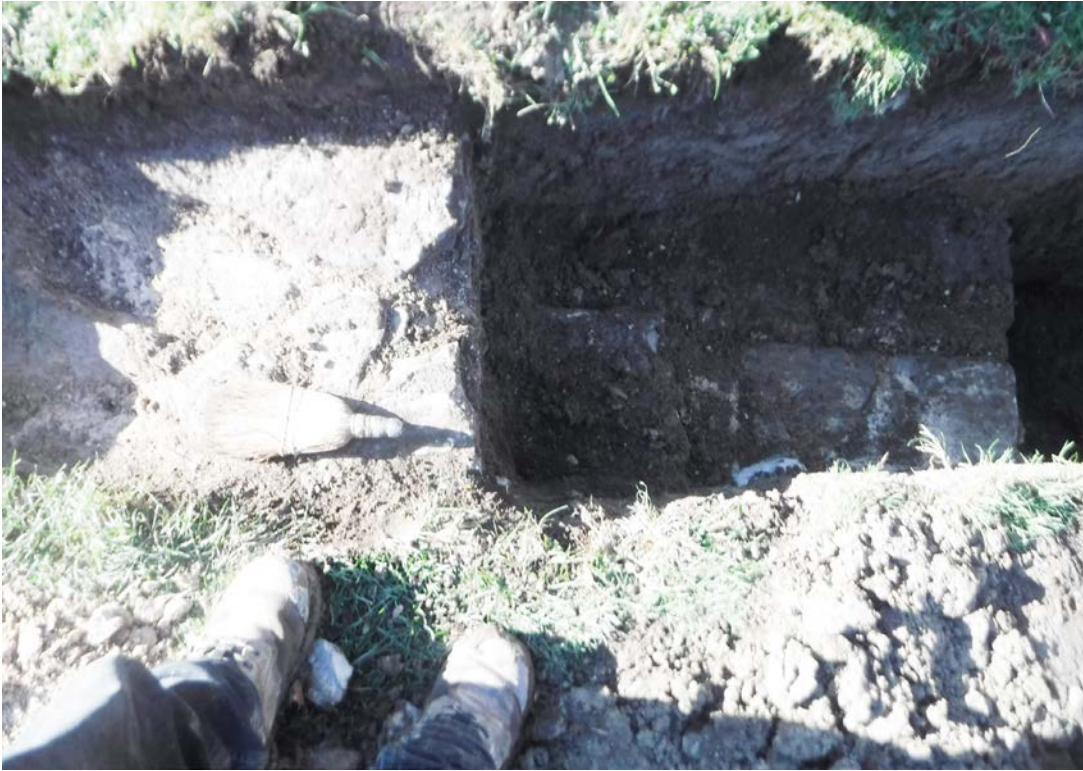
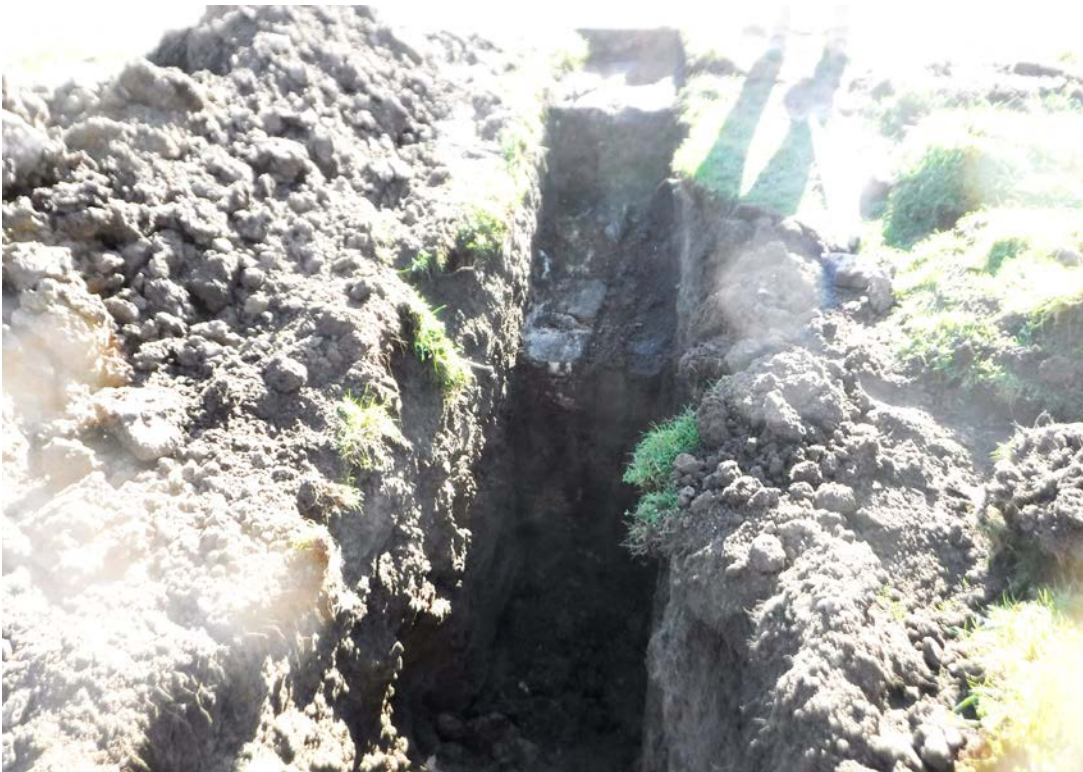
Test Pit #1 – Top of wall and buttress

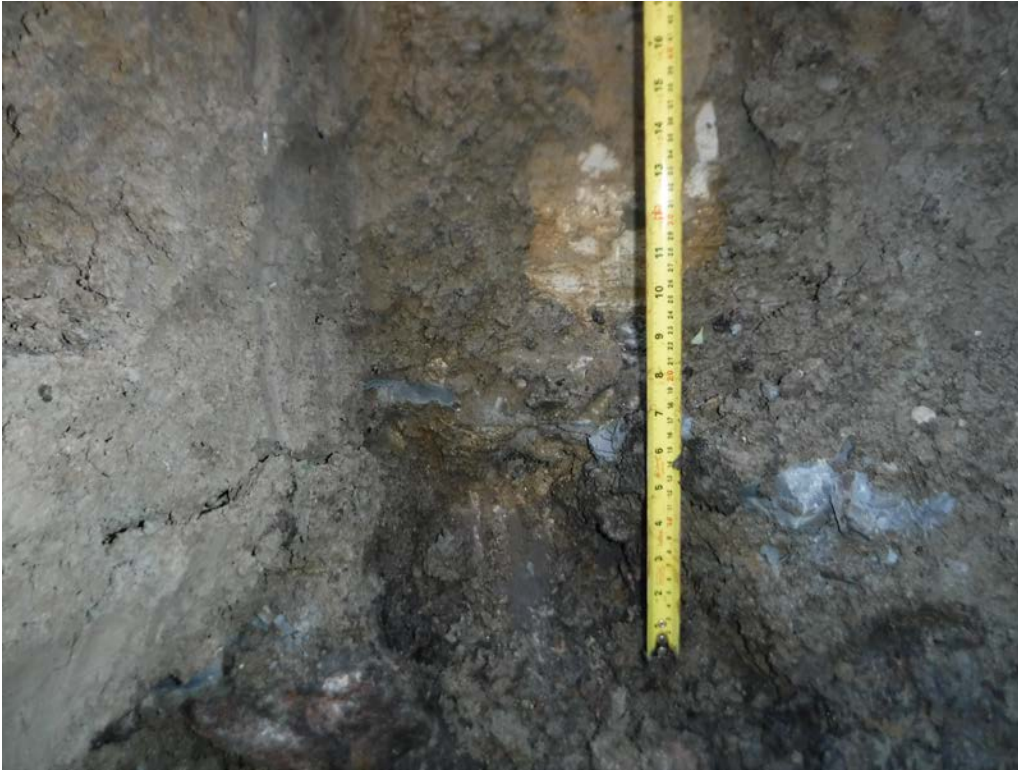
Test pit #1 – Layer of grout at bedrock

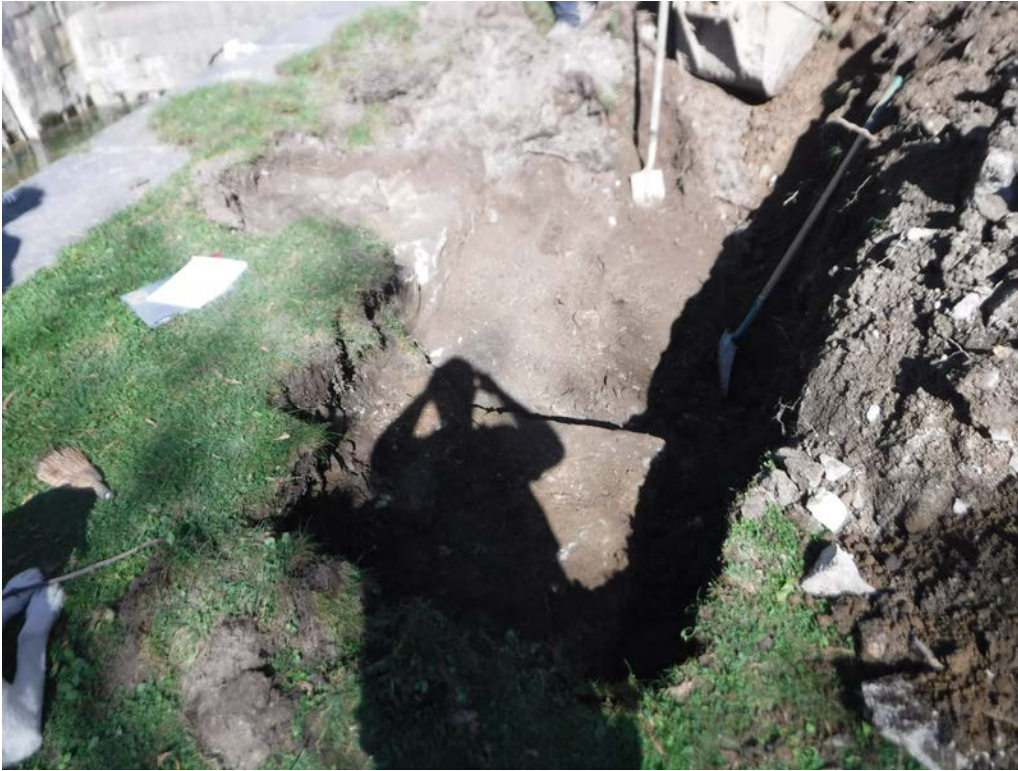
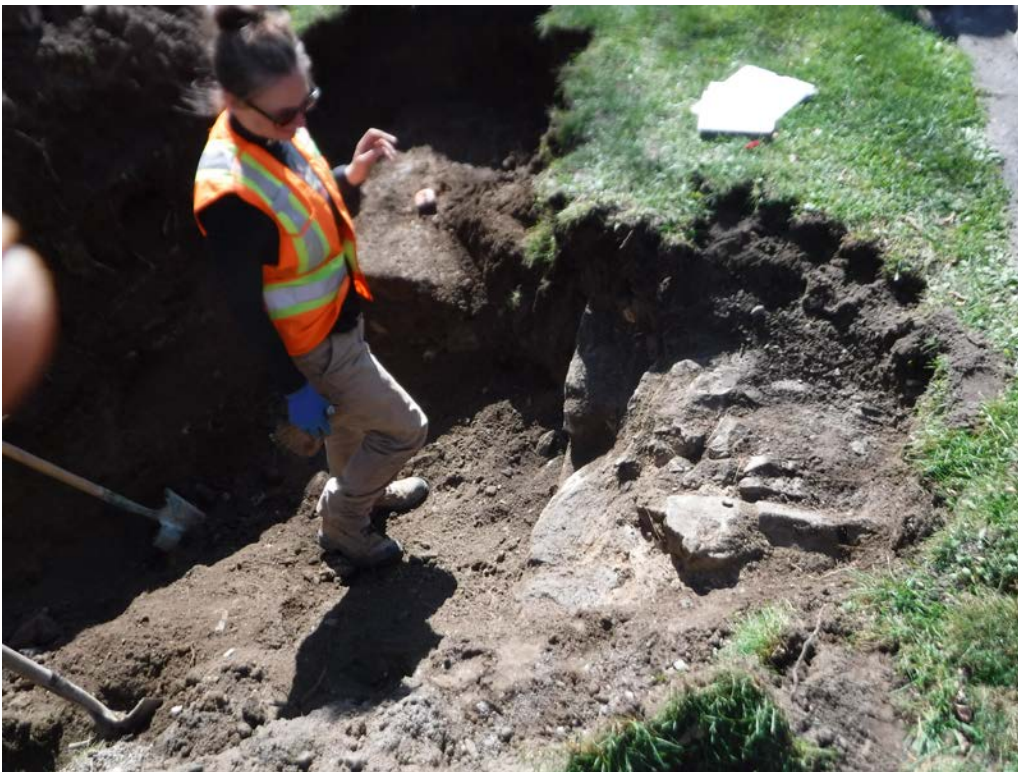
Test Pit #2 – Butters and back of chamber wall

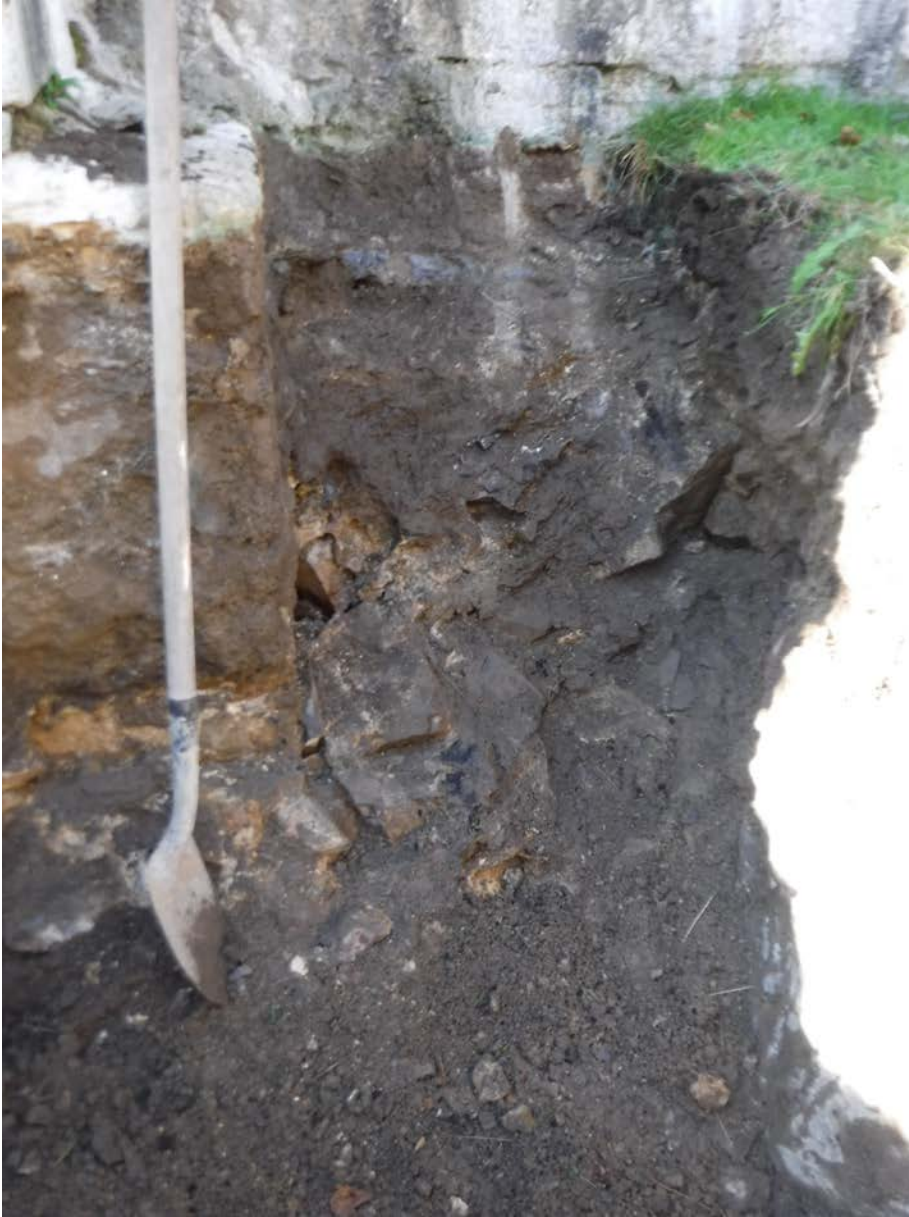
Test Pit #3 – Grouted rubble at base of chamber wall
