**Underwater Bridge Inspection  
Hamlet Swing Bridge  
Hamlet, ON**

**November 2-3, 2016**

**ASI Marine Proposal DH16-066**

**Underwater Inspection – Hamlet Swing Bridge  
1641 Muskoka District Road 49  
Hamlet, ON**

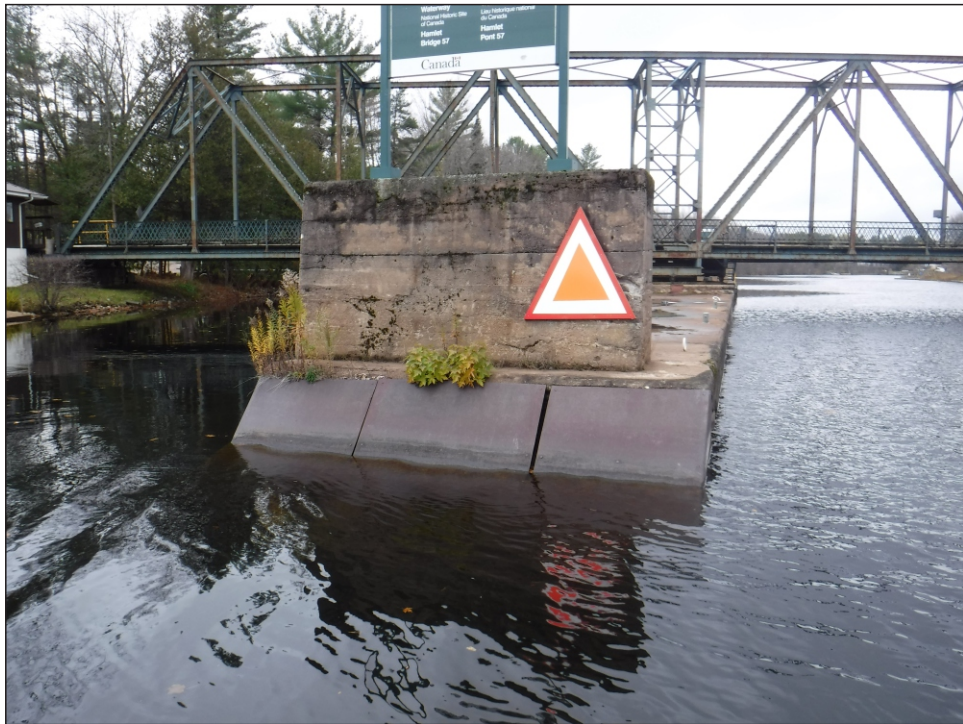
Image 1-6: South face of Rest Pier, looking north, steel plates extending into water

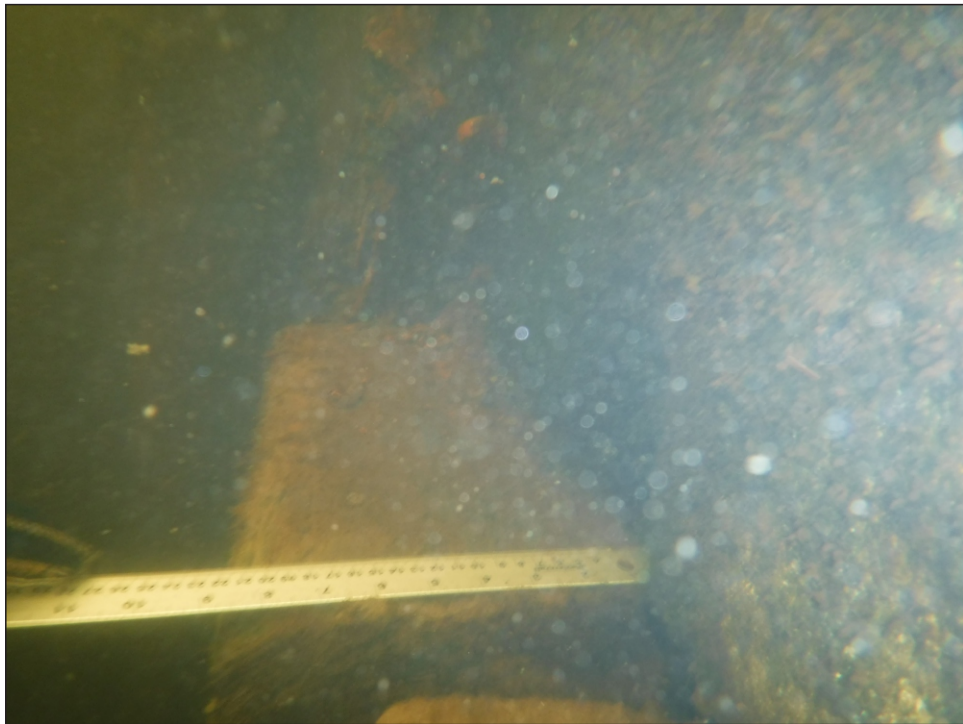
Image 1-18: Top timber offset at north limit of Rest Pier

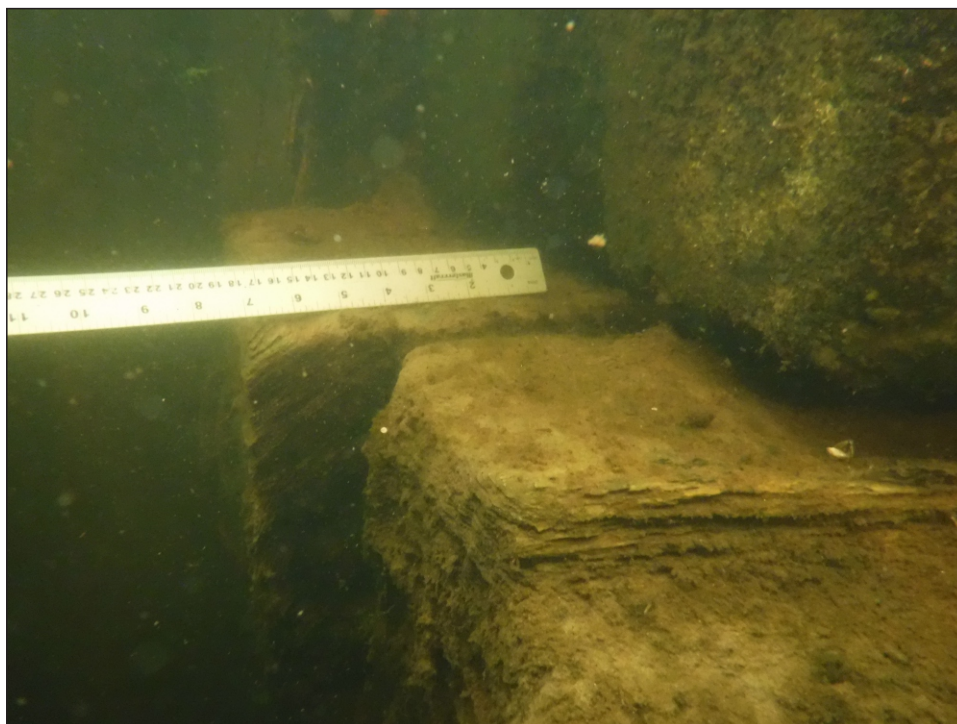
Image 1-19: Top timber offset at north limit of Rest Pier

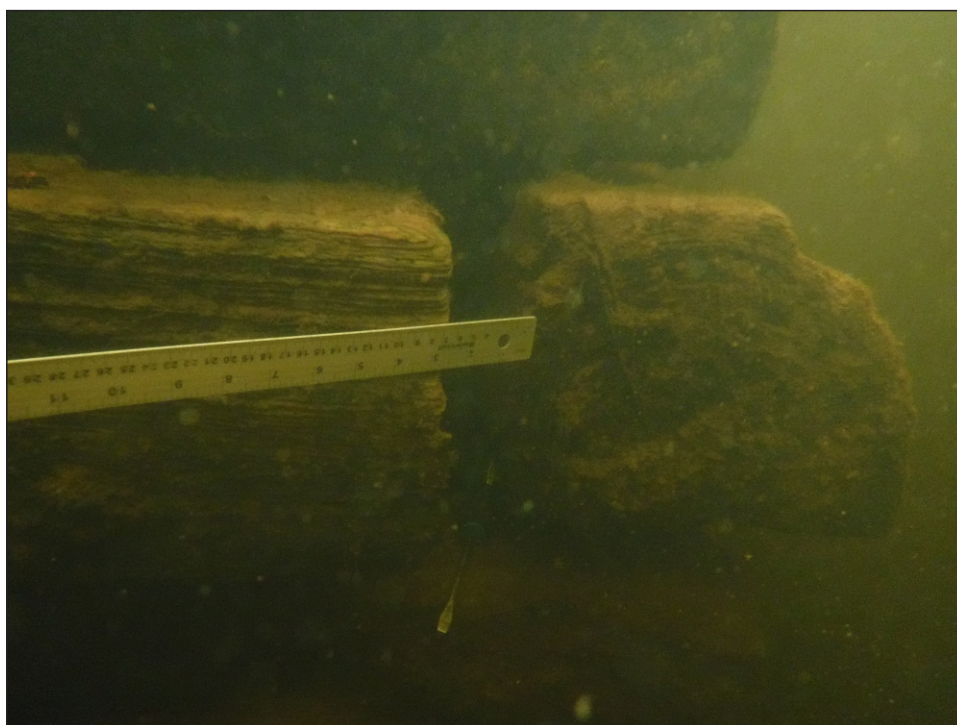
Image 1-20: North west corner of Rest Pier, looking south, gap between timbers

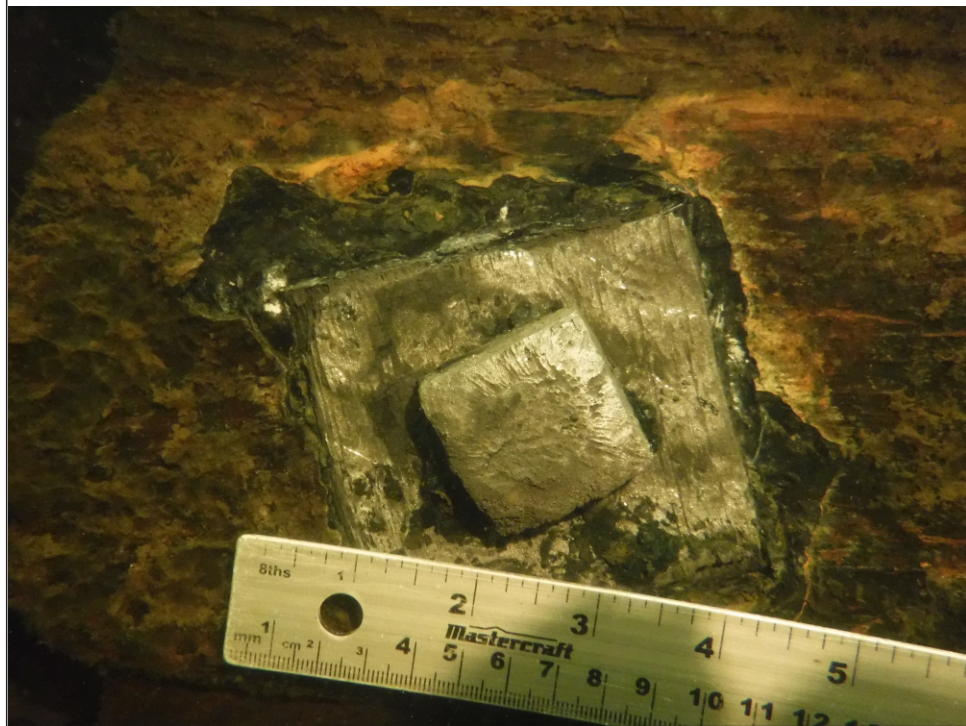
Image 1-21: Square head connection bolt, all bolts and washers in good condition, Rest Pier

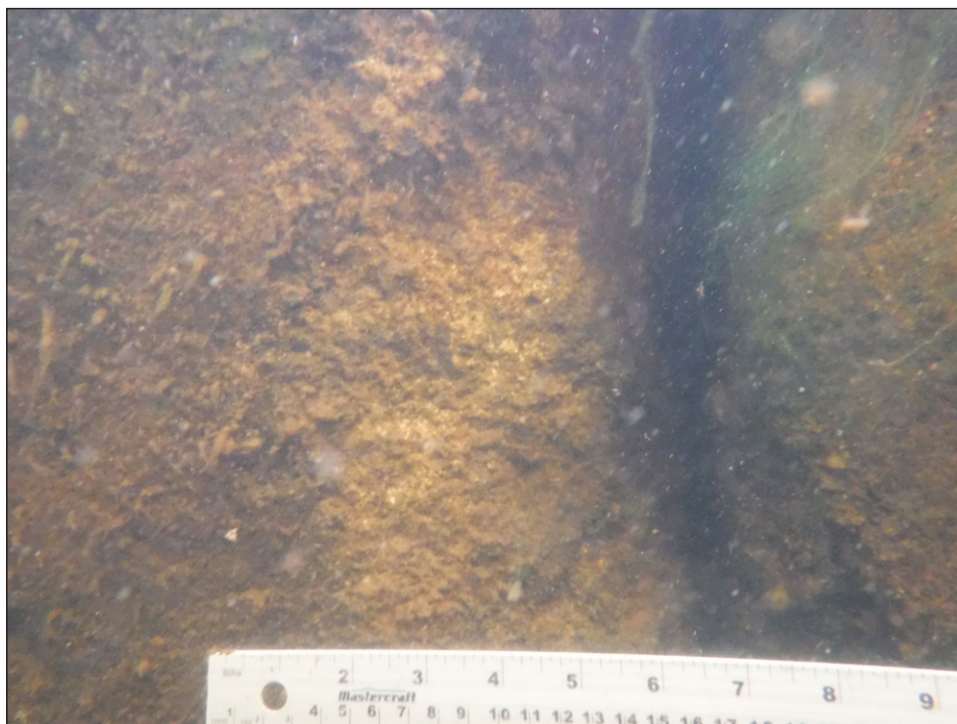
Image 1-23: Spall 1 m below surface at north end of Rest Pier, spall severity typical for Rest Pier

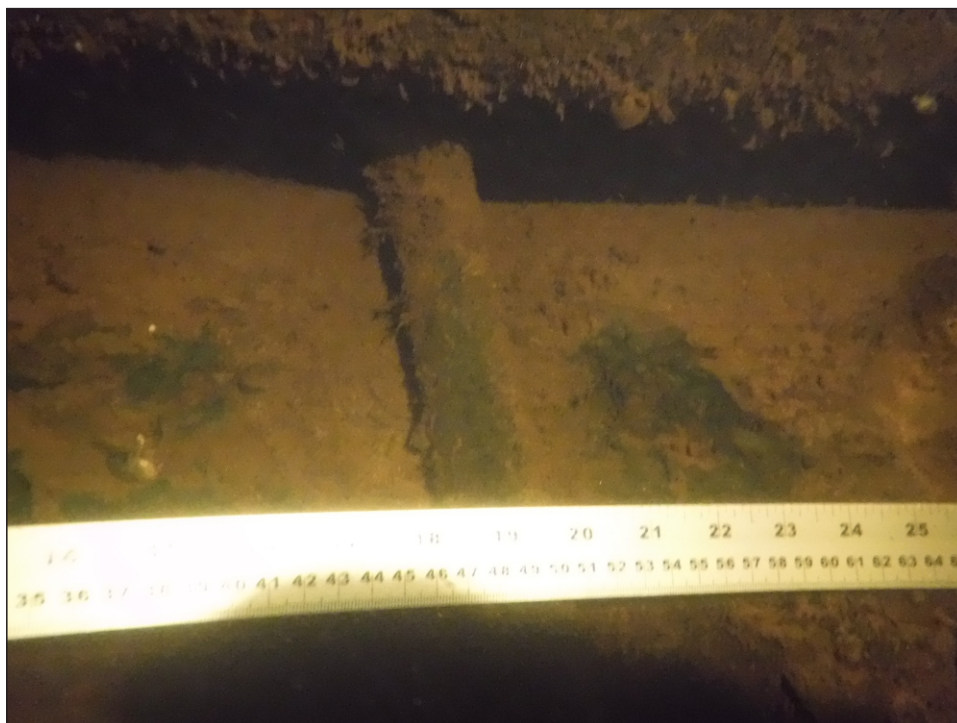
Image 1-24: Electrical conduit on east side of Rest Pier, extending into lake bottom

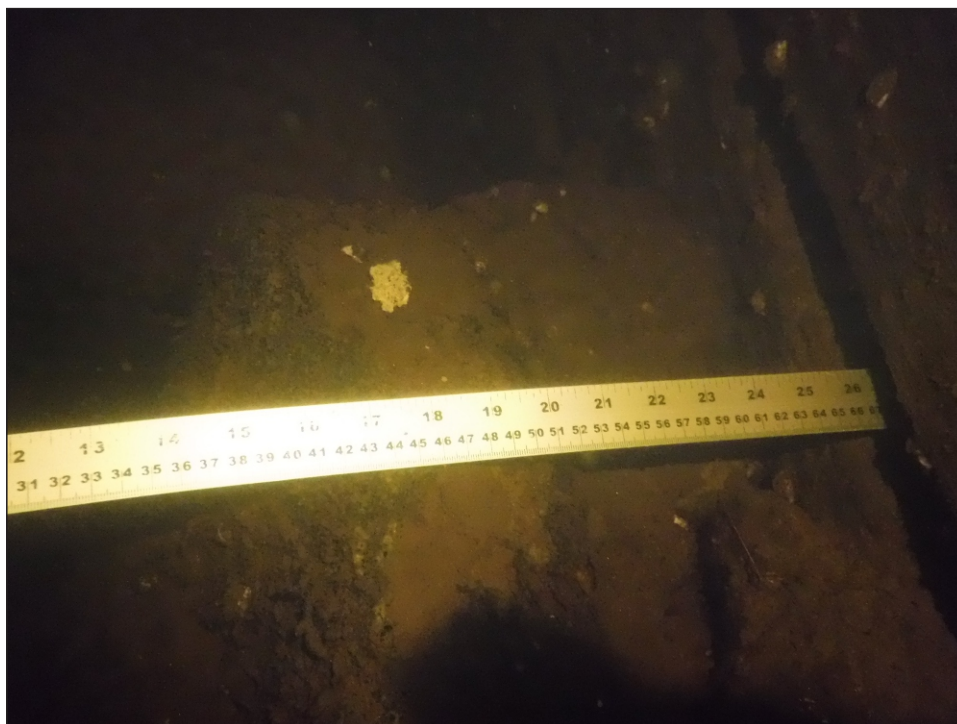
Image 1-25: Rip-rap on lake bottom at 0+024, east side of Rest Pier

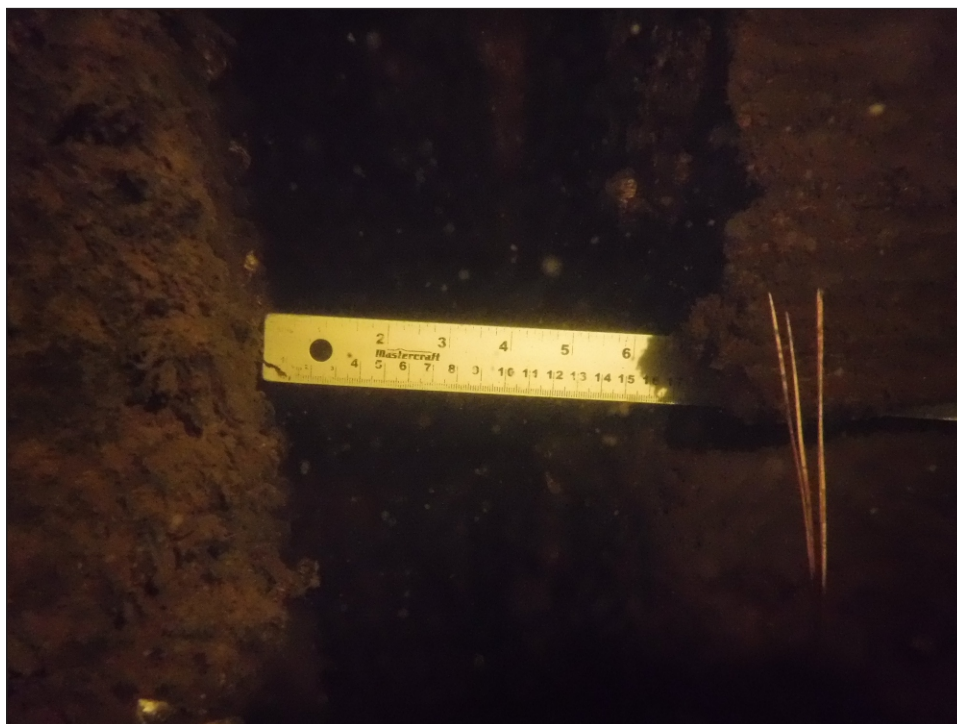
Image 1-27: Gap between timber crib and Pivot Pier, east side of Rest Pier

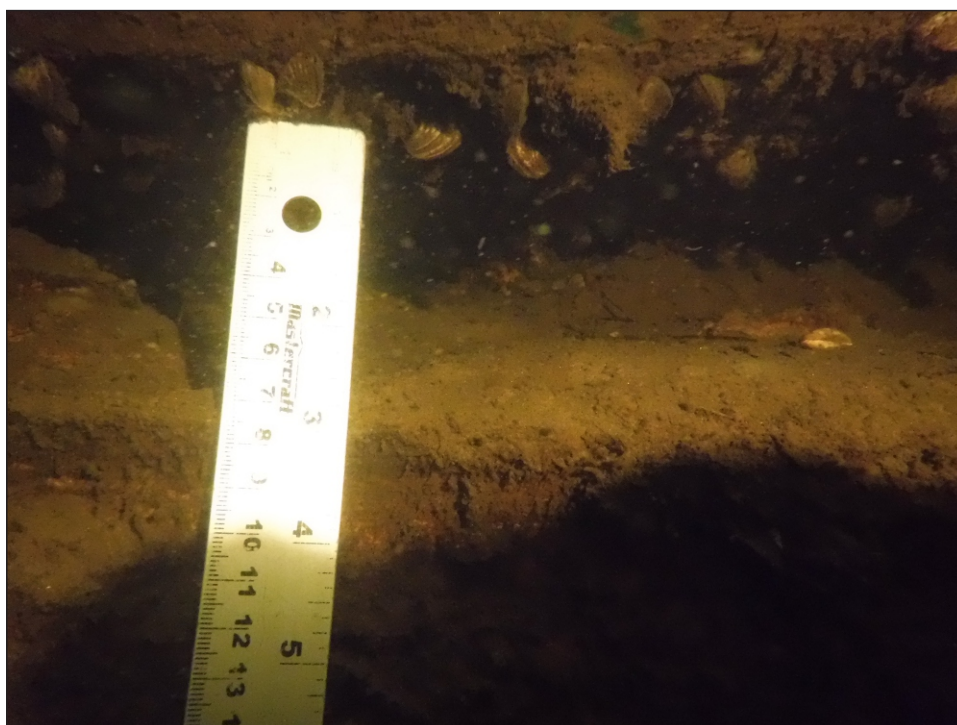
Image 1-28: Gap between timbers, east side of Rest Pier

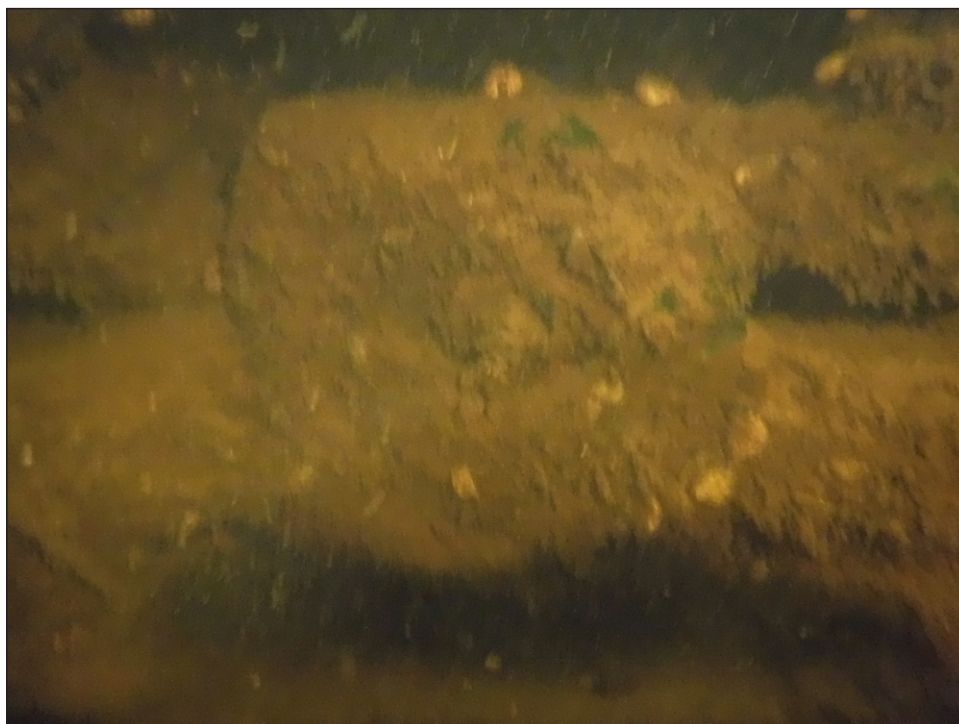
Image 1-29: End grain of tieback timber east side of Rest Pier

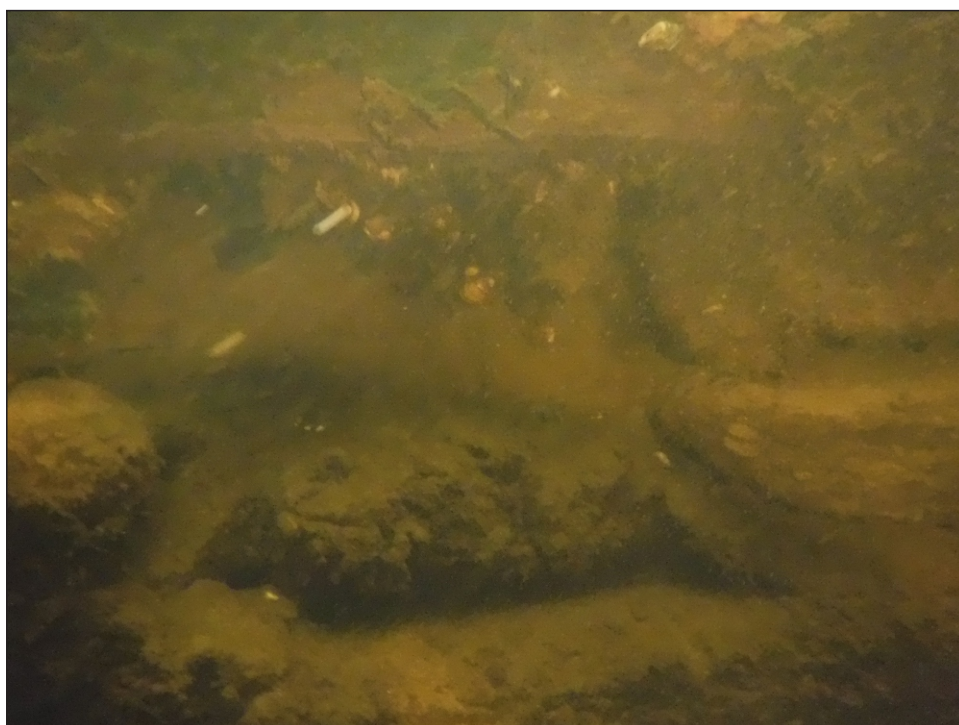
Image 1-30: Tieback timber in poor condition, east side of Rest Pier

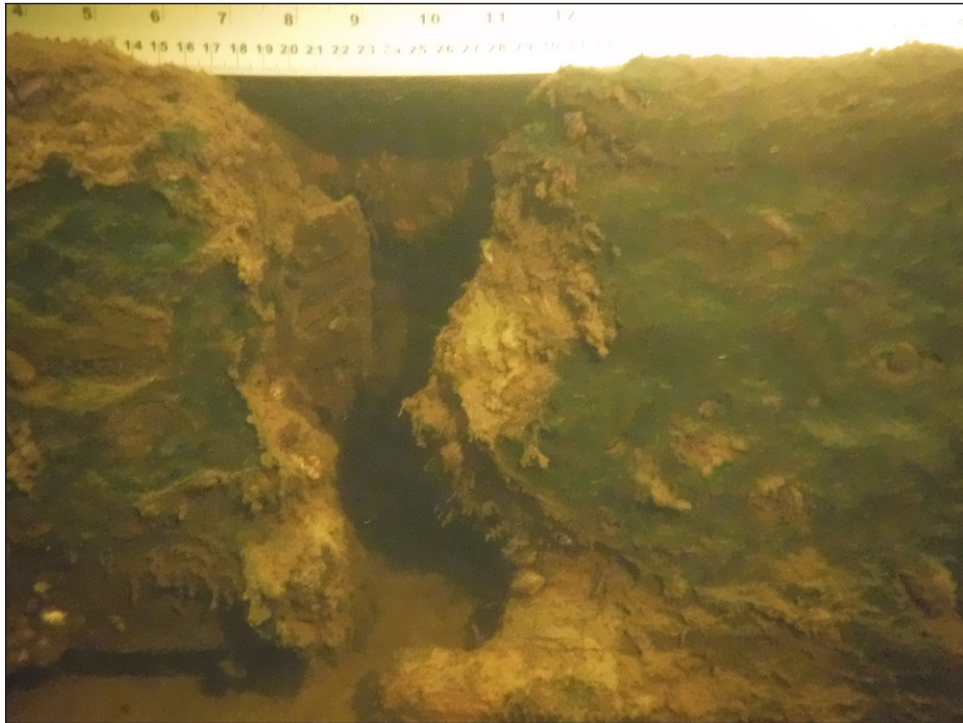
Image 1-31: Tieback timber, gap size typical on east side of Rest Pier

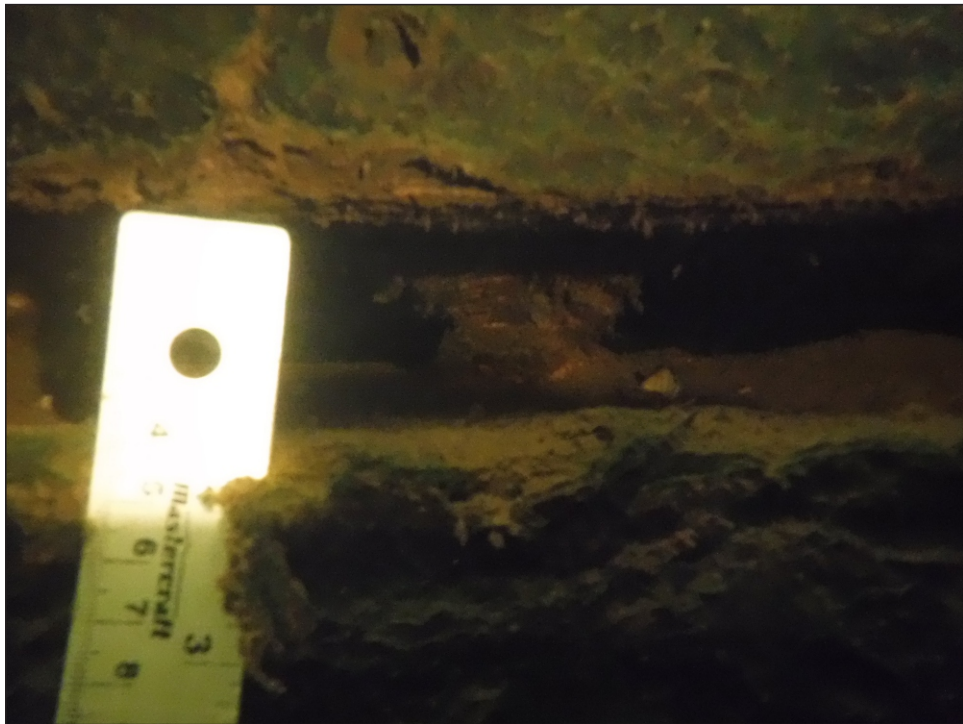
Image 1-32: Horizontal timbers, gap typical on east side of Rest Pier

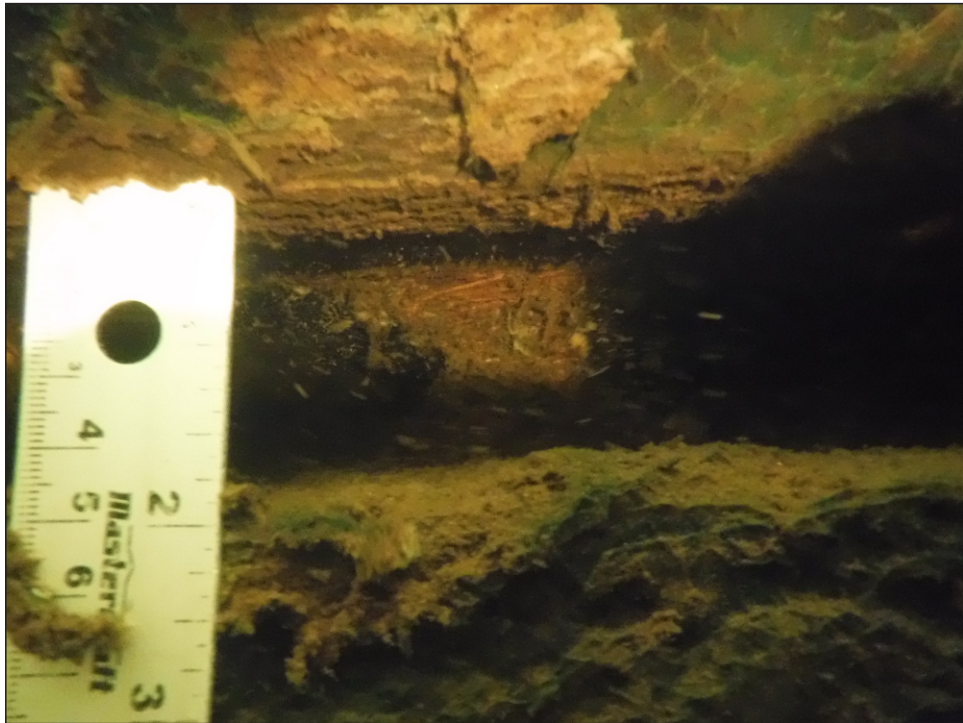
Image 1-33: Gap between horizontal timbers, east side of Rest Pier

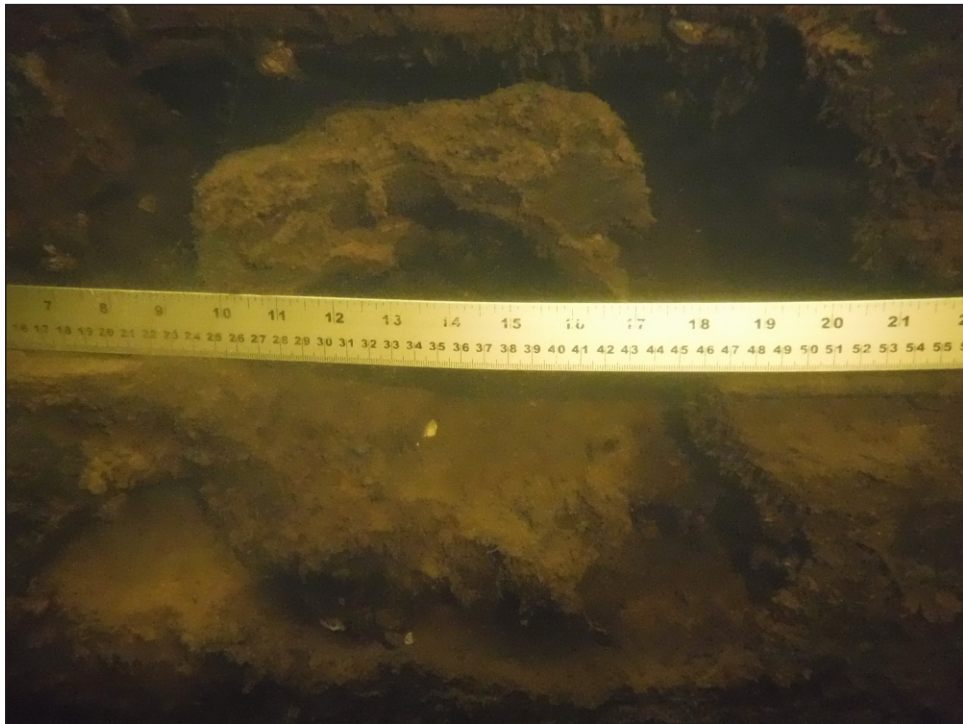
Image 1-34: Rotted tieback timber, east side of Rest Pier

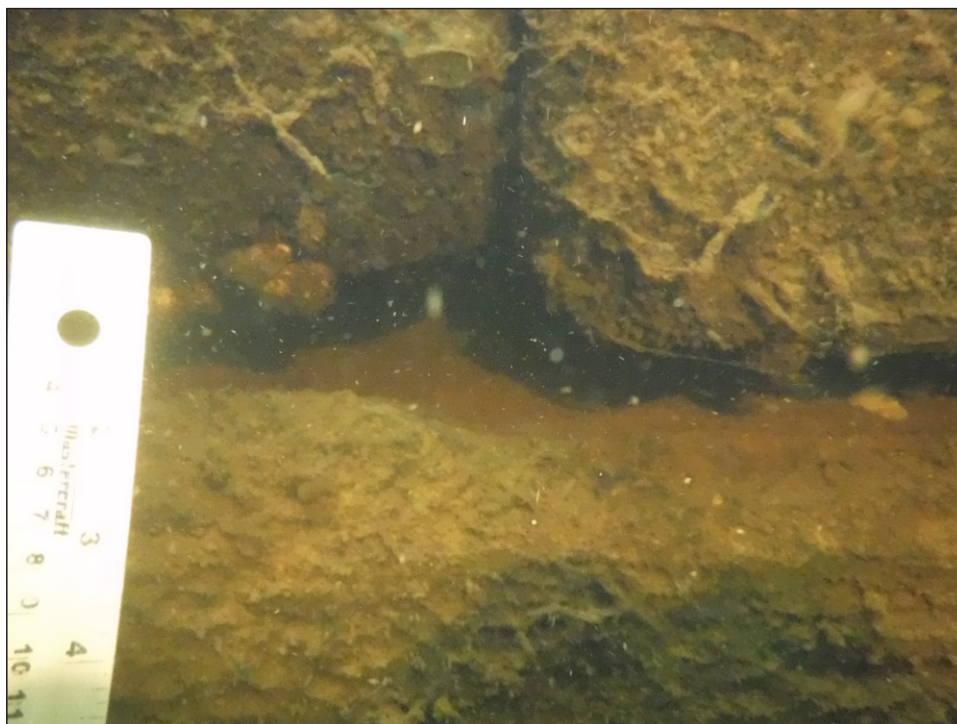
Image 1-37: Spall on concrete block, west side of Rest Pier. Gap/spall between blocks at corners typical throughout inspection

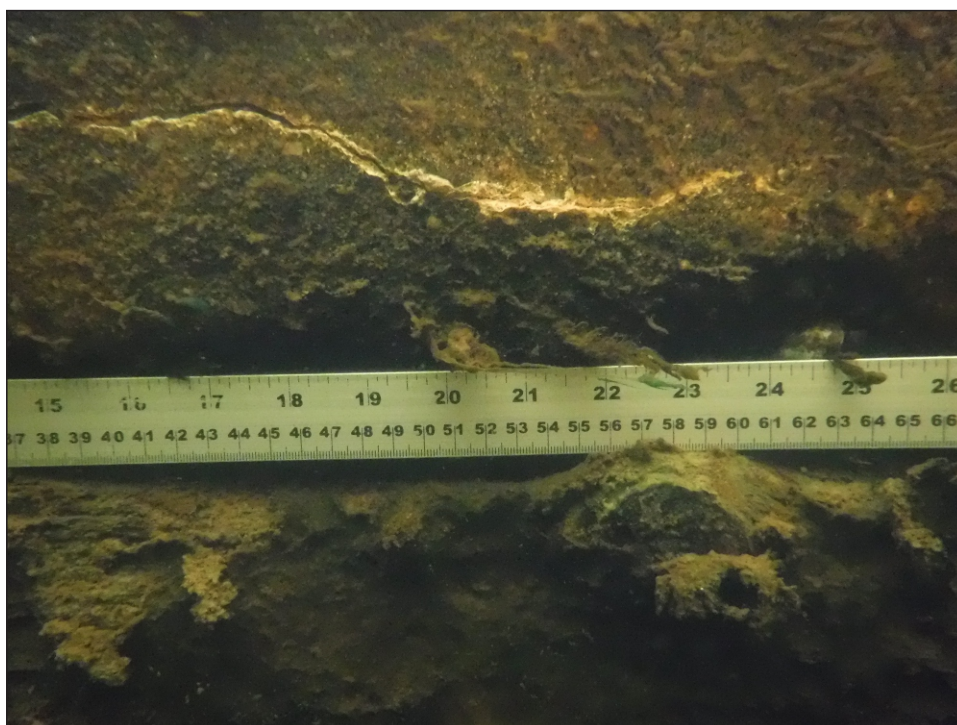
Image 1-38: Horizontal crack, west side of Rest Pier

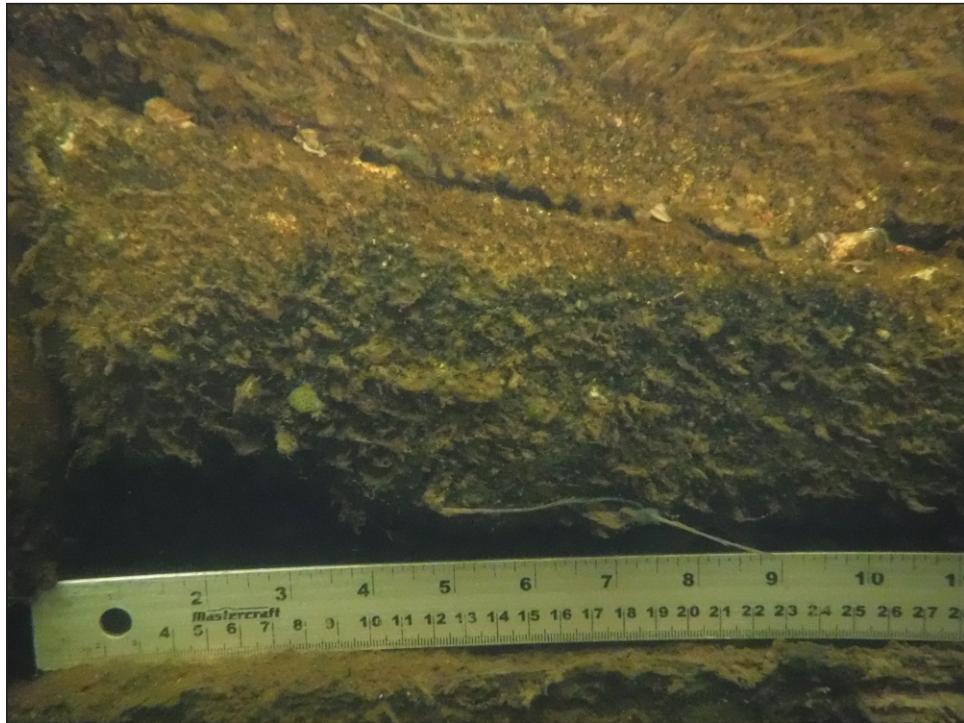
Image 1-39: Crack in concrete, west side of Rest Pier

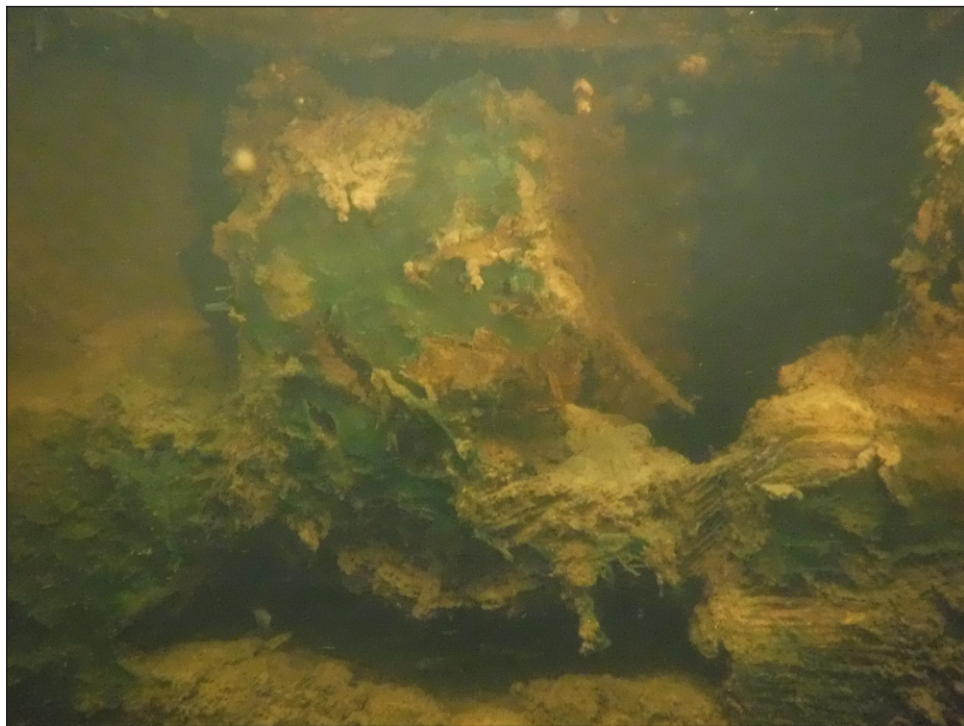
Image 1-40: Tieback timber, end grain rotted, Rest Pier

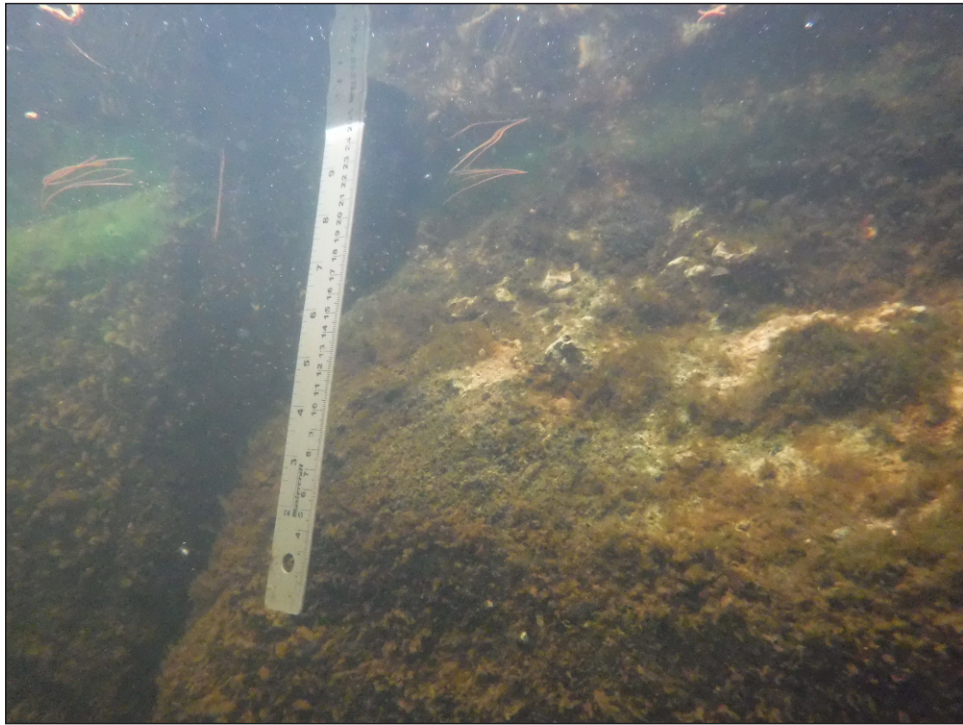
Image 1-41: Spall at waterline, west side of Rest Pier

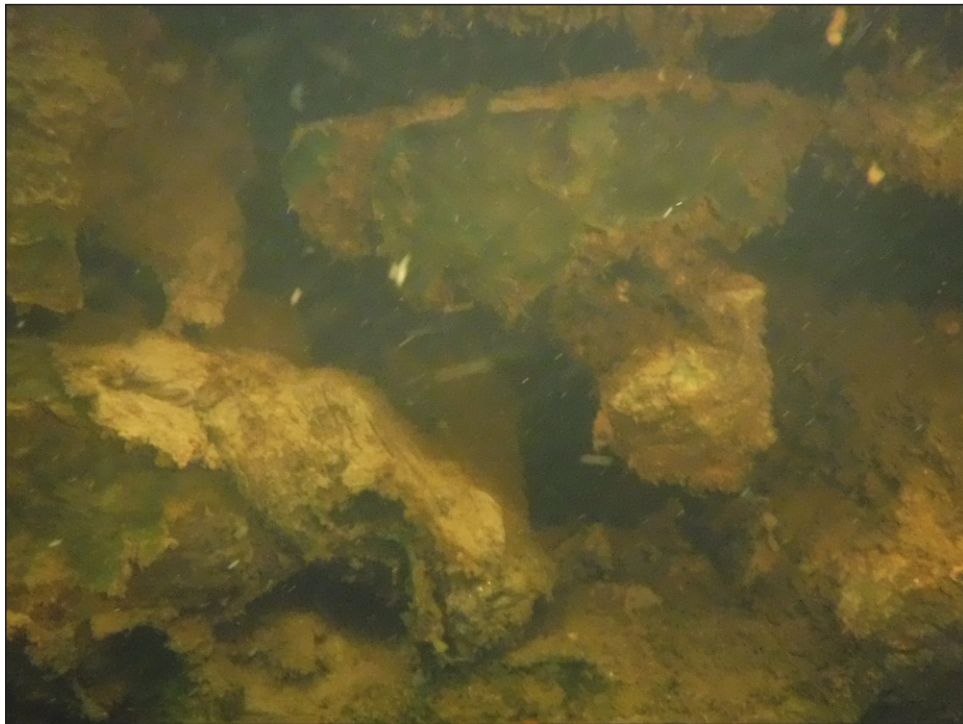
Image 1-42: Tieback timber, end grain rotted, west side of Rest Pier

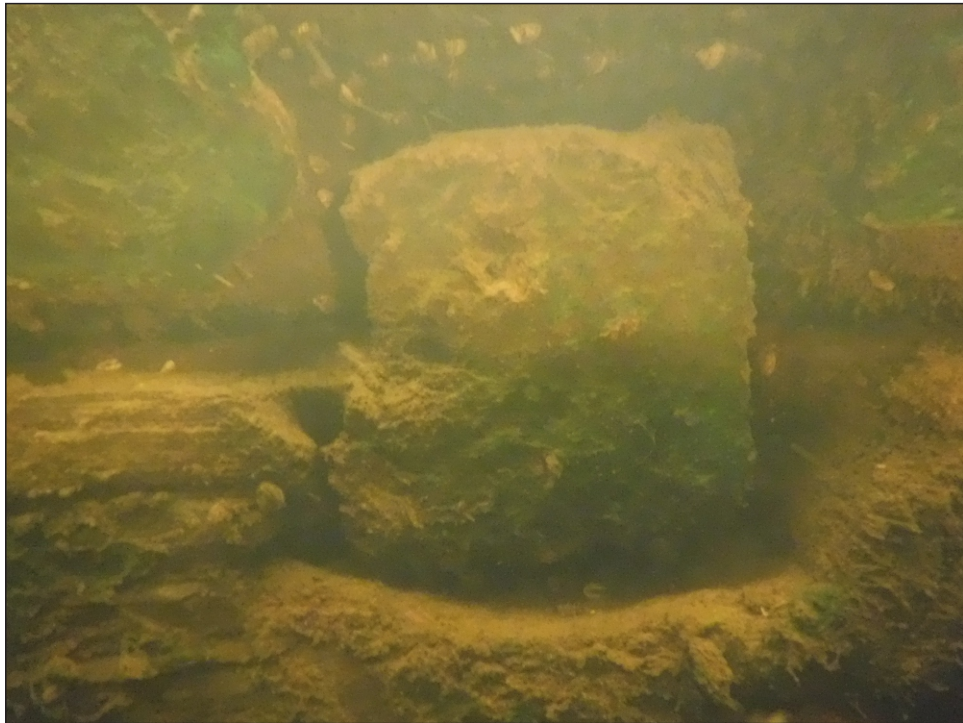
Image 1-43: Tieback timber end grain in good condition, Rest Pier

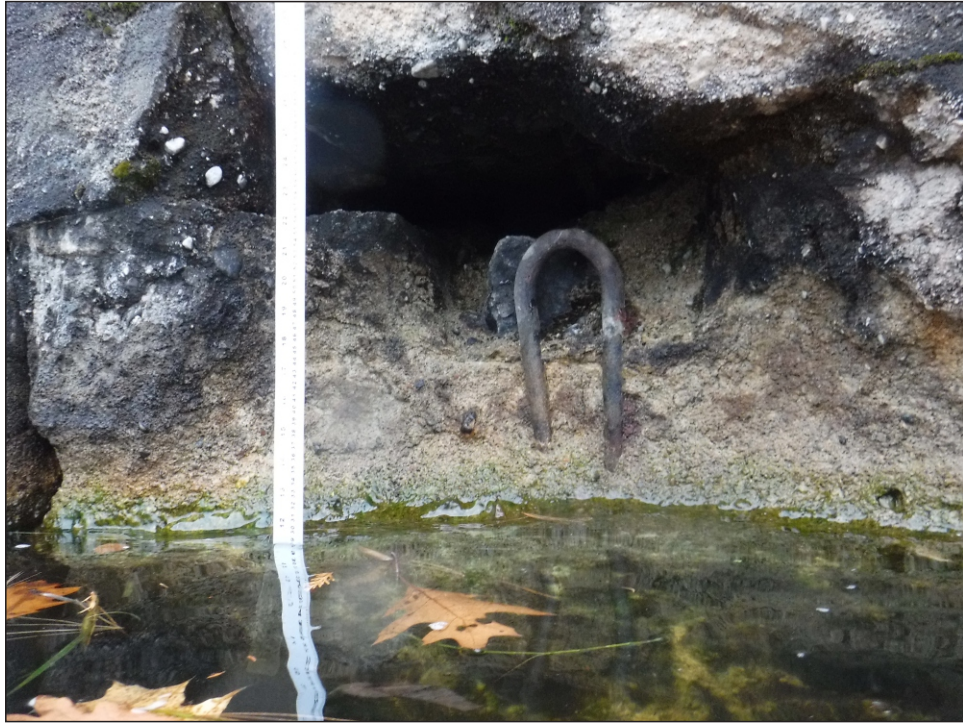
Image 1-45: Severe spall commencing above surface with exposed rebar, Rest Pier

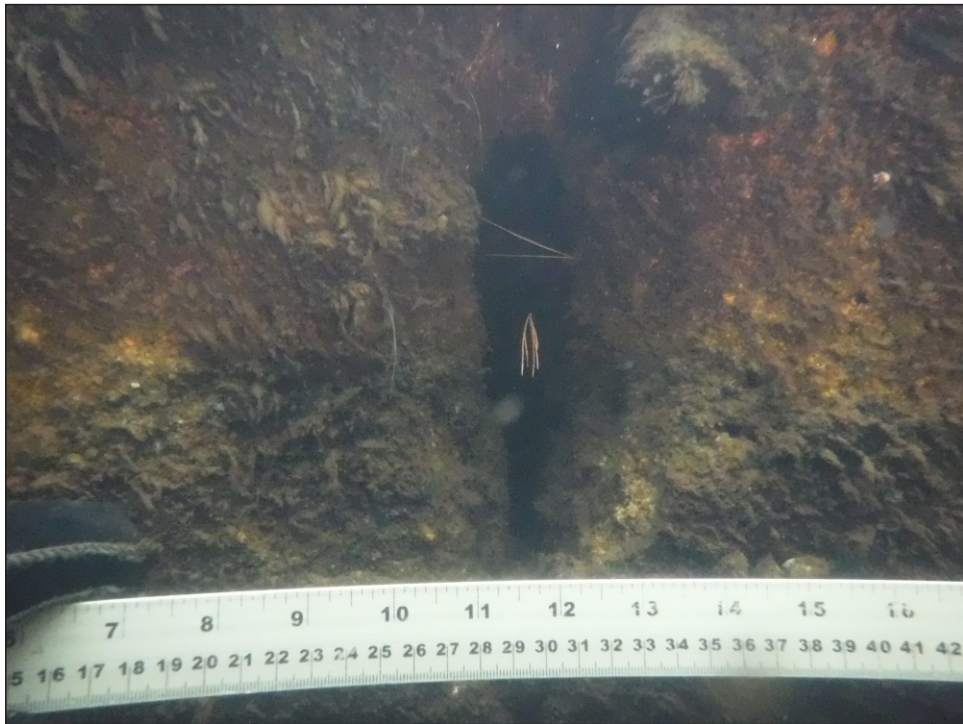
Image 1-46: Gap between concrete blocks west side of rest pier, gap/spall condition typical on west side of Rest Pier

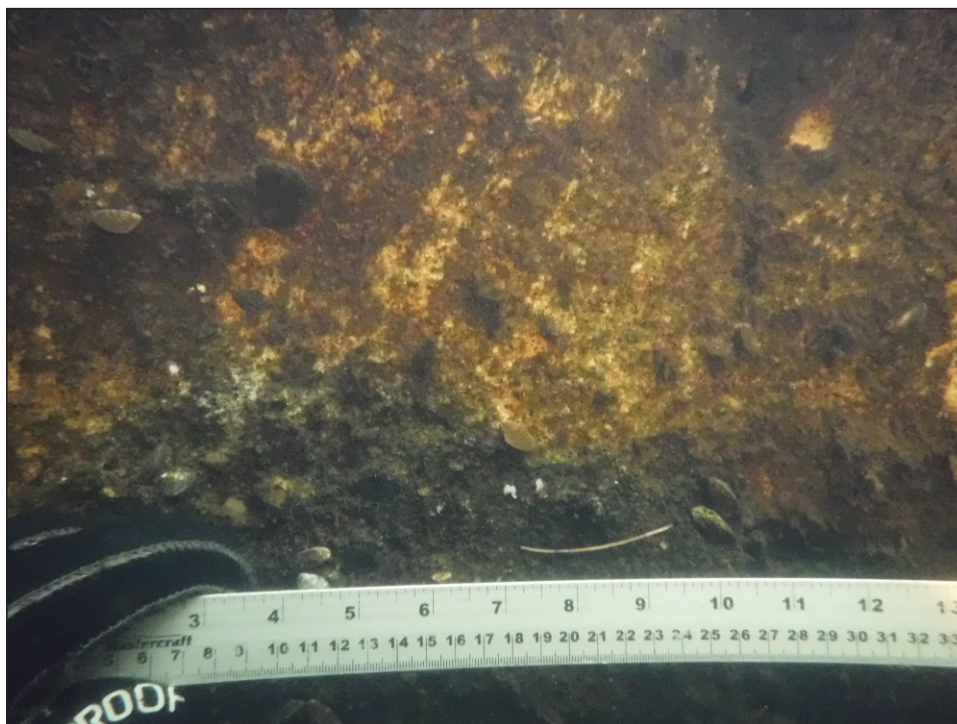
Image 1-47: Spall on concrete blocks, west side of Rest Pier

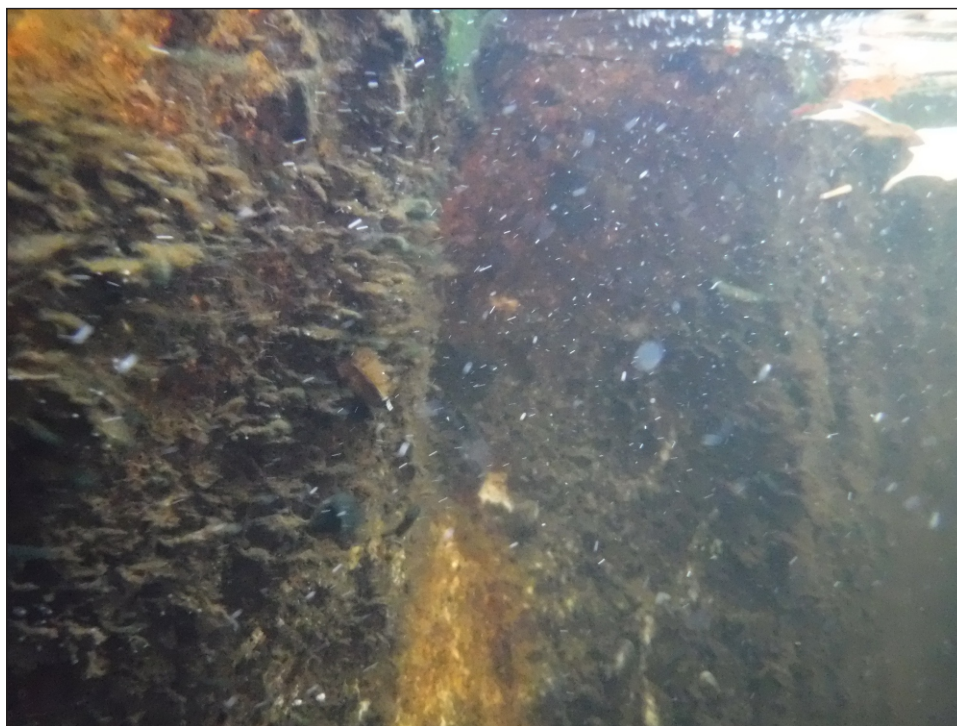
Image 1-48: Spall on concrete blocks, west side of Rest Pier

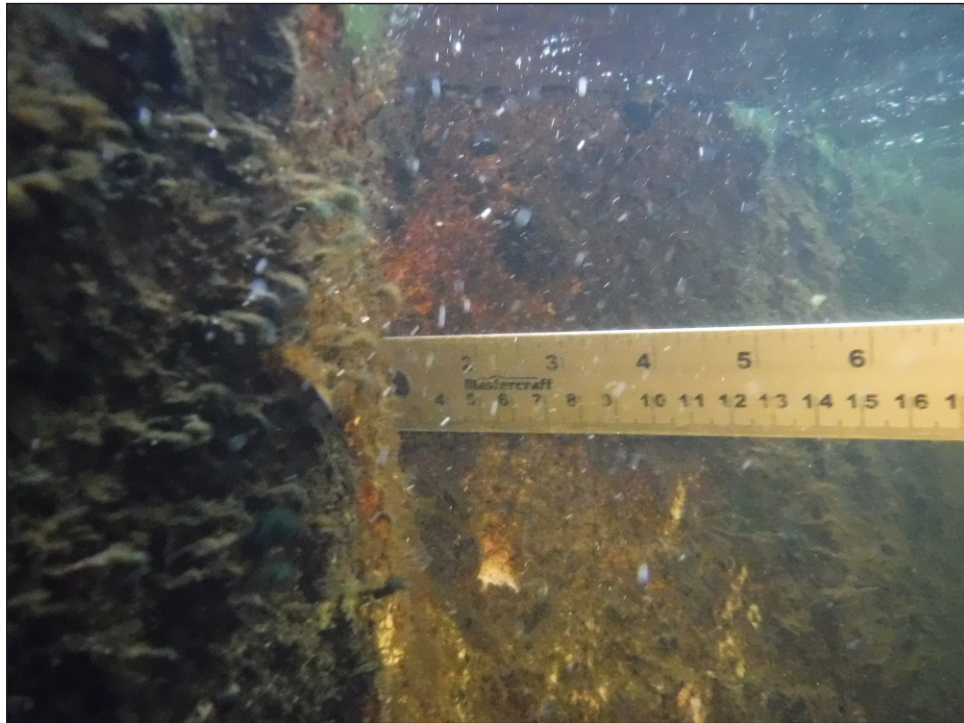
Image 1-49: Spall on concrete blocks, west side of Rest Pier

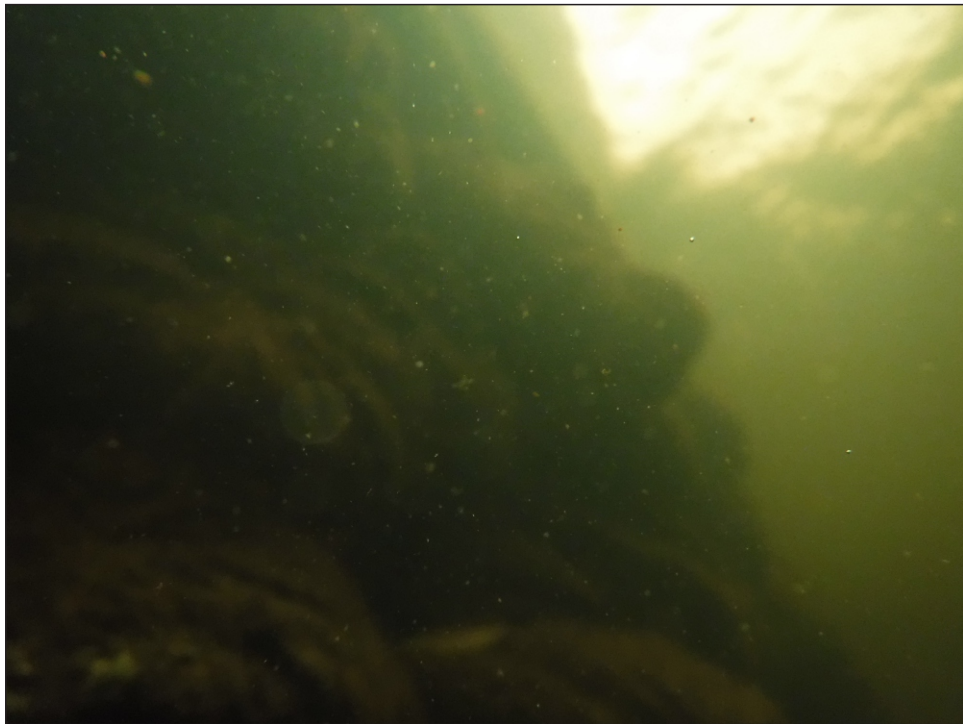
The inspection of the east pier found the concrete cap to be subject to moderate spalling for the full circumference of the pier. The support structure was found to be encased by grout bags for the full circumference of the pier. The transition between the concrete cap and grout bags was found to range between 0.05 m to 0.25 m below surface. The grout bags continued to lake bottom with no undermining observed. As referenced in the previous inspection report, the grout bags were found to be brittle and easily broken therefore; the dive team did not penetrate the bags in order to avoid damage.

Image 1-52: Grout bags, east side of East Pier

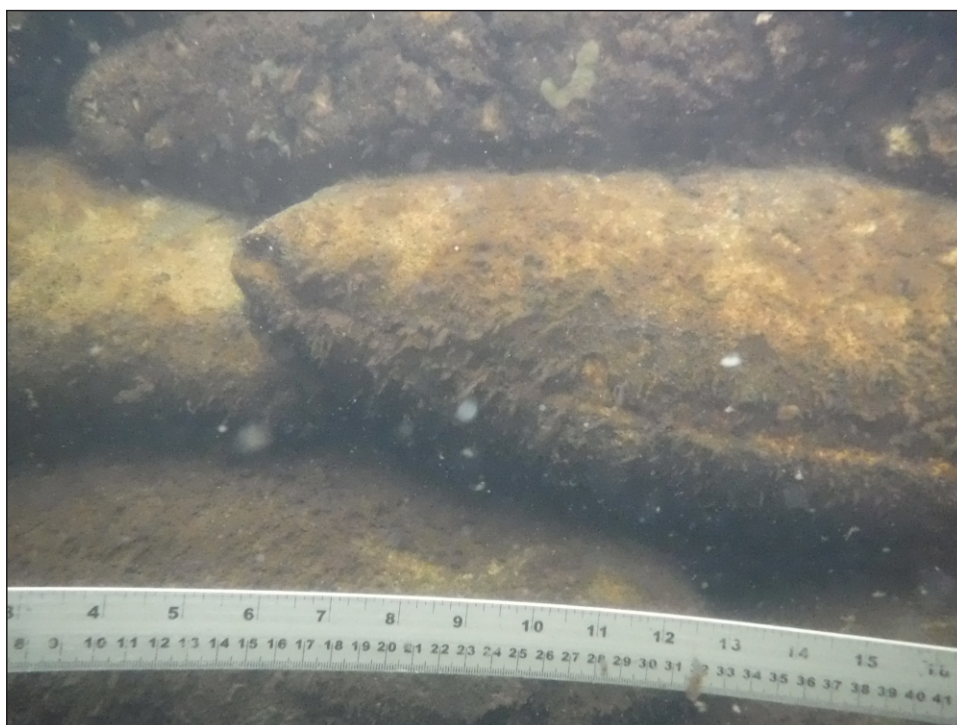
Image 1-54: Typical condition of grout bag, East Pier
