FINAL **Hazardous Building** **Materials Assessment**

Hamlet Bridge Control Building, Hamlet, Ontario

**Parks Canada, Ontario Waterways,
Trent-Severn Waterway**

September 24, 2015

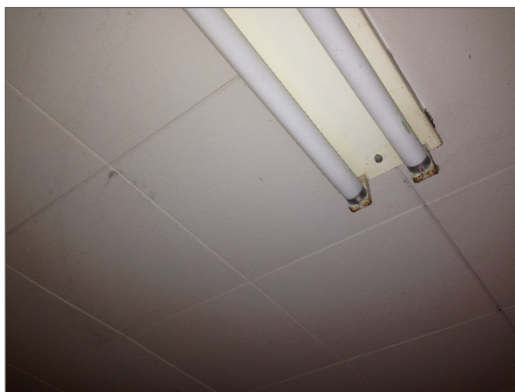
Non-asbestos white (12" x 12") wood fibre ceiling tiles are present in the building. Building materials constructed of wood fibre historically do not contain asbestos.

Photo 1 – Wood fibre ceiling tiles.

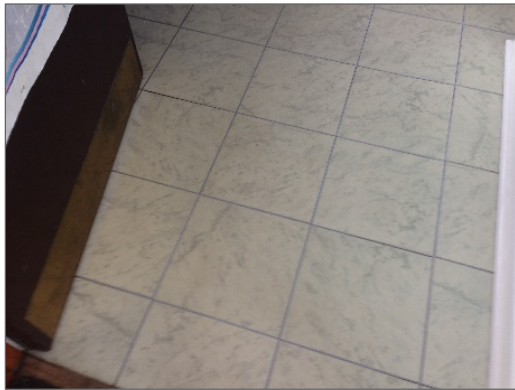
Non-asbestos white (12" x 12") peel and stick vinyl floor tiles are present in the building. Vinyl floor tiles were presumed to be non-asbestos based on visual new appearance of the tile (installed in the last five years).

Photo 2 – Non-asbestos peel and stick vinyl floor tiles

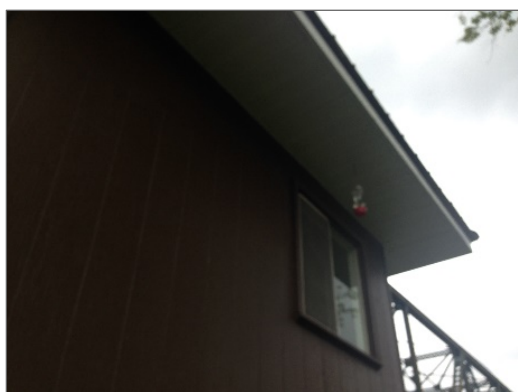
Brown paint on exterior siding is lead-based and was found to be in good condition and not flaking, peeling or delaminating.

Photo 3 – Lead-based brown paint on exterior siding.

If construction activities affect lead based paints on the exterior of the building, protect workers using the precautions specified by current "Best Practice" documents such as the Environmental Abatement Council of Ontario (EACO) Lead Guideline or the Ontario Ministry of Labour Guideline "Lead on Construction Projects".
