HAZARDOUS BUILDING MATERIALS ASSESSMENTS

Parks Canada Buildings
Kluane National Park
Haines Junction, YT

Project No.: 144901924

November 26, 2014

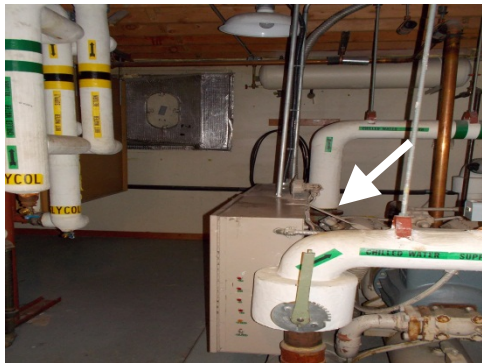
Identified ACM Description and Condition Information		Photo
White mechanical gaskets in flanges of chilled water supply lines in the penthouse

Friability	Friable	
Condition	Good	
Content	25% Chrysotile	
Black window pane caulking between window frames and glass panes throughout, including inner vestibule windows at the front entrance		No photo.
Friability	Non-friable	
Condition	Good	
Content	< 0.25 – 1.4% Chrysotile	
White 2'x4' ceiling tile – Standard fissure and pinhole (light red backing) throughout

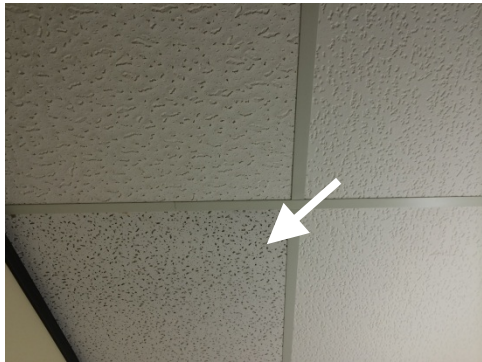
Friability	Friable	
Condition	Good	
Content	< 1% Chrysotile

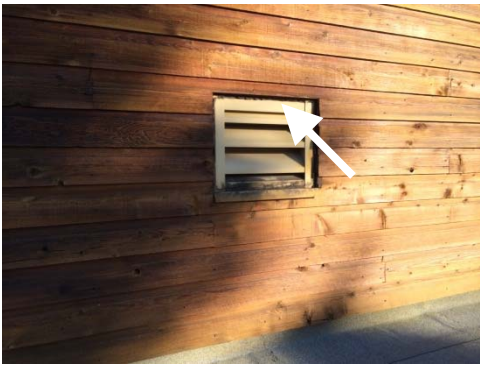
Identified ACM Description and Condition Information		Photo
Black HVAC vent caulking around the seams of a vent from the penthouse to the roof

Friability	Non-friable	
Condition	Good	
Content	< 0.25 – 1.2% Chrysotile	
12"x12" vinyl floor tile – Brown with white streaks in locations as indicated on attached drawings

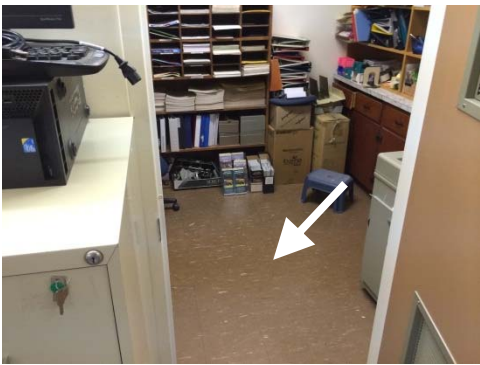
Friability	Non-friable	
Condition	Good	
Content	< 0.25% Chrysotile	
Cement panel around the base of exterior walls

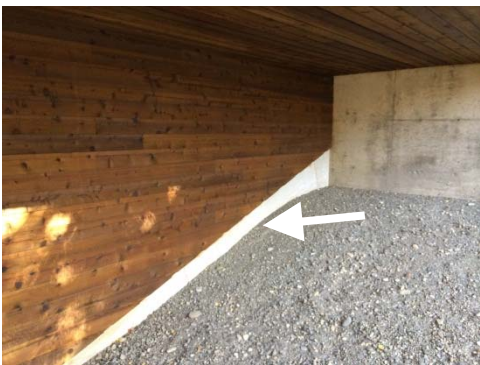
Friability	Non-friable	
Condition	Good	
Content	8% Chrysotile

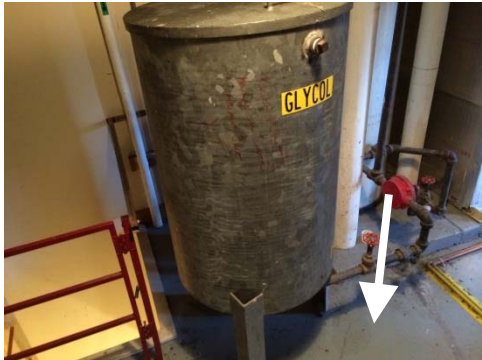
Identified LCP Description	Photo
Grey paint on the floor of the penthouse. This paint was observed to be in good condition (not bubbling, flaking or peeling).

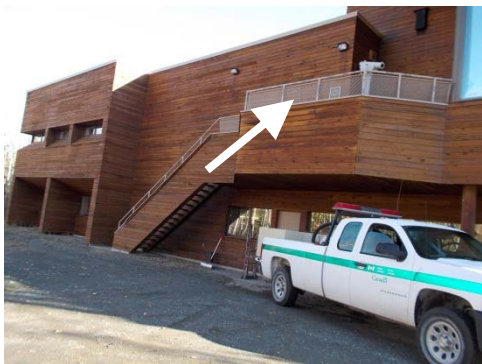
Red paint on structural steel components throughout. This paint was observed to be in good condition (not bubbling, flaking or peeling).	No photo.
Beige paint on exterior railings. This paint was observed to be in good condition (not bubbling, flaking or peeling).

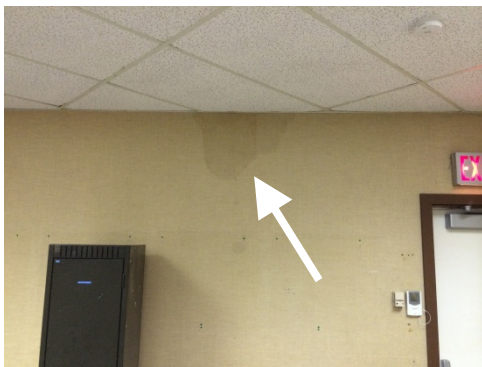
Identified Mould and/or Moisture Impacted Materials Description	Photo
Moisture stained drywall was observed at the top of the South wall in the theater.

- Remove and replace moisture-stained materials (drywall) with new materials.
 - This work can be conducted by renovation workers that are notified of the potential presence of mould contamination and provided with appropriate training and personal protective equipment (e.g. N95 respirators, disposable protective clothing).
 - If significant concealed mould contamination is identified during the work, additional assessment and/or completion of work by an experienced mould abatement contractor may be required.
 - An assessment to determine the likely source(s) of the observed moisture staining should be undertaken once building materials are removed, and the source(s) should be corrected as part of the renovation project.

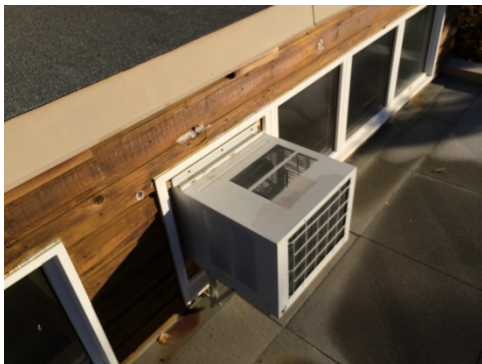
Suspected ODS-Containing Equipment	Photo
The small air conditioning unit located on the roof is suspected to contain ODSs.

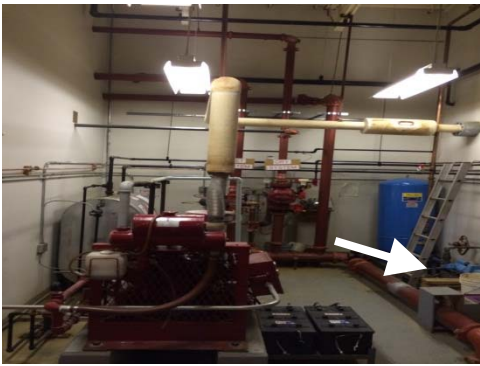
Identified ACM Description and Condition Information		Photo
Black window pane caulking between window frames and glass panes throughout		No photo.
Friability	Non-friable	
Condition	Good	
Content	1.3% Chrysotile	
Cream pipe sealant inside fittings of 2" decommissioned black pipes next to water tank in the pump room

Friability	Non-friable	
Condition	Good	
Content	0.32 – 0.42% Chrysotile	
White window frame caulking between window frames and siding throughout the exterior

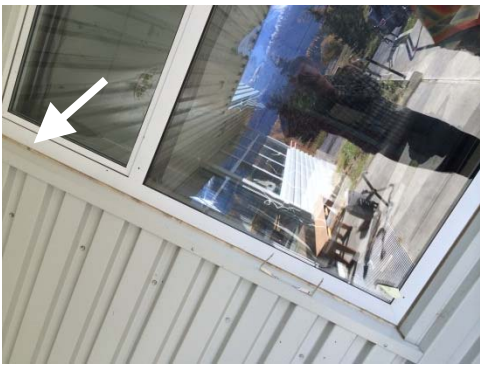
Friability	Non-friable	
Condition	Good	
Content	<0.25 – 0.97% Chrysotile

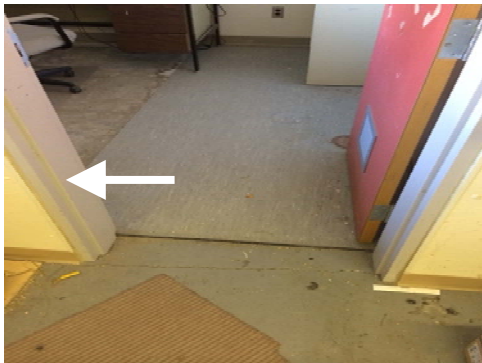
Identified LCP Description	Photo
<p>Grey paint on interior trim.</p> <p>This paint was observed to be in good condition (not bubbling, flaking or peeling).</p>

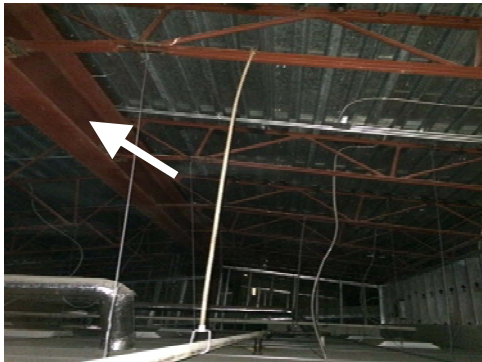
<p>Red paint on structural steel.</p> <p>This paint was observed to be in good condition (not bubbling, flaking or peeling).</p>

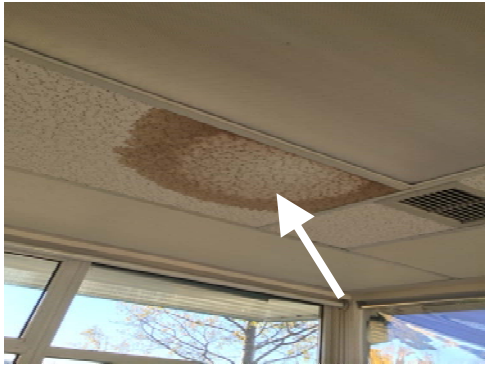
Identified Mould and/or Moisture Impacted Materials Description	Photo
Moisture stained ceiling tiles were observed in various locations throughout.

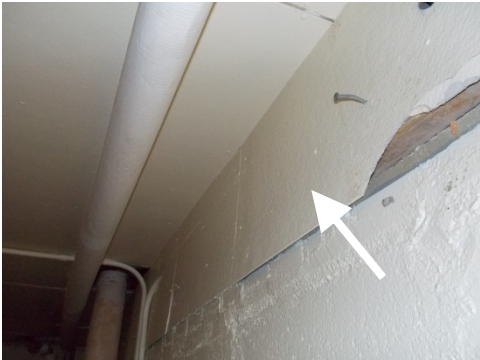
Identified ACM Description and Condition Information		Photo
Cement panel around the top of the walls in the boiler room.

Friability	Non-friable	
Condition	Good	
Content	8% Chrysotile	
Pipe fitting insulation throughout (cementitious insulation applied to elbows, t's, and valves)

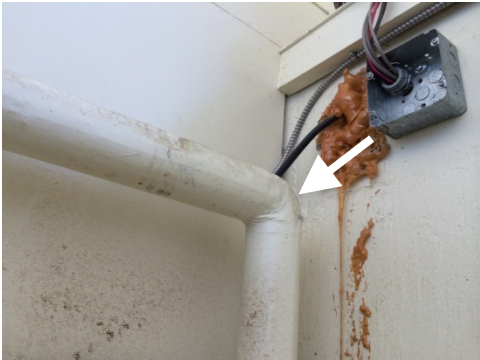
Friability	Friable	
Condition	Good	
Content	45% Chrysotile	
Pipe straight insulation throughout (“Air-O-Cel” corrugated paper insulation on straight sections of pipe)

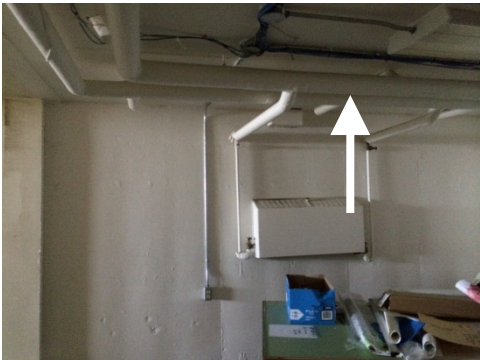
Friability	Friable	
Condition	Good	
Content	20% Chrysotile

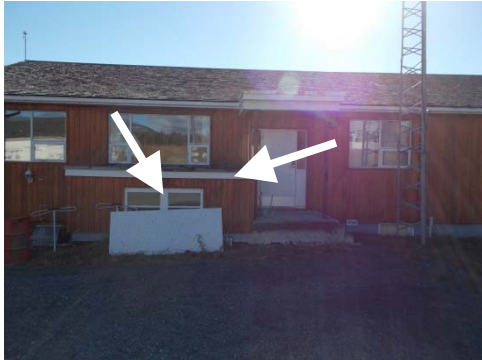
Identified LCP Description	Photo
<p>White paint on exterior trim.</p> <p>This paint was observed to be in good condition (not bubbling, flaking or peeling).</p>

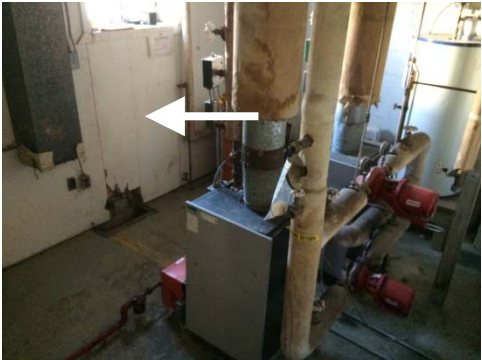
Identified ACM Description and Condition Information		Photo
Cement panel on interior walls and ceiling throughout.

Friability	Non-friable	
Condition	Good	
Content	10% Chrysotile	
Pipe sealant cream/black inside cast iron pipe fittings throughout

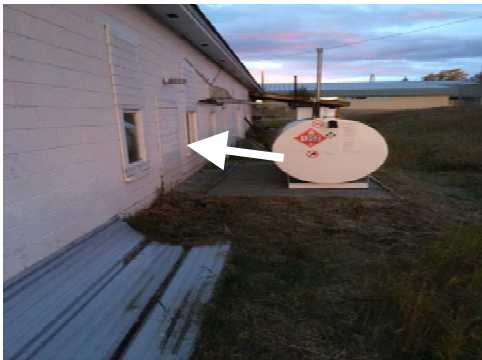
Friability	Non-friable	
Condition	Good	
Content	0.39% Chrysotile	
Yellow window frame caulking (painted black) on the exterior of windows at the rear of the building (between window frame and the building)

Friability	Non-friable	
Condition	Good	
Content	1.1% Chrysotile

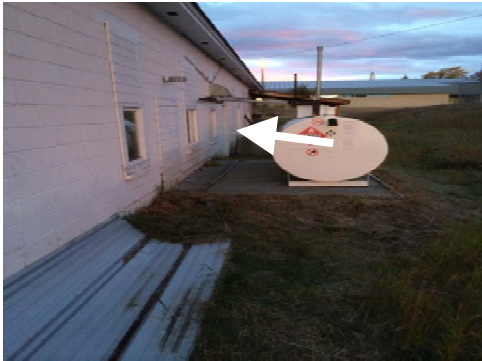
Identified ACM Description and Condition Information		Photo
Cream caulking around doors on the exterior of the building

Friability	Non-friable	
Condition	Good	
Content	0.29 - 0.47% Chrysotile	
Beige mastic on the backside of corrugated wall panels throughout

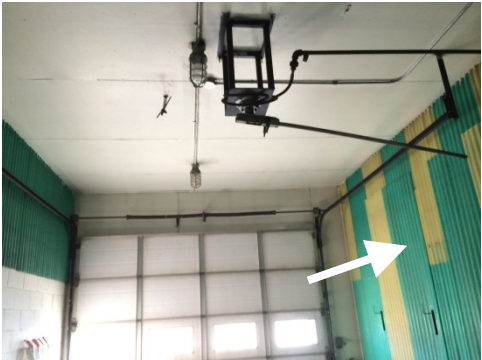
Friability	Non-friable	
Condition	Good	
Content	0.48 – 1.3% Chrysotile

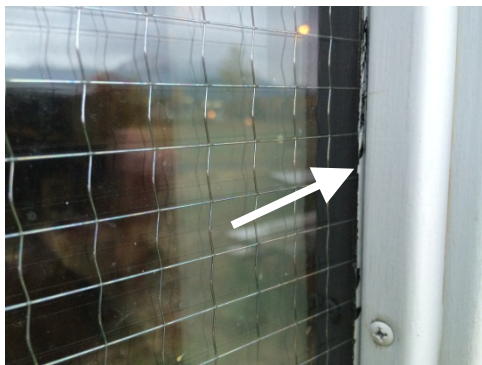
Identified ACM Description and Condition Information		Photo
Black/grey window pane caulking between window frame and glass pane on exterior of windows beside doors

Friability	Non-friable	
Condition	Good	
Content	1.7% Chrysotile	
Grey/white door caulking around the exterior door frames

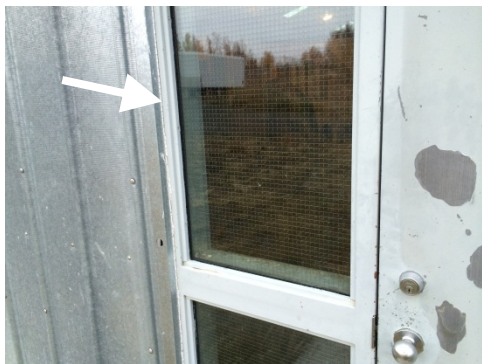
Friability	Non-friable	
Condition	Good	
Content	<0.25% Chrysotile

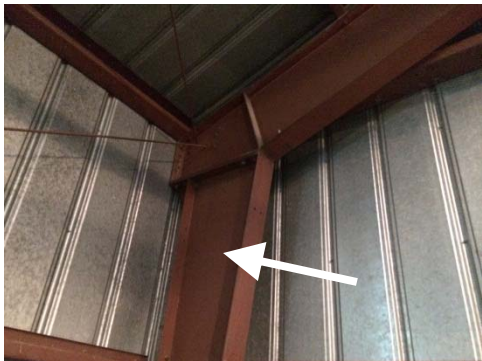
Identified LCP Description	Photo
Red paint on the structural steel throughout. This paint was observed to be in good condition (not bubbling, flaking or peeling).

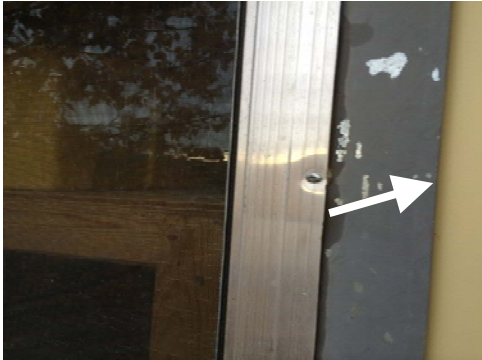
Identified ACM Description and Condition Information		Photo
Grey window frame caulking between window frame and building on the exterior

Friability	Non-friable	
Condition	Good	
Content	3.1% Chrysotile

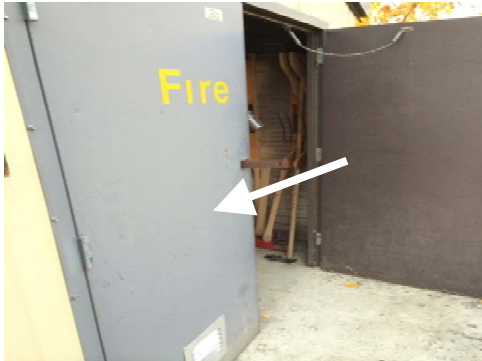
Identified LCP Description	Photo
<p>Grey paint on the exterior trim.</p> <p>This paint was observed to be in good condition (not bubbling, flaking or peeling).</p>

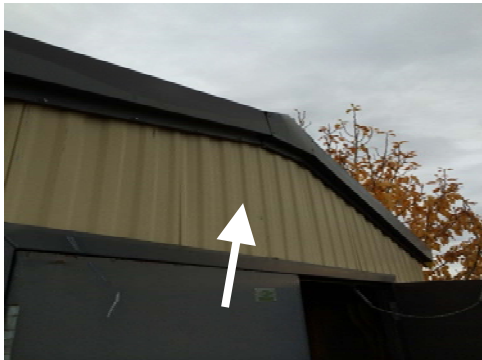
<p>Beige paint on the exterior siding.</p> <p>This paint was observed to be in good condition (not bubbling, flaking or peeling).</p>

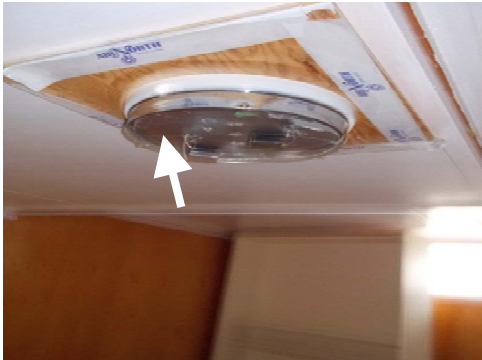
Identified ACM Description and Condition Information		Photo
Heat shields (foil covered) inside round incandescent light fixtures on the main floor and in the basement

Friability	Friable	
Condition	Good	
Content	45% Chrysotile	
9"x9" vinyl floor tile in basement rooms 4 and 5 (both beige and red)

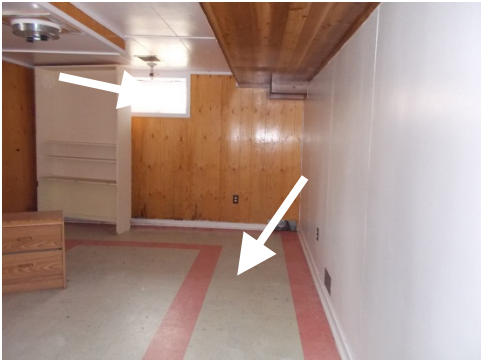
Friability	Non-friable	
Condition	Good	
Content	1.0% Chrysotile	
Grey window pane caulking between window frame and glass pane in main house windows

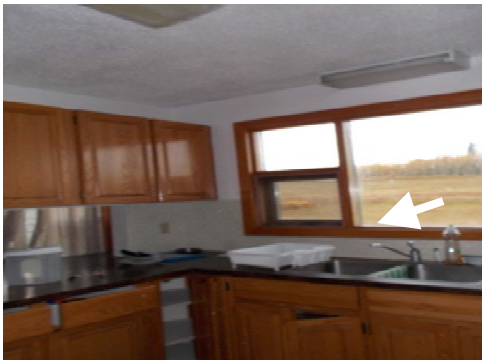
Friability	Non-friable	
Condition	Good	
Content	1.6 - 2.6% Chrysotile

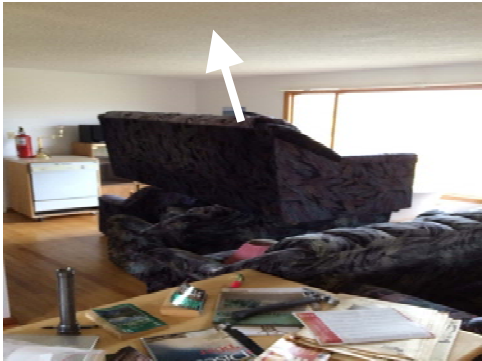
Identified ACM Description and Condition Information		Photo
White ceiling texture coat throughout the main house

Friability	Non-friable in situ can be made friable during removal	
Condition	Good	
Content	1 - 3% Chrysotile	
Drywall joint compound throughout

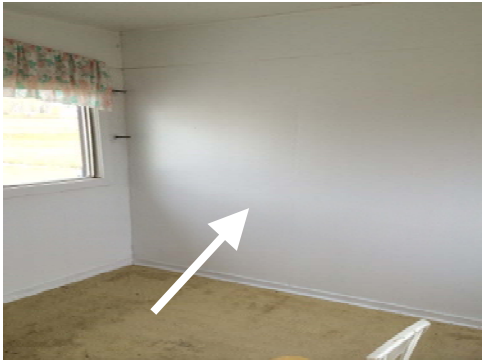
Friability	Non-friable in situ can be made friable during removal	
Condition	Good	
Content	<1 - 2% Chrysotile

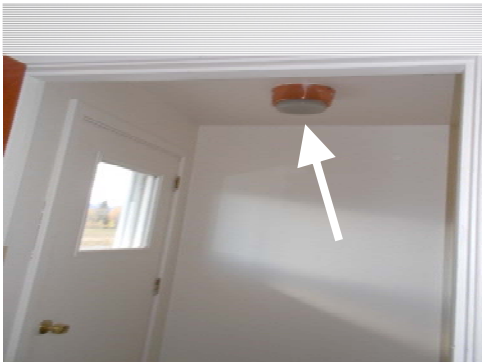
Identified ACM Description and Condition Information		Photo
Heat shields (foil covered) inside round incandescent light fixtures throughout

Friability	Friable	
Condition	Good	
Content	45% Chrysotile	
Tan squares vinyl sheet flooring in the mudroom

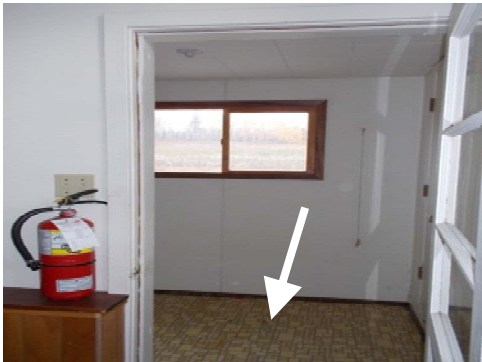
Friability	Friable during removal	
Condition	Good	
Content	15.6% Chrysotile	
9"x9" vinyl floor tile, both green and white, in basement room 3

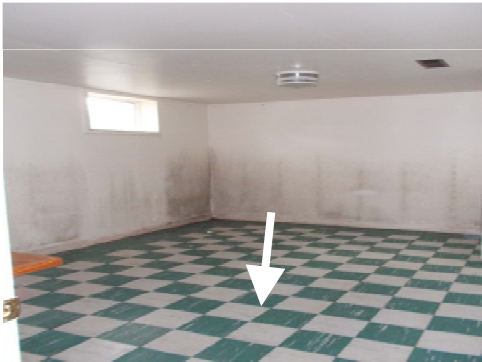
Friability	Non-friable	
Condition	Good	
Content	0.57 – 0.71% Chrysotile

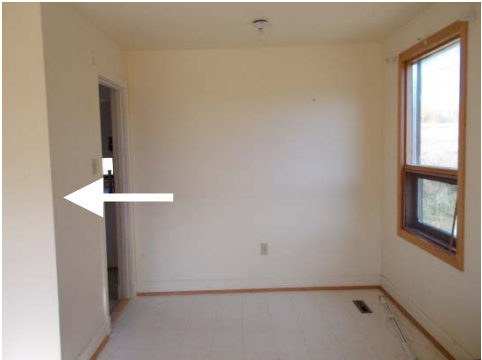
Friability	Non-friable	
Condition	Good	
Content	1.1 – 1.3% Chrysotile	
Drywall joint compound throughout

Friability	Non-friable in situ; can be made friable during removal	
Condition	Good	
Content	<1 - 2% Chrysotile	
Grey window pane caulking between window frame and glass panes throughout

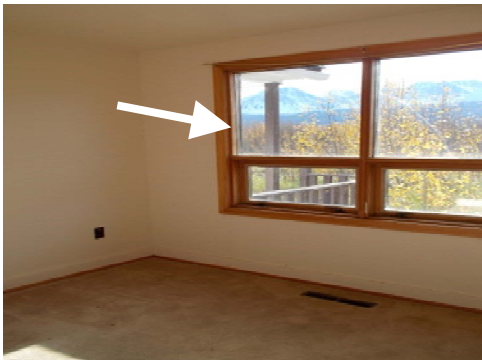
Friability	Non-friable	
Condition	Good	
Content	2.0% Chrysotile

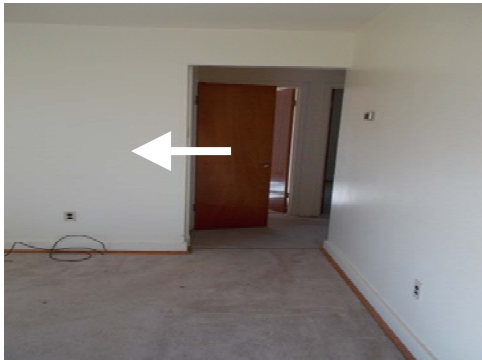
<p>White paint on interior walls.</p> <p>This paint was observed to be in good condition (no bubbling, flaking or peeling).</p>

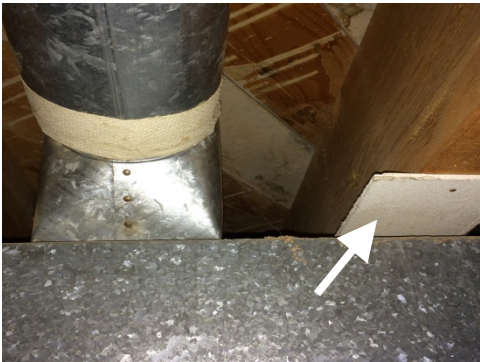
Friability	Friable	
Condition	Good	
Content	55% Chrysotile	
White duct shields on wooden joists in the basement above furnace ducting

Friability	Friable	
Condition	Good	
Content	45% Chrysotile	
Brown square pattern sheet flooring in the kitchen

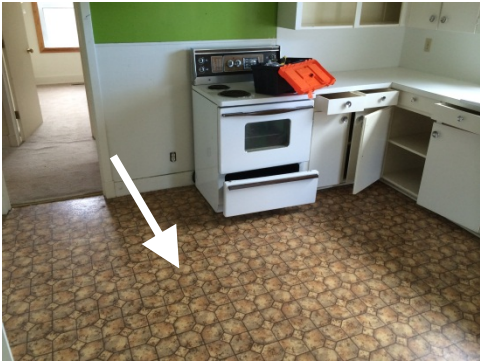
Friability	Friable during removal	
Condition	Good	
Content	22.4% Chrysotile

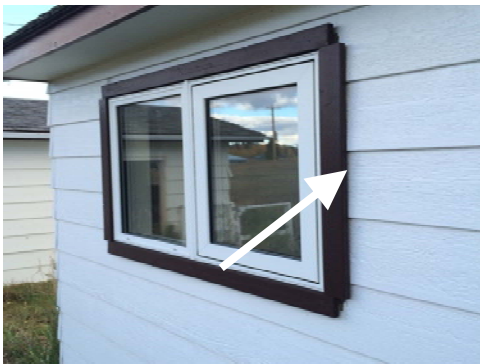
Friability	Non-friable	
Condition	Good	
Content	1.4 – 1.7% Chrysotile	
Brown exterior window frame caulking between window frames and the building on the exterior of windows

Friability	Non-friable	
Condition	Good	
Content	0.66% Chrysotile

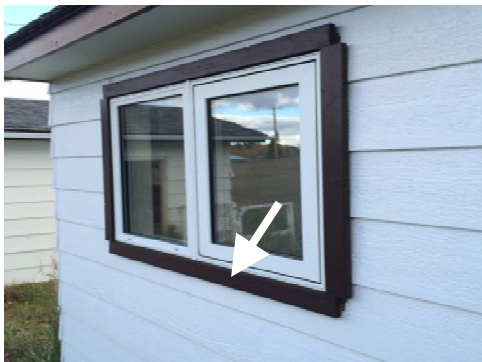
Brown paint on exterior trim. This paint was observed to be in good condition (no bubbling, flaking or peeling).
