<b>Title - Sujet</b> GOCB Flooring & Fire Separations	
<b>Solicitation No. - N° de l'invitation</b> EW038-190845/A	<b>Amendment No. - N° modif.</b> 004
<b>Client Reference No. - N° de référence du client</b> PSPC	<b>Date</b> 2018-08-15
<b>GETS Reference No. - N° de référence de SEAG</b> PW-\$PWU-066-11410	
<b>File No. - N° de dossier</b> PWU-8-41059 (066)	<b>CCC No./N° CCC - FMS No./N° VME</b>
<b>Solicitation Closes - L'invitation prend fin</b> <b>at - à 02:00 PM</b> <b>on - le 2018-08-24</b>	<b>Time Zone</b> <b>Fuseau horaire</b> Mountain Daylight Saving Time MDT
<b>F.O.B. - F.A.B.</b> <b>Plant-Usine:</b> <input type="checkbox"/> <b>Destination:</b> <input type="checkbox"/> <b>Other-Autre:</b> <input type="checkbox"/>	
<b>Address Enquiries to: - Adresser toutes questions à:</b> Lee, Mony	<b>Buyer Id - Id de l'acheteur</b> pwu066
<b>Telephone No. - N° de téléphone</b> (780) 224-6675 ( )	<b>FAX No. - N° de FAX</b> (780) 497-3510

Fort Simpson GOCB Carpet Replacement & Fire Rating Upgrade

*Asbestos Survey  
Government of Canada Building  
9606 – 100<sup>th</sup> Street, Fort Simpson NWT*

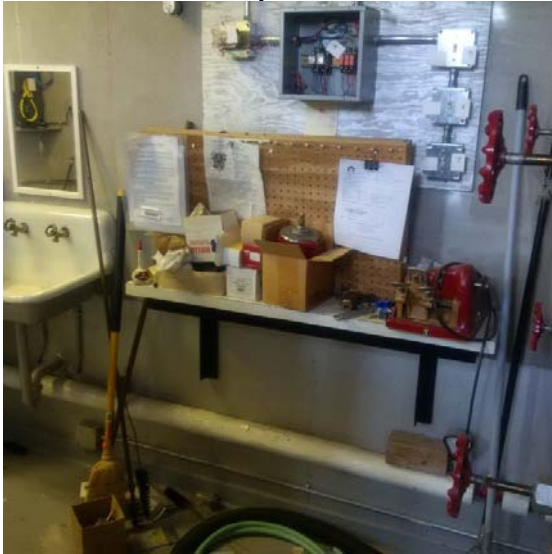
1. Sink shelf and electrical equipment

The Contractor is to ensure all conduit and mechanical piping is properly temporarily supported to ensure continuous operation when this equipment is removed from its existing wall fasteners. Photos of the existing site conditions is in the appendix of this document.

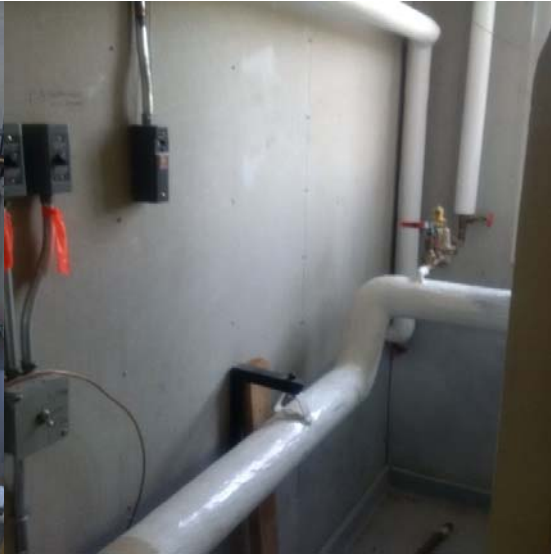
2. Insulated piping, misc. wiring

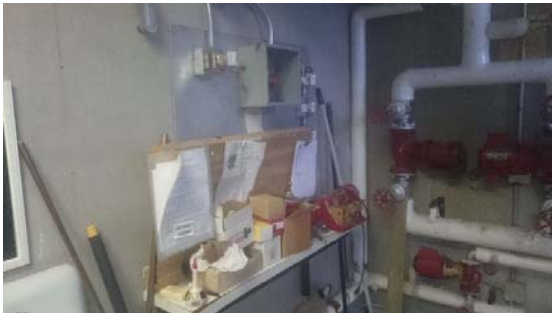
3. Insulated piping and valves

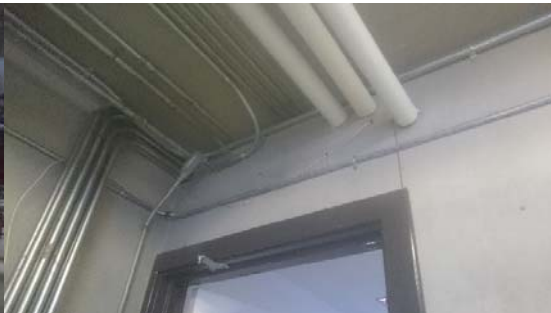
4. Miscellaneous wiring

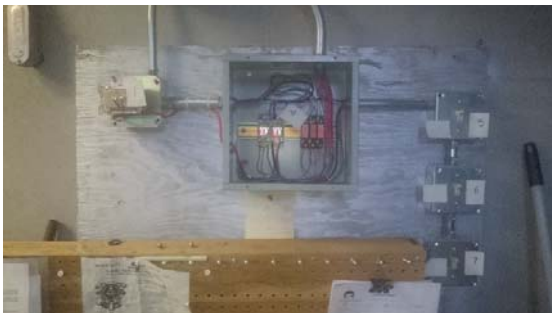
5. Electrical equipment

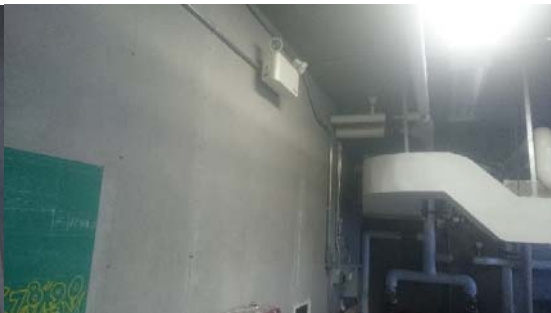
6. Emergency lighting

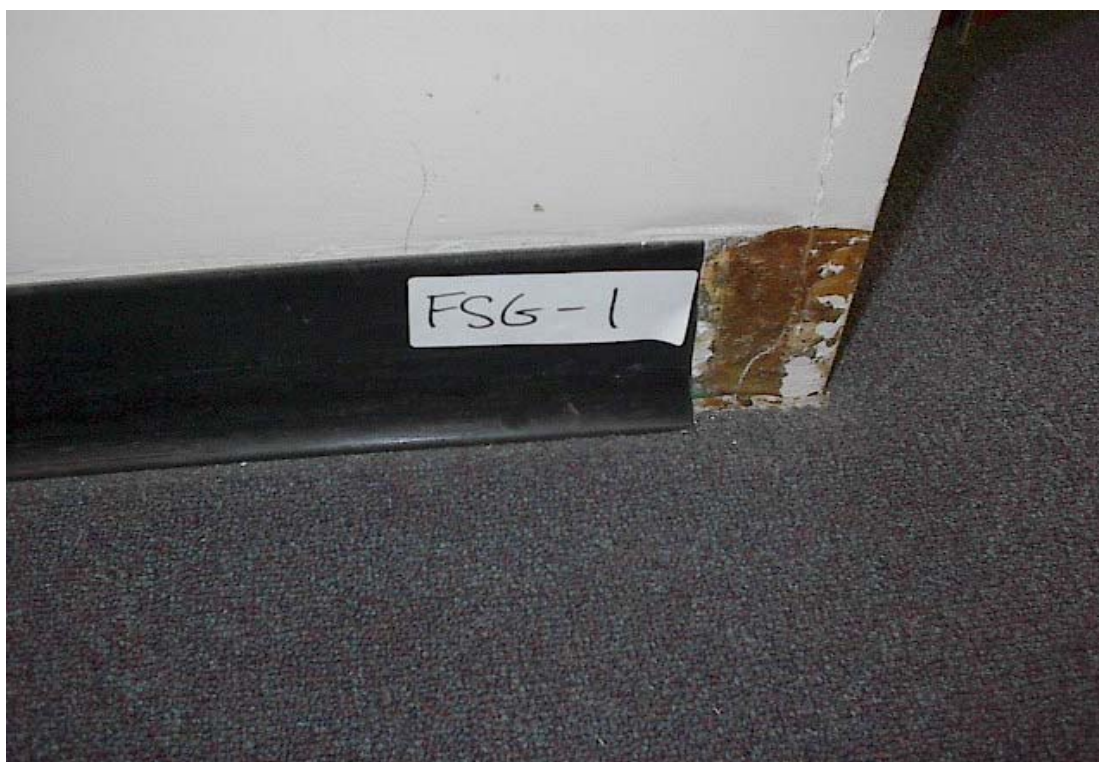
Photo 2: Baseboard and parging, Sample 1.

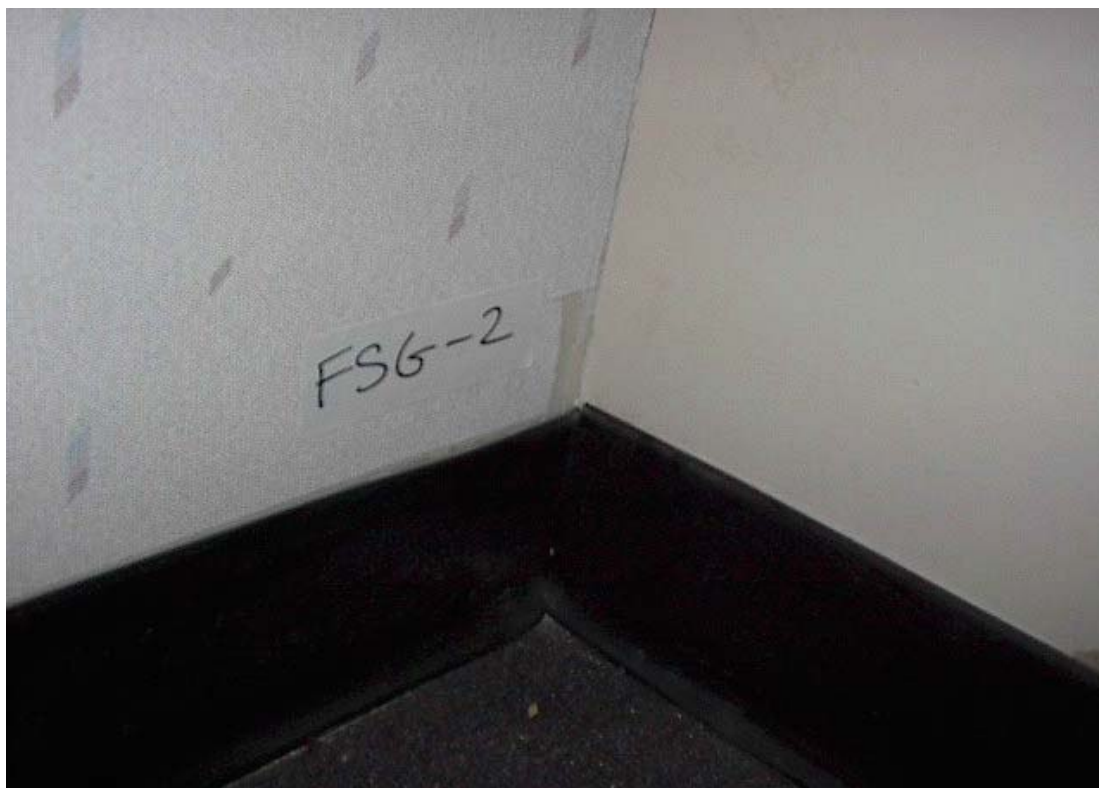
Photo 3: Wallpaper, Sample 2.

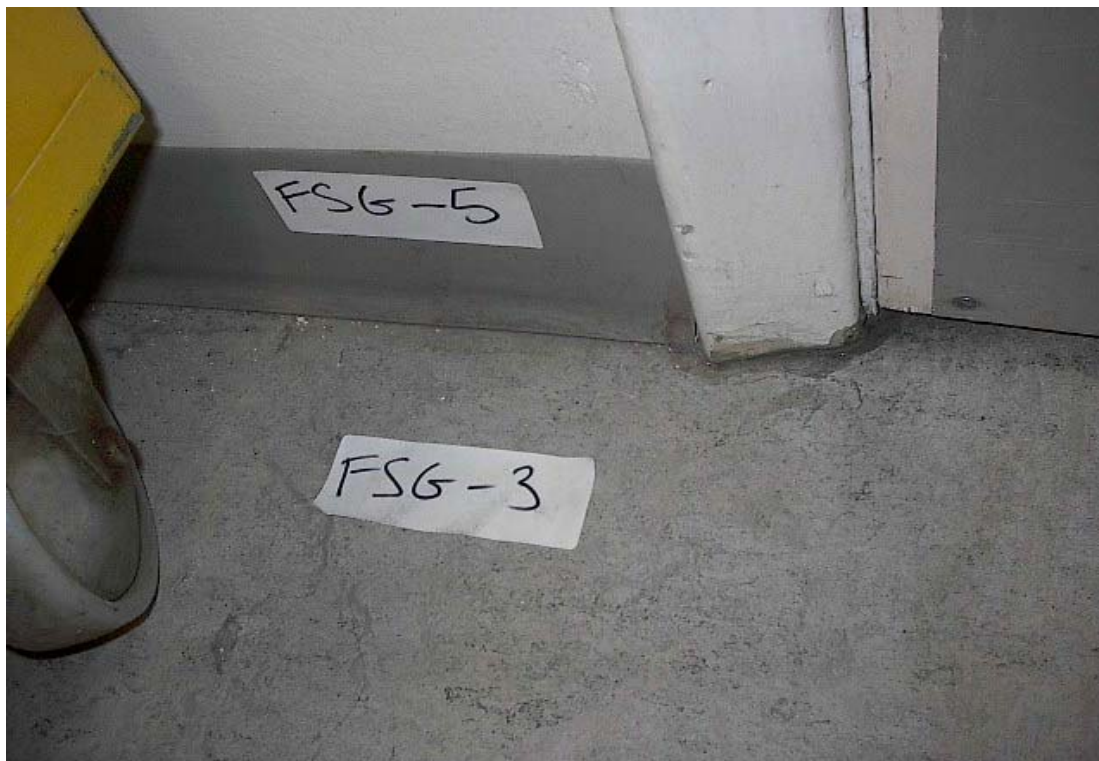
Photo 4: Sheet flooring and baseboard composite, Samples 3, 4 and 5.

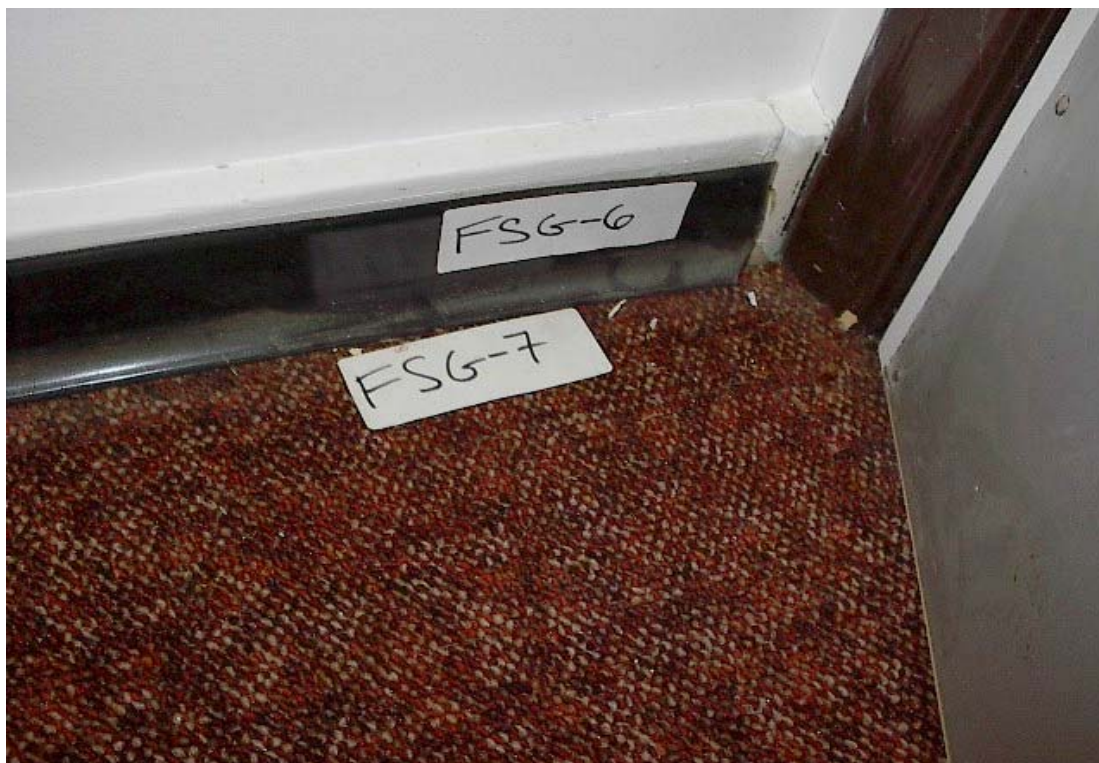
Photo 5: Baseboard composite and carpet, Samples 6 and 7.

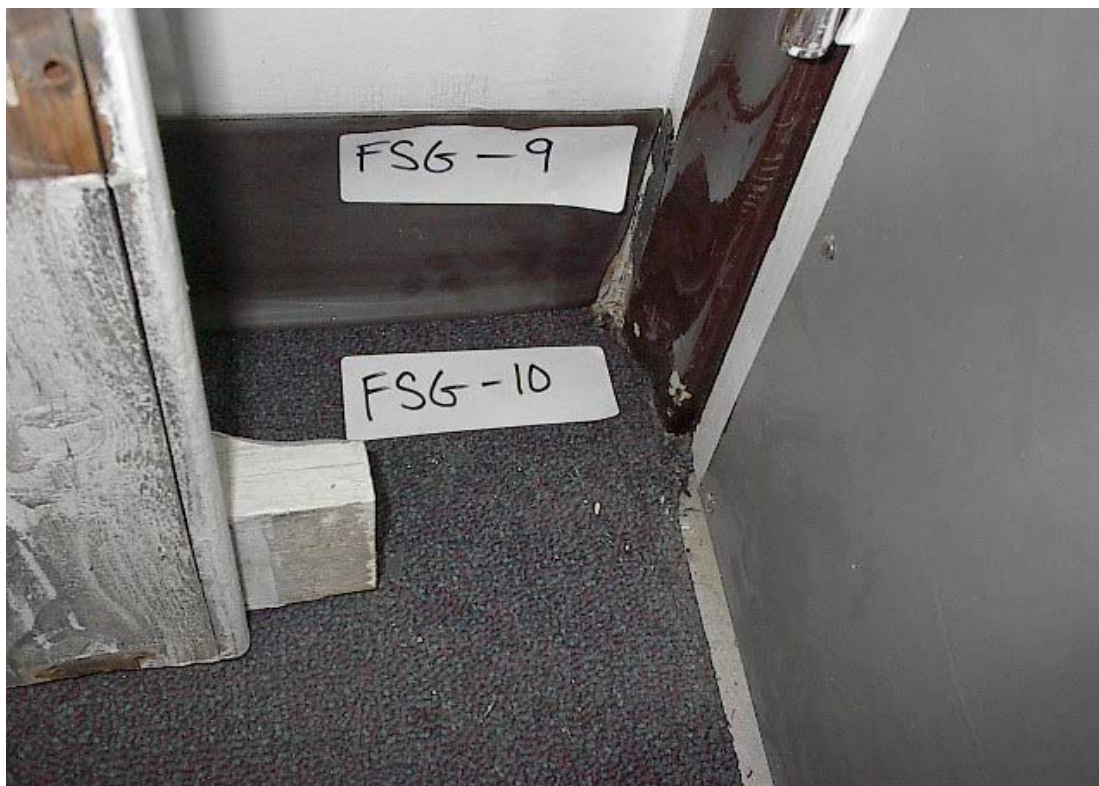
Photo 7: Baseboard composite and carpet, Sample 9 and 10.

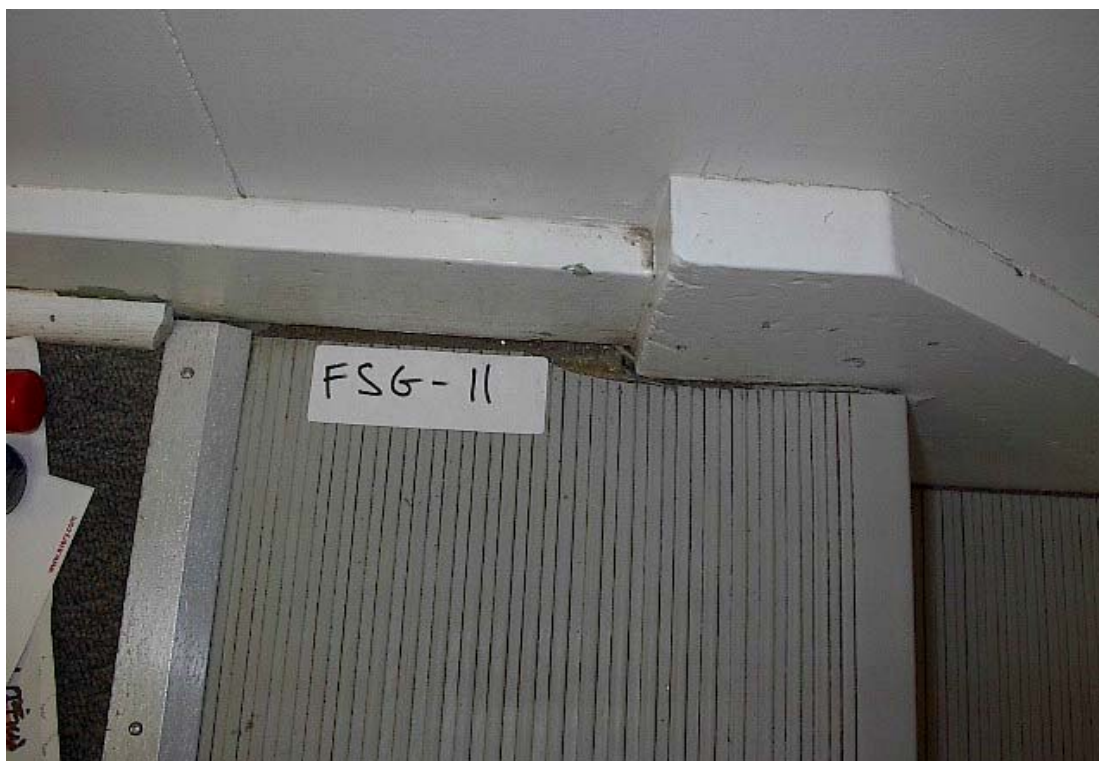
Photo 8: Treads on stairs, Sample 11.

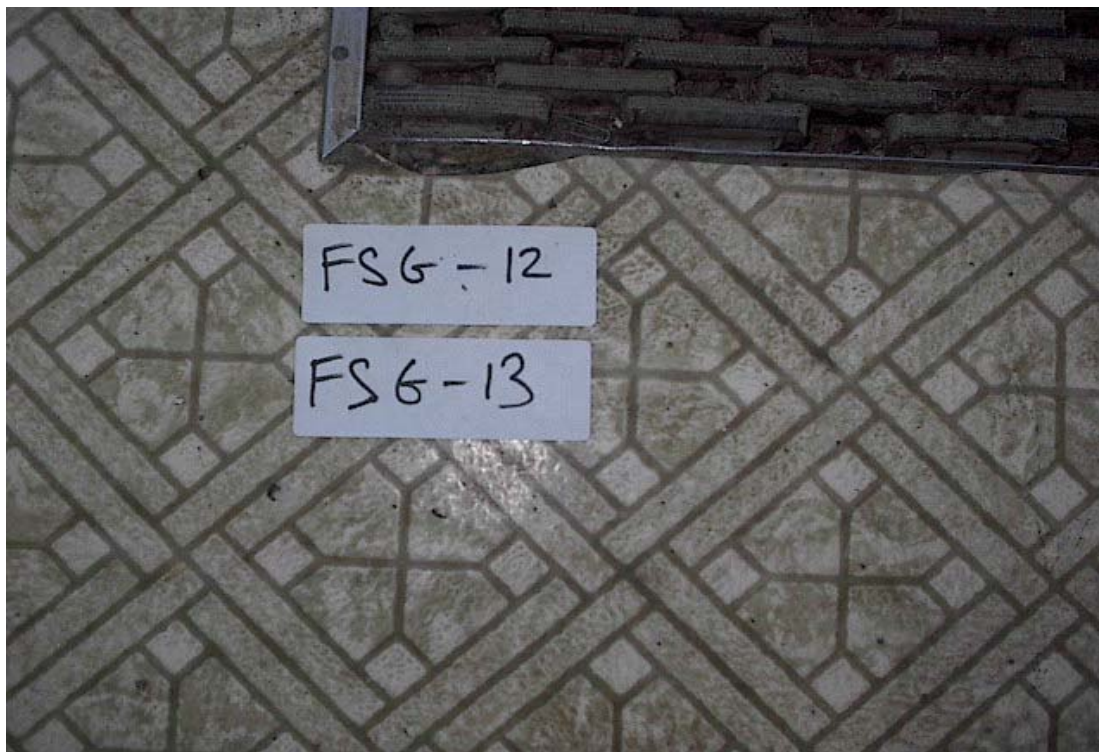
Photo 9: Sheet flooring and adhesive compound, Samples 12 and 13.

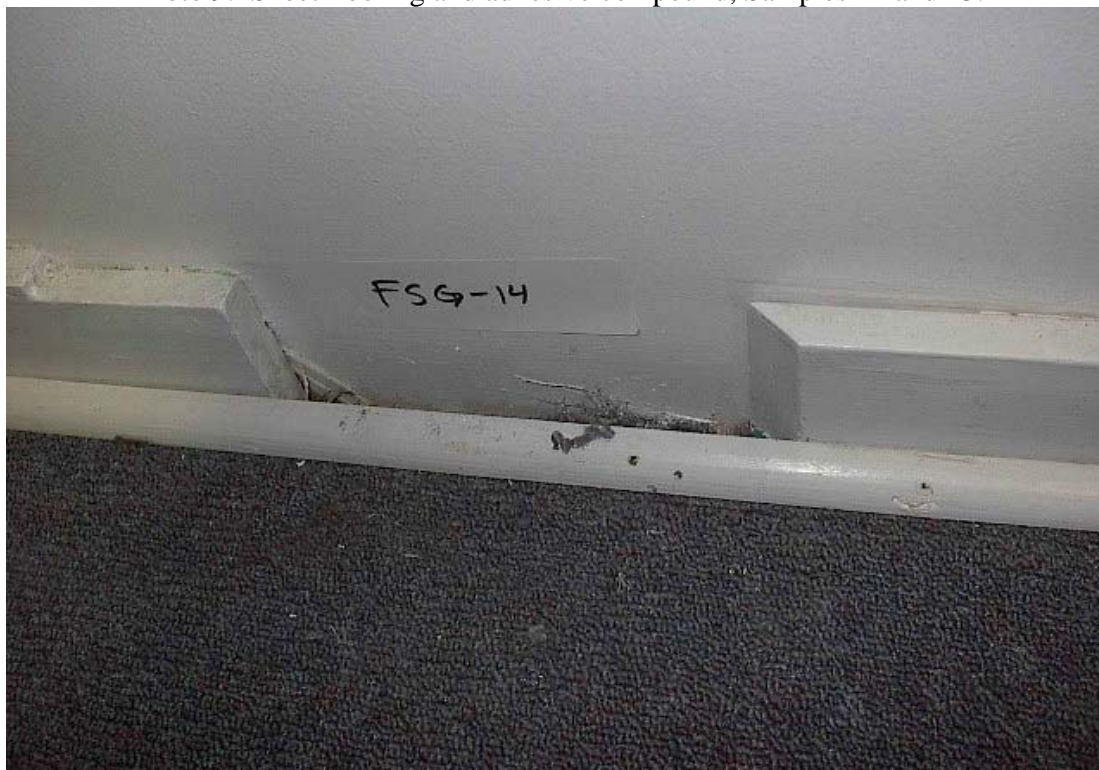
Photo 10: Carpet, Sample 14.

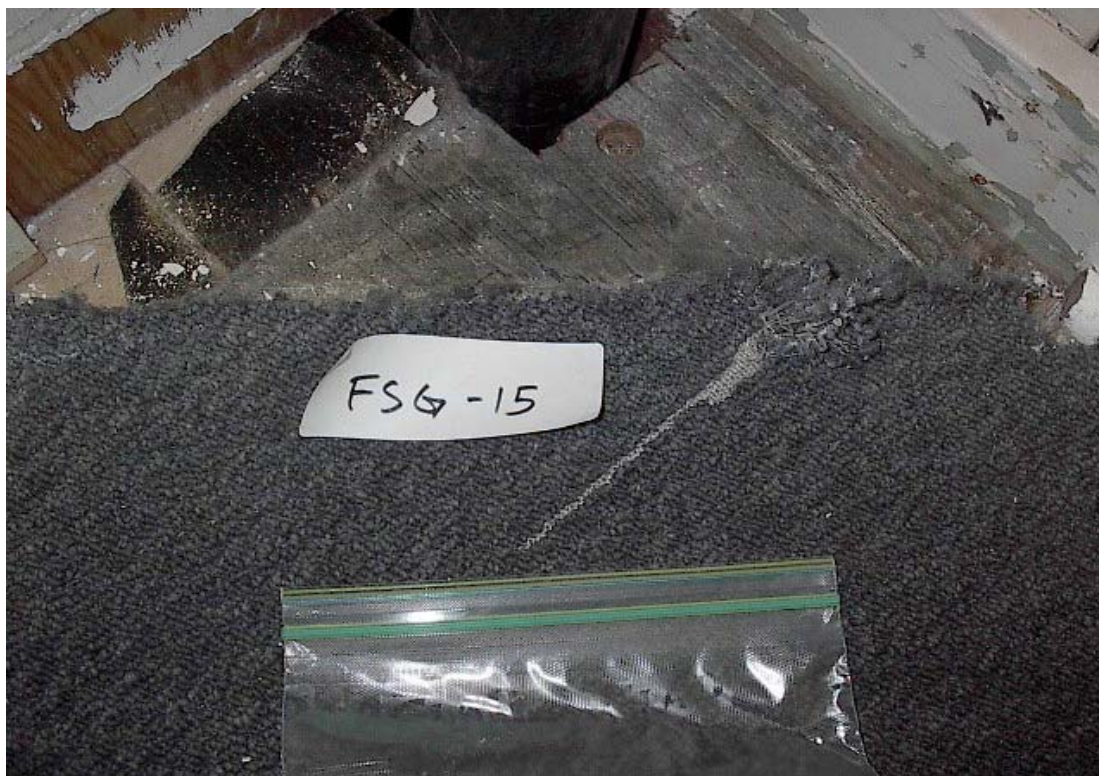
Photo 11: Carpet, Sample 15.

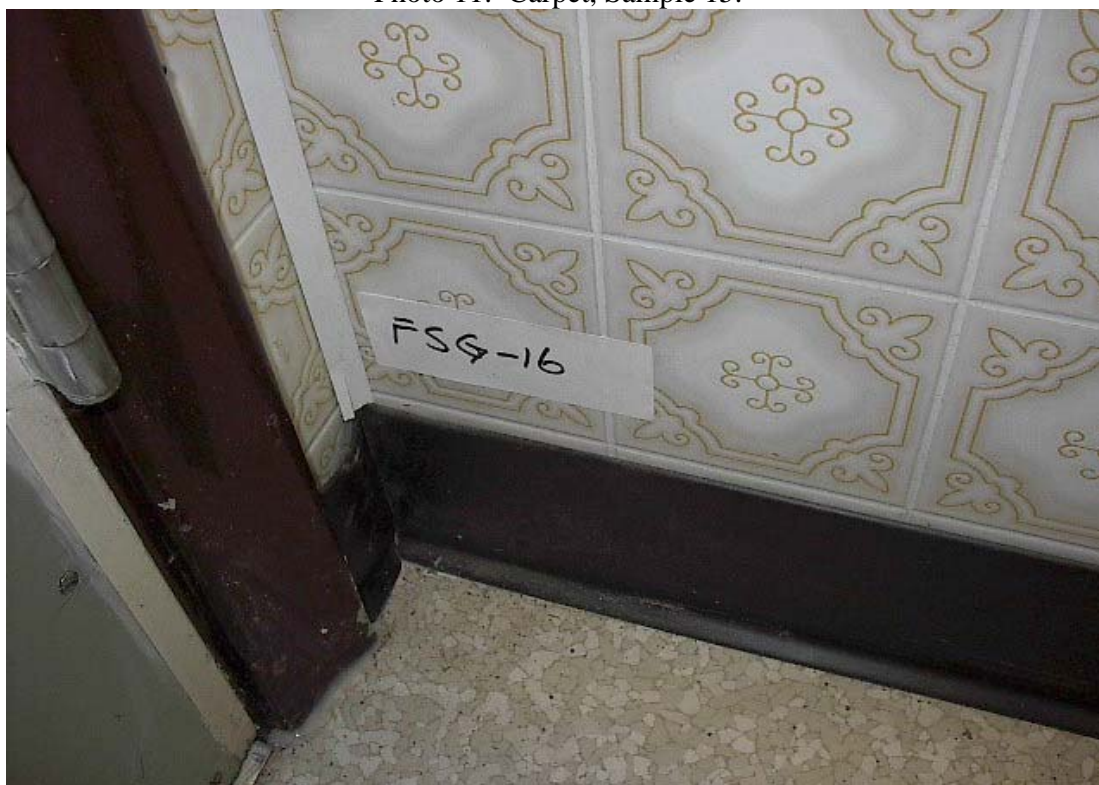
Photo 12: Ceramic tile, Sample 16.

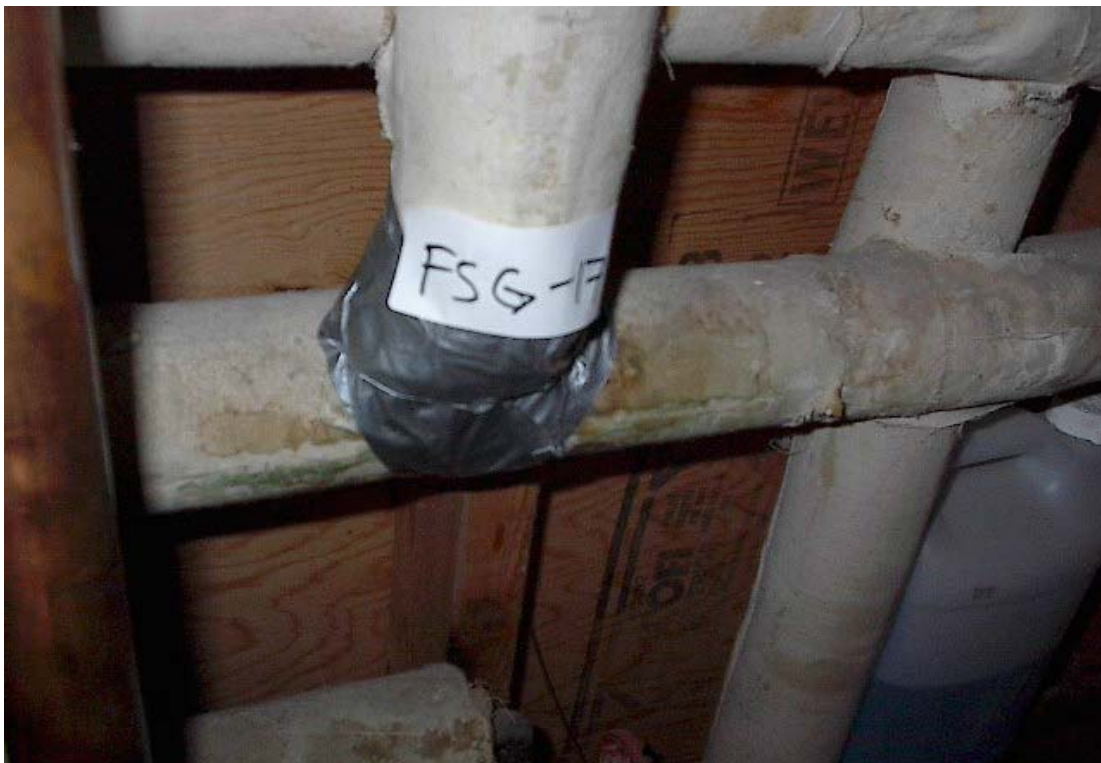
Photo 13: Pipe elbows, Sample 17.

Ceiling	Gypsum Board (Drywall)		C-N-A					No
Electrical	None Observed		none					No
Floor	Concrete		C-N-A					No
Pipe	Fittings Insulated	14.0	Units	A17	Chrysotile 75.00%	B	3	Yes
Wall	Drywall		C-N-A					No
Wall	Wood Frame Construction		C-N-A					No

Based on the findings of the survey and on the condition and location of the ACM that was detected, it is recommended that PWGSC institute a routine surveillance program to monitor the majority of the remaining ACM. Piping elbows in one room are recommended for removal and proactive removal is recommended for the vinyl floor tile and transite panels (if the presence of asbestos in GOOD condition is not desirable). If the ACM is not removed, routine surveillance is required.

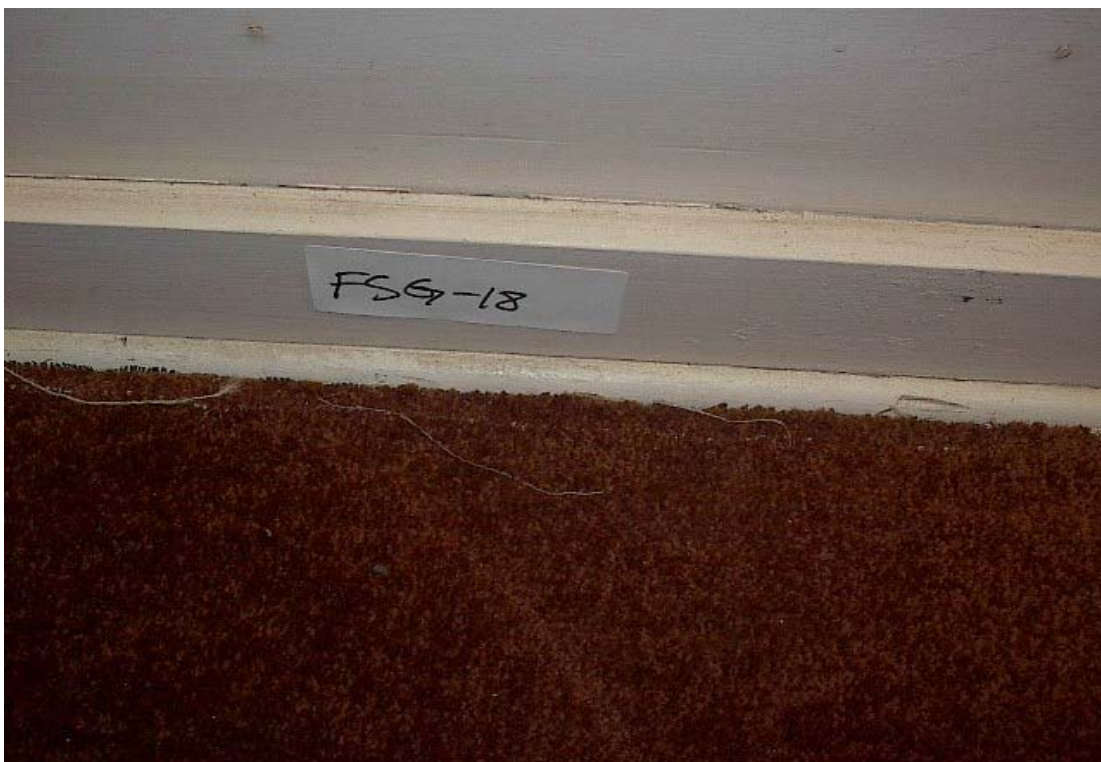
Photo 14: Carpet, Sample 18.

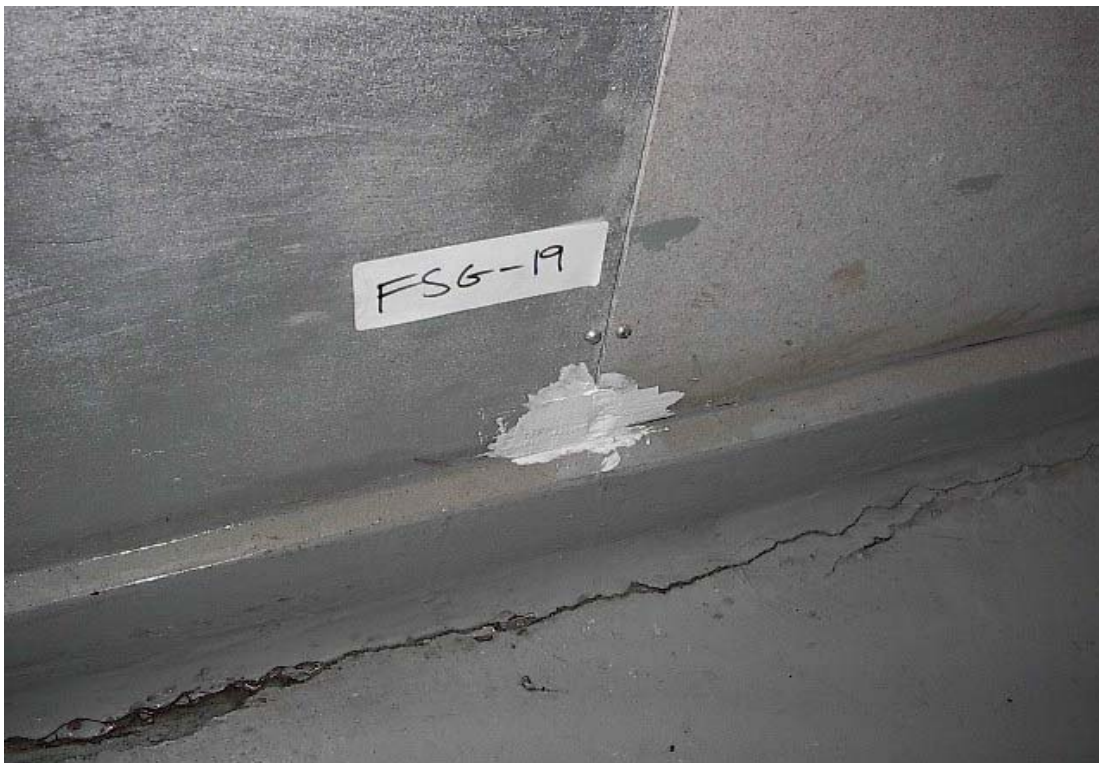
A19	Room 118 - Wallboard	20% Chrysotile	B – Within reach of maintenance staff in frequently entered maintenance areas	Good	7	Room 128 also contains wallboard which is suspected of containing asbestos materials.
A21	Exterior – Transite panels on exterior of building	5% Chrysotile	A – Within reach of all building users	Good	5/7	Proactive removal recommended if the presence of asbestos in GOOD condition is not desirable. If ACM is not removed, routine surveillance is required.

Photo 15: Wallboard, Sample 19.

LEX Sample #:	19	Chrysotile:	20%	Fibreglass:	None Detected
Sample #:	FSG-19	Amosite:	None Detected	Glasswool:	None Detected
Sample Colour:	grey/red/yellow	Crocidolite:	None Detected	Rockwool:	None Detected
Analyst:	ED	Other Amphiboles:	None Detected	Cellulose:	None Detected
Sample Condition	Sealed Bag			Other:	None Detected
Comments:				Non-Fibrous:	80%

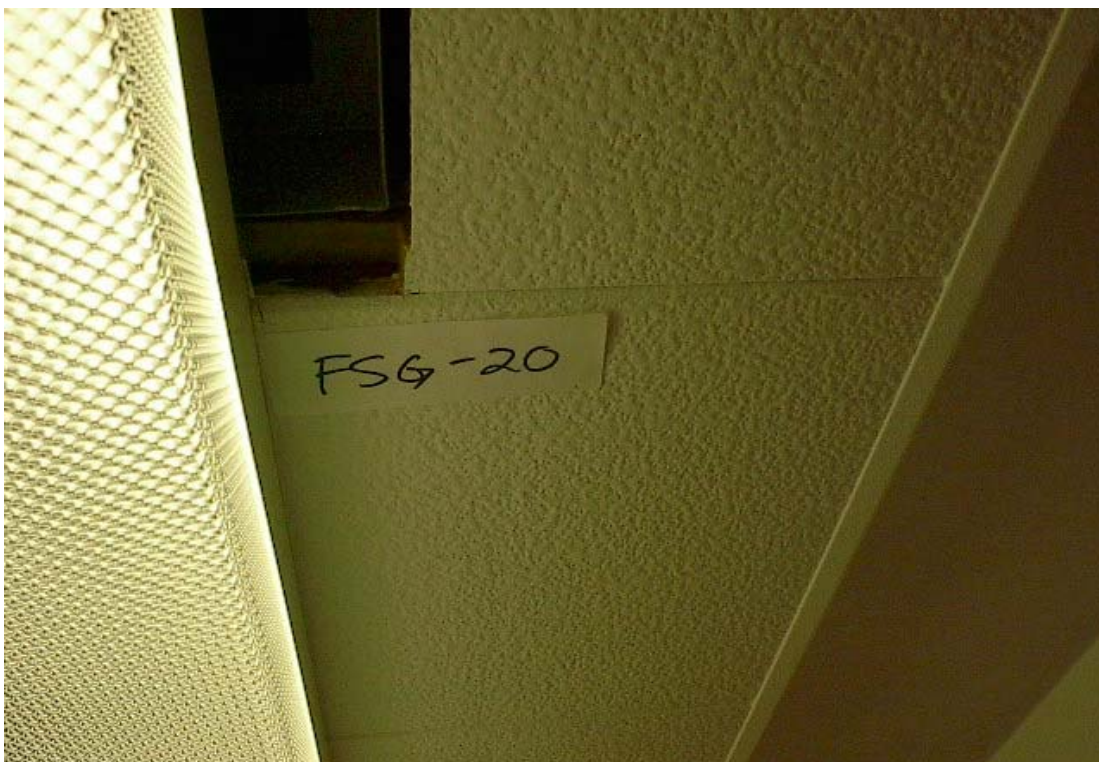
Photo 16: Ceiling tiles, Sample 20.

LEX Sample #:	20	Chrysotile:	None Detected	Fibreglass:	20%
Sample #:	FSG-20	Amosite:	None Detected	Glasswool:	None Detected
Sample Colour:	beige/white	Crocidolite:	None Detected	Rockwool:	None Detected
Analyst:	ED	Other Amphiboles:	None Detected	Cellulose:	None Detected
Sample Condition	Sealed Bag			Other:	None Detected
Comments:				Non-Fibrous:	80%

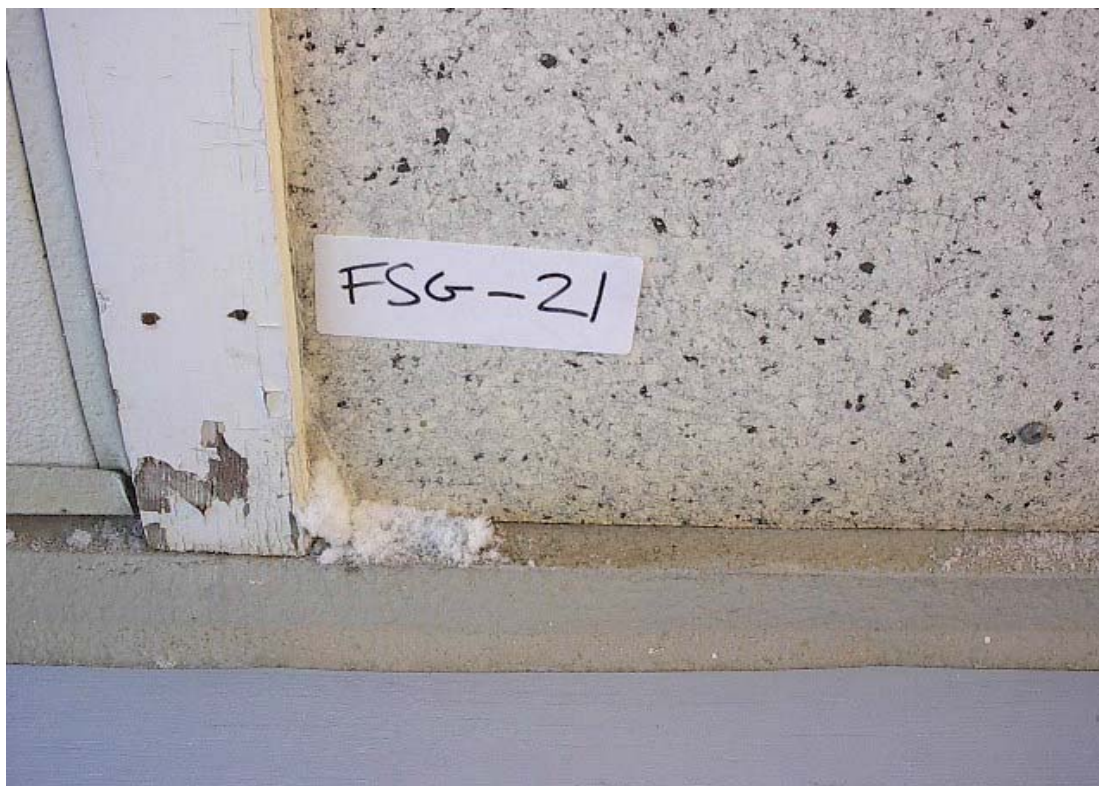
Photo 17: Transite panels on exterior of building, Sample 21.

LEX Sample #:	21	Chrysotile:	5%	Fibreglass:	None Detected
Sample #:	FSG-21	Amosite:	None Detected	Glasswool:	None Detected
Sample Colour:	black/grey	Crocidolite:	None Detected	Rockwool:	None Detected
Analyst:	ED	Other Amphiboles:	None Detected	Cellulose:	None Detected
Sample Condition	Sealed Bag			Other:	None Detected
Comments:				Non-Fibrous:	95%

Wall	Foundation-Insul Transit			n/a	A22				No
Wall	Windows with Transit Panels	37.5	Sq. M	Good	A21	Chrysotile 5.00%	A	5	Yes

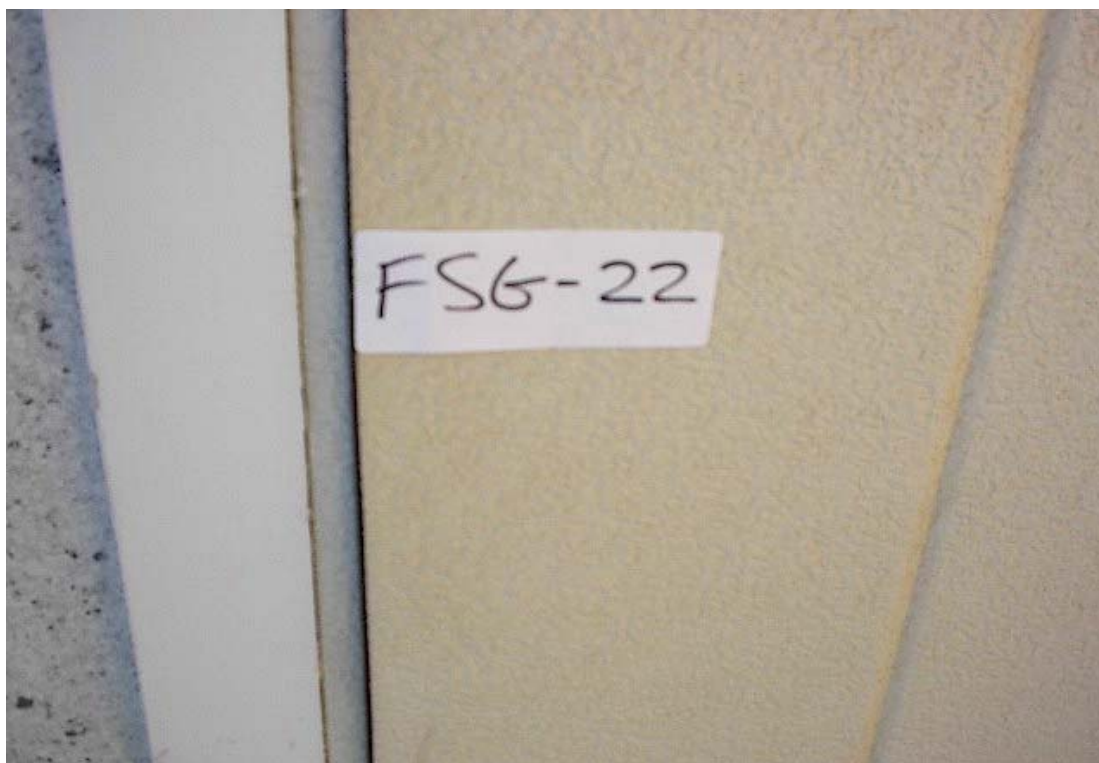
Photo 18: Foundation-Insul Transite, Sample 22.

LEX Sample #:	22	Chrysotile:	None Detected	Fibreglass:	None Detected
Sample #:	FSG-22	Amosite:	None Detected	Glasswool:	None Detected
Sample Colour:	beige/black	Crocidolite:	None Detected	Rockwool:	None Detected
Analyst:	ED	Other Amphiboles:	None Detected	Cellulose:	20%
Sample Condition	Sealed Bag			Other:	None Detected
Comments:				Non-Fibrous:	80%

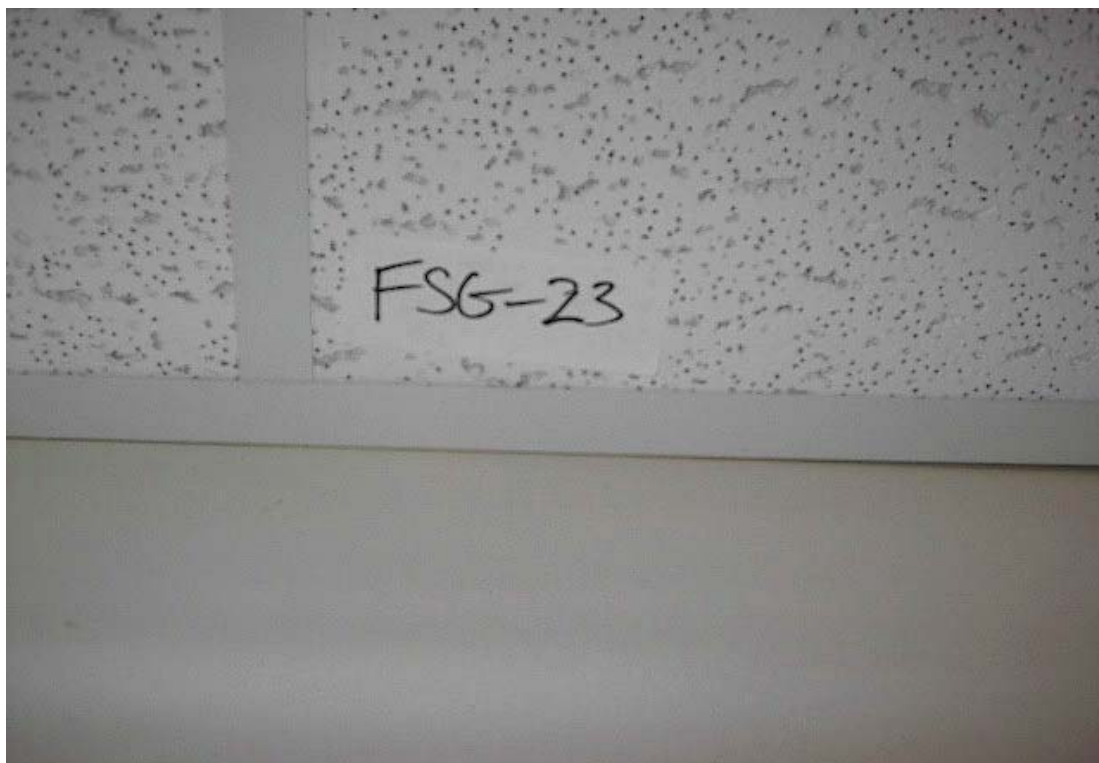
Photo 19: Acoustical Tile, Sample 23.

Fibrous Asbestos Content%	Other Materials Content %
LEX Sample #:	23	Chrysotile: None Detected	Fibreglass: None Detected
Sample #:	FSG-23	Amosite: None Detected	Glasswool: None Detected
Sample Colour:	beige/white	Crocidolite: None Detected	Rockwool: 20%
Analyst:	ED	Other Amphiboles: None Detected	Cellulose: 20%
Sample Condition	Sealed Bag		Other: None Detected
Comments:			Non-Fibrous: 60%
LEX Sample #:	24	Chrysotile: None Detected	Fibreglass: None Detected
Sample #:	FSG-24	Amosite: None Detected	Glasswool: None Detected
Sample Colour:	beige/white	Crocidolite: None Detected	Rockwool: 25%
Analyst:	ED	Other Amphiboles: None Detected	Cellulose: 25%
Sample Condition	Sealed Bag		Other: None Detected
Comments:			Non-Fibrous: 50%

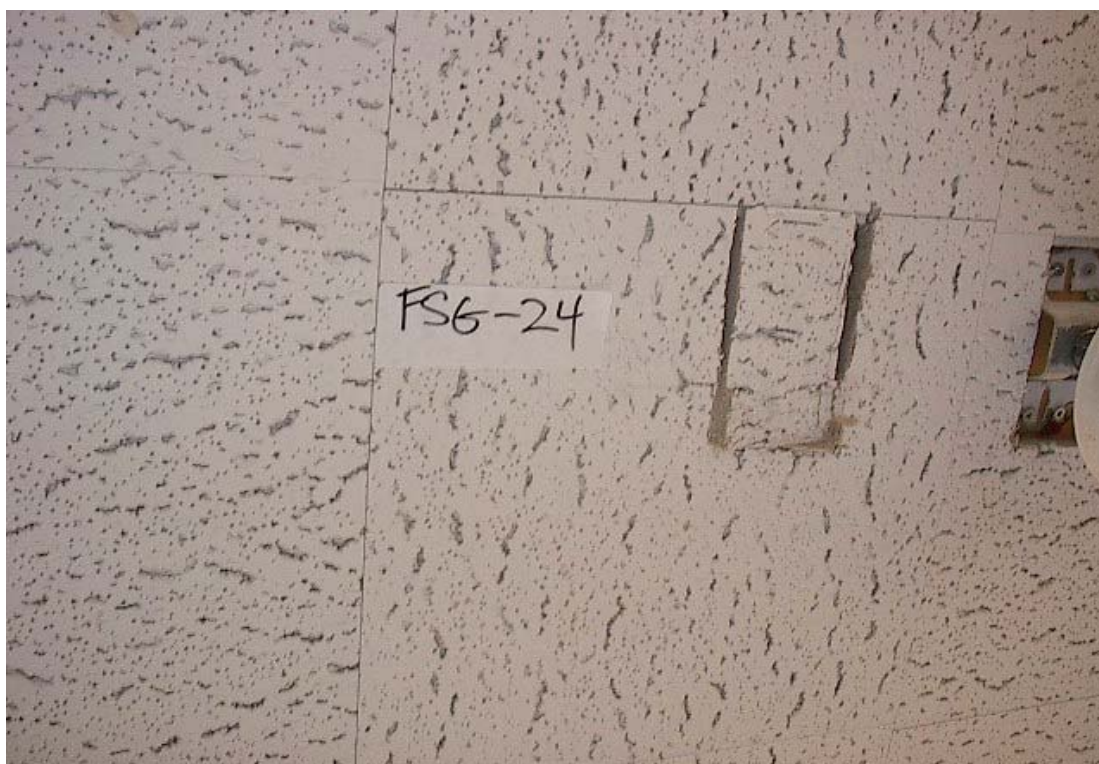
Photo 20: Acoustical tile, Sample 24.
