Title - Sujet GOCB Flooring & Fire Separations	
Solicitation No. - N° de l'invitation EW038-190845/A	Amendment No. - N° modif. 004
Client Reference No. - N° de référence du client PSPC	Date 2018-08-15
GETS Reference No. - N° de référence de SEAG PW-\$PWU-066-11410	
File No. - N° de dossier PWU-8-41059 (066)	CCC No./N° CCC - FMS No./N° VME
Solicitation Closes - L'invitation prend fin at - à 02:00 PM on - le 2018-08-24	Time Zone Fuseau horaire Mountain Daylight Saving Time MDT
F.O.B. - F.A.B. Plant-Usine: <input type="checkbox"/> Destination: <input type="checkbox"/> Other-Autre: <input type="checkbox"/>	
Address Enquiries to: - Adresser toutes questions à: Lee, Mony	Buyer Id - Id de l'acheteur pwu066
Telephone No. - N° de téléphone (780) 224-6675 ()	FAX No. - N° de FAX (780) 497-3510
Destination - of Goods, Services, and Construction: Destination - des biens, services et construction:

Fort Simpson GOCB Carpet Replacement & Fire Rating Upgrade

Asbestos Survey
Government of Canada Building
9606 – 100th Street, Fort Simpson NWT

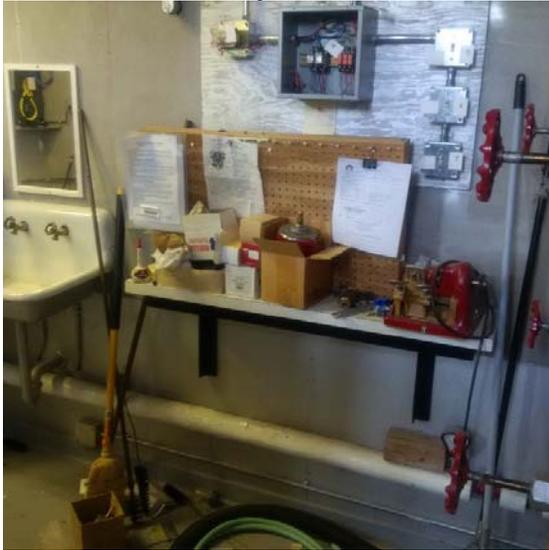
1. Sink shelf and electrical equipment

The Contractor is to ensure all conduit and mechanical piping is properly temporarily supported to ensure continuous operation when this equipment is removed from its existing wall fasteners. Photos of the existing site conditions is in the appendix of this document.

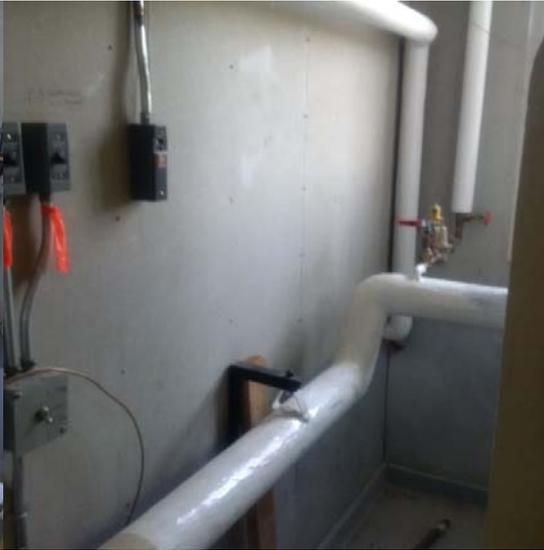
2. Insulated piping, misc. wiring

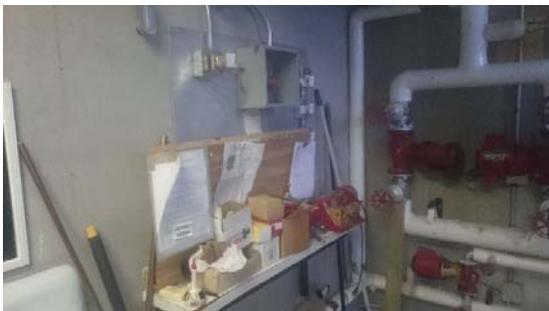
3. Insulated piping and valves

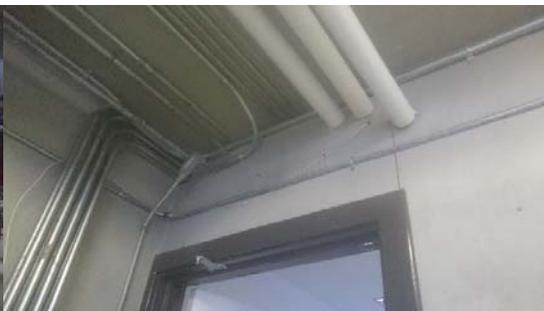
4. Miscellaneous wiring

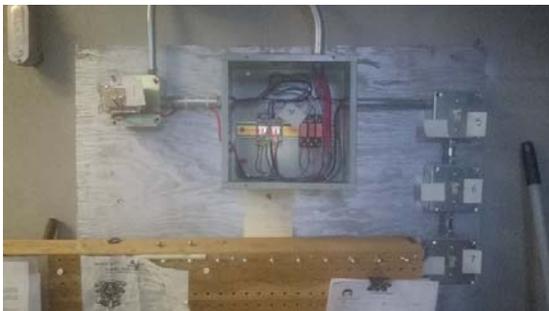
5. Electrical equipment

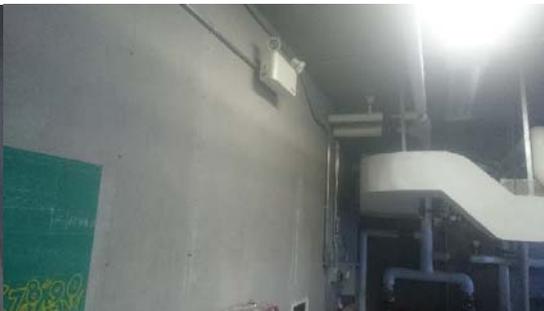
6. Emergency lighting

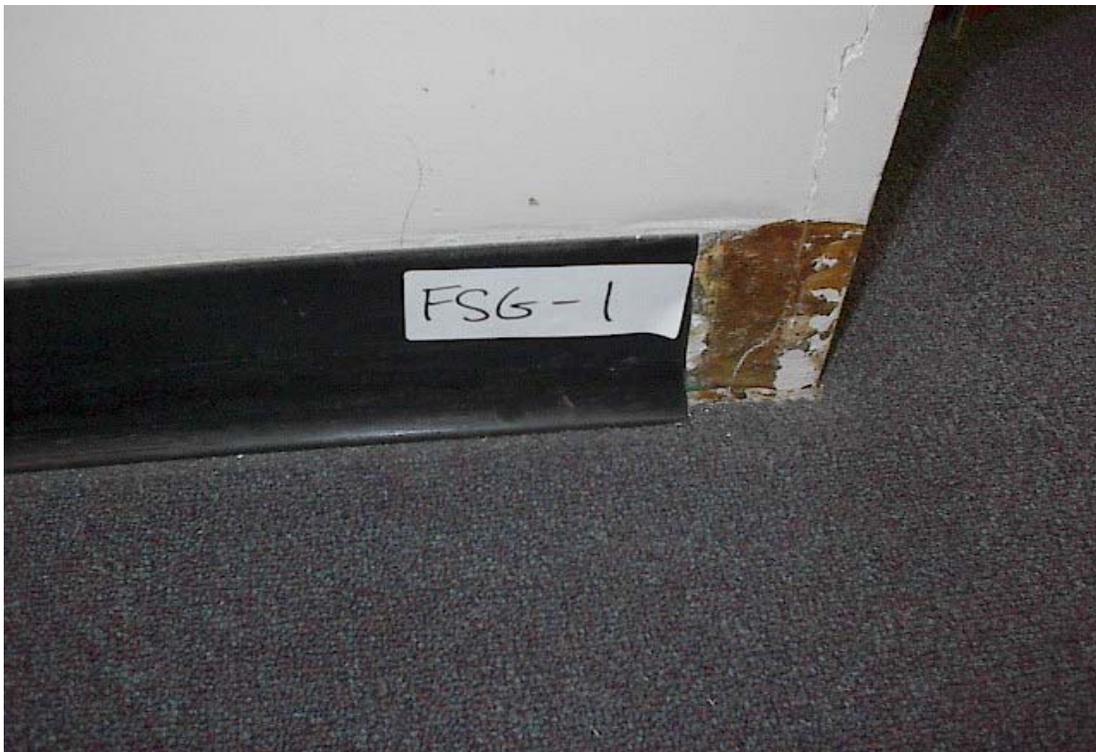
Photo 2: Baseboard and paring, Sample 1.

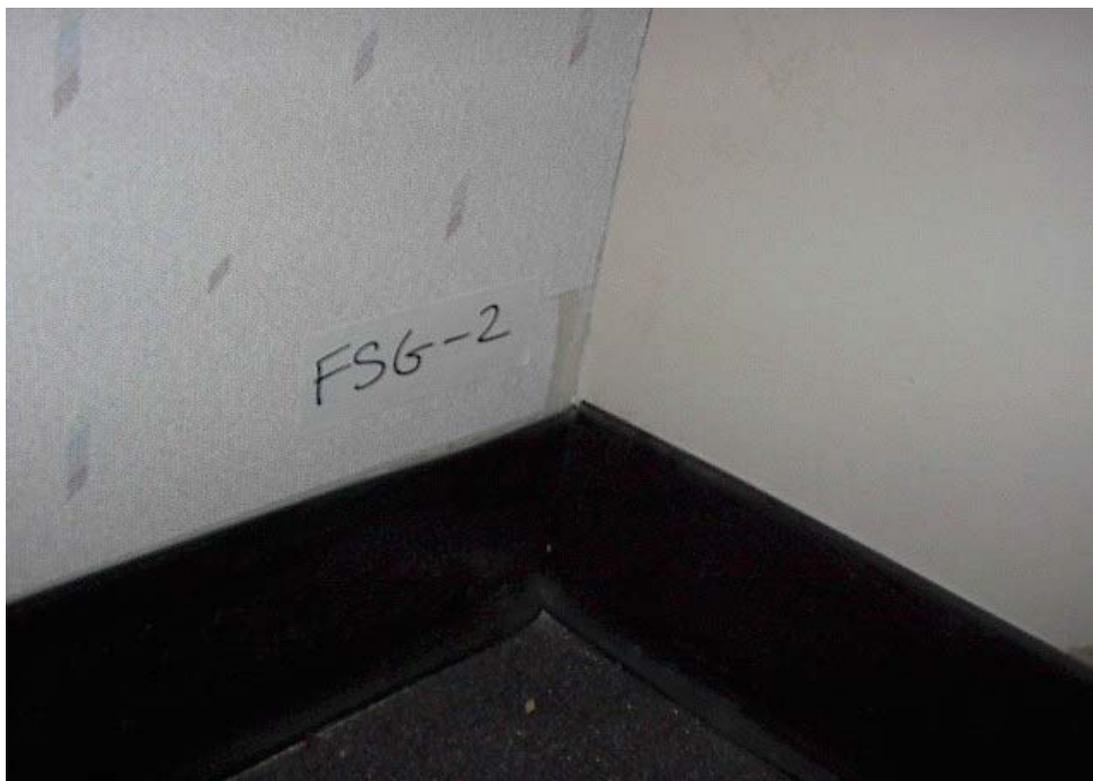
Photo 3: Wallpaper, Sample 2.

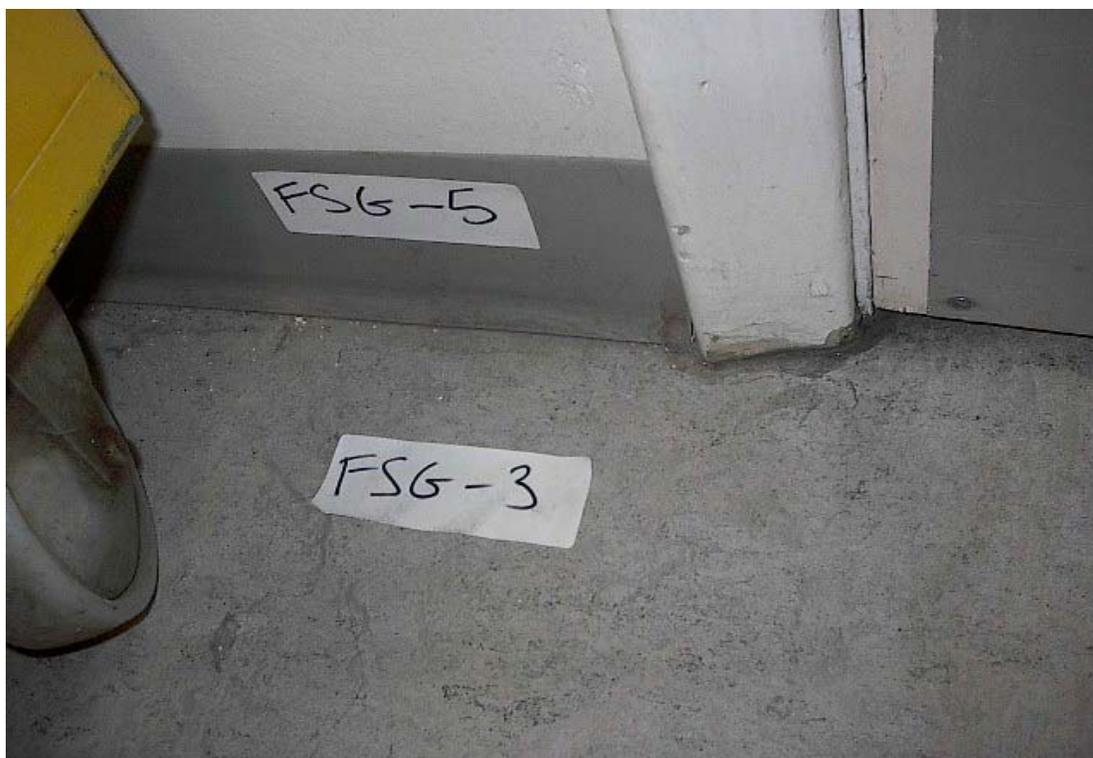
Photo 4: Sheet flooring and baseboard composite, Samples 3, 4 and 5.

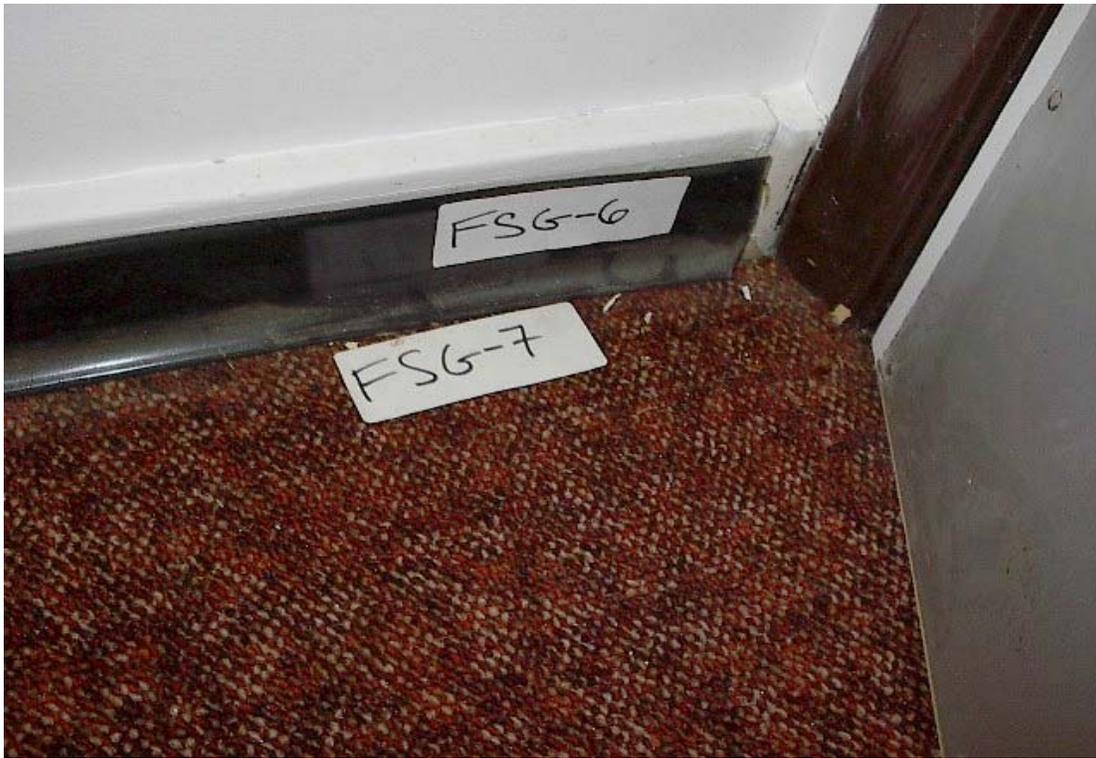
Photo 5: Baseboard composite and carpet, Samples 6 and 7.

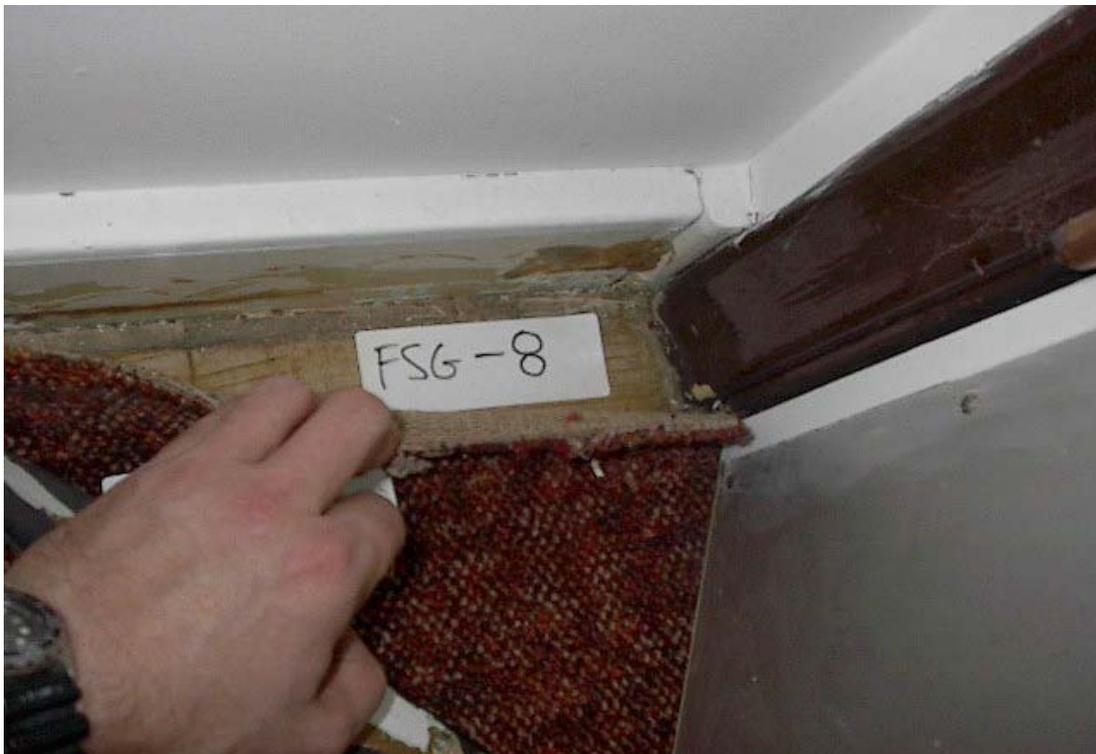
Photo 6: Tile, Sample 8.

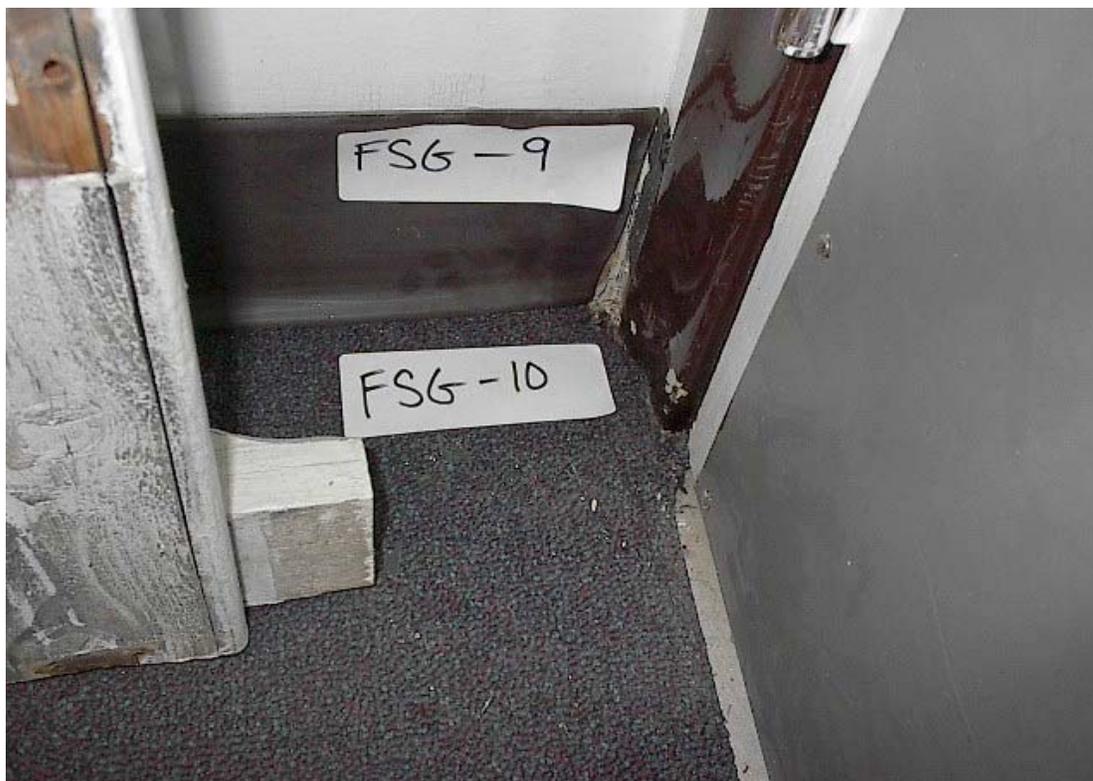
Photo 7: Baseboard composite and carpet, Sample 9 and 10.

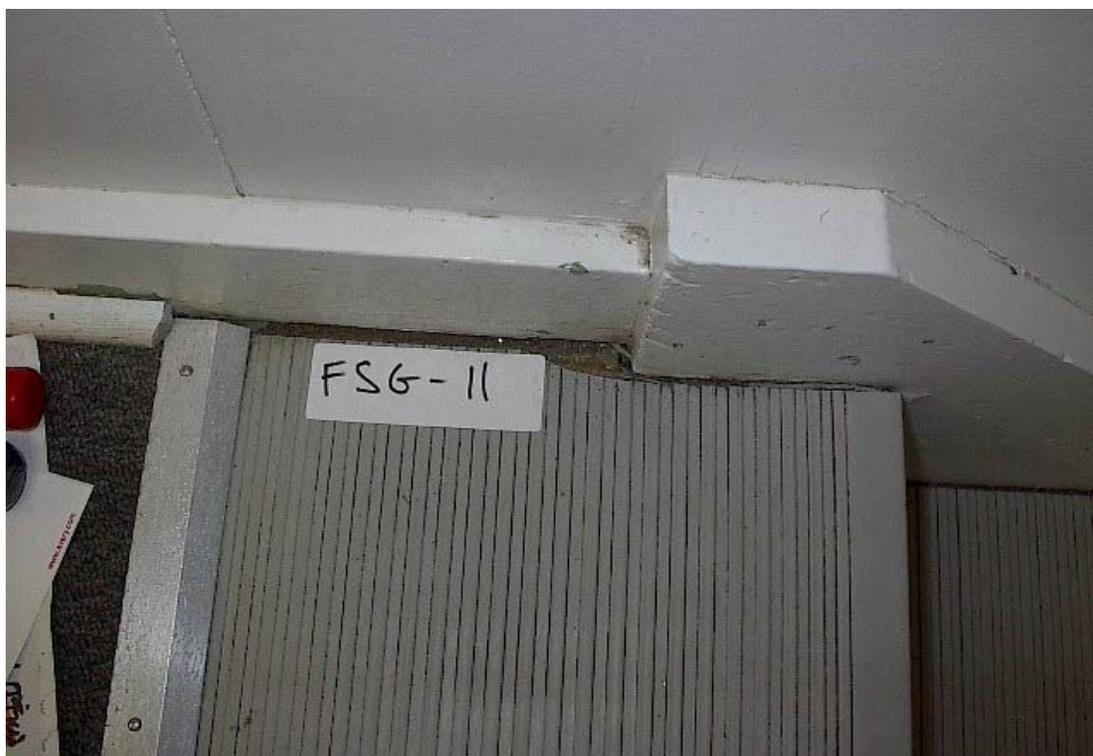
Photo 8: Treads on stairs, Sample 11.

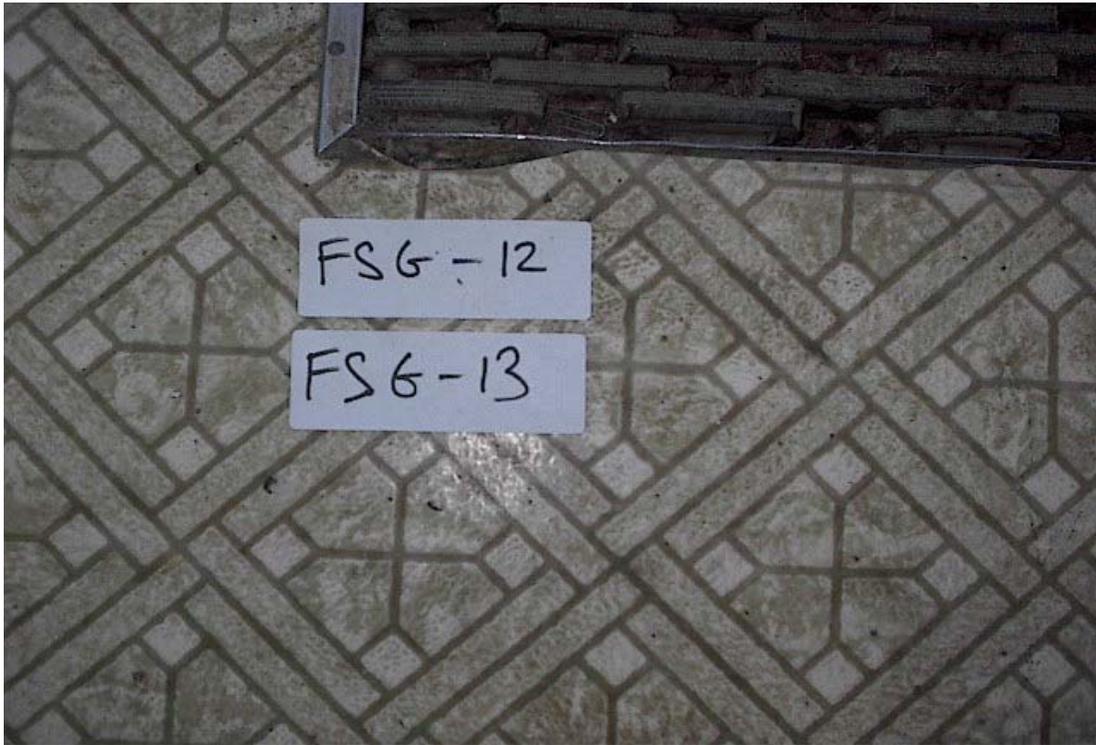
Photo 9: Sheet flooring and adhesive compound, Samples 12 and 13.

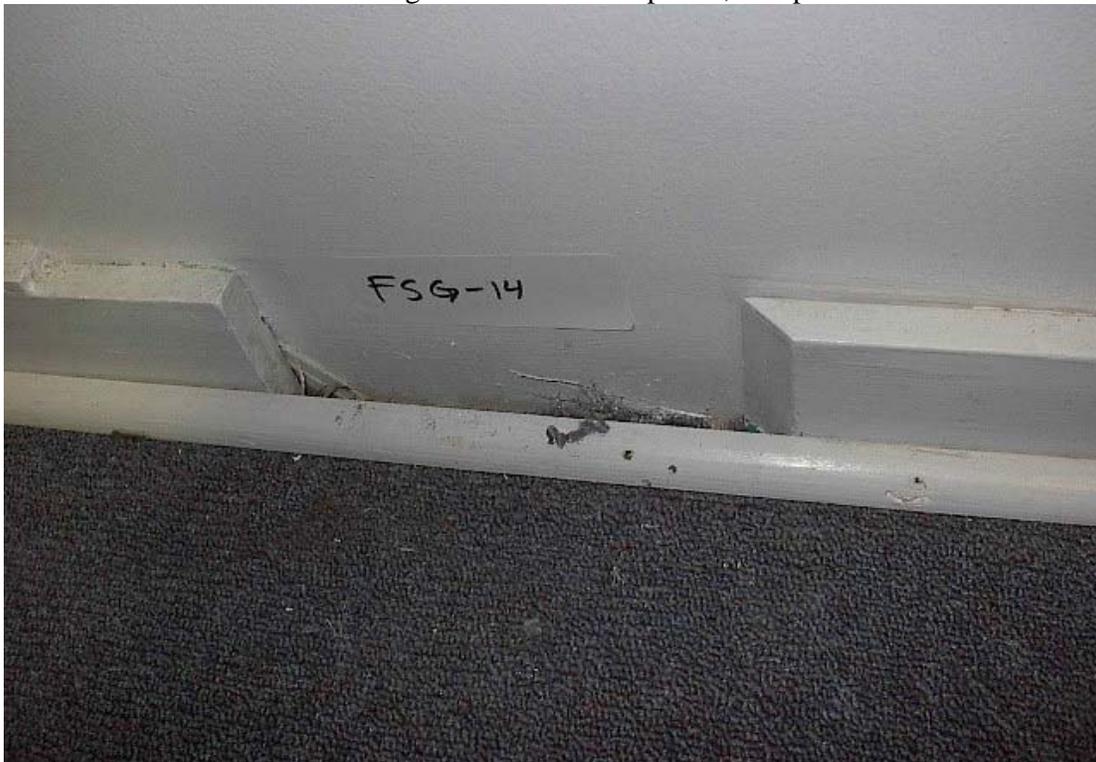
Photo 10: Carpet, Sample 14.

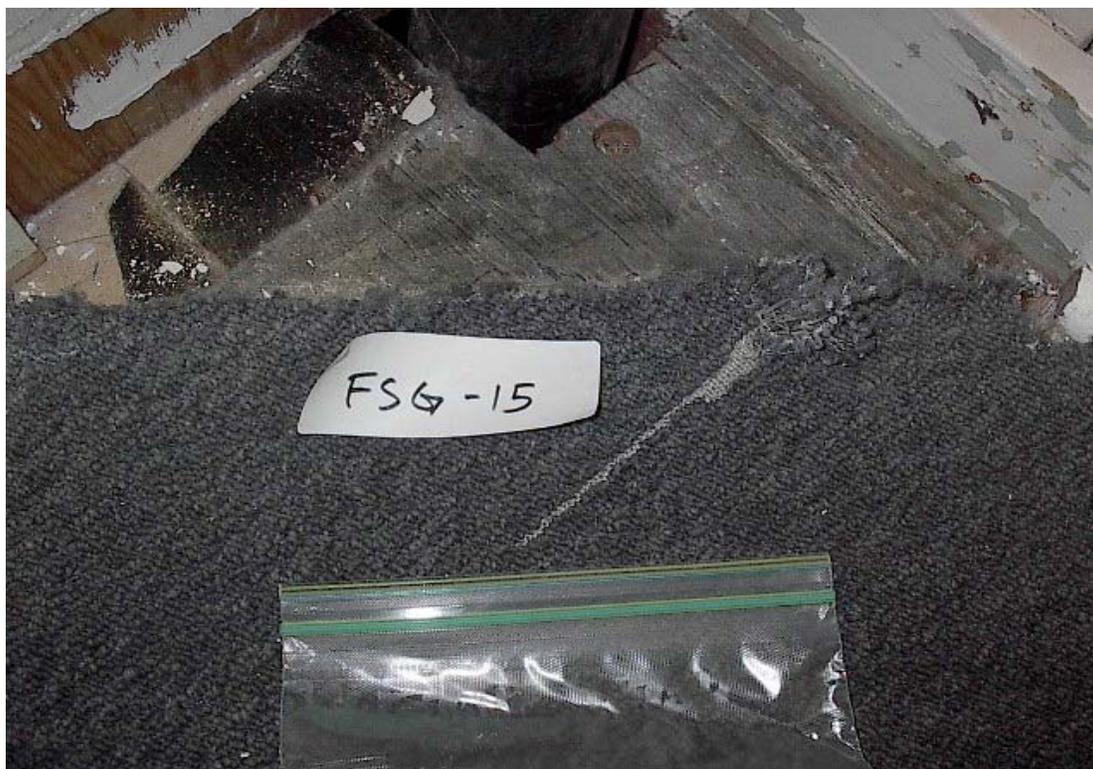
Photo 11: Carpet, Sample 15.

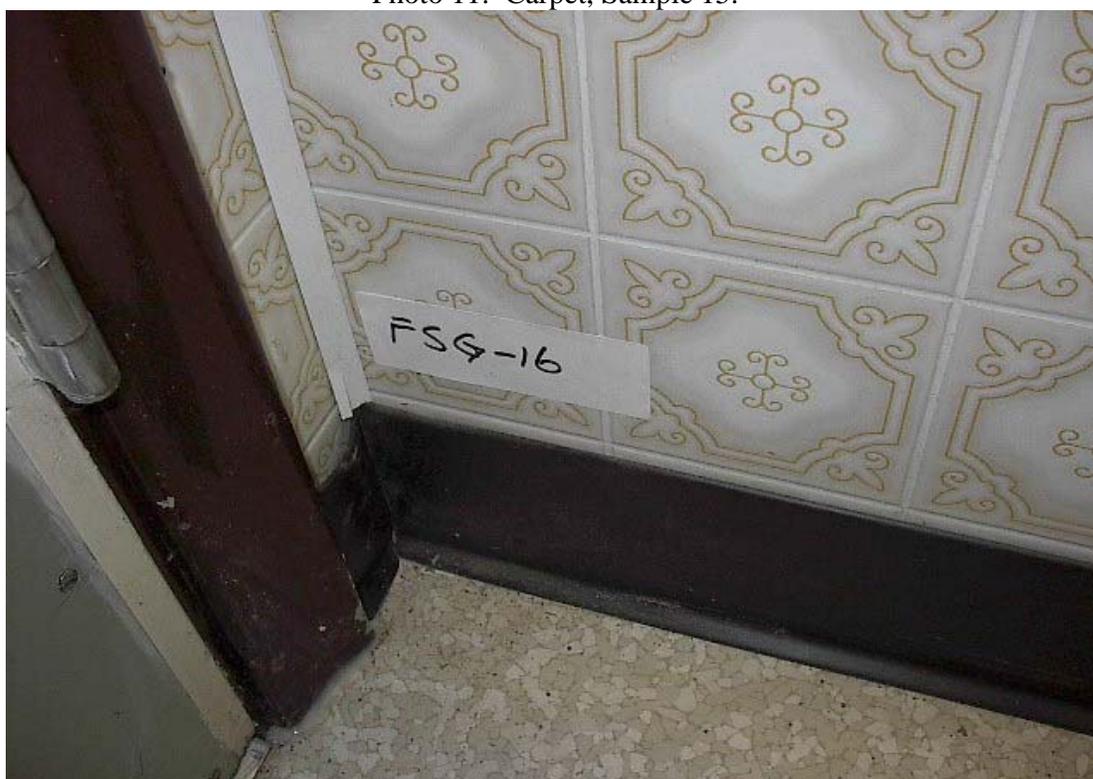
Photo 12: Ceramic tile, Sample 16.

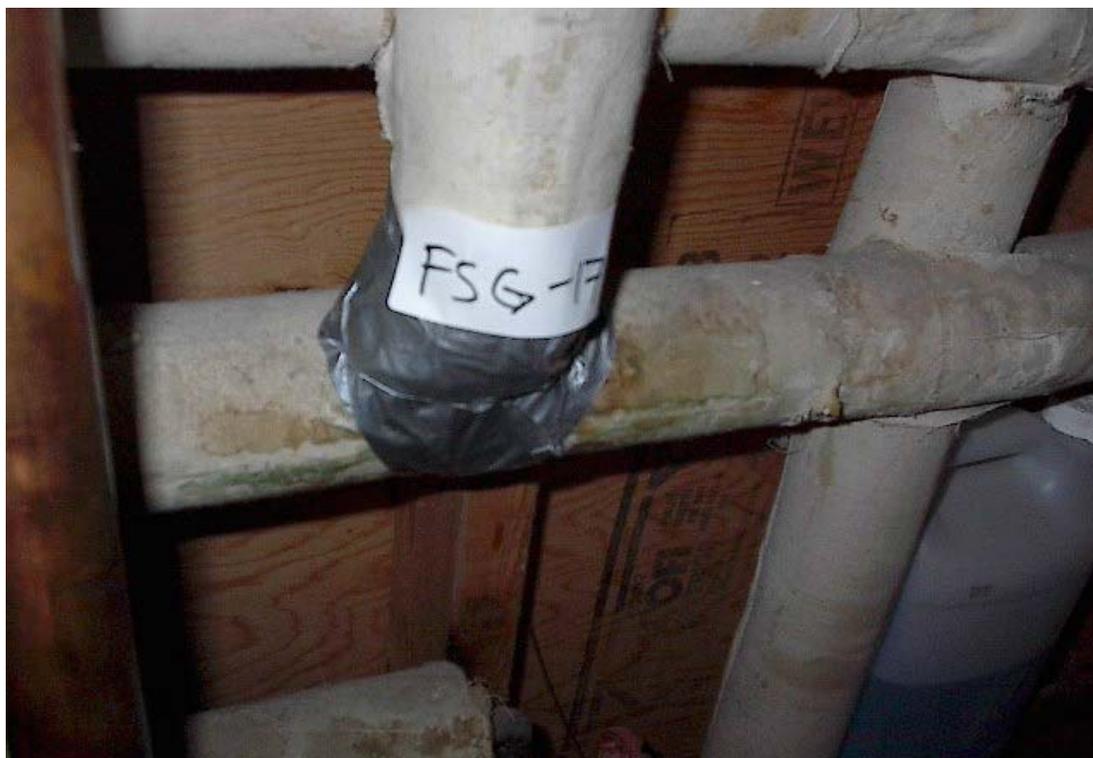
Photo 13: Pipe elbows, Sample 17.

Ceiling	Gypsum Board (Drywall)		C-N-A					No
Electrical	None Observed		none					No
Floor	Concrete		C-N-A					No
Pipe	Fittings Insulated	14.0	Units	A17	Chrysotile 75.00%	B	3	Yes
Wall	Drywall		C-N-A					No
Wall	Wood Frame Construction		C-N-A					No

Based on the findings of the survey and on the condition and location of the ACM that was detected, it is recommended that PWGSC institute a routine surveillance program to monitor the majority of the remaining ACM. Piping elbows in one room are recommended for removal and proactive removal is recommended for the vinyl floor tile and transite panels (if the presence of asbestos in GOOD condition is not desirable). If the ACM is not removed, routine surveillance is required.

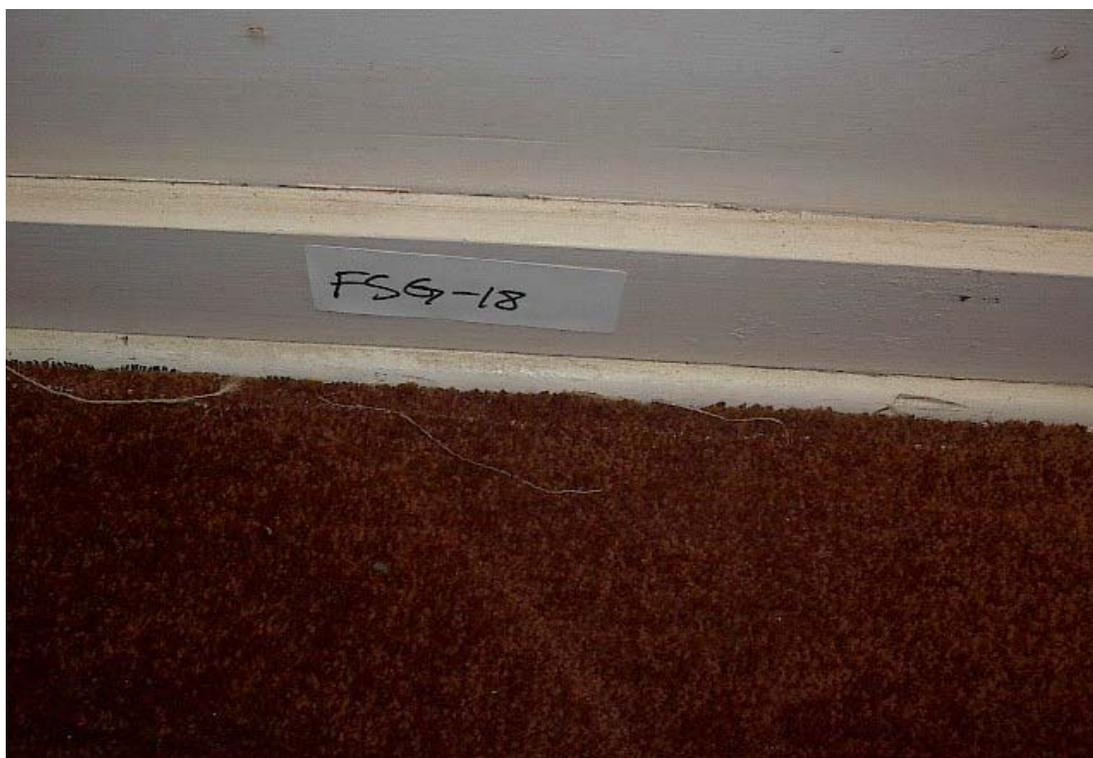
Photo 14: Carpet, Sample 18.

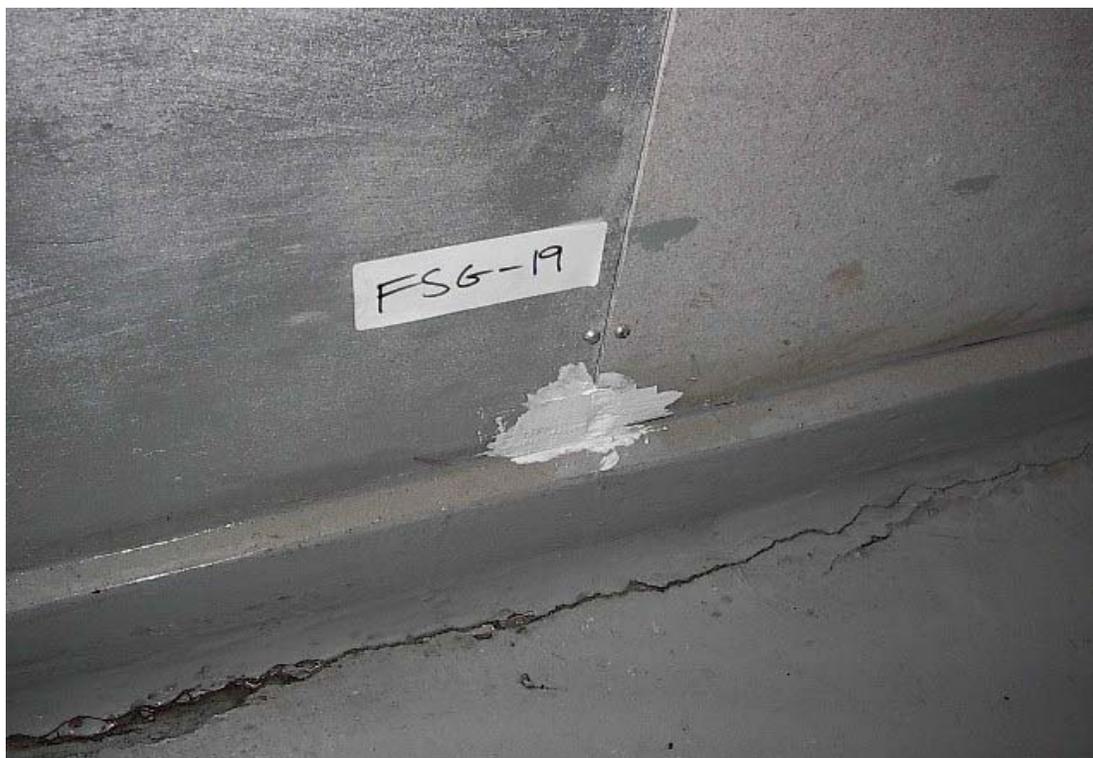
A19	Room 118 - Wallboard	20% Chrysotile	B – Within reach of maintenance staff in frequently entered maintenance areas	Good	7	Room 128 also contains wallboard which is suspected of containing asbestos materials.
A21	Exterior – Transite panels on exterior of building	5% Chrysotile	A – Within reach of all building users	Good	5/7	Proactive removal recommended if the presence of asbestos in GOOD condition is not desirable. If ACM is not removed, routine surveillance is required.

Photo 15: Wallboard, Sample 19.

Fibrous Asbestos Content%	Other Materials Content %
LEX Sample #:	19	Chrysotile: 20%	Fibreglass: None Detected
Sample #:	FSG-19	Amosite: None Detected	Glasswool: None Detected
Sample Colour:	grey/red/yellow	Crocidolite: None Detected	Rockwool: None Detected
Analyst:	ED	Other Amphiboles: None Detected	Cellulose: None Detected
Sample Condition	Sealed Bag		Other: None Detected
Comments:			Non-Fibrous: 80%
LEX Sample #:	20	Chrysotile: None Detected	Fibreglass: 20%
Sample #:	FSG-20	Amosite: None Detected	Glasswool: None Detected
Sample Colour:	beige/white	Crocidolite: None Detected	Rockwool: None Detected
Analyst:	ED	Other Amphiboles: None Detected	Cellulose: None Detected
Sample Condition	Sealed Bag		Other: None Detected
Comments:			Non-Fibrous: 80%
LEX Sample #:	21	Chrysotile: 5%	Fibreglass: None Detected
Sample #:	FSG-21	Amosite: None Detected	Glasswool: None Detected
Sample Colour:	black/grey	Crocidolite: None Detected	Rockwool: None Detected

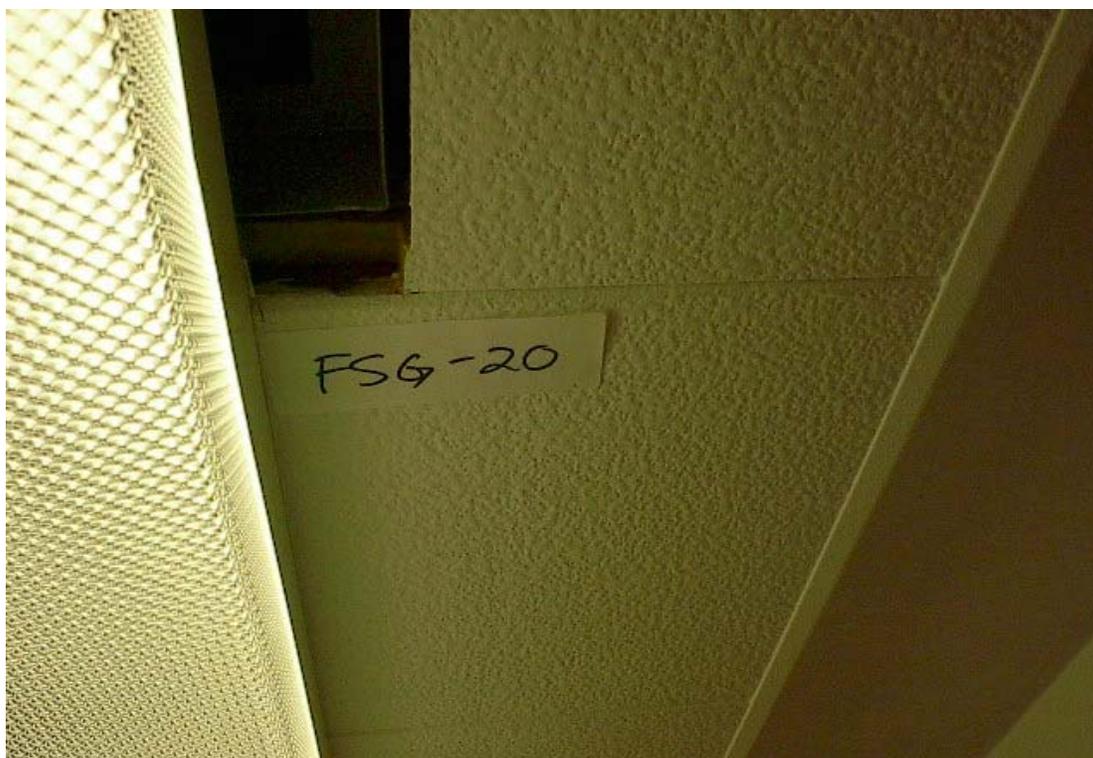
Photo 16: Ceiling tiles, Sample 20.

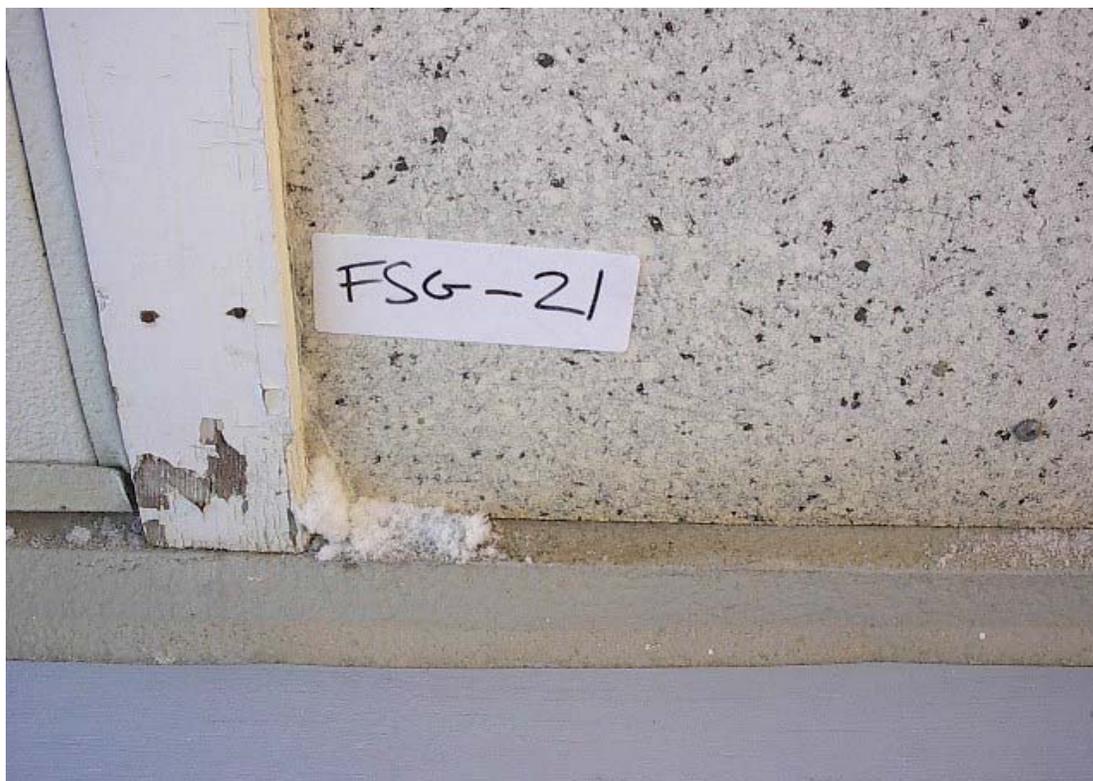
Photo 17: Transite panels on exterior of building, Sample 21.

Wall	Foundation-Insul Transite			n/a	A22				No
Wall	Windows with Transite Panels	37.5	Sq. M	Good	A21	Chrysotile 5.00%	A	5	Yes

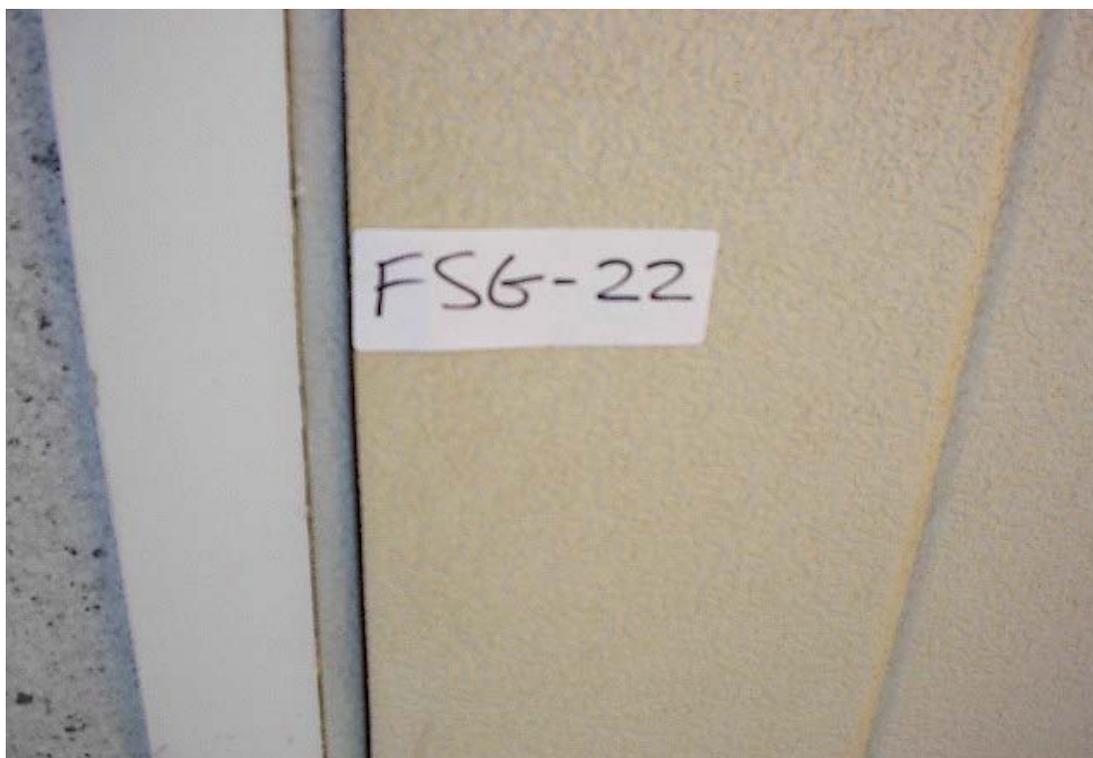
Photo 18: Foundation-Insul Transite, Sample 22.

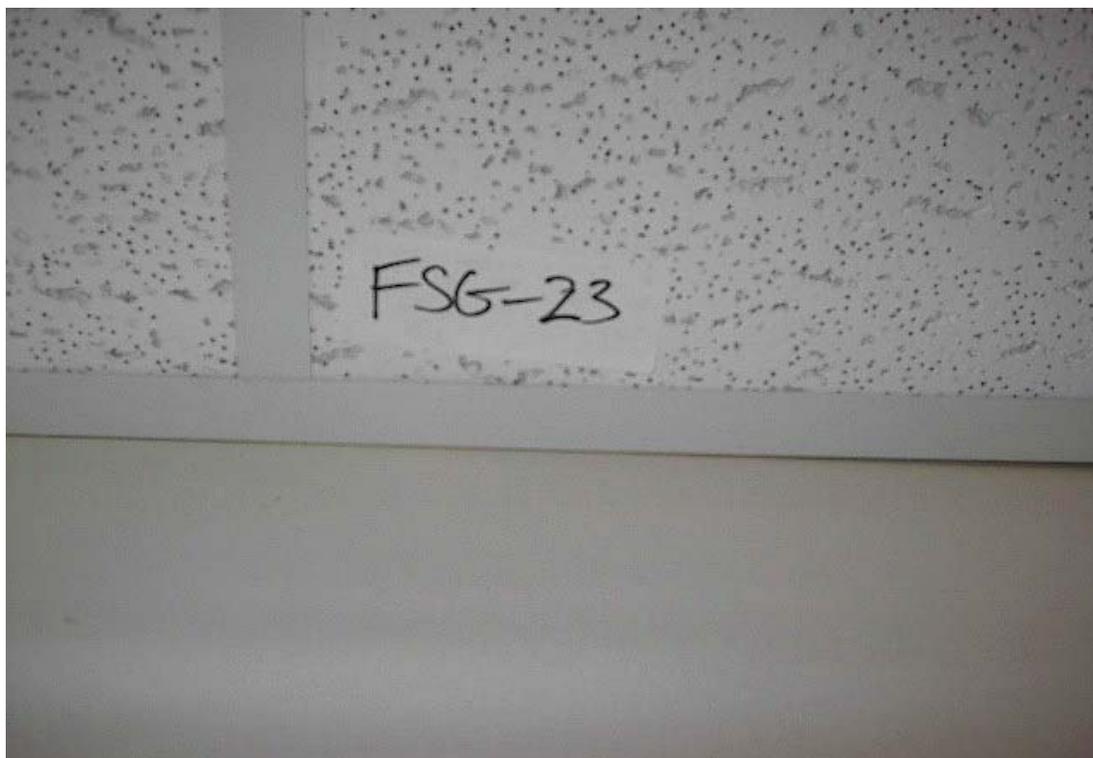
Photo 19: Acoustical Tile, Sample 23.

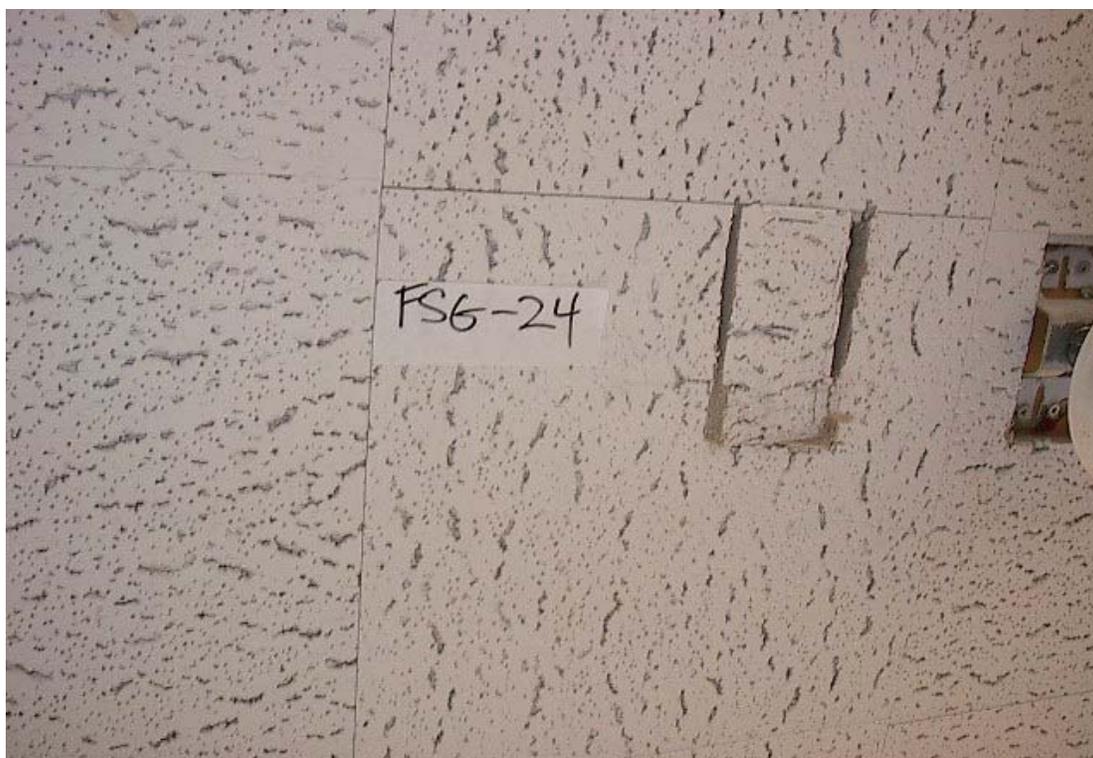
Photo 20: Acoustical tile, Sample 24.
