## TECHNICAL MEMORANDUM

**Date:** June 5, 2012  
**To:** Shawn Fillion, P.Eng. - PWGSC  
**Copies:** Harvey Walsh, P.Eng. - GENIVAR  
**From:** Steve Ash, P.Eng.  
**Project No.:** 111-26271-00  
**Subject:** Concrete Coring Results – Coboconk Dam – DRAFT No. 2

GEOTECHNICAL INVESTIGATION  
GULL RIVER BUNDLE DAM SAFETY REVIEW  
COBOCONK DAM  
For Public Works & Government Services Canada

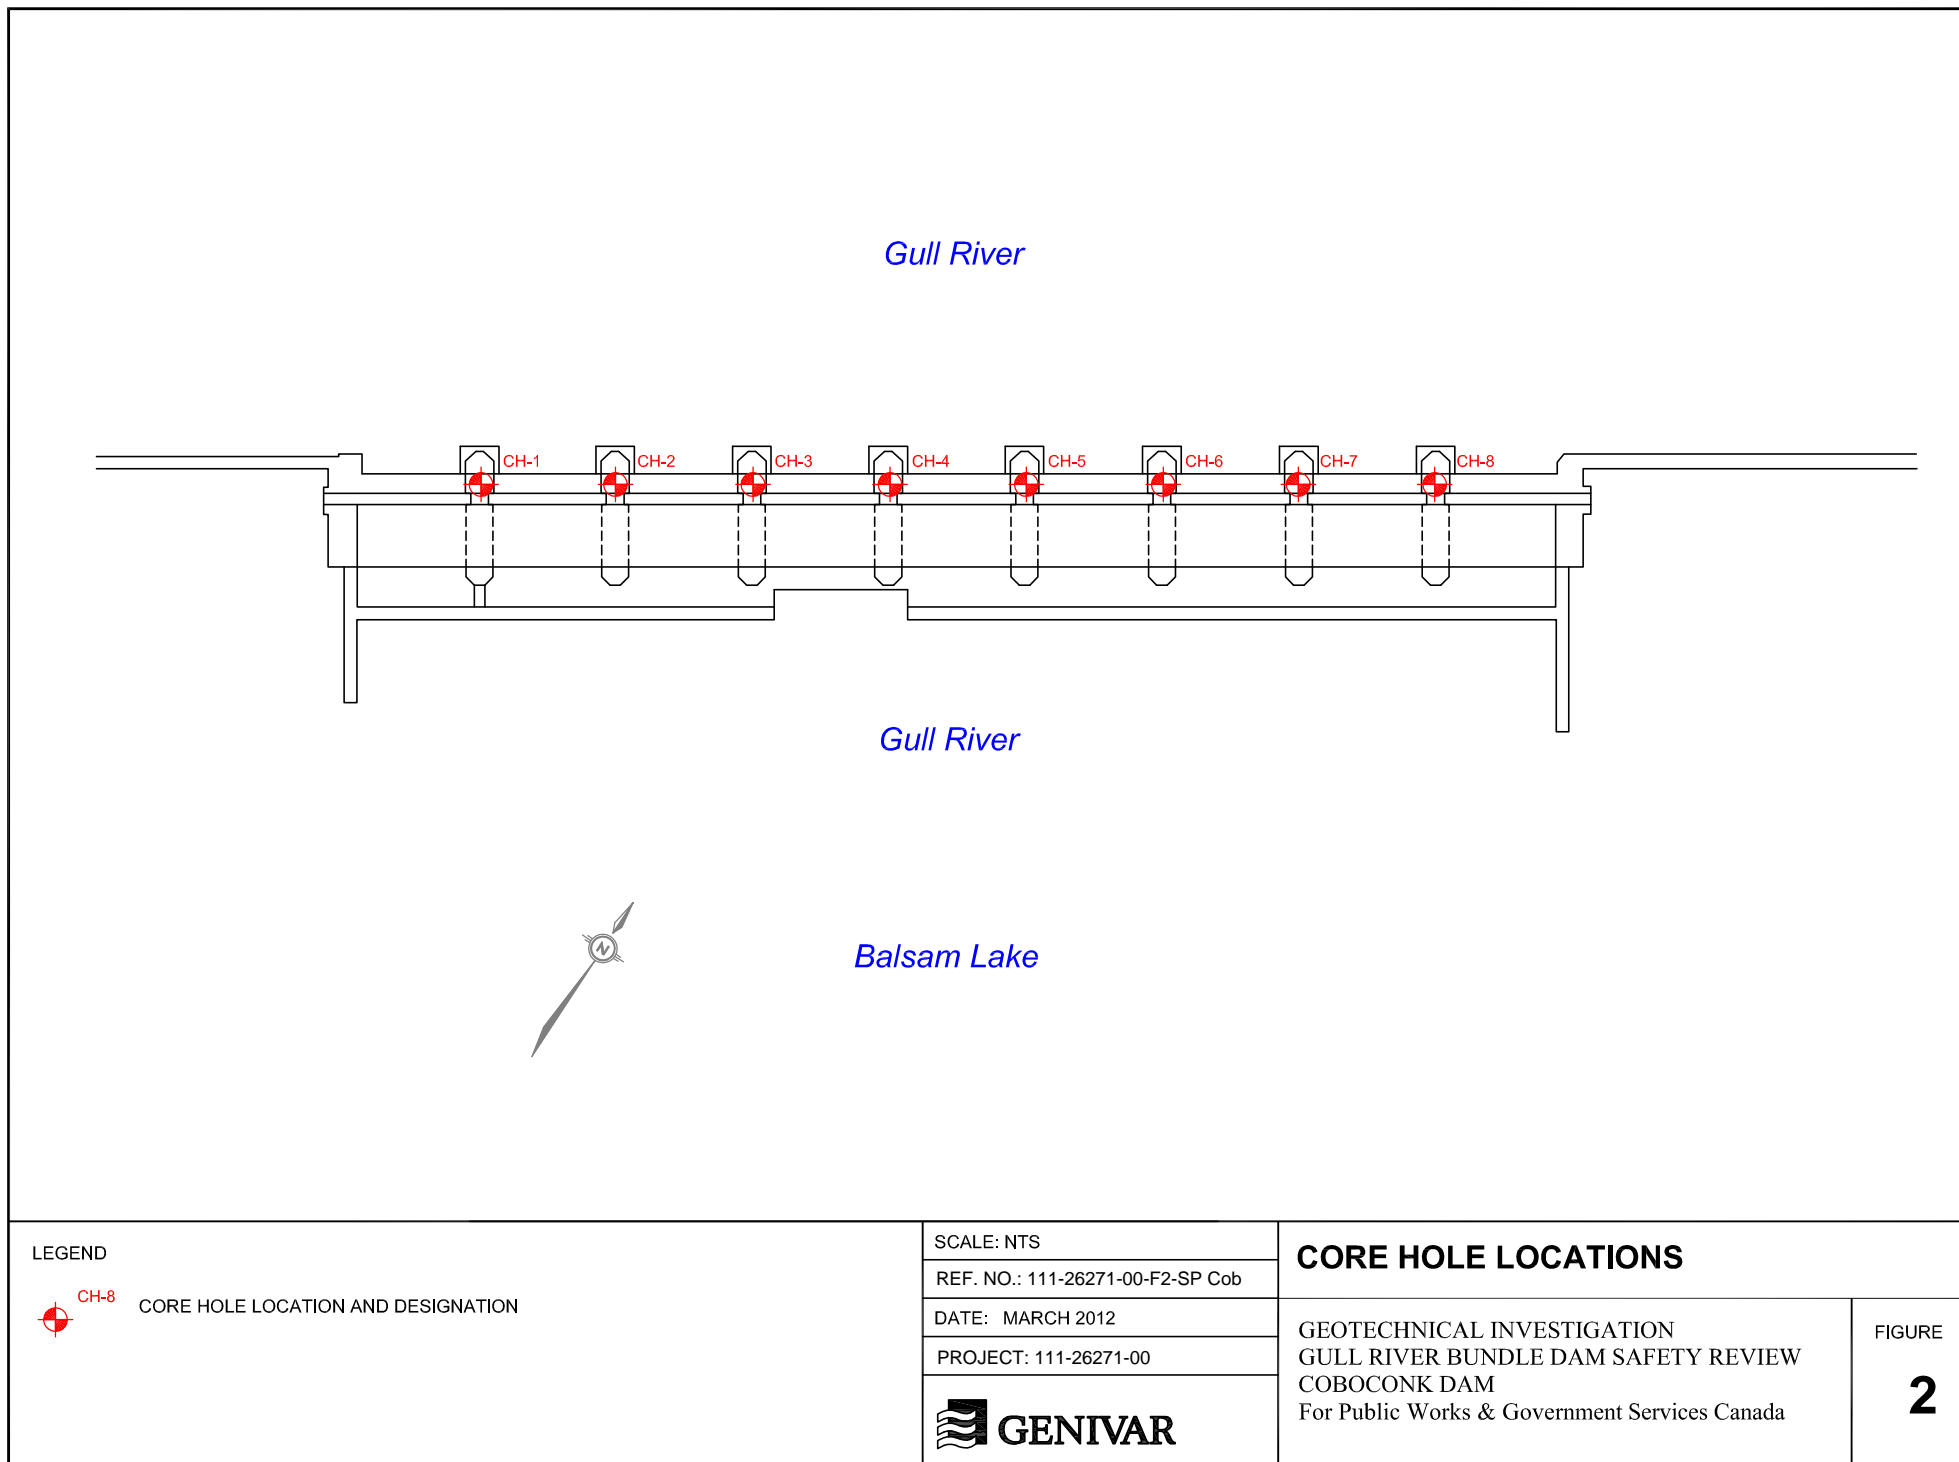
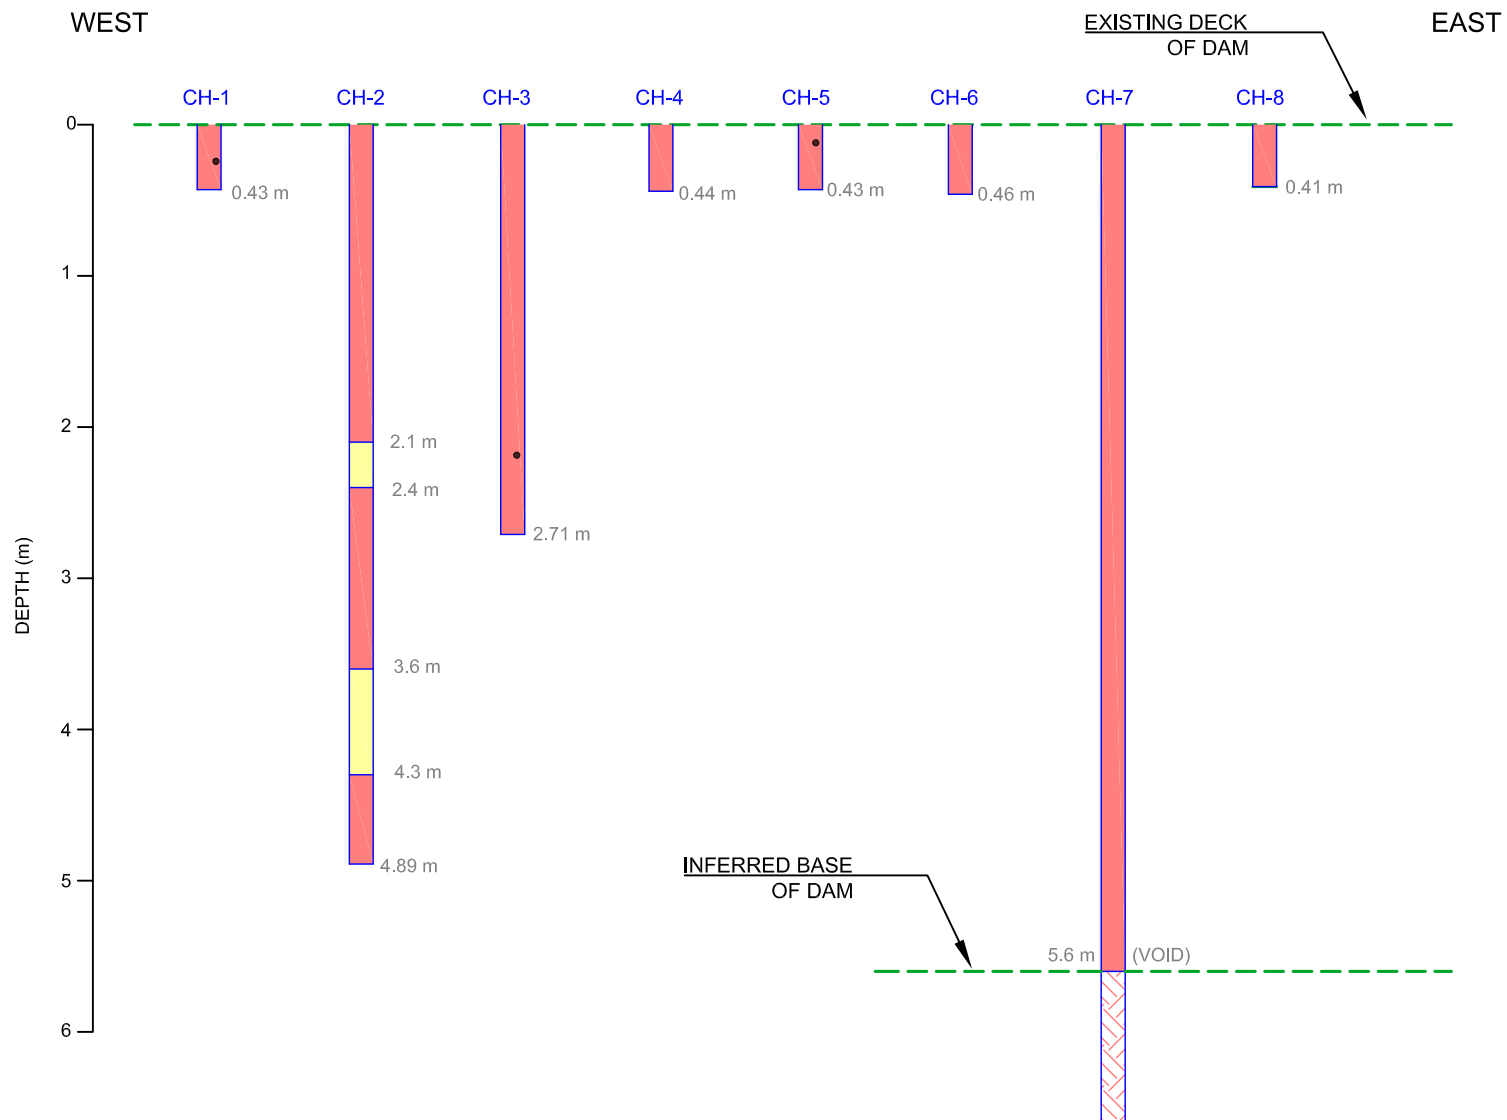
#### CROSS SECTION

Core hole CH-7 encountered the pier/apron interface at 4.78 m depth, and limestone bedrock at a depth of 5.56 m. A small void was encountered between the concrete and the bedrock, which may be a result of erosion or possibly a construction gap. The bedrock was core sampled for a length of 0.46 m after which the borehole was terminated. The limestone was slightly weathered and sound.
